# Fatigue Life of a NiCr-Coated Powder Metallurgy Disk Superalloy After Varied Processing and Exposures

*Timothy P. Gabb and James A. Nesbitt  
Glenn Research Center, Cleveland, Ohio*

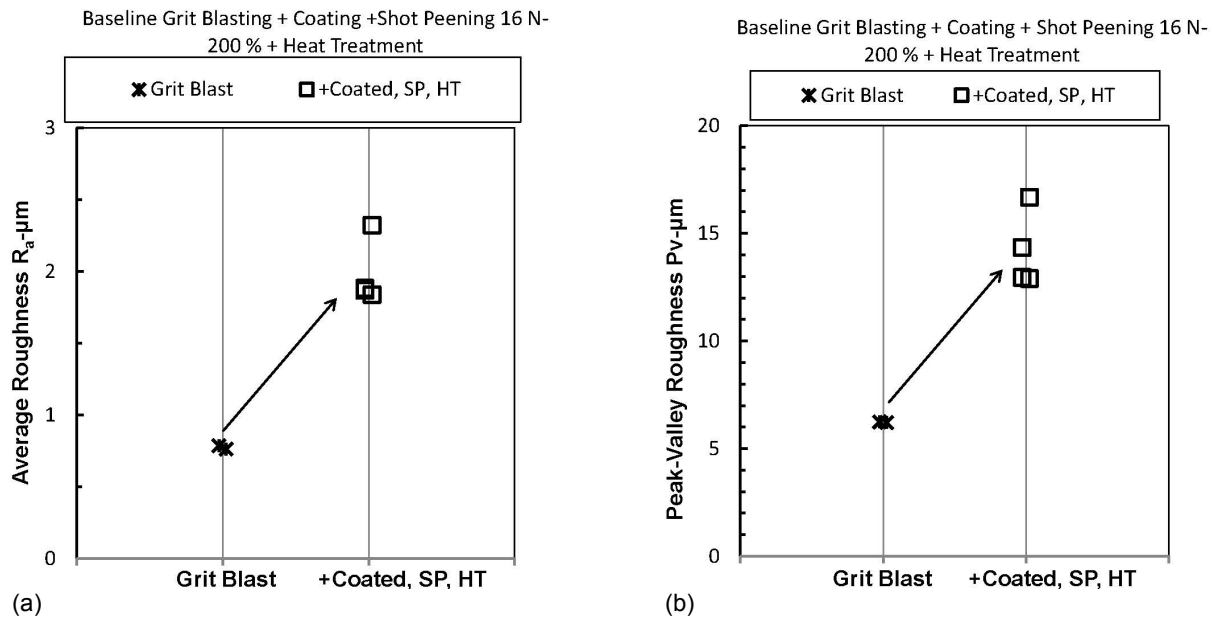
Figure 5.—Roughness after grit blasting, and after subsequent coating, shot peening, plus heat treatment. (a) Average roughness. (b) Peak-valley roughness. The hollow symbols are for coated specimens.

Uncoated specimen gage surfaces after grit blasting are shown in Figure 4(a). The grit blast surface had a finely textured, roughly scalloped appearance. An area fraction of 0.034 alumina grit particles up to 10 µm in diameter was embedded in the grit blast surface. Deposition of the coating gave a fine texture that was generally nodular, shown in Figure 4(b). More prominent nodules known as spits were also observed, sometimes produced during this coating process. The shot peened and heat treated surfaces were more fairly uniform, with the formerly grooved and nodular surface textures mostly eliminated, being replaced with an undulating, dimpled texture, as shown in Figure 4(c). Shot peening of the coated surface flattened the spits, and resulted in folds of metal ("laps") sometimes occurring at the edges of dimples created by the impact of shot. As shown in Figure 5, both measured average roughness and peak-valley roughness increased between grit blasting and the final coated, shot peened, and heat treated condition. While the coating had a mean thickness of 23.1 µm for the unexposed specimens, measurements of fracture surfaces adjacent to the failure initiation point indicated the coating thickness typically varied with a 95% confidence interval of 2.2 µm around the mean, due in part to the shot peening.

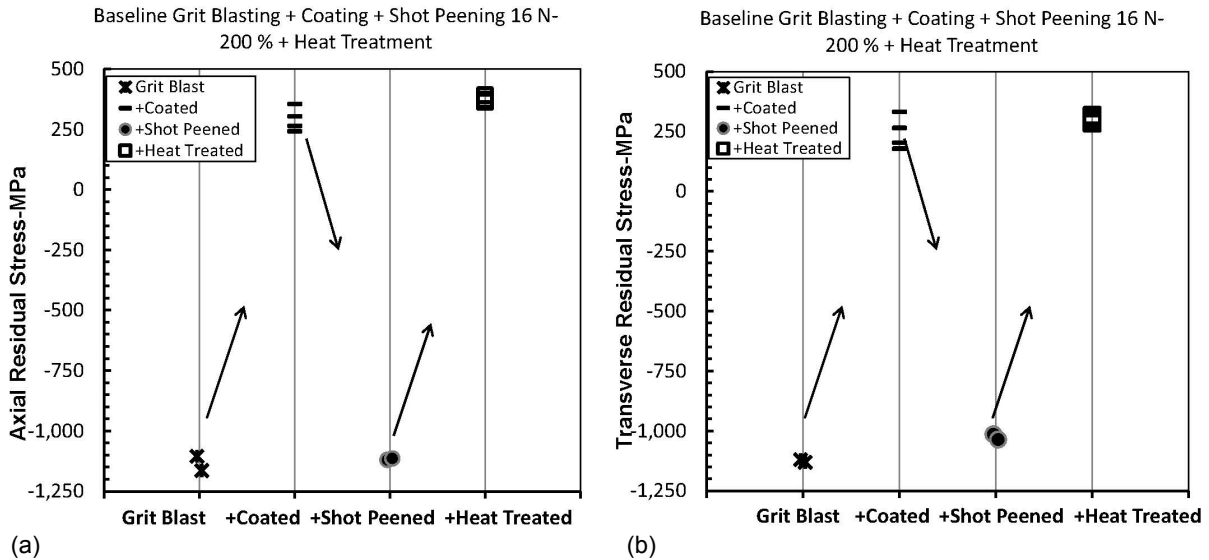
Figure 6.—Residual stresses measured at the surface after successive baseline processing steps. (a) Axial direction parallel to the fatigue load. (b) Transverse direction.

Residual stresses measured at the surfaces are shown in Figure 6. Residual stresses changed significantly for each processing step between grit blasting and final heat treatment. Uncoated grit blast surfaces had compressive residual stresses exceeding -1,100 MPa. But the applied coating had a low tensile residual stress near 250 MPa. Shot peening at 16 N-200% restored the compressive residual stress at the coated surface to initial grit blast levels. Yet, the final step of heat treatment at 760 °C for 8 h relaxed the compressive residual stresses at the coated surface, back to the low tensile levels previously measured as-coated. The generation of compressive residual stresses in the coating by shot peening has been described for MCrAlY coatings applied on superalloys in general by several processes (Ref. 20) and for NiCr coatings on disk superalloys (Ref. 21). The complete relaxation in the coating of these compressive stresses during subsequent heat treatment at the high temperature used in the present study had been previously observed for a Ni45CrY  $\gamma + \alpha$  phase coating applied on LSHR (Ref. 22). This response of such coatings appears to be related to their low stress relaxation resistance.

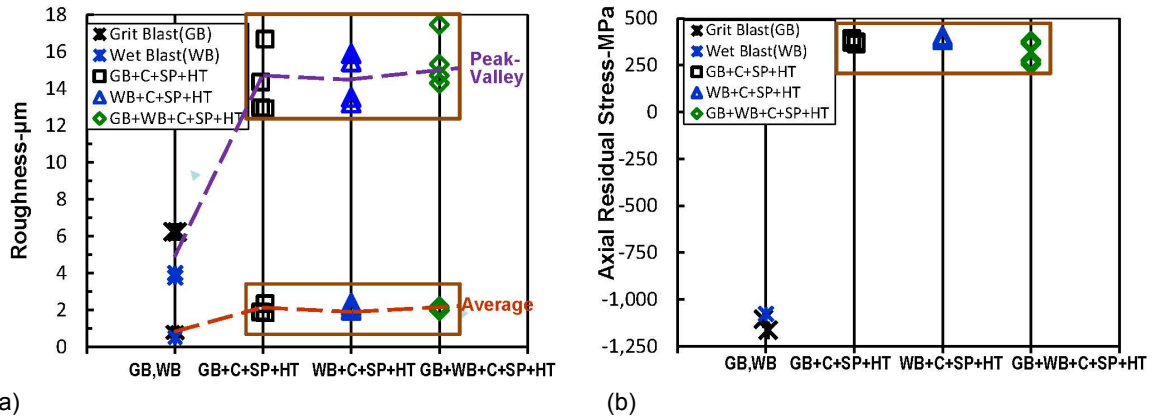
Figure 11.—Comparison of specimen surfaces'. (a) Roughness. (b) Axial residual stress for baseline grit blast and alternative wet blast pre-treatments: grit blast (GB); grit blast, coated, shot peened 16 N-200%, and heat treated (GB+C+SP+HT); wet blast (WB); wet blast, coated, shot peened 16 N-200%, and heat treated (WB+C+SP+HT).

measured for grit blasting. The wet blast surfaces also had a lower average roughness  $R_a$  of  $0.51 \mu\text{m}$  in comparison to  $0.77 \mu\text{m}$  for the baseline grit blast surfaces, shown in Figure 11(a). Yet, axial residual stresses measured on the blasted surfaces were comparable, as shown in Figure 11(b). Ultimately, the wet and grit blast specimen surfaces were indistinguishable, after coating, shot peening at 16 N-200%, and heat treatment at  $760^\circ\text{C}$  for 8 h, also compared in Figures 10 and 11. Surface appearance, average roughness, and axial residual stresses were not significantly affected by the alternate pre-treatment of wet blasting. Several other fatigue specimens were subjected to grit blasting followed by wet blasting, in search of additive effects. These “grit+wet blast” specimens also had appearance, roughness, and surface residual stress values indistinguishable from the above specimens, after coating, shot peening, and heat treatment.

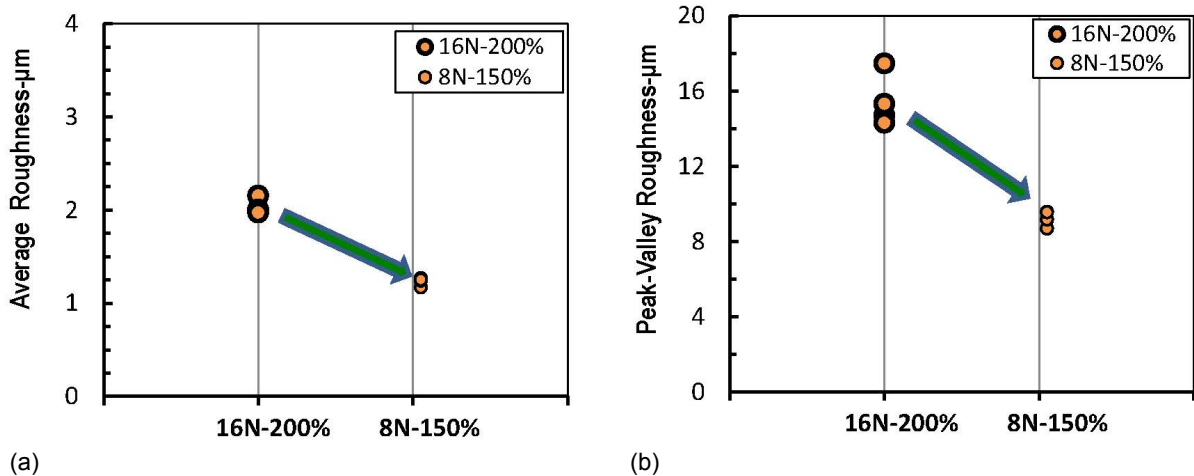
Figure 15.—Associated roughness measurements of coated specimens after different post-coating shot peening treatments, no subsequent oxidation plus corrosion. (a) Average roughness. (b) Peak-valley roughness.

The surface conditions are compared in Figure 14 for coated specimens shot peened at 8 N-150% versus the baseline 16 N-200%. These surfaces were generally similar in overall appearance, with an undulating, dimpled texture. Shot peening at 8 N-150% still produced dimples with laps. However, the lap heights and dimple depths were moderated in comparison to the baseline 16 N-200% condition. Average roughness and peak-valley roughness were each reduced about 40% for coated specimens given the alternative 8 N-150% shot peening conditions, as shown in Figure 15.

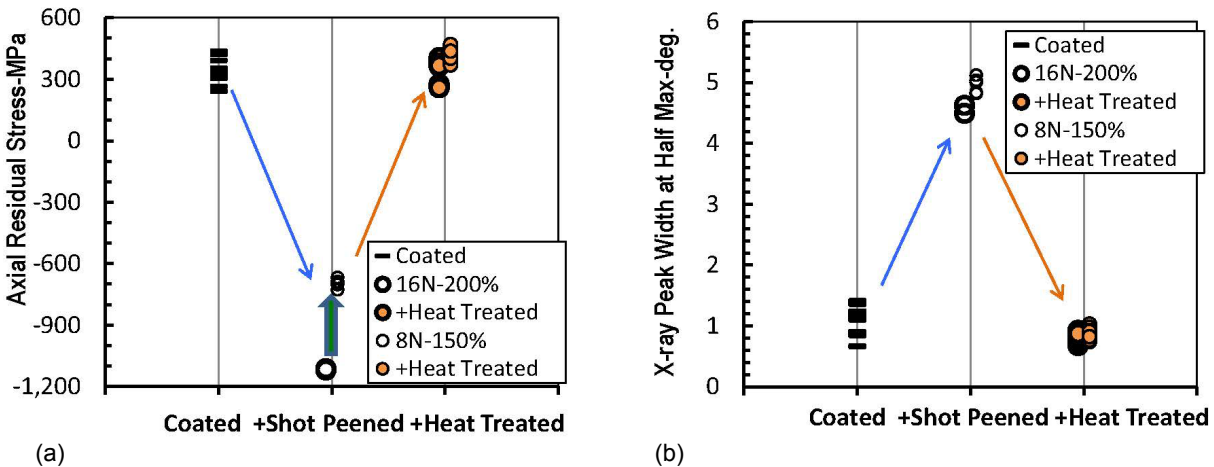
Figure 16.—Associated x-ray measurements of coated specimens after different post-coating shot peening conditions, no subsequent oxidation plus corrosion. (a) Axial residual stress, relaxed to low tensile values after heat treatment from either shot peening condition. (b) Peak width at half maximum intensity, indicating elimination of shot peening's cold work after heat treatment from either shot peening condition.

The axial residual stresses measured at the surface are compared in Figure 16. Shot peening at 8 N-150% gave a 35% lower magnitude of axial compressive residual stress on the coated surface, in comparison to the baseline 16 N-200% condition. The corresponding X-ray peak width has often been related to the plasticity (cold work) generated by shot peening (Refs. 14 and 18). This was therefore measured, and was curiously found to be slightly higher after 8 N-150% shot peening condition than for the baseline 16 N-200% condition. This implied slightly higher plasticity generated by shot peening at 8 N-150% than for 16 N-200%.

Nevertheless, final heat treatment at 760 °C for 8 h relaxed compressive surface residual stresses and corresponding peak width for both shot peening conditions to comparable levels at the coated surfaces, Figure 16. Heat treated coated specimens had modest tensile residual stresses of 350 to 450 MPa at the surface for both shot peening conditions. The generation of compressive residual stresses in the coating by shot peening has also been described for MCrAlY coatings applied by various processes (Ref. 20) and for NiCr coatings on superalloys (Ref. 21). Yet, evaluations of residual stress for a similar NiCrY coating with the baseline 16 N-200% shot peening and heat treatment indicated that significant compressive residual stresses of over  $-400$  MPa remained at depths of up to 150 µm in this superalloy beneath the coating (Ref. 22). Therefore, the overall mechanics of the residual stress response at the surface can be

Ranking these influences is more difficult, but can be aided by further considering the plasticity introduced by shot peening. Corresponding x-ray peak width was also greatly reduced by the heat treatment as shown in Figure 16. Peak width was reduced to actually equal that measured after only applying the coating. This implied the shot peening-induced plasticity had been largely eliminated by the heat treatment, through an enhanced recovery process occurring in the coating. Prior tensile stress relaxation tests of Nichrome specimens having a composition quite close to the coating indicated very low strength and accelerated stress relaxation of this alloy and coating (Ref. 22). So of the influences listed above, the impressive relaxation of compressive residual stresses in such NiCr coatings appears largely attributable to the low strength and an enhanced recovery – stress relaxation process in the coating at temperatures near 760 °C. The higher thermal contraction also previously measured (Ref. 22) for this alloy may then generate the low tensile stresses during cooling to room temperature, where residual stress measurements were conducted by x-ray diffraction.

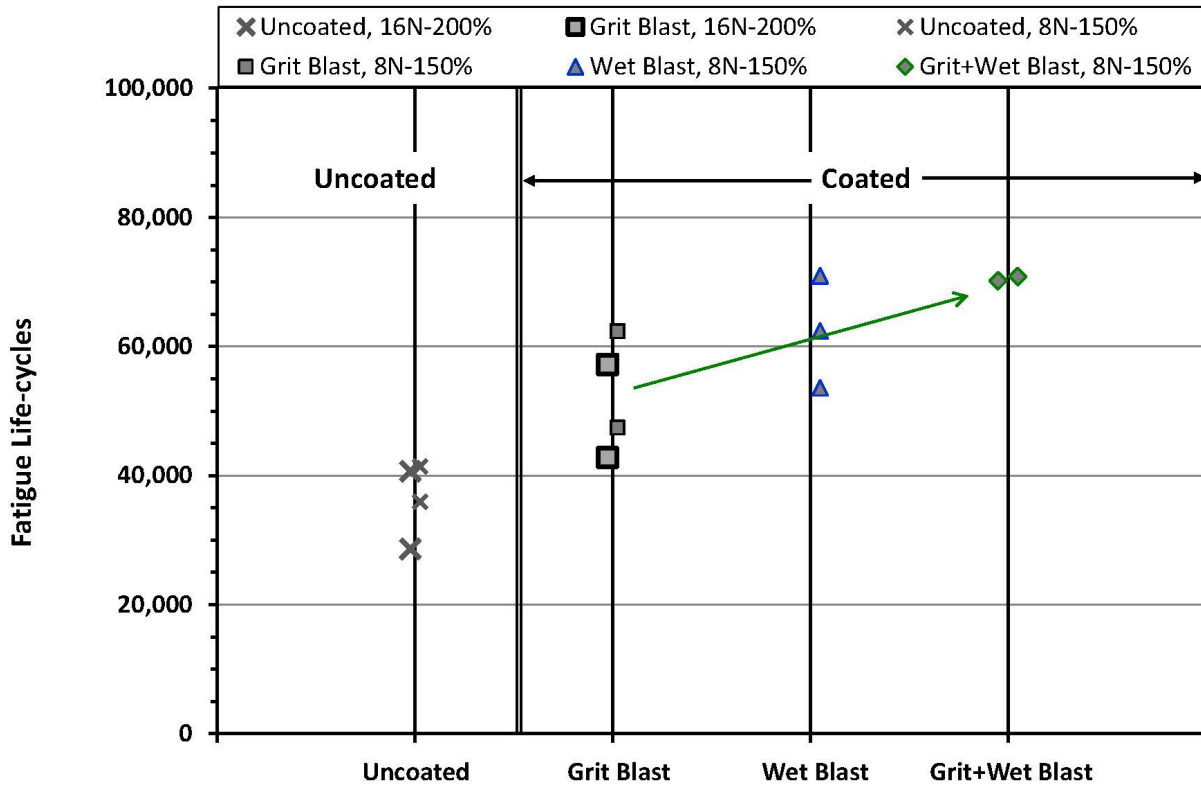
Figure 17.—Comparison of fatigue lives for alternative pre-coating and post-coating treatments, after oxidation plus corrosion. Larger symbols indicate baseline (16 N-200%) post-coat shot peen treatment, while smaller symbols indicate alternative (8 N-150%) post-coat shot peen treatment.

Fatigue lives are compared in Figure 17 after varied pre-treatments, coating, 8 N-150% shot peening, heat treatment, and finally the combined oxidation plus corrosion exposures at 760 °C. The alternative pre-coating and post-coating treatments gave modestly improved coated fatigue lives after subsequent oxidation plus corrosion. Nevertheless, the coating could still be considered successful with the alternative conditions, enabling twice the fatigue life of uncoated specimens after combined oxidation and hot corrosion. Specimens with a final wet blasting treatment before coating and shot peening at 8 N-150% performed most favorably.
