Detection of Damage during Quasi-Static Loading of a Single Stringer Panel using Passive Thermography and Acoustic Emission

The purpose of this paper is to describe the methodology of measuring damage onset and growth in a composite structure during quasi-static loading using passive thermography and acoustic emission. The early detection and measurement of damage progression is important to understand failure modes. A single stringer panel was subjected to quasi-static loading to induce deformation which resulted in the formation of damage between the stiffener flange and skin. The loading was stopped when damage growth was detected. Passive thermography and acoustic emission were used to detect damage in real-time as a function of the applied load. Of particular interest are the small transient thermographic signals resulting from damage formation which can be challenging to detect, as compared to the persistent passive thermography indications of cyclic fatigue loading. We describe a custom developed thermal inspection system for detection of composite damage during quasi-static loading. The thermal results are compared to a two-dimensional multi-layered thermal simulation base

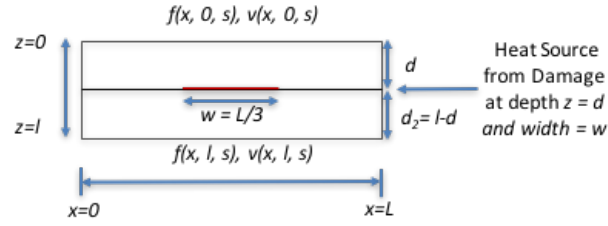
Figure 8: Configuration for two-dimensional model with embedded heat source.

generated is at the flaw location within the structure, as shown in Fig. 8. For static loading scenarios, the heat flux is produced during damage formation and has been observed to be instantaneous. A two-layer configuration with a finite lateral dimension is shown in Fig. 8 with no heat flow across the vertical edges at $x = 0$ and $x = L$.

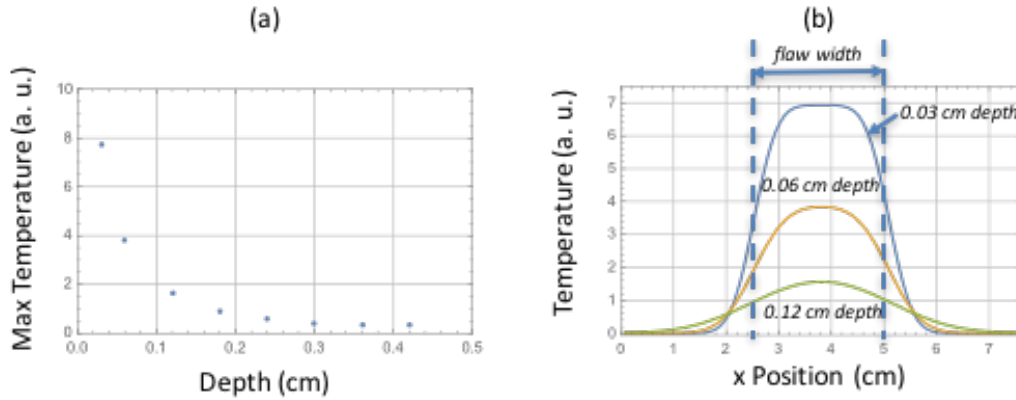
Figure 9: Temperature drop as a function of source depth and blurring of source edge for different depths.

Both a_j and a_m are equal to 1 if the index j (or m) = 0 or $N-1$ and 2 otherwise. The heat flux vector, $\mathbf{F}^s(s)$, is a vector representation of the heat generated during the formation of the flaw during loading at depth $z = d$ and is modeled as an impulse function. For each point, the inverse Laplace transform is calculated at a given time to give temperature as a function of x position. The inverse Laplace transform for the surface temperature, $V(0, s)$, is calculated using the Talbot inversion algorithm [18]. Typical results are shown in Figs. 9a, 9b, and 10 for maximum temperature as a function of flaw depth, blurring as a function of flaw depth for the maximum temperature and blurring as a function of time for a flaw depth of 0.24 cm respectively. For these plots, the values used were $\alpha_z = 0.00425 \text{ cm}^2/\text{sec}$, $\alpha_x = 0.0425 \text{ cm}^2/\text{sec}$, l (the slab thickness) = 0.46 cm, $K = 0.00883 \text{ W/cm/K}$, the $Flux = 1 \text{ Watt/cm}^2$, flaw width set from 2.5 to 5.0 cm, and L the slab width set to 7.6 cm. As can be seen from Fig. 9a, there is considerable temperature drop for sources that are deeper. This is especially problematic if one takes into account camera noise. Additionally, for deep sources, there is considerable blurring of the edges of the source as shown in Fig. 9b. There is also considerable blurring over time as shown in Fig. 10. This indicates that the earliest detectable thermal signal will give the best sizing of the defect.

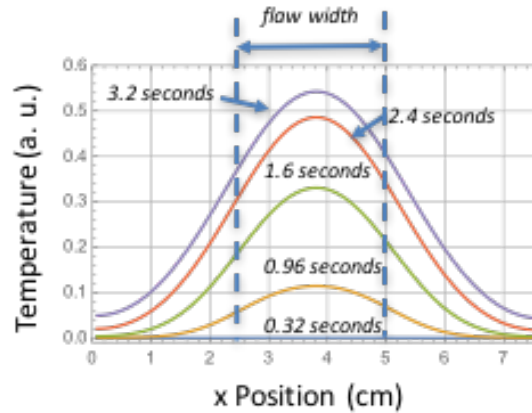
Figure 10: Temperature as a function of time for a flaw source buried 0.24cm.

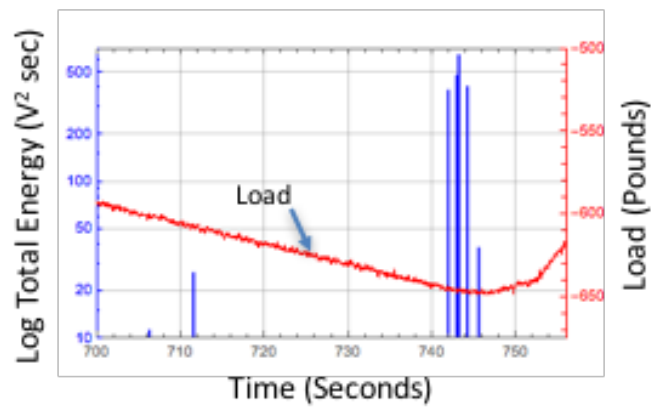
Figure 11: Quasi-static load profile with detected acoustic emission events.

Acoustic emission data were collected during each quasi-static load test. When a sufficient number of acoustic emission events clustered in a short period of time were detected, this represents rapid damage formation and the loading was stopped to characterize the damage. A typical load profile along with the detected acoustic emission events are shown in Fig. 11. The acoustic emission is sensitive to fiber breaks and matrix cracks and these events can produce heat. Shown in Fig. 12, are the corresponding processed thermal images. The thermal images show heating resulting from a small edge delamination growing along the edge of the stiffener flange. This is shown in the ultrasound results in Fig. 12. This is a successful capture of an early delamination formation that can be grown and characterized during subsequent load runs. The acoustic emission data was compared to thermal data by aligning the recorded load profiles from each system. The results are shown in Table 1, for
