NASA/TM—2019–220551

The Effect of Impact Damage Next to Holes on the Bearing Strength of Carbon Fiber Laminates

A.T. Nettles

Marshall Space Flight Center, Huntsville, Alabama

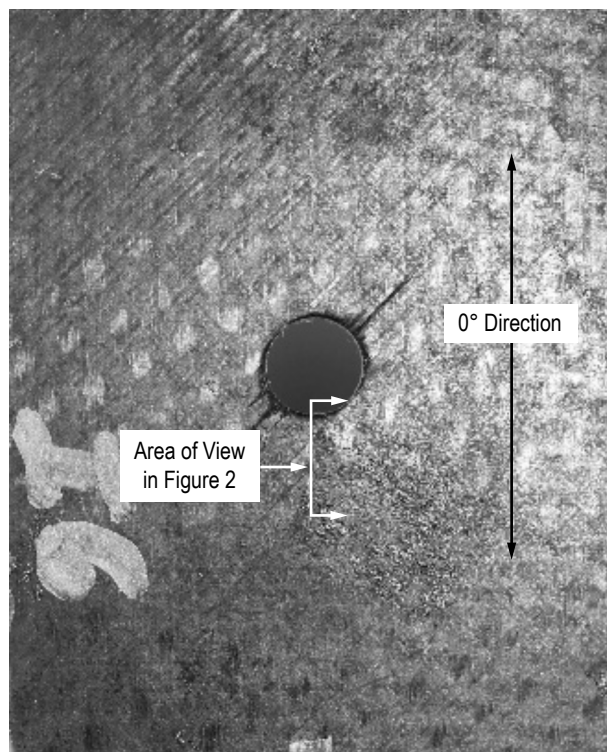
The good holes were made with a high quality 6-flute square diamond-coated end mill rotating at a fast speed and fed very slowly through the laminate. No backing plate was used. This quality hole was intended to mimic field drilling conditions where sometimes a backing plate cannot be used due to inaccessibility.

The visual appearance of the back side (drill bit exit side) of a typical hole is shown in figure 1.

Figure 1. Photograph of hole quality used in this study (view of drill bit exit side).

A cross-sectional photomicrograph of the hole quality is shown in figure 2. The specimen was sectioned through the center of the holes in the 0° direction (as shown in fig. 1). Only one edge of the hole is shown, since the other side had a similar appearance.

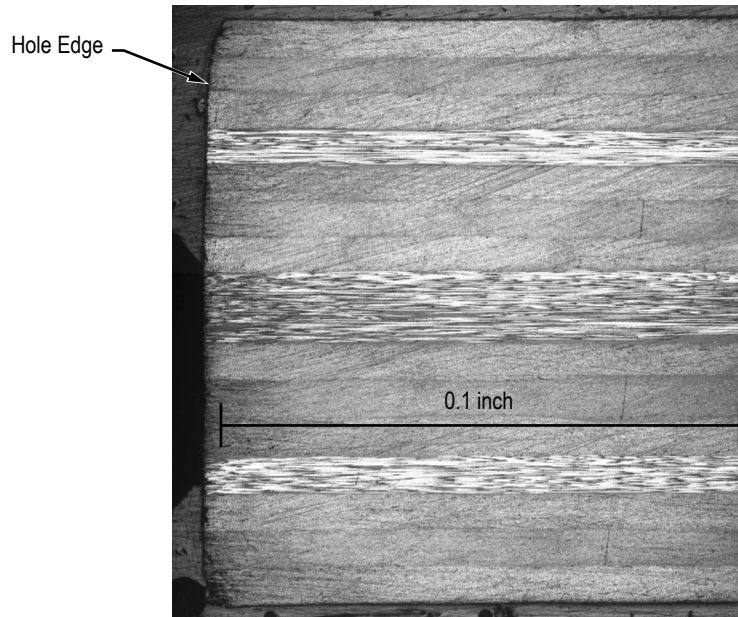
Figure 2. Cross-Sectional micrograph of the hole quality used in this study.

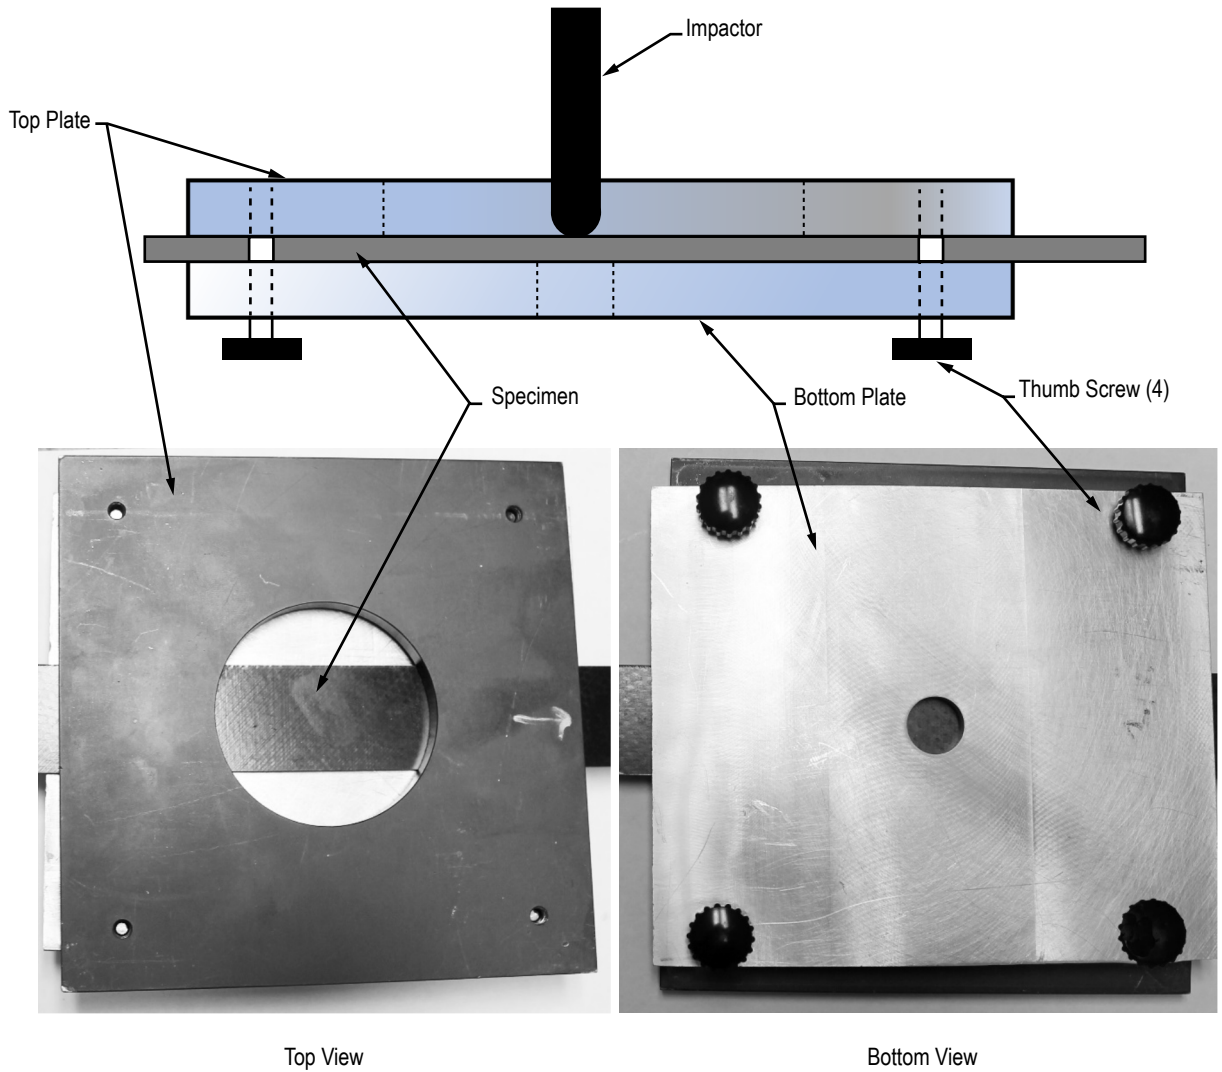
A drop weight instrumented impact tower was used to inflict damage to the specimens. The impactor had a diameter of 0.5 in, and the specimens were sandwiched between two steel plates with holes to allow the tup to pass through (top plate) and to allow some transverse flexing of the laminate (bottom plate), which would produce more damage than if the laminate rested on a rigid surface. A schematic and photograph of the specimen clamping apparatus is shown in figure 3.

Figure 3. Schematic and photographs of impact test set-up.

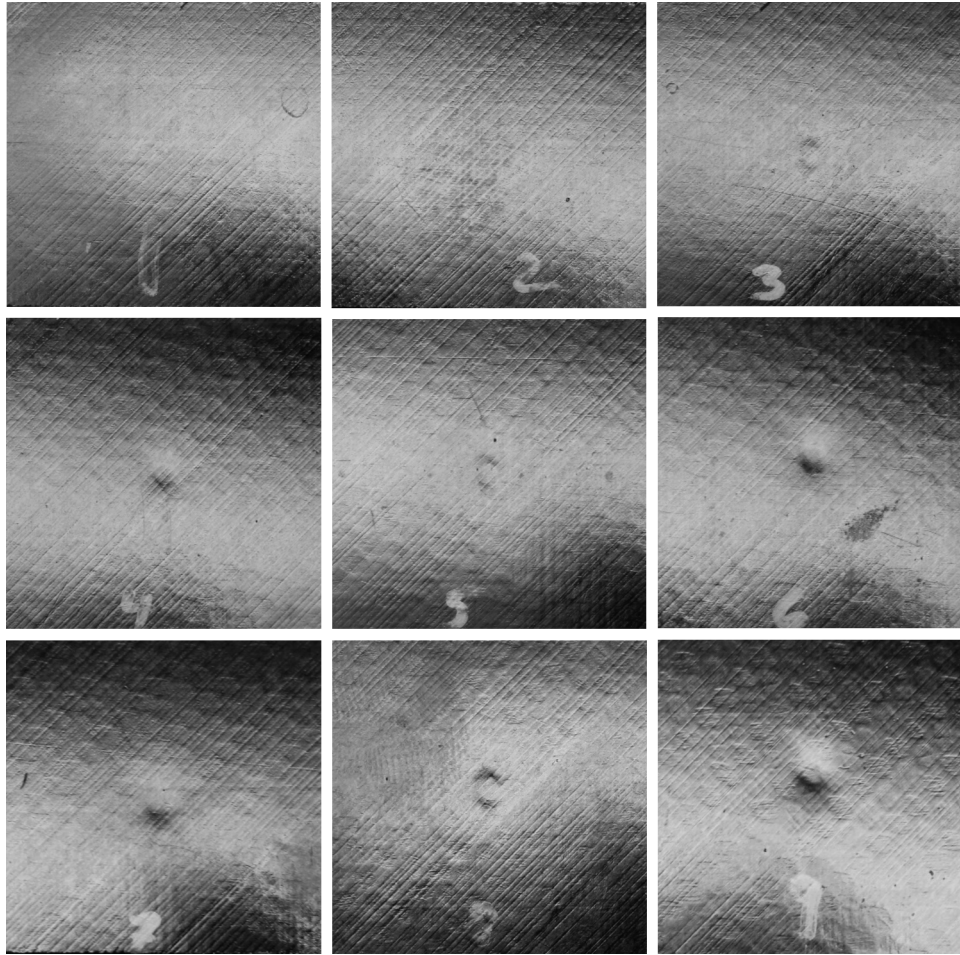
A series of impact tests with increasing impact energies were performed on laminates to assess the “Barely Visible Impact Detectability” (BVID) level. Table 1 lists the impacts, and figure 4 shows a close-up of the visual results.

Figure 4. Visual indications of the impacts in table 1.

As a conservative measure, hit number 8 (5.6 ft•lb) was used in the remainder of this study.

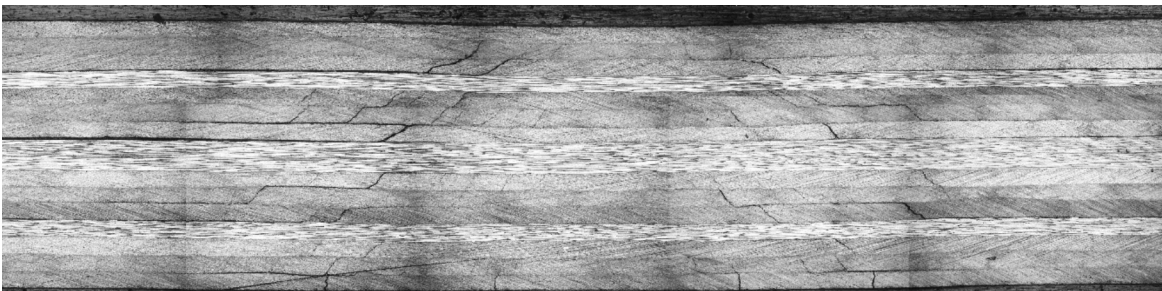
A cross-section through the damage zone of a specimen (without a hole) impacted at 5.6 ft•lb is shown in figure 5 to give the reader an indication of the amount of damage formed within the laminate due to an impact of that severity.

Figure 5. Cross-section of damage used in this study (without hole).

A cross-section of a specimen with impact damage near the hole is shown in figure 8 and, as expected, looks like figure 5 only with material removed due to the hole.

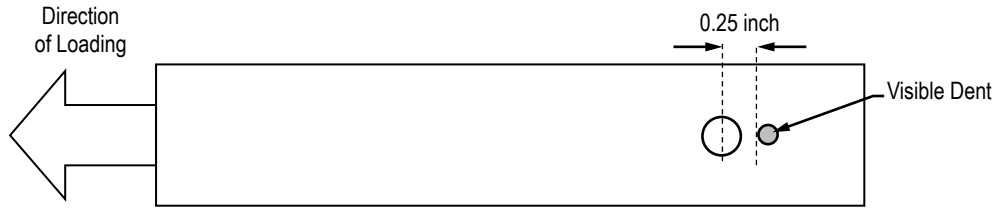
The first set of tests consisted of imparting impact damage and then drilling a hole 0.25 in away from the top section of the visible impact dent. The alignment of the hole and impact damage was such that a worst case scenario was represented. This would occur if the impact damage was below the loaded hole, since the material below the hole carries all of the bearing load. This is shown schematically in figure 6. A photograph of a hole near impact damage is shown in figure 7.

Figure 6. Schematic of hole/impact damage locations on specimens.

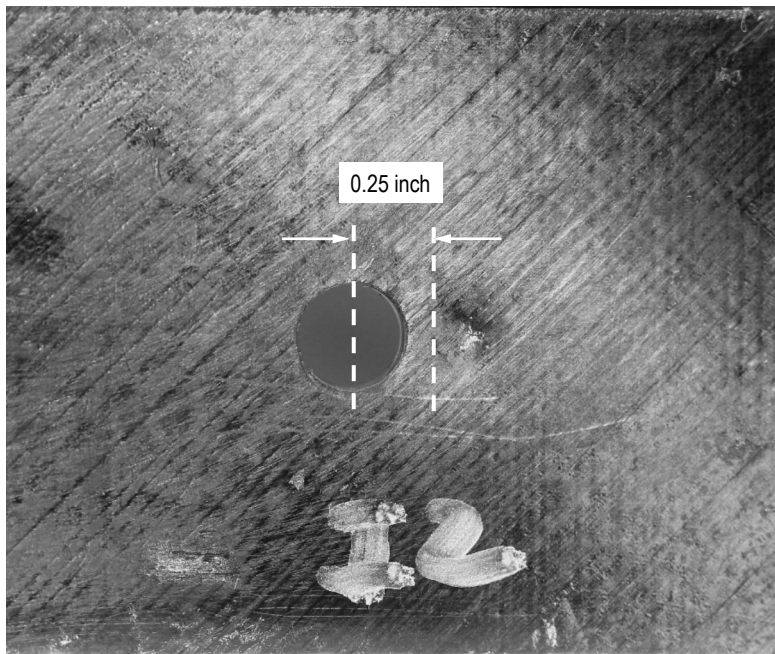
Figure 7. Photograph of hole/impact damage locations on specimens.

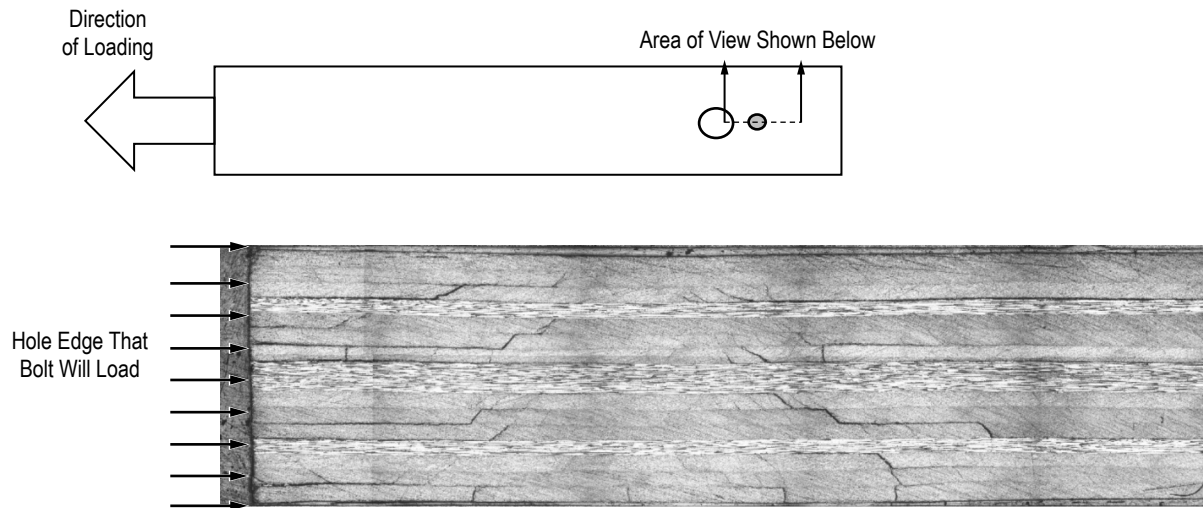
Figure 8. Cross-section of damage (with hole).

As can be seen, there is significant delamination at the hole edge due to the impact damage which looks somewhat like the ‘bad’ quality drilled holes in reference 1, though not quite as severely damaged.

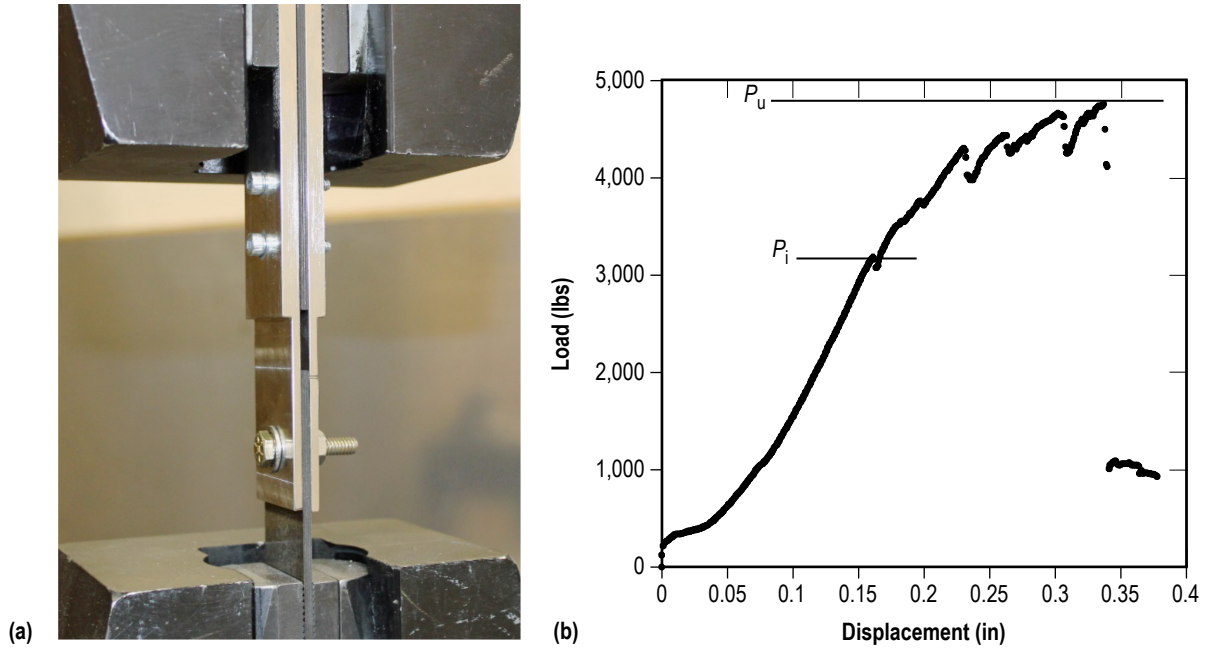
The bearing test used was patterned after ASTM D5961 Procedure A, double shear in tension.⁴ The holes in the specimen measured $0.245 +0.001/-0.000$, and the bolt diameter measured $0.245 +0.000/-0.001$, giving a light interference fit. The bolts were torqued at 25 in•lb as suggested by reference 4. A photograph of a specimen undergoing a bearing test and a typical load-displacement plot are shown in figure 9. It should be noted that the displacement values presented in this study are crosshead displacement and do not represent the true elongation of the hole. The displacement values presented are not used in this study in any calculations, thus a more precise measurement of hole elongation was not attempted. This study focused on two areas of the load-displacement curve: 1) the initial load drop (denoted as P_i), which may be of interest to applications in which small displacements of the bolted part may be critical, and 2) the ultimate load (denoted as P_u), which is of interest if the goal of the bolted joint is to simply have the part not fall off the vehicle. In this study, the ‘initial load drop’ was defined to be at least 1% of the load at which the drop began.

Figure 9. Photograph of (a) bearing test used in this study with (b) typical load-displacement curve

The two values used for bearing strength are shown on the load-displacement plot in figure 9. Both of these values will be reported throughout this manuscript for completeness.

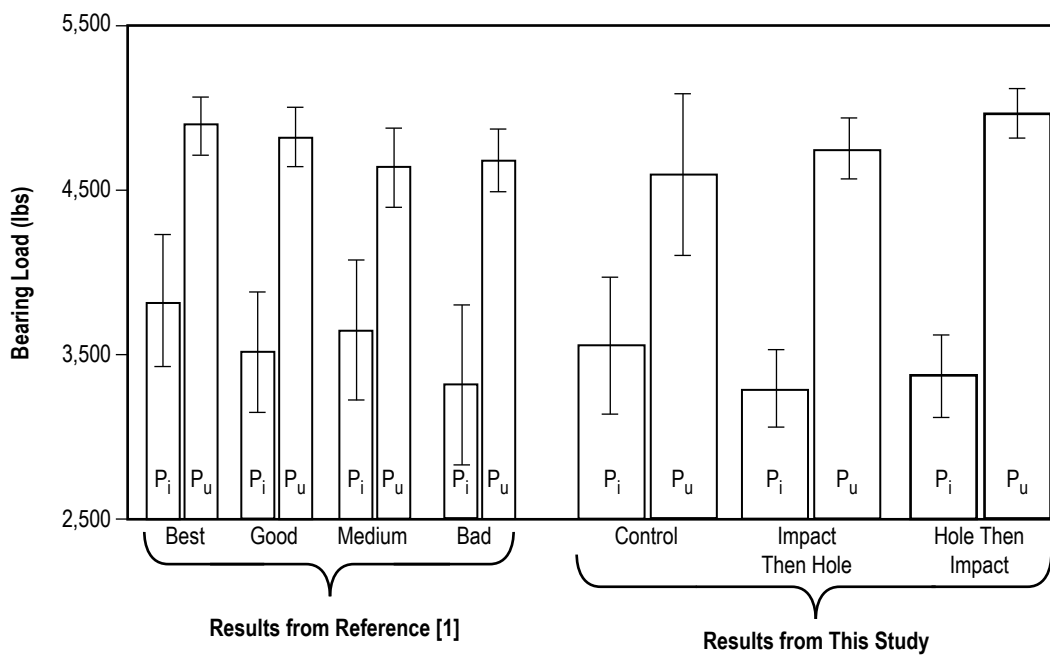
From the data obtained in this study, it is evident that impact damage near a hole will decrease the initial load drop of bearing strength but have no effect on the ultimate bearing strength. These results are similar to those of ‘poorly’ drilled holes in which the load at initial drop was slightly decreased due to poor hole quality, but the ultimate bearing strength was unaffected. The results are summarized graphically in figure 10.

Figure 10. Bar graph summary of results from this study and those from reference 1.
