# **Repair of Sandwich Structure in Support of the Payload Adapter Fitting (PAF) Part II: Severe Damage Repair**

*A.T. Nettles, W.E. Guin, J.R. Jackson  
Marshall Space Flight Center, Huntsville, Alabama*

As part of a program examining a Payload Adaptor Fitting (PAF) for NASA's Space Launch System (SLS), a repair study of impact damage and misdrilled holes in composite sandwich structure was undertaken.<sup>1</sup> In that study, it was shown that small holes and barely visible impact damage (BVID) could be repaired and all the measured undamaged in-plane compression strength recovered without removing the damaged material using a simple patch repair. It was noted that for more severe damage, either larger patches or removal of damage (or both) may be necessary to regain all of the measured undamaged compression strength. This Technical Memorandum (TM) presents the results of an experimental investigation into repair of more severely damaged sandwich structure than what was studied in reference 1.

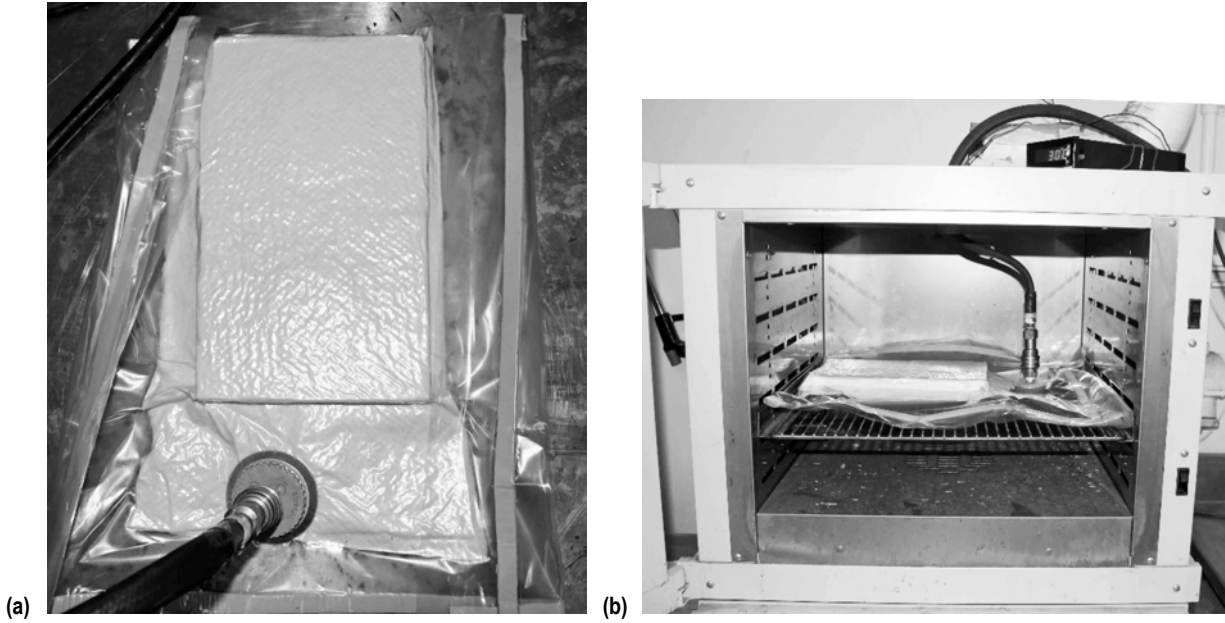
Figure 8. Photographs showing vacuum bagged: (a) repaired specimen and (b) specimen in oven to be cured.

Since in an earlier study<sup>1</sup> it was found that the average compression strength measured for undamaged specimens could be regained for small impact damage without removing the damage, the first attempts at repair of large damage were attempted without removing the damage. The damage was filled as much as possible with epoxy paste adhesive and then sanded smooth to give the patch a flat surface to adhere to. This was found necessary in reference 1 in order to avoid the patch draping into the damage during cure. The patches in this study were larger than those used in reference 1 and had the same layup as the parent laminate ( $[45/90/-45/0]_S$ ). The unidirectional pre-preg used to make the patches was an out-of-autoclave IM7/5320-1 carbon/epoxy which has about the same compression modulus and strength as the parent material (IM7/8552-1) since the same fiber is used. FM 209-1M film adhesive was used between the patches and the specimens to aid in adhesion of the patch to the specimen. The plies of the patches were made successively smaller by 0.25 inch per ply to minimize edge effects. The patches were circular with an outermost diameter of 4 inches (innermost diameter of 2.5 inches). The two centermost  $0^\circ$  plies were both the same size (3.25 inches). A schematic of this repair technique is shown in figure 7. The patches were placed at the center of the specimen over the filled damage area and the specimen was then vacuum bagged and placed in a programmable oven for cure of the patch (figure 8). The results of four specimens repaired as shown schematically in figure 7 are presented in table 3.
