# LCF Life of NiCr-Y Coated Disk Alloys After Shot Peening, Oxidation and Hot Corrosion

*James A. Nesbitt, Robert A. Miller, Timothy P. Gabb, and Susan L. Draper  
Glenn Research Center, Cleveland, Ohio*

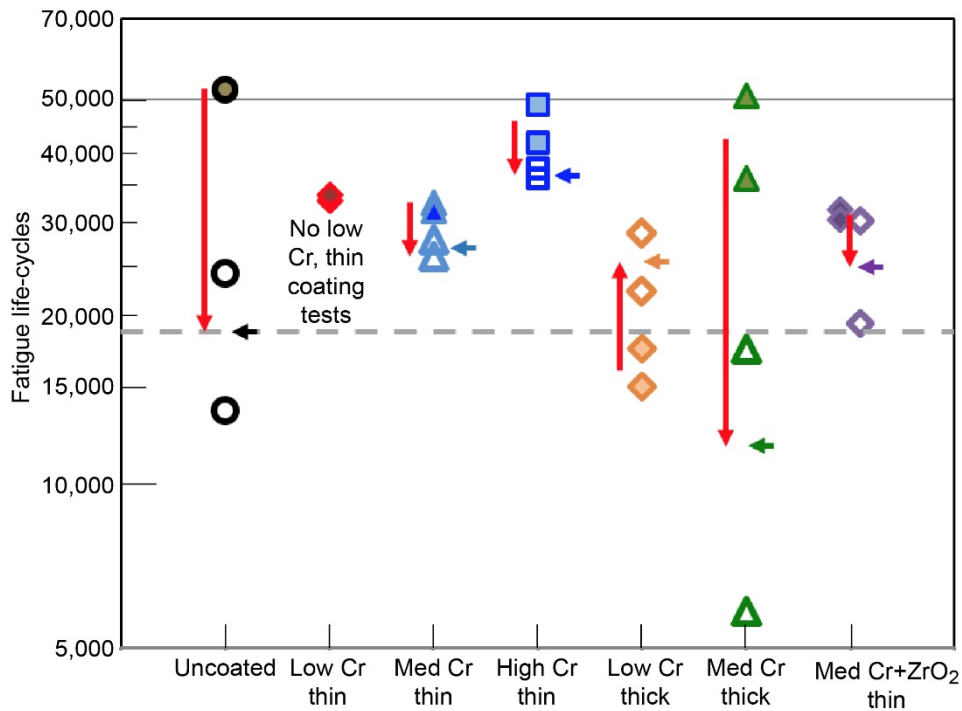
Figure 24.—LCF life for each of the coated samples showing the effect of the oxidation and hot corrosion exposures. Filled symbols show the LCF lives after shot peening and low PO<sub>2</sub> anneal. Open symbols show the LCF life after the oxidation and hot corrosion exposures. The red arrows indicate the approximate change in the LCF life. No samples of the *Low Cr, Thin* coated bars were available for testing. The results for uncoated bars are shown to the left. The dashed gray line gives the average life of the two uncoated samples. The short horizontal arrows give the average life of the two oxidized and hot corroded coated and uncoated replicate specimens. Note the logarithmic scale.

After the oxidation plus hot corrosion exposures and ultrasonic washing, the specimens were LCF tested at 760 °C as previously described. The LCF lives after oxidation and hot corrosion are compared with that prior to the environmental exposures in Figure 24. The red arrows indicated the change in life with the addition of the 500 h oxidation and 50 h hot corrosion exposures. As expected, most of the lives decreased with the exception of the *Med Cr, Thin* coating which, surprisingly, showed an increase in life. The largest decrease in life was for the *Med Cr, Thick* coating which was known to have a poor bond with the substrate. Not surprisingly, the uncoated specimens also showed a significant decrease in life with the environmental exposures. The LCF lives for each specimen after oxidation and hot corrosion exposures are also tabulated in Appendix A.

The benefit of a coating for turbine disks can only be assessed by comparing the LCF lives of coated and uncoated specimens after an appropriate environmental exposure. The average life of the two uncoated specimens after oxidation and hot corrosion attack, shown by the dashed gray line and short black horizontal arrow in Figure 24, was 18,800 cycles. The average life with the two **High Cr, Thin** coating was 36,501 cycles, almost double (1.94X) the average life of the uncoated specimens. Not surprisingly, the coating with the poor bond to the substrate (**Med Cr, Thick**) performed worse after environmental exposures than the uncoated specimens. The other three coatings (**Med Cr, Thin; Low Cr, Thick; Med Cr+ZrO<sub>2</sub>, Thin**) all gave average lives better than the uncoated specimens (26,745, 25,423, and 24,714 cycles, respectively) but with only 32 to 42 percent improvement. It should also be noted that although the surface of the coating was sometimes exposed after the hot corrosion attack, no pits were observed in any coating. Hence, for the environmental and LCF conditions used in this study, all of the coatings, with the exception of the poorly bonded **Med Cr, Thick** coating, were able to provide some protection with average lives between 1.3X to nearly 2X that of the uncoated specimens.
