Effectiveness of Surface Treatment Techniques for Composite Bonding with Different Contamination Levels

Xiaomei Fang¹, Gurbinder S. Sarao², Wenping Zhao³, Daniel G. Goberman³, and John W. Connell⁴

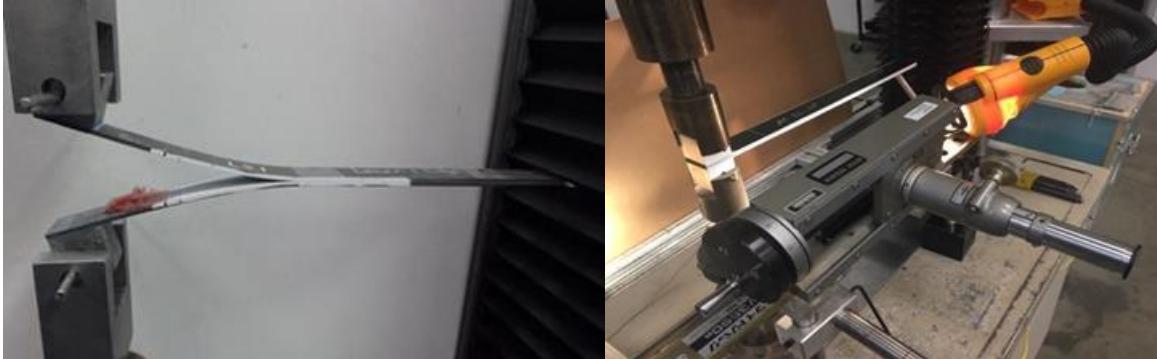
Mechanical testing: DCB panels were water jet cut into 1" wide coupons. Each coupon was pre-cracked by a 1" wide wedge. The coupon edges were painted white for the observation of crack propagation. The DCB tests were performed similar to ASTM D5528, as shown in Figure 3. Three to five coupons were measured for each panel. Fracture toughness of adhesive bond ($G_{\text{lc avg}}$) was determined by equation (1) as follows.

Figure 3. Double cantilever beam testing
