Ultrasonic Lamb wave inspection of composite defects

Zhaoyun Ma, Lingyu Yu

Department of Mechanical Engineering, University of South Carolina

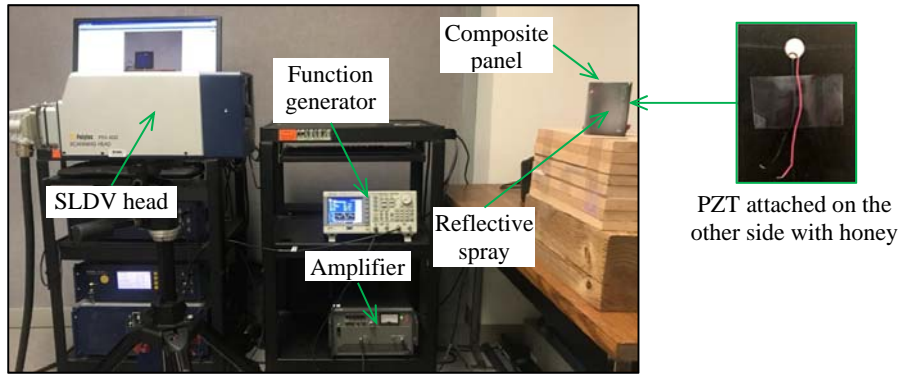
The overall laboratory experimental setup of the PZT-SLDV system is illustrated in Figure 1. A Tektronix AFG3022C arbitrary waveform generator is used to excite the selected excitation signal to the actuator PZT. Through in-plane piezoelectric coupling, guided waves are excited in the testing plates, a.k.a. Lamb waves. To improve the signal strength and quality, a bipolar amplifier (NF HSA 4014) is employed to magnify the excitation signal strength. For the sensing part, the SLDV head is placed normal to the specimen surface so that only the out-of-plane surface particle velocity will be measured in the predefined scanning line or area.

Figure 1 Nonintrusive PZT-SLDV Lamb wave inspection system experimental setup

The PZT-SLDV Lamb wave inspection system is implemented to inspect the target composite panels. The system employs contact type PZT as actuator to excite Lamb waves in the testing plate [5]. Traditionally the PZT is bonded on the surface of specimen using adhesive, and it can generate Lamb waves by coupling its in-plane motion with the structure through the adhesive layer [1]. For the Lamb wave sensing and visualization, noncontact, rapid and high-spatial-resolution SLDV is employed. SLDV is capable of scanning a predefined area by directing the laser beam to multiple points. Displacement or velocity of the particle motion is measured along the laser beam based on the Doppler effect. However, reflective tape is generally attached on the specimen surface for light reflection enhancement, especially for composite material with less reflective surface properties. Removing the PZT or the tape are time and labor consuming and will likely modify the condition of the sample surface. Hence, in the subject inspection completely non-invasive PZT-SLDV installation and setup are implemented, using honey as couplant for PZT actuation and wipe-off reflective spray for SLDV signal enhancement.
