# **An Investigation On The Use Of A Laser Ablation Treatment On Metallic Surfaces And The Influence Of Temperature On Fracture Toughness Of Hybrid Co-cured Metal-pmc Interfaces**

John Connell and Frank Palmieri

**Baekeland Symposium**

Guildford, UK, Aug. 30-Sept. 1, 2016

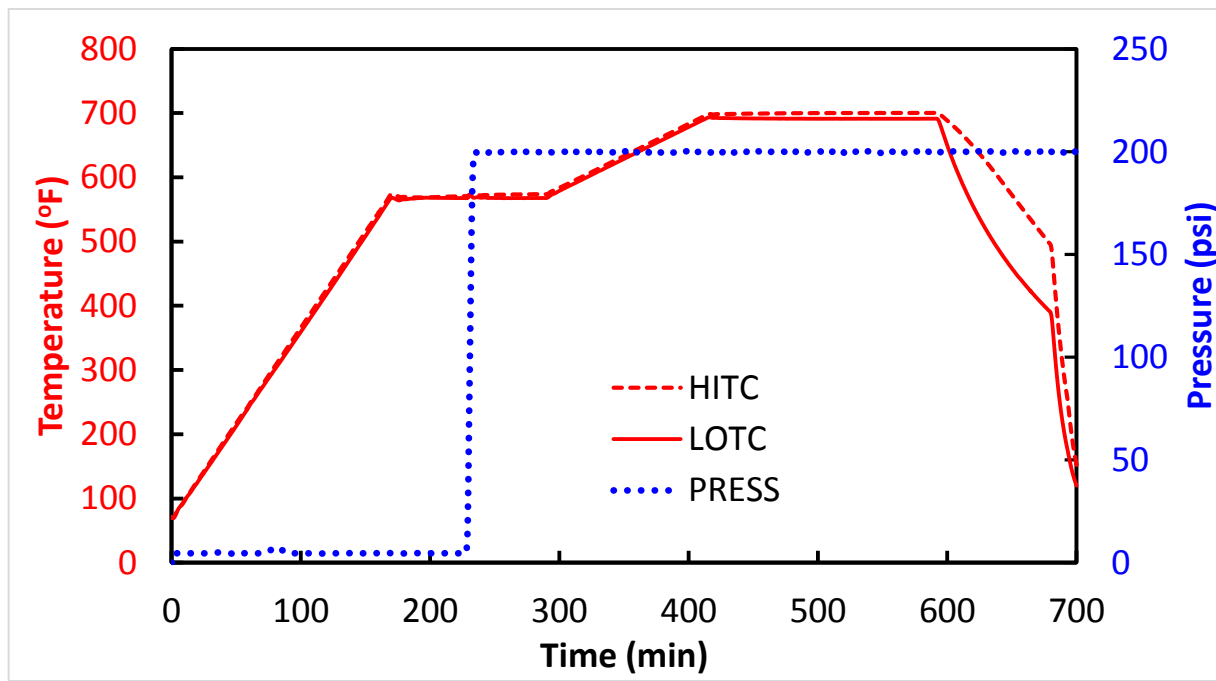
T650/AFR-PE-4 curing cycle

- Ti and Ni/Ti foil (127  $\mu\text{m}$  thick) was laser ablated on both sides
- After hydrolysis of the sol-gel solution (either **1 hour** or **16 hours**), the solution was sprayed on both sides of the laser ablated foil, dried at RT in air for 1 hour, then cured at 110°C and 220°C each for 30 min
- Panel preform was vacuum-bagged over night
- Curing was done in a Wabash vacuum press (12 hours run)

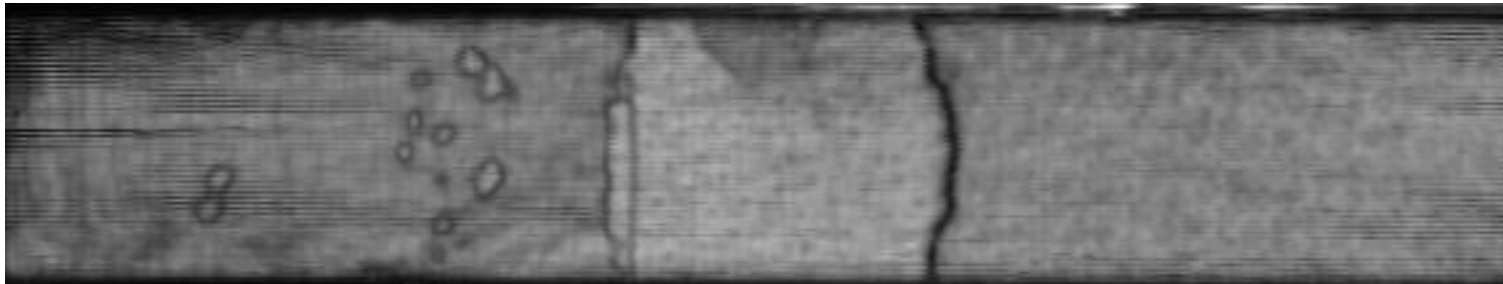
Monitor delamination growth with ultrasonic scanning

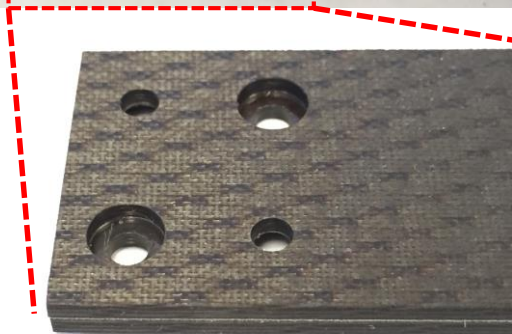
Hinges are mechanically attached to DCB using screws to facilitate high temperature testing

Top view of drilled DCB specimens

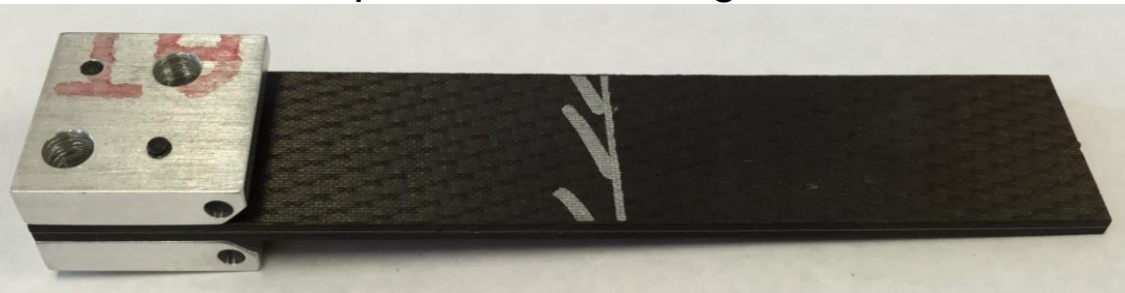
DCB specimen with hinges attached

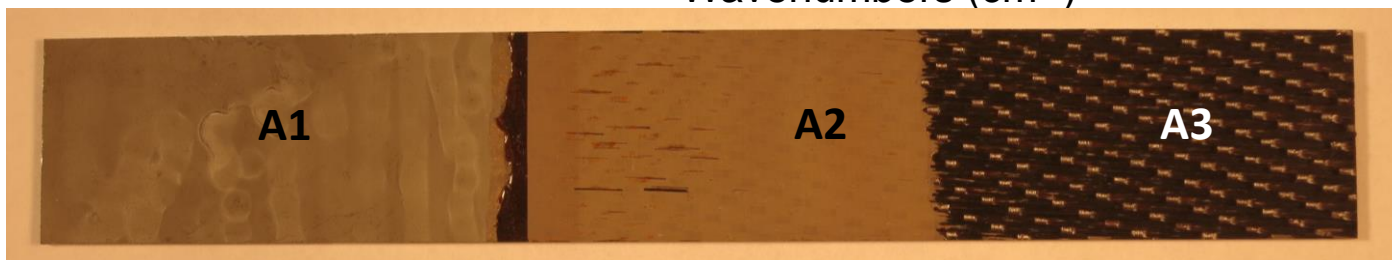
# FTIR Spectra

Ti side of Sample 17 (4-ENF test crack on tension side)

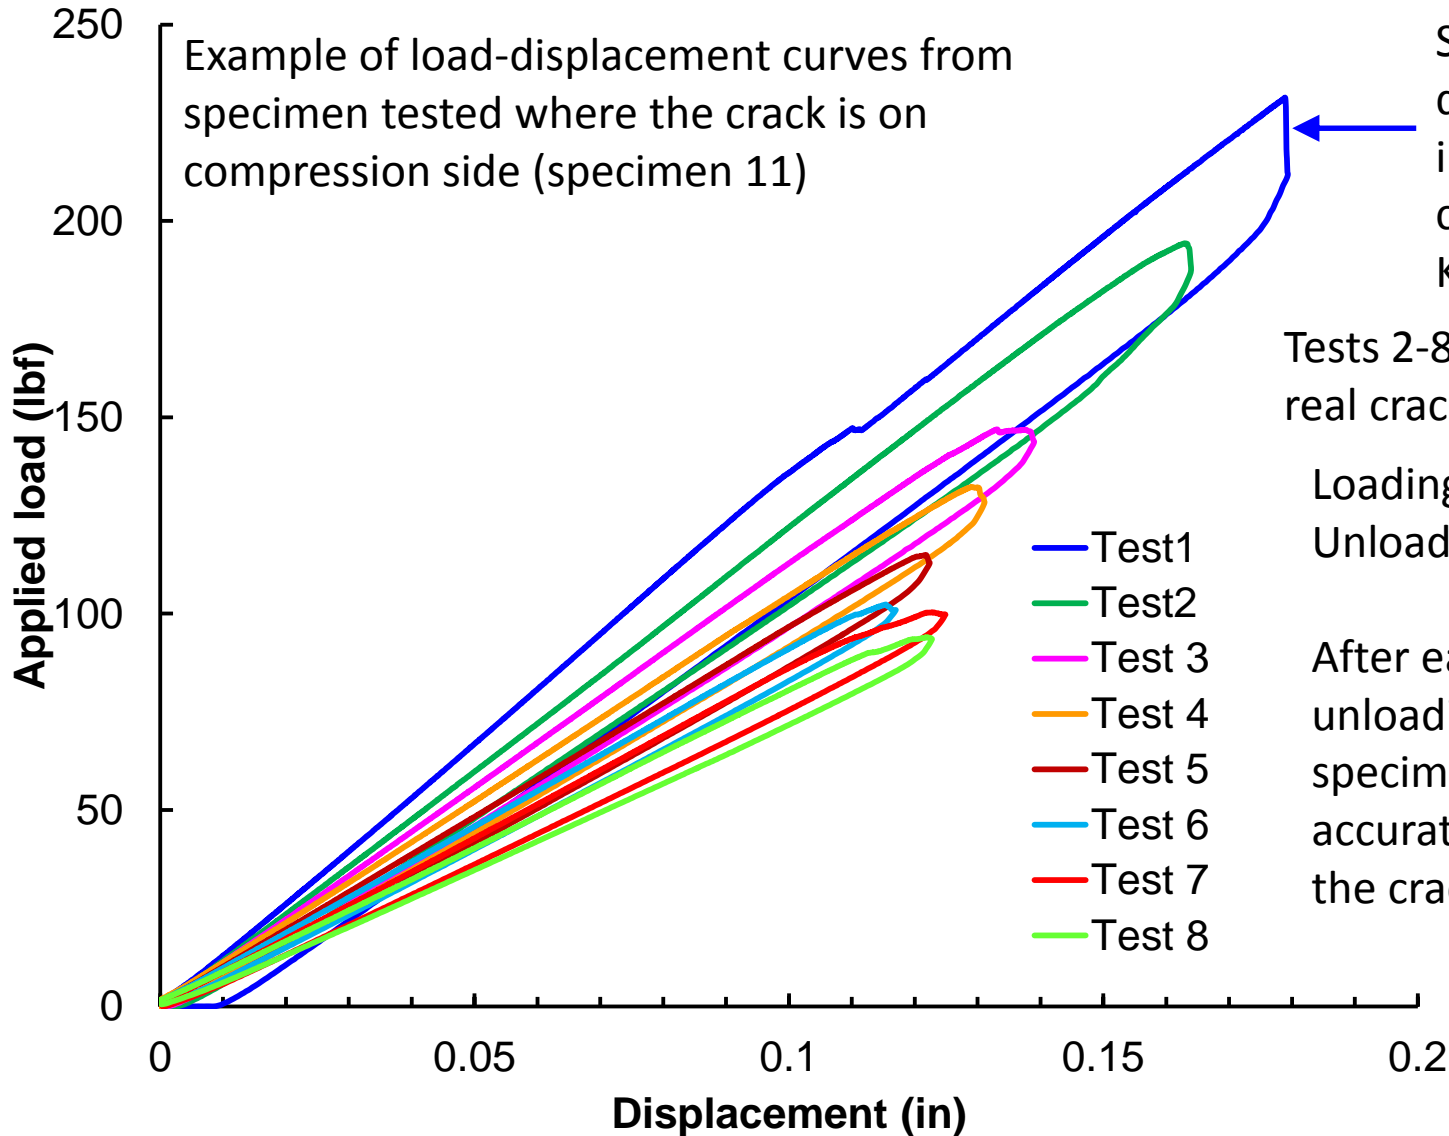
# Load-Displacement Plots

Sudden (sharp) load drop during Test 1 indicates unstable crack growth from Kapton insert.

Tests 2-8: crack growth from real crack front is stable.

After each test (1 loading-unloading cycle), the specimen is UT scanned for accurate measurement of the crack length.

- Saw-tooth behavior is observed from tests at 25 °C, 150 °C and 250 °C, indicating cohesive failure.
- At 315 °C, the failure mode is adhesive.

- Saw-tooth behavior is observed from tests at 25 °C and 150 °C. This shows unstable crack growth (growth-arrest) in the composite region, indicating cohesive failure at the interface.
- Smooth load-displacement curve is obtained from test at 250 °C. This shows stable crack growth near the Ti surface, indicating weak interface or adhesive failure.
