# Vorago RH-OBC-1

## Single Event Effect Characterization Test Report

Report Date: August 6, 2020

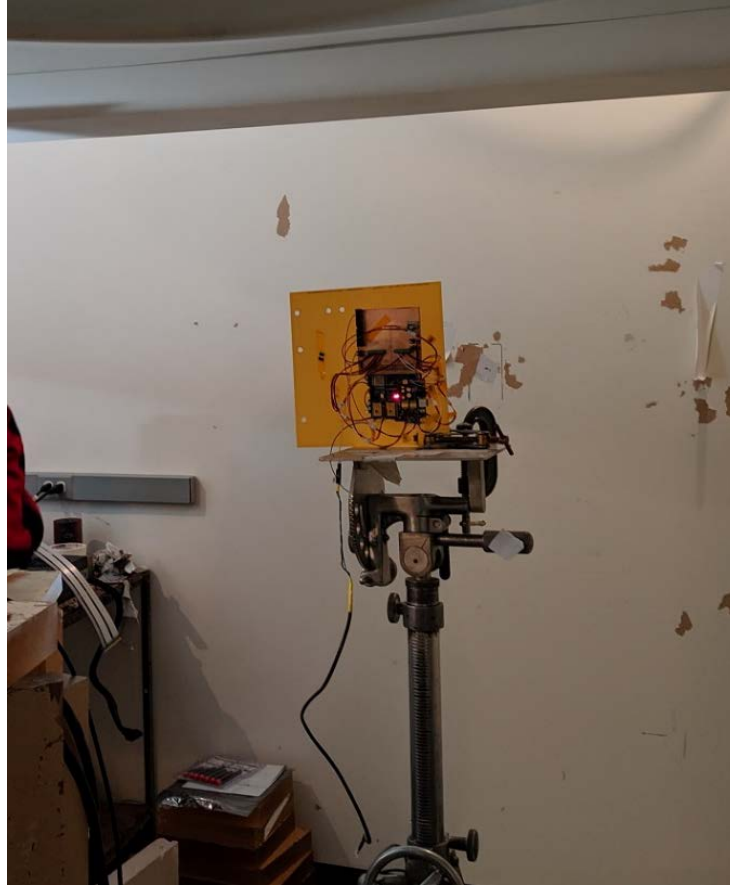
**Figure 3: Test board in direct beam line (see laser dot) inside the irradiation cave**
