HIGH TEMPERATURE SOLID PARTICLE EROSION IN A MELT-INFILTRATED SiC/SiC CERAMIC MATRIX COMPOSITE

Michael J. Presby

NASA Glenn Research Center, Cleveland OH 44135
Email: michael.presby@nasa.gov

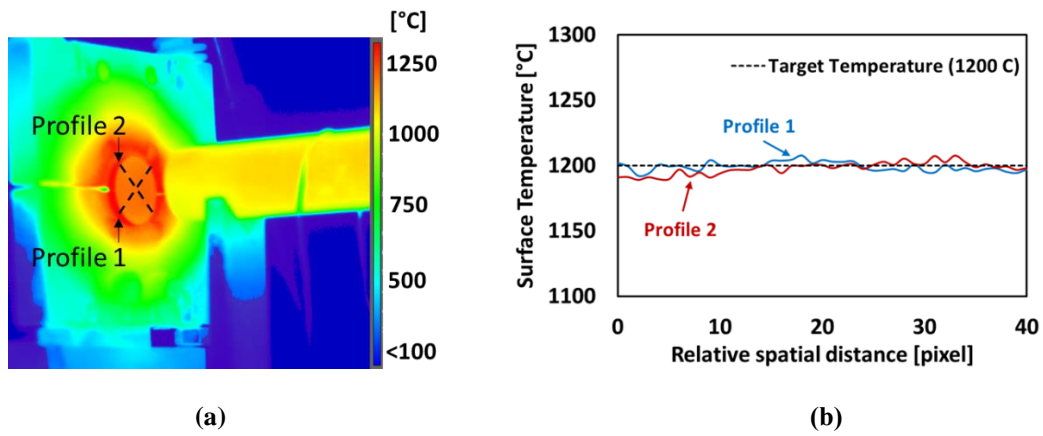
Figure 2. Surface temperature distribution as measured using a FLIR A655sc. (a) Thermal image of sample heated to 1,200 °C. (b) Temperature profiles measured across the sample as shown in (a).

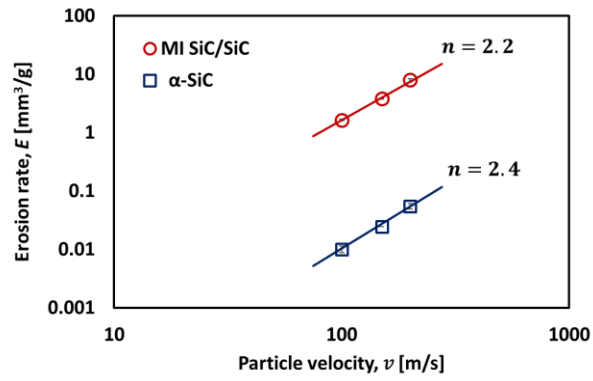
Figure 5. Steady-state erosion rate as a function of particle velocity for the MI SiC/SiC and α -SiC at 90° particle impingement and particle velocities of 100, 150, and 200 m/s. Note that the error bars (standard deviation) are contained within the symbols.

It is also evident from the cumulative mass loss versus cumulative mass erodent curves in Fig. 4 that an increase in mass loss and steady-state erosion rate is observed as particle velocity increases from 100 to 200 m/s. Figure 5 shows the steady-state erosion rate as a function of particle velocity. Note that the steady-state erosion rate shown in Fig. 5 is represented as volume loss [mm³] per gram of erodent to better compare the steady-state erosion rates since the materials have different densities. The bulk densities reported earlier in the Experimental Procedure section were used to convert from mass to volume loss.

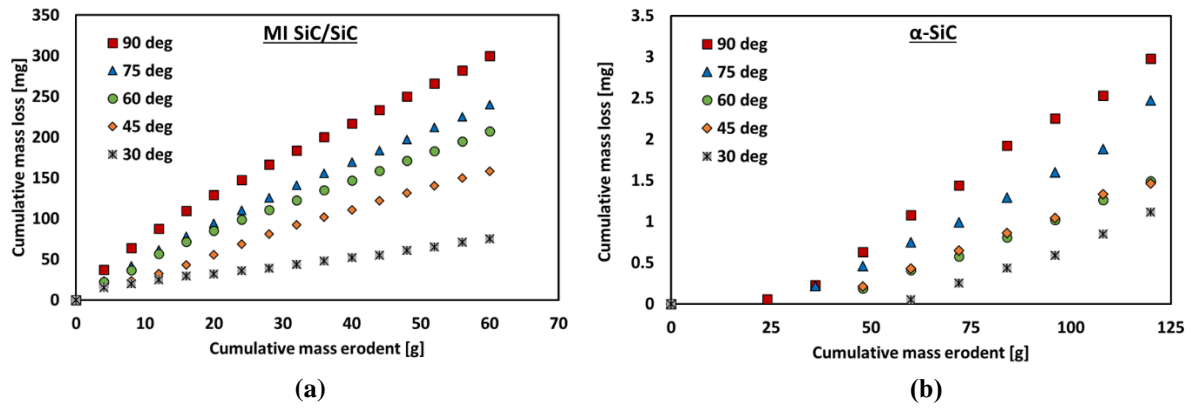
Figure 6. Cumulative mass loss versus cumulative mass erodent curves for various impingement angles. (a) MI SiC/SiC. (b) α -SiC.

The effect of particle impingement angle was further evaluated since particles will impinge components over a wide range of angles during service. Exemplary cumulative mass loss versus cumulative mass erodent curves for the various impingement angles are shown in Fig. 6. For the MI SiC/SiC, a higher initial slope is observed prior to gradually decreasing to steady-state for all impingement angles. Conversely, little to no change in mass followed by a gradual increase to steady-state is observed for the α -SiC.

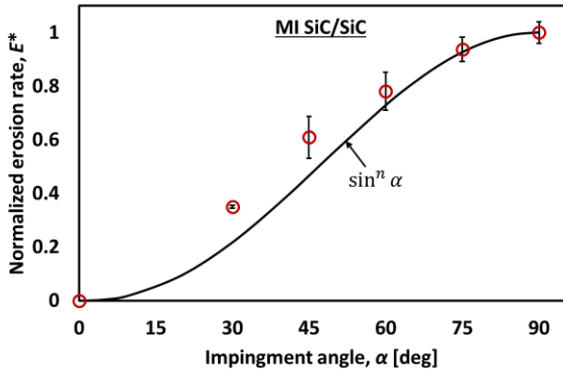
(a)

(b)

Figure 7. Normalized steady-state erosion rate, E^* , plotted as a function of impingement angle along with the $\sin^n \alpha$ law. (a) MI SiC/SiC ($n = 2.2$). (b) α -SiC ($n = 2.4$).

Figure 7(a) and (b) plots the normalized steady-state erosion rate, E^* as a function of impingement angle for the MI SiC/SiC and α -SiC, respectively. The $\sin^n \alpha$ law for brittle controlled fracture where $n = 2.2$ for the MI SiC/SiC and $n = 2.4$ for the α -SiC, as experimentally determined from normal impingement, are also included. As shown in Fig. 7, both materials exhibit a maximum erosion rate at 90° and exhibit a general decrease in erosion rate as the impingement angle decreases. The trend in decreasing erosion rate as impingement angle decreases is in reasonable agreement with that predicted by the $\sin^n \alpha$ law for $\alpha \geq 60^\circ$. As α decreases below 60° , the erosion rate becomes increasingly underpredicted. This suggests that there may be a change in mechanism as α decreases; namely an increasing contribution of the tangential component of velocity (defined here as the velocity component parallel to the sample surface, $v \cos \alpha$) which may indicate a larger contribution of plastic deformation.

This change in apparent mechanism from brittle-dominated material removal at higher impingement angles to a more ductile, ploughing process at lower impingement angles has been reported in other ceramic materials at ambient and elevated temperatures [13, 19, 20, 21, 22]. The increasing contribution of a ductile mode to the erosion process also supports the underprediction of the $\sin^n \alpha$ (Eq. (3) and Fig. 7) relationship as α decreases since the tangential component of velocity becomes non-negligible.
