# Thermochemical/Thermomechanical Synergies in High Temperature Particle Erosion of CMAS Exposed EBCs

Jamesa L. Stokes<sup>1</sup>, Michael J. Presby<sup>1</sup>, Rebekah I. Webster<sup>1</sup>,  
John A. Setlock<sup>2</sup>, Bryan J. Harder<sup>1</sup>

*<sup>1</sup>NASA Glenn Research Center*

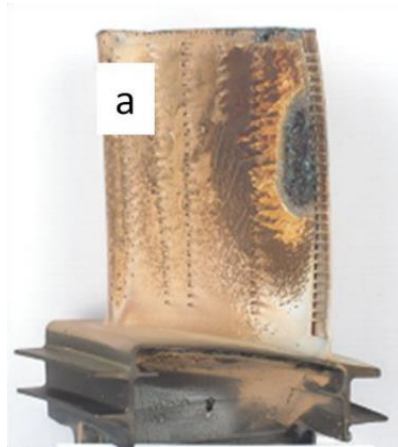
*Damage on a turbine blade caused by CMAS >1200°C*

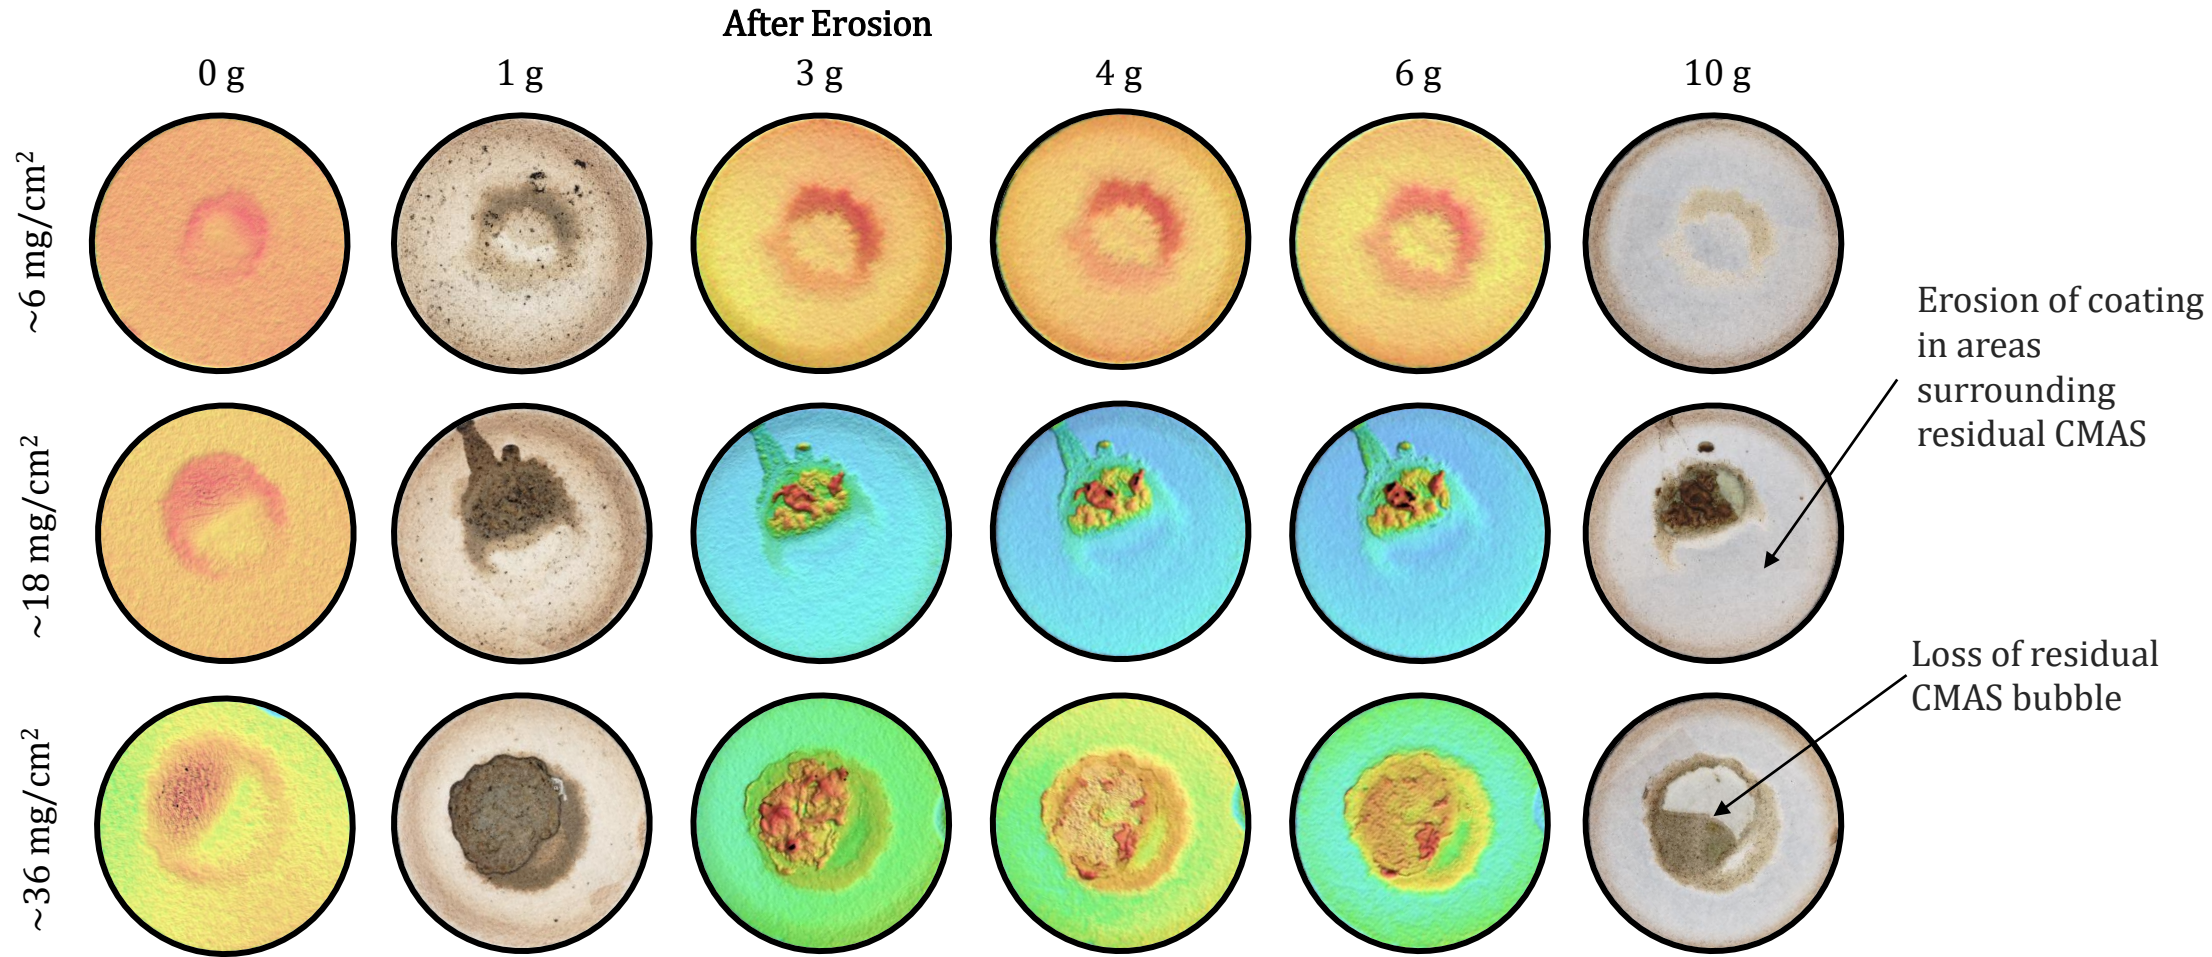
After Erosion

- SEM cross sections show large cracks throughout bond coat; cracks were much wider in  $\sim 36 \text{ mg/cm}^2$  sample after erosion testing.
- Bubbling and rumpling of residual CMAS due to burner rig exposure
