THE EFFECT OF OXIDATION IN ENVIRONMENTAL BARRIER COATINGS SUBJECT TO FOREIGN OBJECT DAMAGE

Leland C. Hoffman
HX5, LLC.
Brook Park, OH

Michael J. Presby, Jamesa L. Stokes, Bryan J. Harder, Jonathan A. Salem
NASA Glenn Research Center
Cleveland, OH

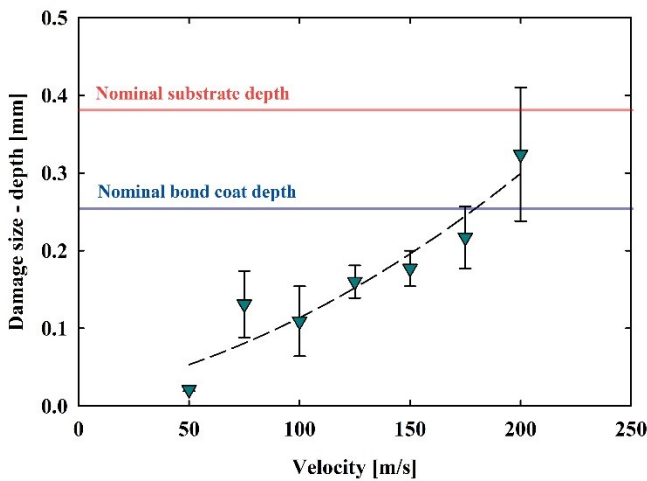
FIGURE 6: DEPTH OF IMPACTED REGION VERSUS IMPACT VELOCITY. THE NOMINAL BOND COAT AND SUBSTRATE DEPTHS ARE SHOWN FOR COMPARISON.

From the profilometry data, the impact crater depth (Fig. 6) and diameter (Fig. 7) were plotted as a function of projectile velocity. The crater diameter and depth follow a similar increasing trend with increasing impact velocity. At velocities lower than 150 m/s, the prevailing external damage was a simple crater with material protrusion and ejection around the perimeter of the crater as shown in Fig. 8. Above 150 m/s, the damaged zone reached the depth of the Si bond coat resulting in spallation of the EBC along the Si bond coat interface. At 200 m/s, half of the samples experienced catastrophic failure of the substrate, as did all samples tested above 200 m/s.

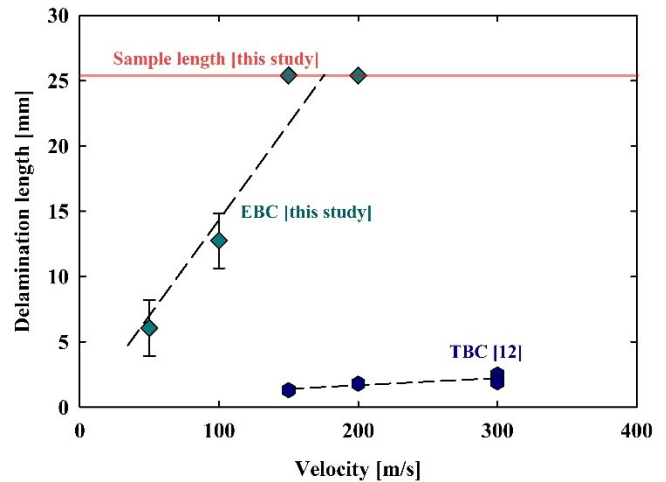
FIGURE 8: DELAMINATION LENGTH FROM THE AS-DEPOSITED EBCS IMPACTED IN THE PRESENT STUDY AS WELL AS PREVIOUS DATA FROM THERMAL BARRIER COATINGS (TBC) DEPOSITED ON HOT-SECTION VANE AIRFOILS [12].

The delamination length at the Si bond coat – SiC substrate interface was measured and increased with impact velocity up to 150 m/s, at which point complete delamination along the length of sample was observed as shown in Fig. 8. A previous FOD study performed on hot-section metallic vane airfoils with a columnar thermal barrier coating (TBC) deposited by electron beam, physical vapor deposition (EB-PVD) [12] showed that delamination in that system primarily occurred at the TBC topcoat and platinum aluminide (PtAl) bond coat interface, or along the TGO interface that exists between the TBC topcoat and PtAl bond coat. For comparison, the delamination data observed the TBC system [12] has been plotted along with that of the present work. There are two important differences when comparing the results of these two studies. First, the delamination in the EBC/Si/SiC system is primarily observed to occur at the Si bond coat – SiC substrate interface while the delamination in the TBC/PtAl superalloy system primarily occurred at the TBC/PtAl bond coat interface. Second, the measured delamination length in the TBC system is much smaller suggesting the TBC system has better FOD and delamination resistance.
