Ultrasonic Inspection During Autoclave Cure of Reflowable-Interface Composite Joints

Tyler B. Hudson¹, Fatimata Baro², Austin J. Smith¹, Jin Ho Kang¹,
Roberto J. Cano¹, Frank L. Palmieri¹

¹NASA Langley Research Center, Hampton, VA 23681, USA

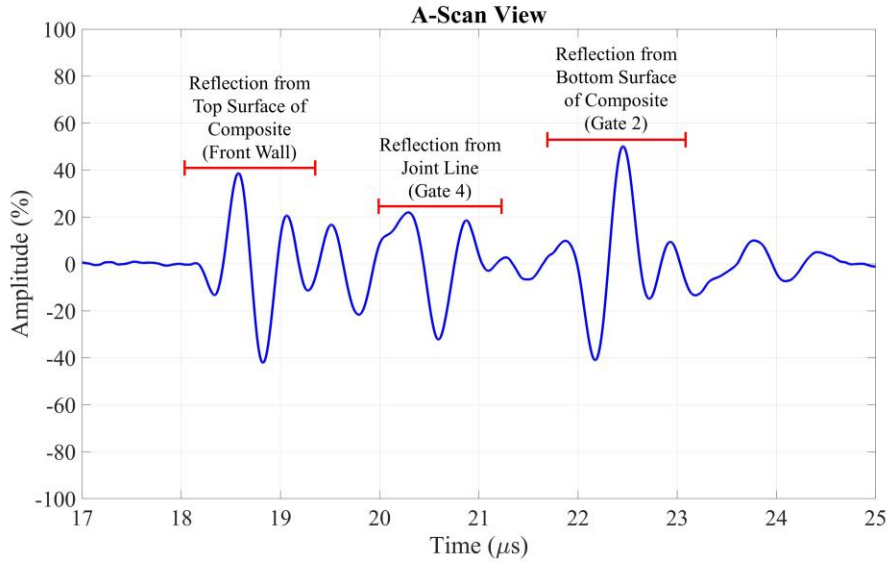
Fig. 5: A-scan waveform from Panel 2A at location $x = 44$ mm and $y = 10$ mm (Cursor location in Fig. 6) during scan 67 (just prior to cooldown).

For each panel and scan, time gates were setup in the ultrasonic waveforms to calculate the maximum absolute amplitude of the reflection at the joint line (Fig. 5). The maximum absolute amplitude within each time gate was calculated at every location and the result assigned to that location. For example, during scan 67 (just prior to cooldown) for Panel 2A at location $x = 44$ mm and $y = 10$ mm, the maximum absolute amplitude at the joint line (gate 4) was 0.32 (32%) (Fig. 5).

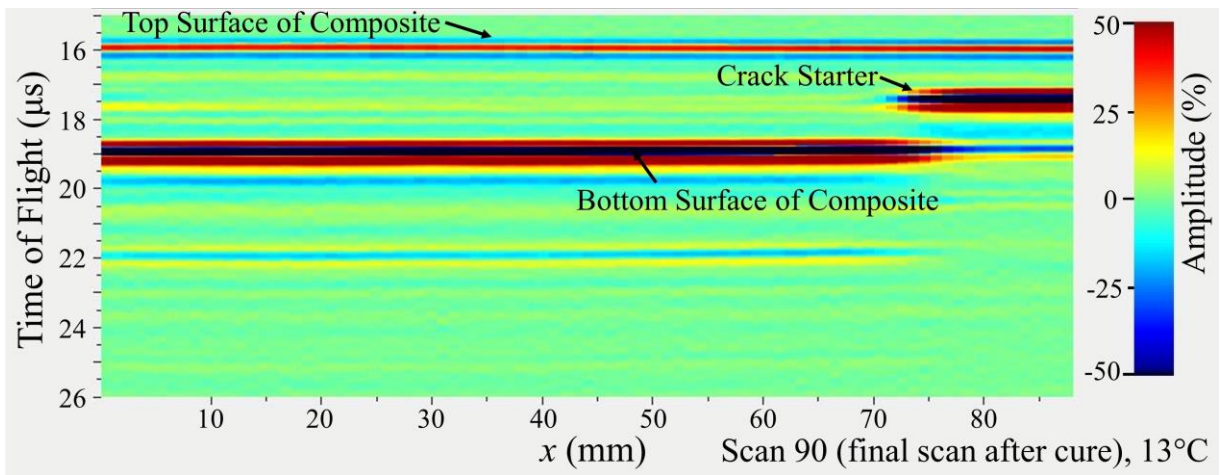
Fig. 8: B-scan image of scan 90 (final scan after cure) of Panel 2A.

The B-scan (cross-sectional slice) from the final inspection is shown in Fig. 8, which was performed the following day. The crack starter was fully visible. Reflections from the joint line were minimal and there were little to no voids at the joint, which is an indication of a high-quality bond that would be expected to exhibit good mechanical strength [16]. A montage of B-scan images taken throughout cure in shown in Fig. 9.

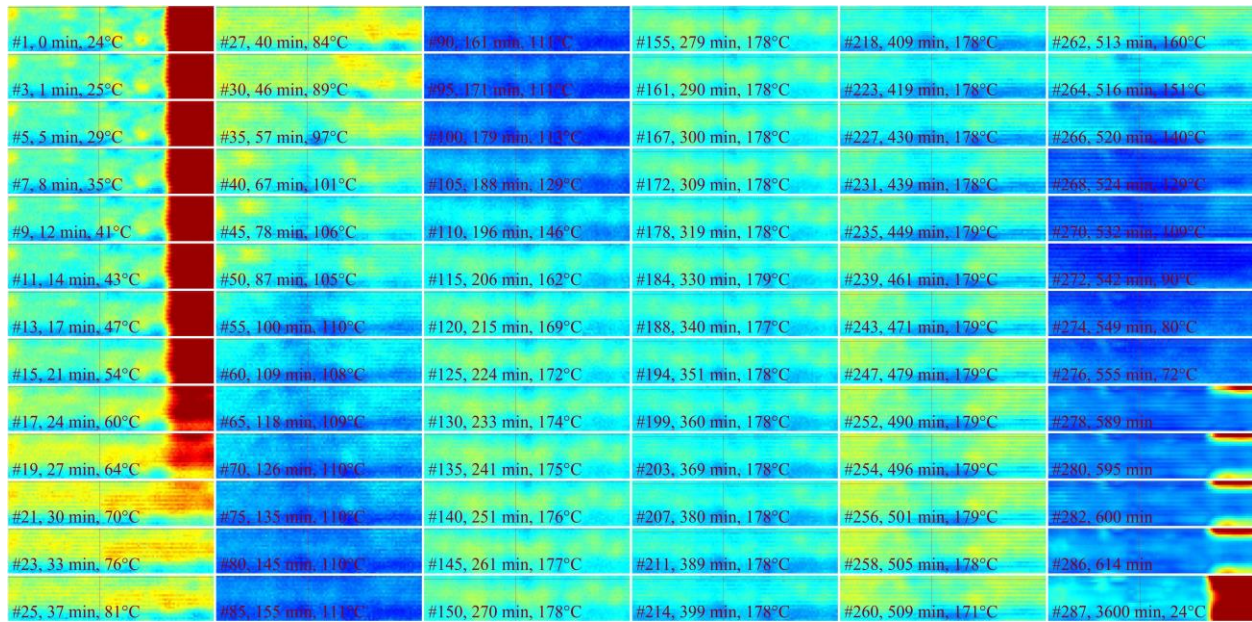
Fig. 12: Panel 1A C-scan images of the maximum amplitude measured at the AERoBOND joint line throughout the cure cycle.

Montage images of both the B-scans and C-scans of the maximum amplitude from the joint line are included in Fig. 12-Fig. 15 in the appendix. During the cure cycle for Panel 3A, there was an equipment malfunction at ~190 minutes that prevented full area C-scans from being collected. B-scans at a single y location were restored at ~230 minutes and C-scans across half the area were resumed at ~420 minutes. Despite the malfunction, the average amplitude was able to be determined from the reduced data for comparison with Panel 1A and 2A.
