Foreign Object Damage in a $\text{Yb}_2\text{Si}_2\text{O}_7$ Environmental Barrier Coating

Leland Hoffman
HX5, LLC. at NASA Glenn
Brook Park, OH

Michael J. Presby, Bryan J. Harder, Jamesa L. Stokes
NASA Glenn Research Center
Cleveland, OH

ICACC Daytona Beach, FL
January 28- February 2 2024

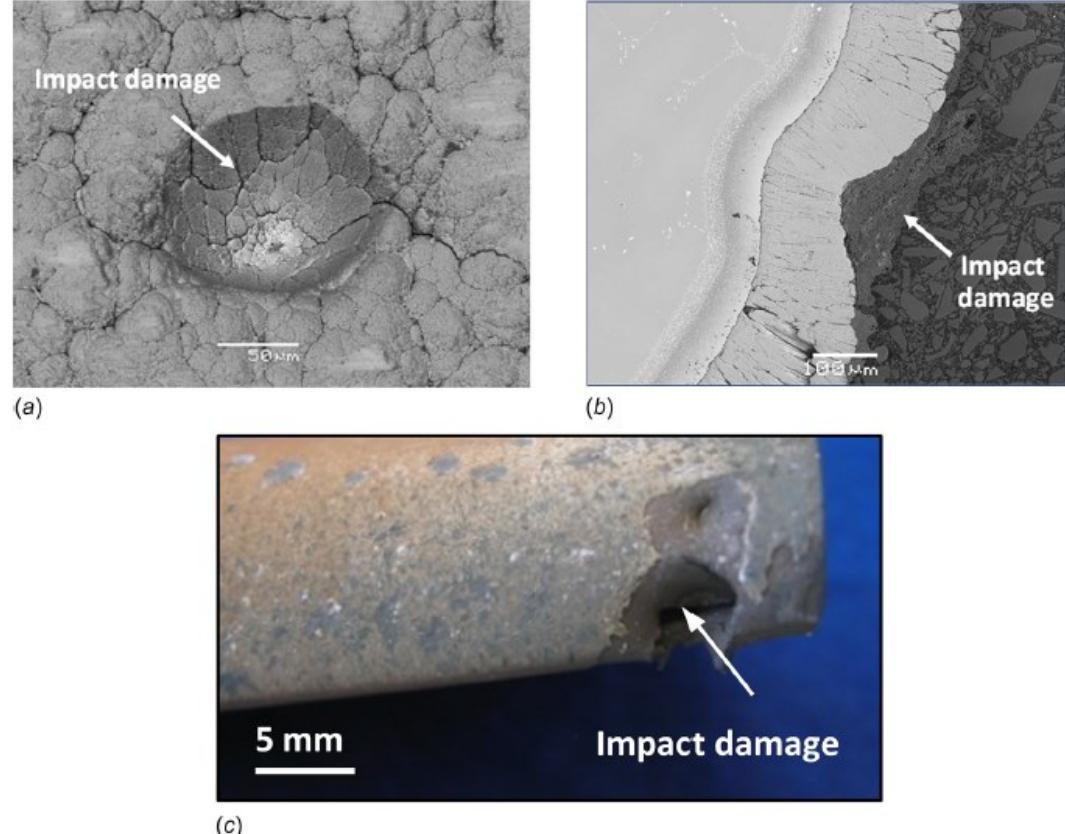
Examples of FOD in US Navy TBC airfoils:
S. Choi, (2014) ASME J. Eng. Gas Turbine Power
