**MERCURY  
NETWORK PERFORMANCE ANALYSIS  
FOR MA-8**

MANNED SPACE FLIGHT SUPPORT DIVISION

OCTOBER 24, 1962

MERCURY NETWORK PERFORMANCE ANALYSIS

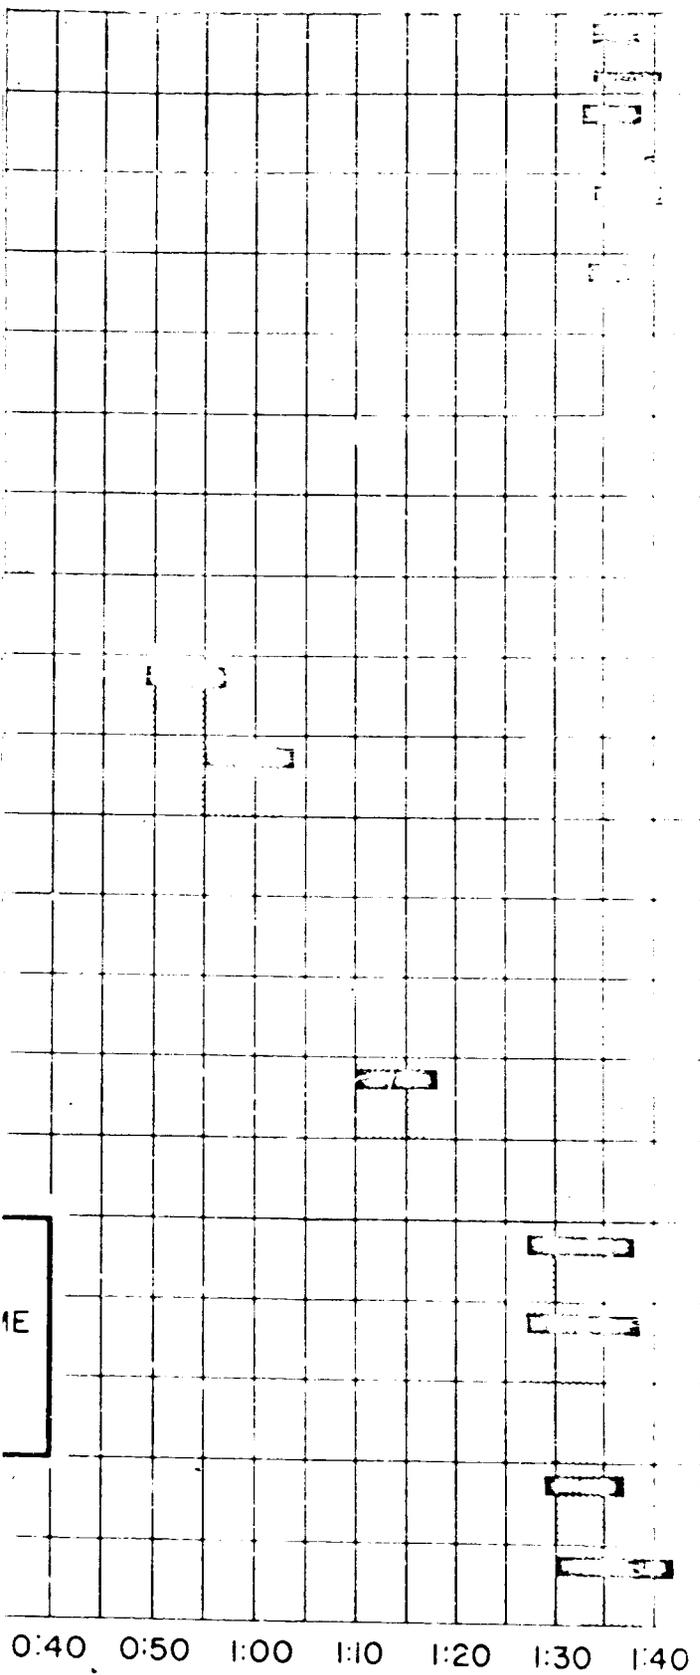
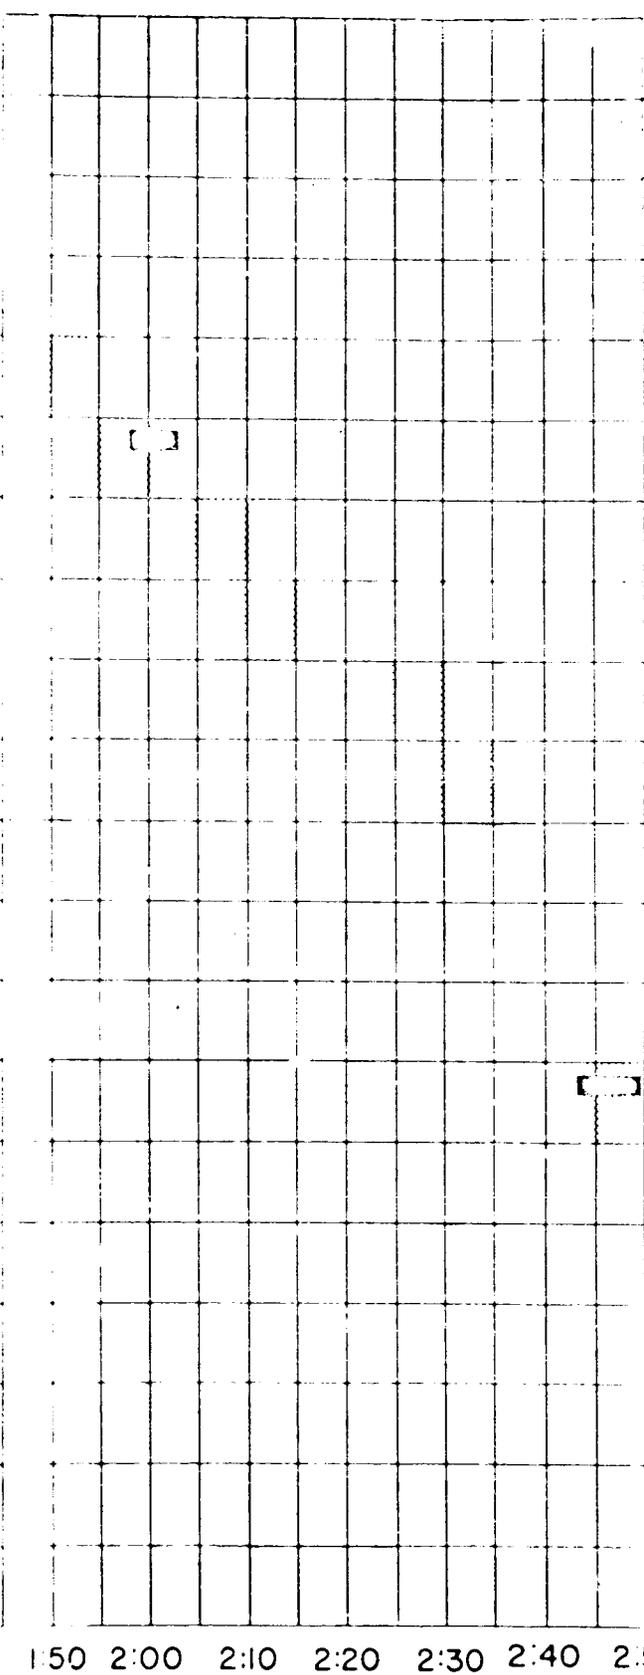
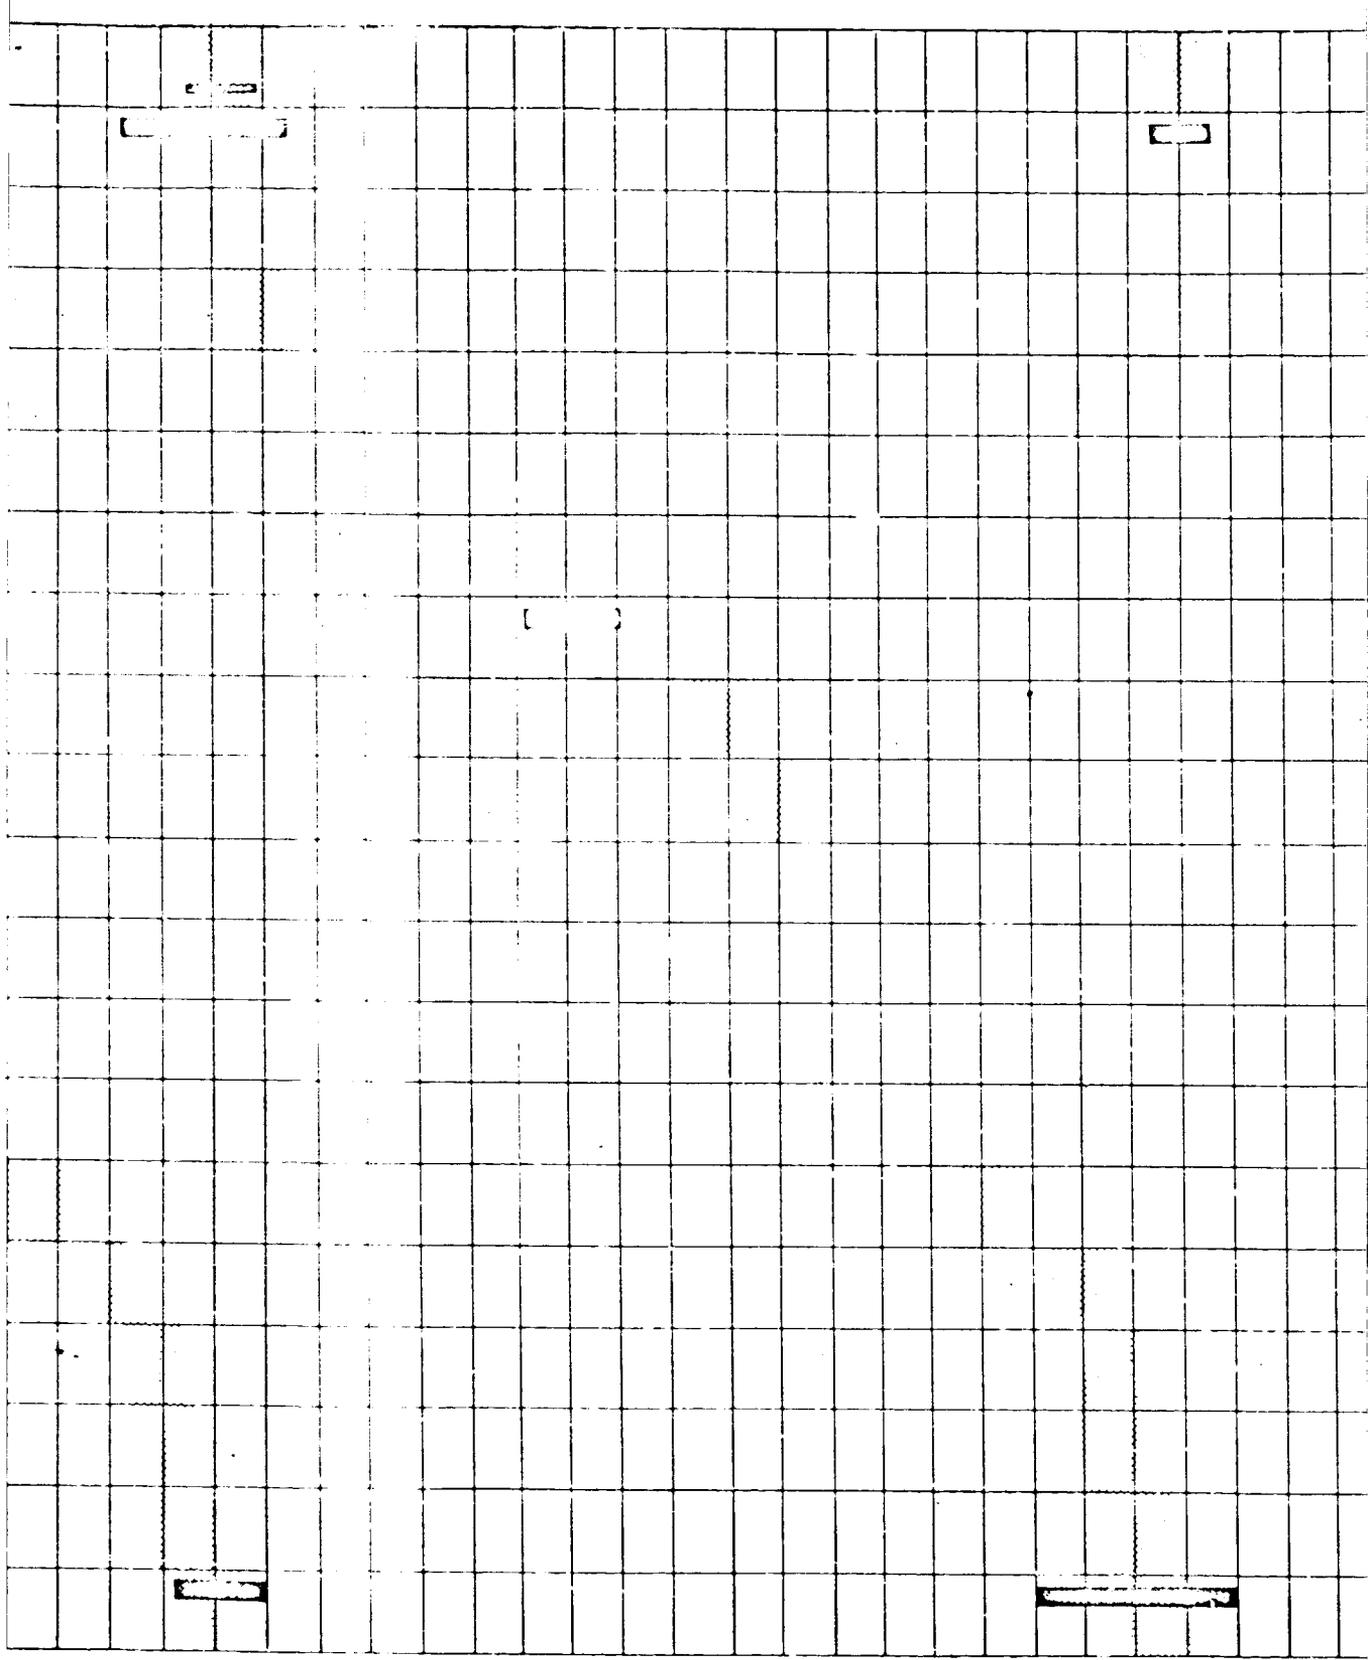
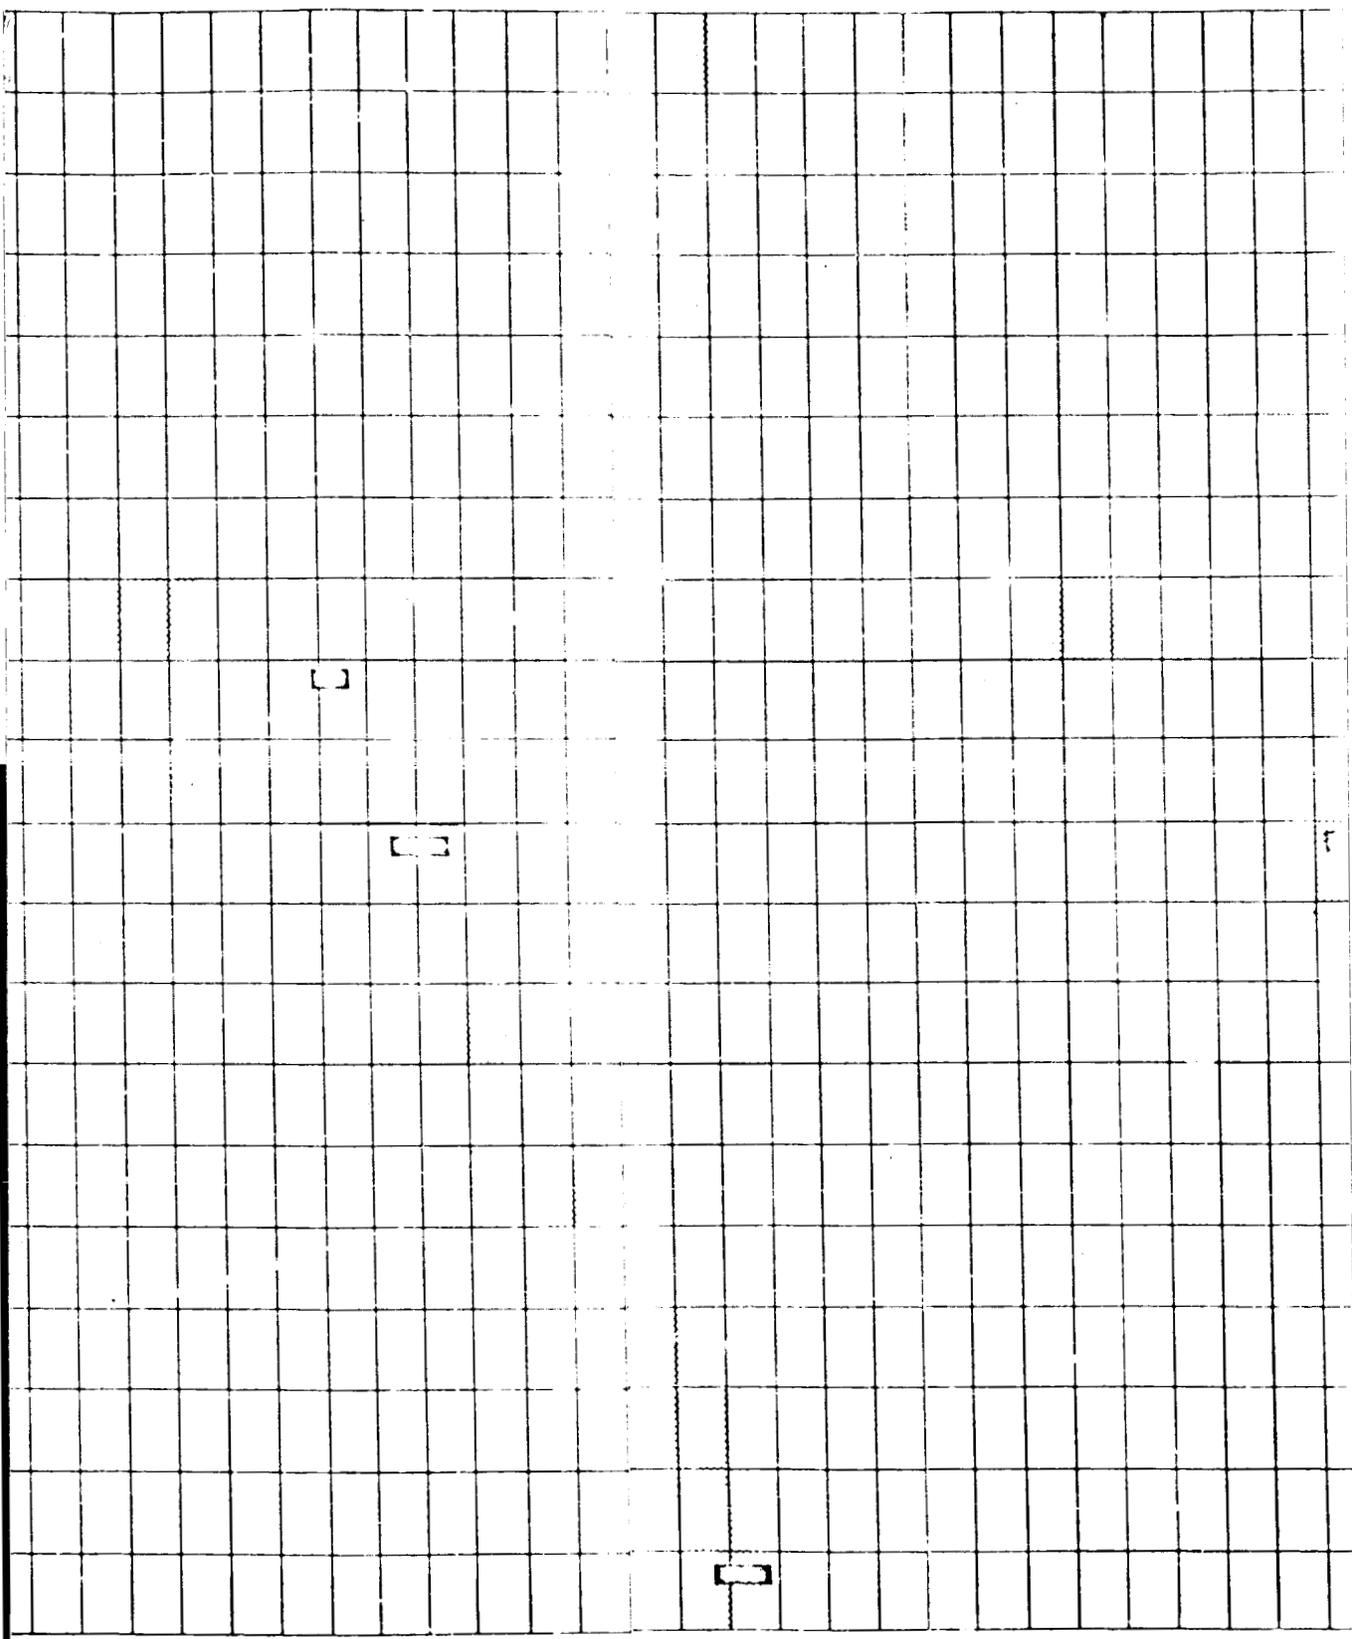
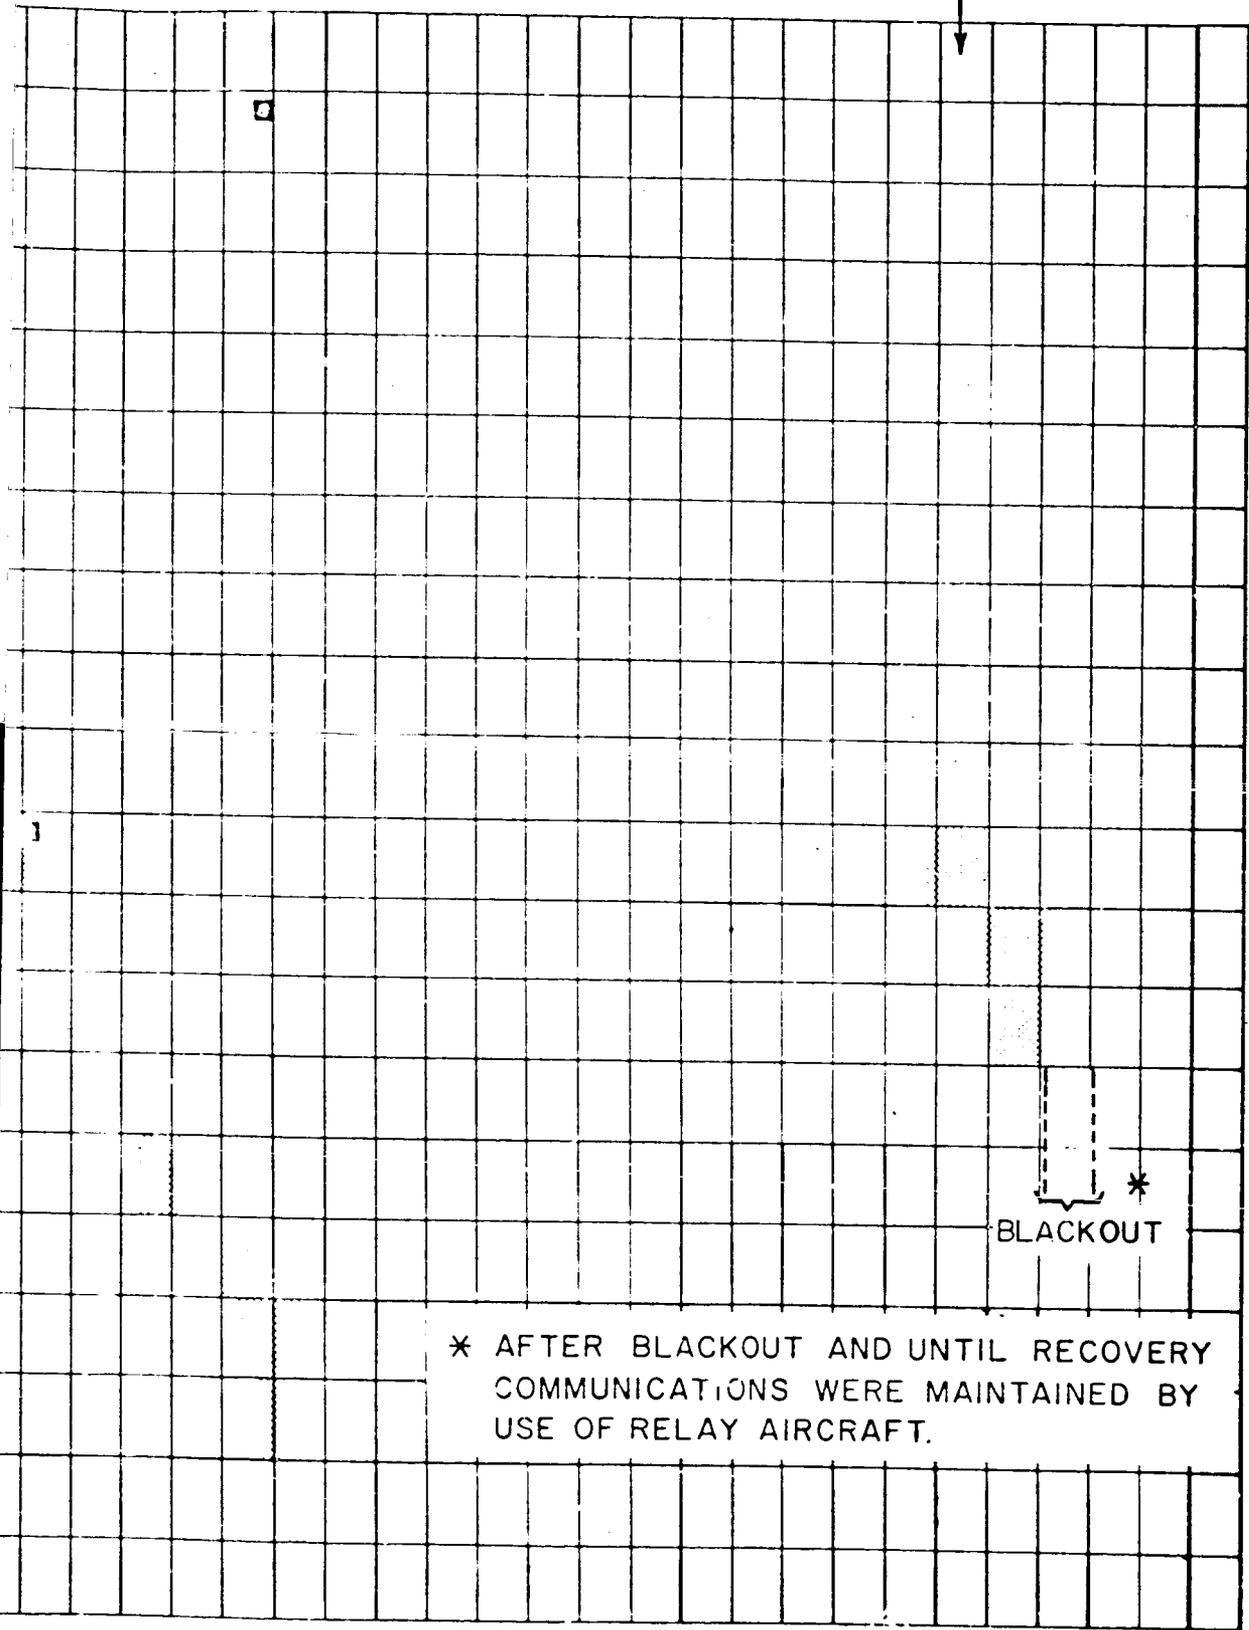
Figure 4. HF Communications Coverage Chart

\* AFTER BLACKOUT AND UNTIL RECOVERY COMMUNICATIONS WERE MAINTAINED BY USE OF RELAY AIRCRAFT.

of the flight. See Table 5 and Figure 4 and 5 for coverage information. UHF coverage times were slightly different from predicted nominal times. As in the previous flight, MCC A/G coverage was extended by using the MCC-BDA remoting system. Although not shown on the HF and UHF charts, Quito, Ascension, and Antigua did have A/G coverage.

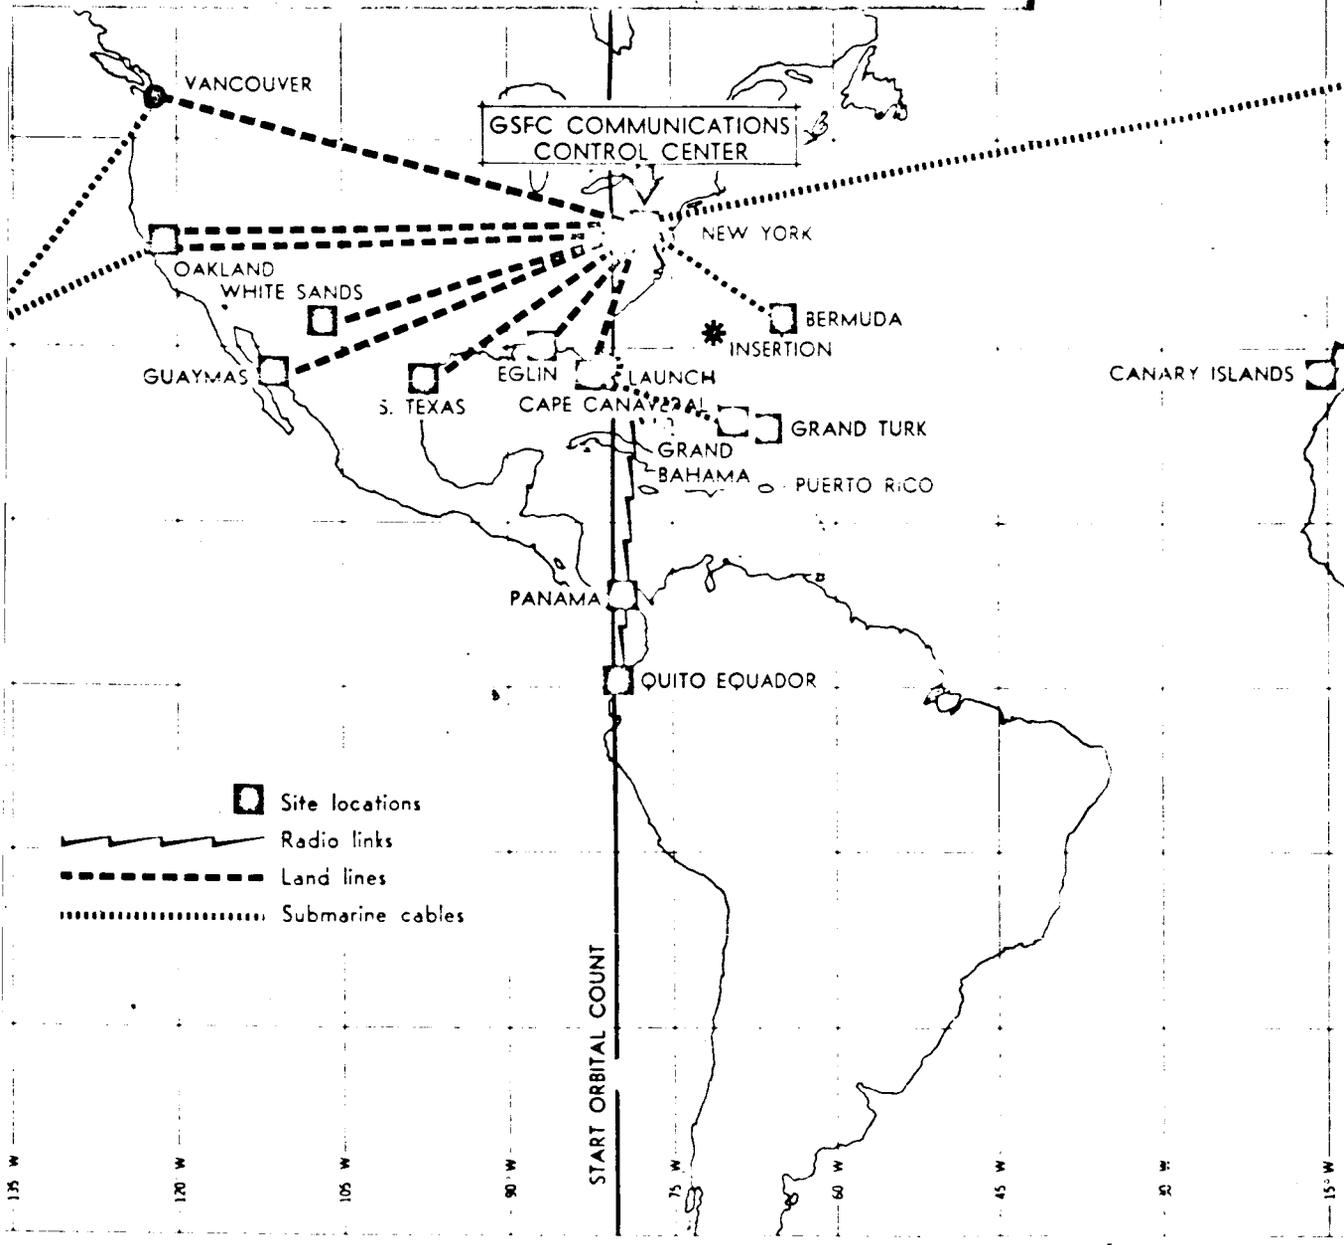
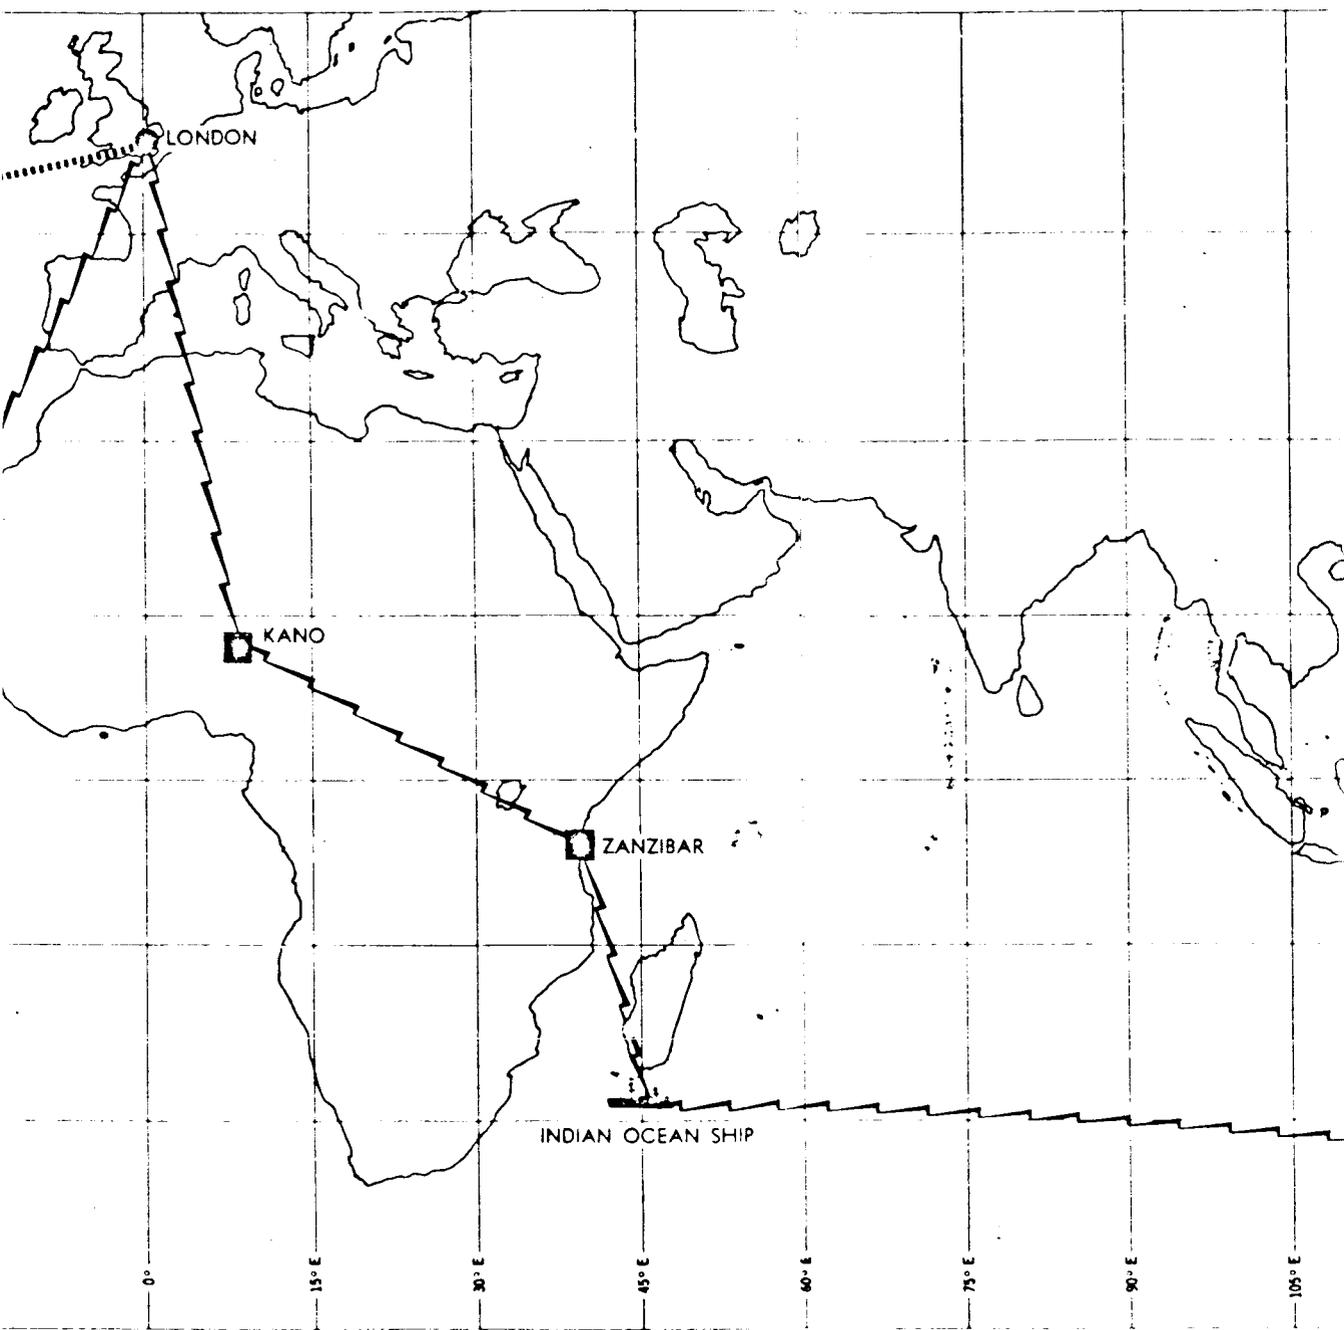
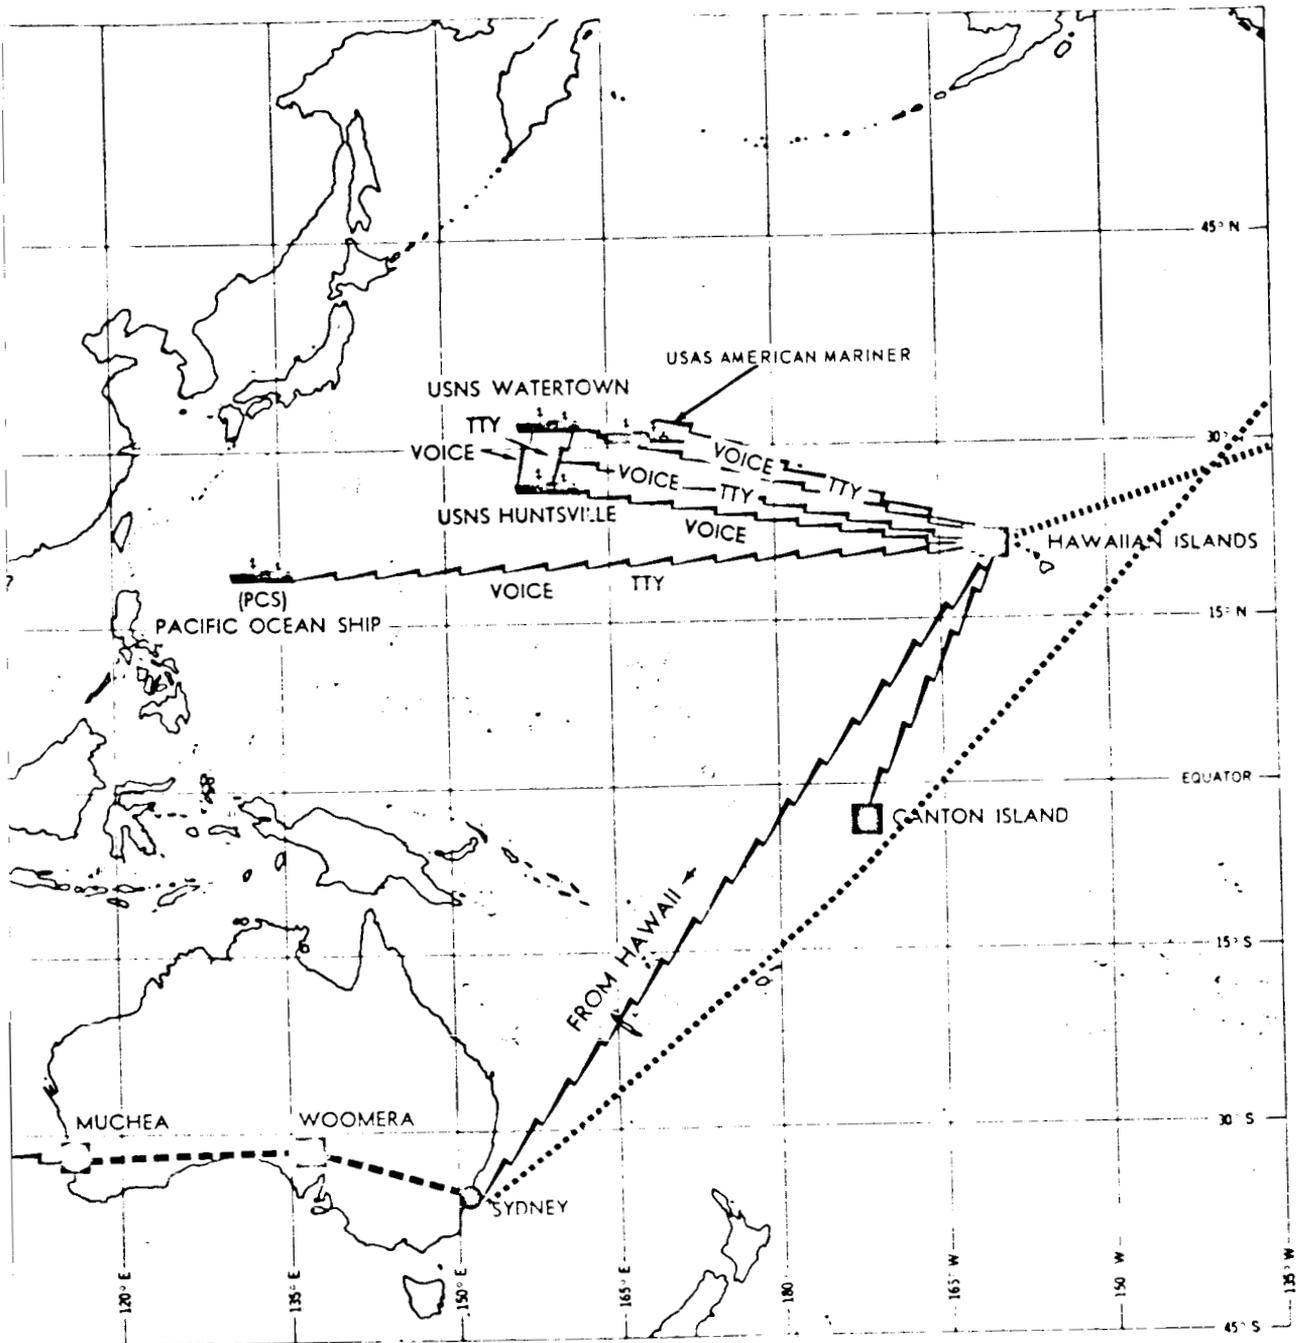
Figure 6. Mercury Communications Network

- Site locations
- Radio links
- - - Land lines
- ..... Submarine cables

Goddard Space Flight Center is the communications center for Project Mercury. See Figure 6 at the end of this section for the network configuration. Voice communications circuits tie together the communication center, the control center, and the remote sites, providing a direct and rapid means of communications between them. Teletype circuits are utilized for flight control message traffic and for radar data from radar tracking sites to the Goddard computers.

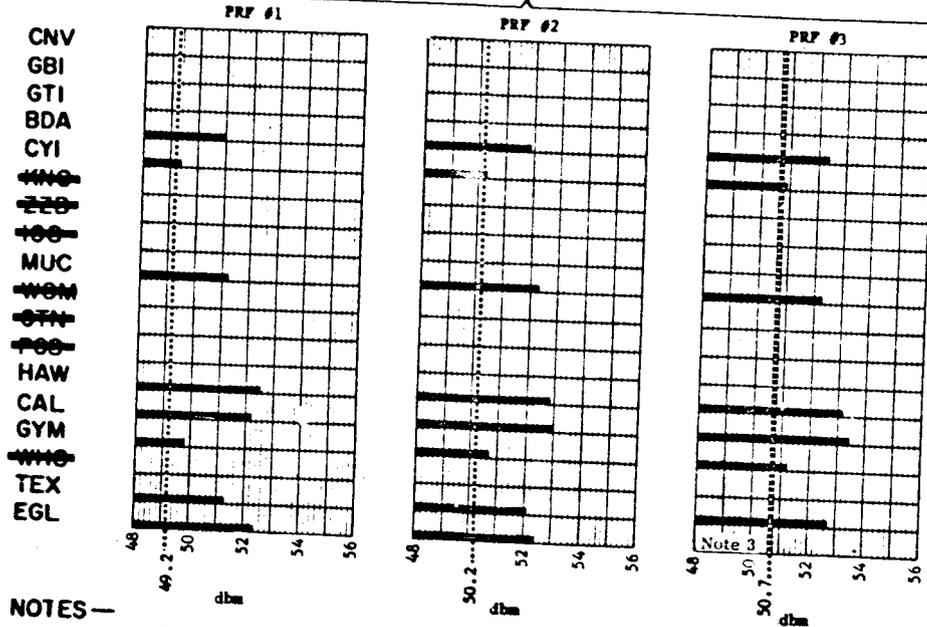
TRANSMITTED POWER OUTPUT - PULSE CODER OFF

S-BAND RADAR  
Detailed System Test (DST 101-1)  
MCG-462 Mission

- NOTES —
1. Minimum limit .....
  2. Average network value  
PRF #1 51.2 dbm  
PRF #2 51.2 dbm  
PRF #3 52.4 dbm
  3. EGL is equipped with an MPQ-31 Radar

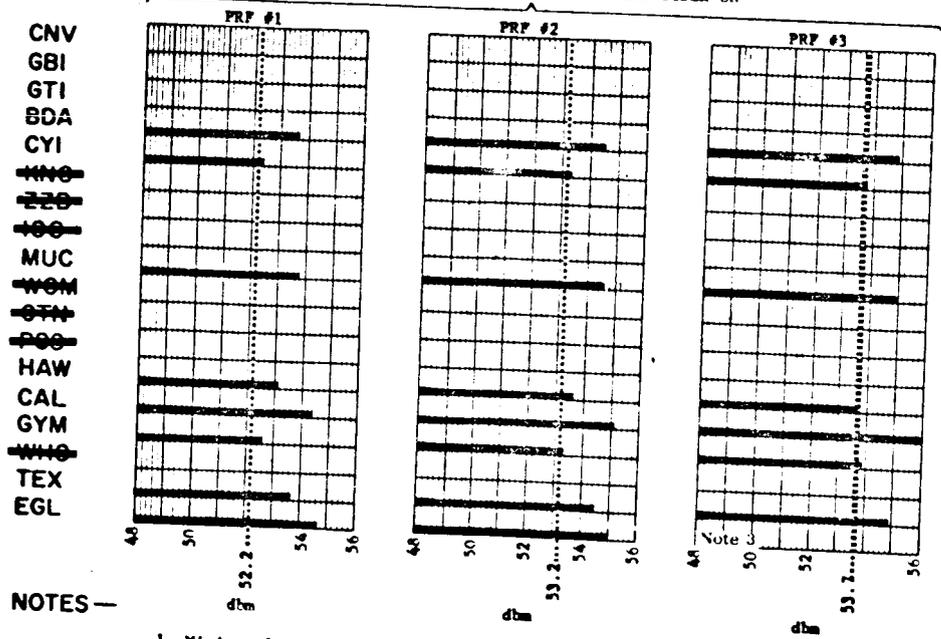
TRANSMITTED POWER OUTPUT - PULSE CODER ON

S-BAND RADAR  
Detailed System Test (DST 101-1)  
MCG-462 Mission

- NOTES —
1. Minimum limit .....
  2. Average network value  
PRF #1 53.4 dbm  
PRF #2 54.1 dbm  
PRF #3 54.6 dbm
  3. EGL is equipped with an MPQ-31 Radar

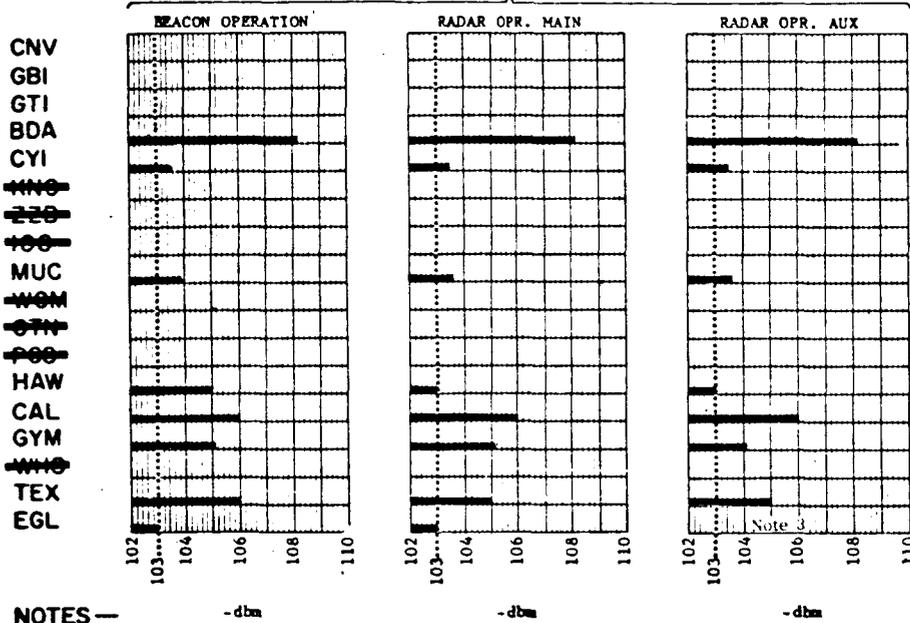
**RECEIVER SENSITIVITY MDS**

**S-BAND RADAR**  
Detailed System Test (DST 101-1)  
NCG-462 Mission

1. Minimum limit .....
2. Average network value  
Beacon operation 105.4 -dbm  
Radar operation main 104.9 -dbm  
Radar operation auxiliary 104.8 -dbm
3. EGL is equipped with an HPQ-31 Radar

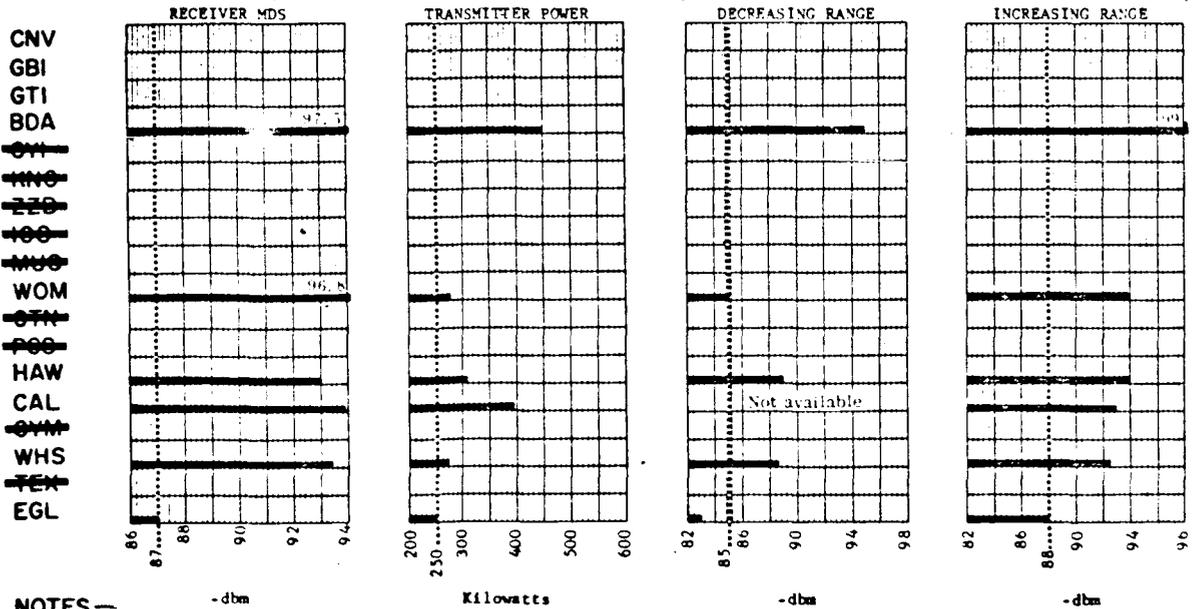
**DYNAMIC LOCK-ON AND RELEASE**

**C-BAND RADAR**  
Detailed System Test (DST 101-2)  
NCG-462 Mission

1. Minimum limit .....
2. Network average  
Receiver MDS -93.6 dbm  
Transmitter power 325 Kw  
Decreasing range -88.1 dbm  
Increasing range -93.4 dbm

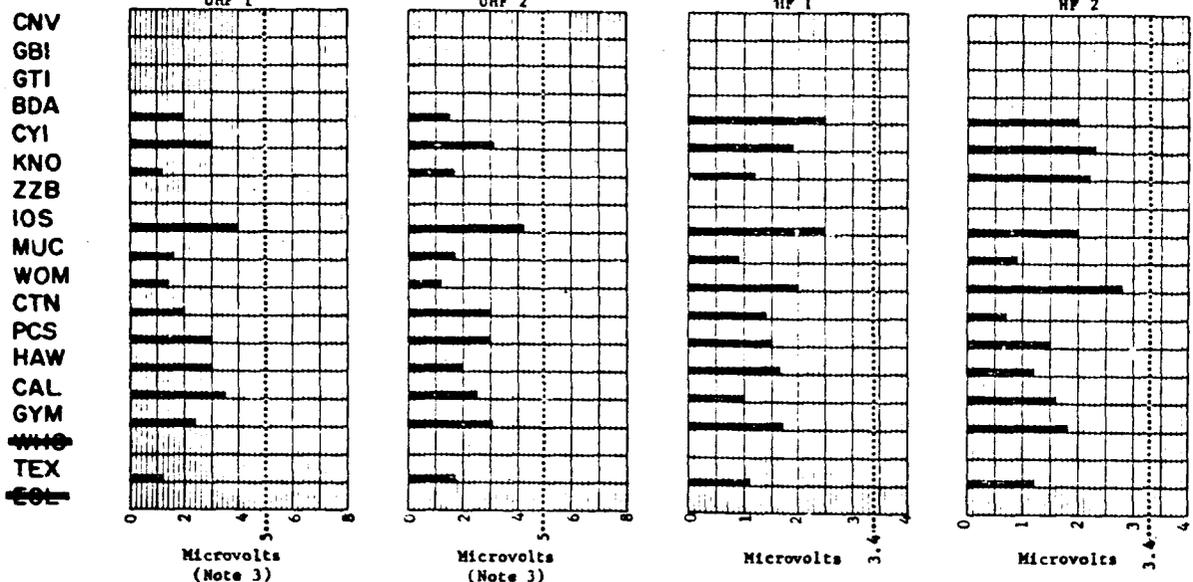
RECEIVER SENSITIVITY FOR  $\frac{S+N}{N}$  OF 10 DB

AIR/GROUND COMMUNICATIONS  
Detailed System Test (DST 102)  
MCC-462 Mission

1. Maximum limits .....
2. Network average  
UHF Rcv'r. 2.19 Microvolts  
HF Rcv'r. 1.74 Microvolts
3. Channel 5 of the UHF receiver. Channel 4 and 6 values are available in MSPSD.

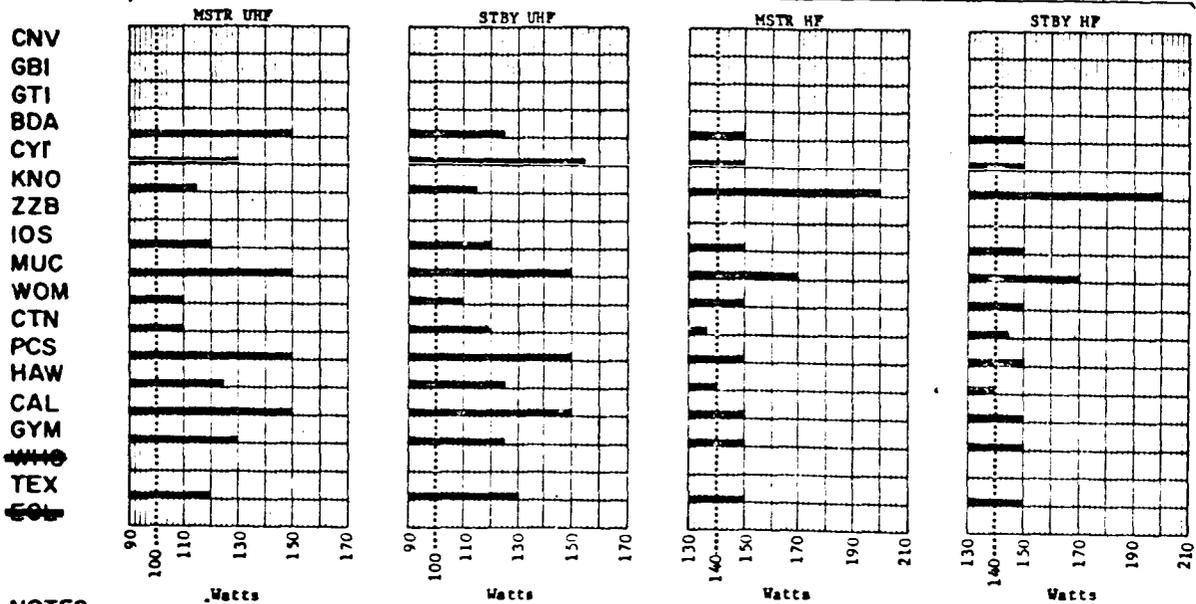
TRANSMITTED POWER OUTPUT

AIR/GROUND COMMUNICATIONS  
Detailed System Test (DST 102)  
MCC-462 Mission

1. Minimum limit .....
2. Network average  
UHF Transmitters 130 Watts  
HF Transmitters 155 Watts

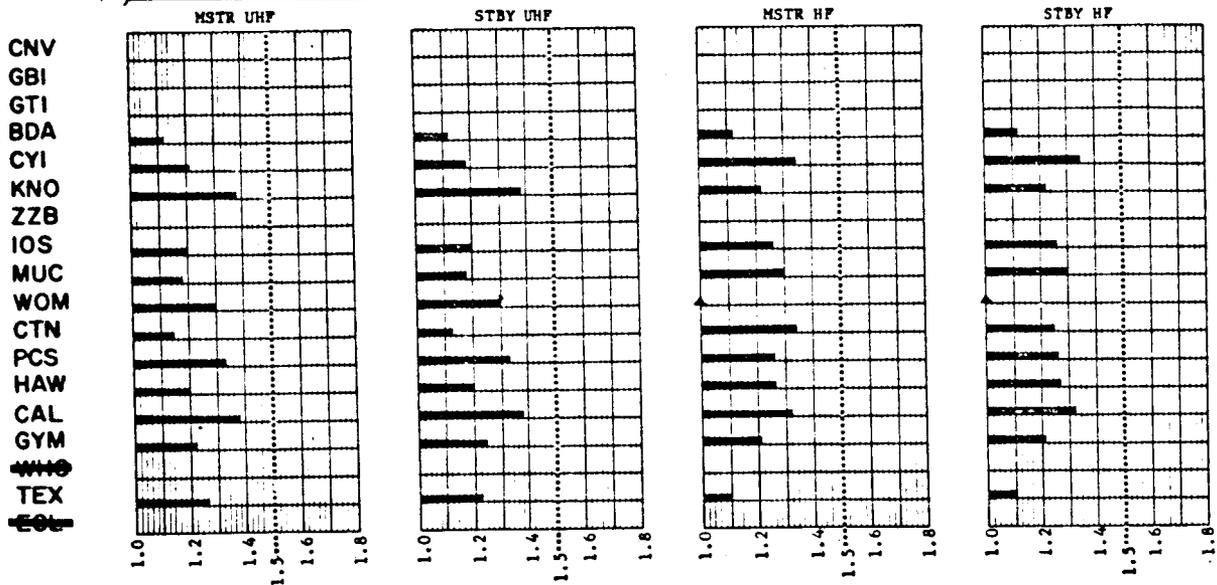
VSWR OF TRANSMITTERS

AIR/GROUND COMMUNICATIONS  
Detailed System Test (DST 102)  
MCG-462 Mission

1. Maximum limit .....
2. Network average  
UHF XMITR'S 1.24:1  
HF XMITR'S 1.25:1
3. All values referenced to unity

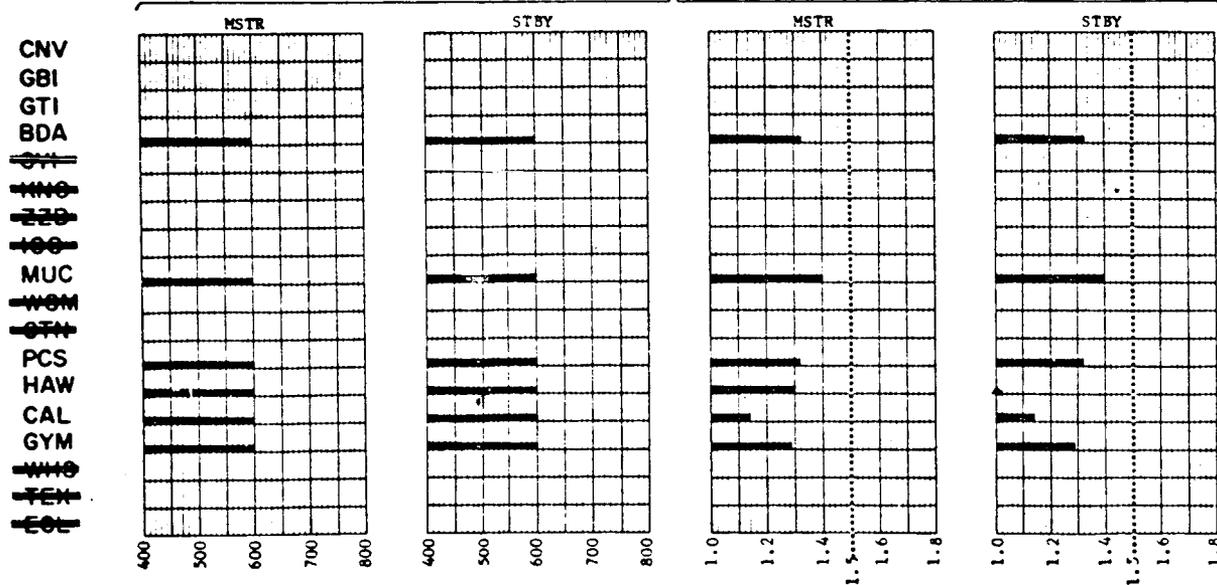
FW-2 TRANSMITTERS

COMMAND CONTROL TRANSMITTERS  
Detailed System Test (DST 103)  
MCG-462 Mission

1. Maximum limit .....
2. Network average  
Mstr. 1.25 VSWR  
Stby. 1.24 VSWR
3. The power output is adjusted to 600 watts nominal.

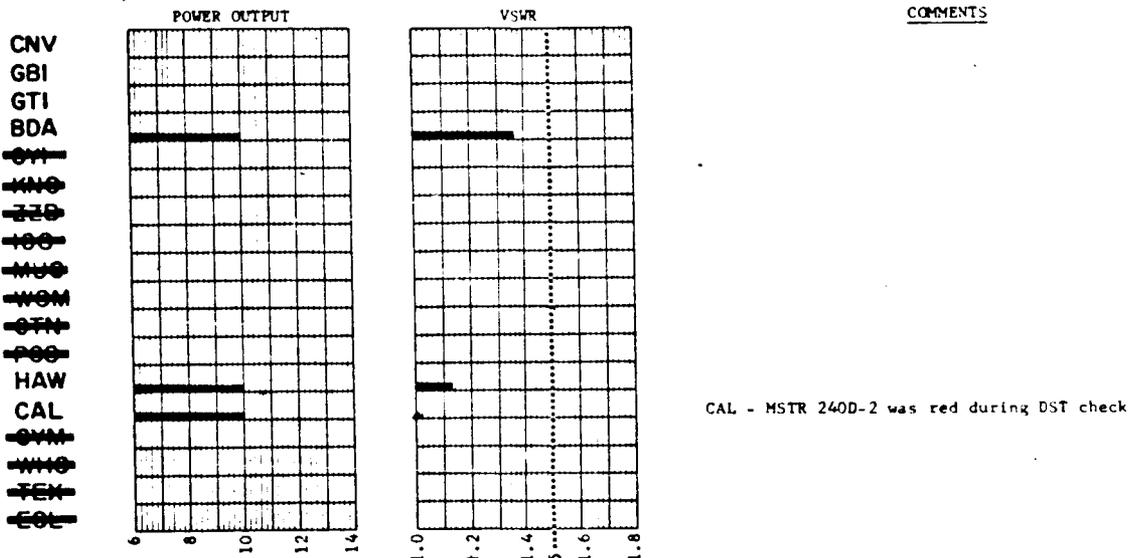
240 D-2 POWER AMPLIFIER

COMMAND CONTROL TRANSMITTERS  
 Detailed System Test (DST 103)  
 NCG-462 Mission

- NOTES—
- Kilowatts  
 (Note 3)
1. Maximum limit -----
  2. Network average of VSWR 1.24
  3. Power output adjusted for 10 KW nominal.

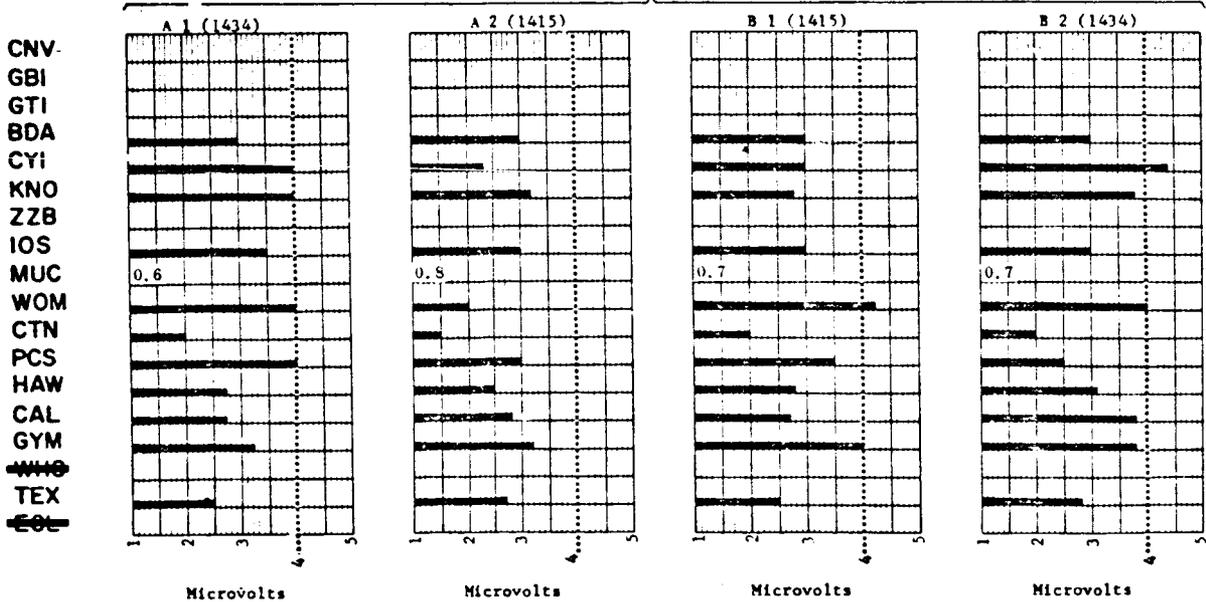
RECEIVER SENSITIVITY FOR  $\frac{S+N}{N}$  OF 20 DB

TELEMETRY  
 Detailed System Test (DST 106)  
 NCG-462 Mission

- NOTES—
1. Maximum limit -----
  2. Network average  
 1434 receivers 3.3 microvolts  
 1415 receivers 2.8 microvolts

Comments: MUC used test procedure described in MUT 106. Values omitted from network averages.

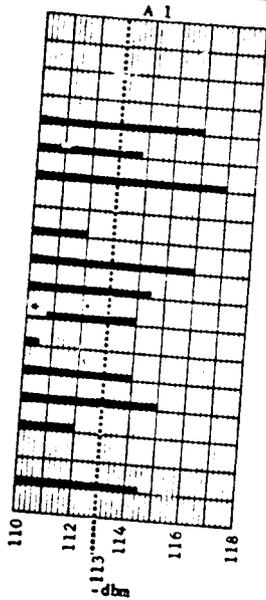
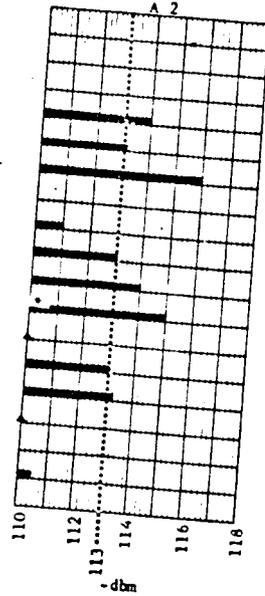
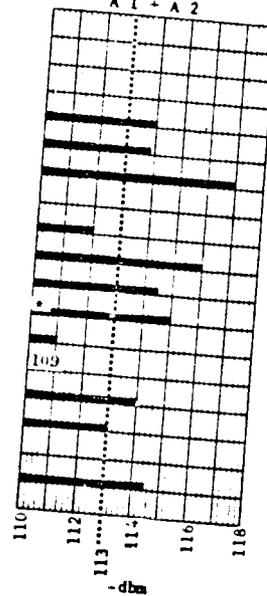
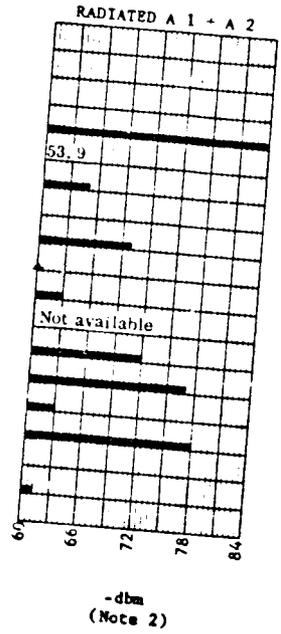
HARDWARE SYSTEM SENSITIVITY TESTS

1. Network average  
A1 -114.7 dbm  
A2 -113.0 dbm  
A1 & A2 -114.0 dbm
2. Space loss = Hardware minus radiated A1 + A2.
3. Minimum limit..... (not definitely established).

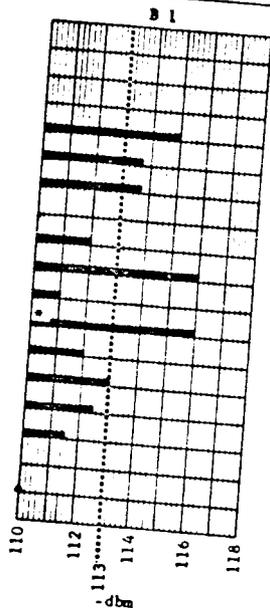
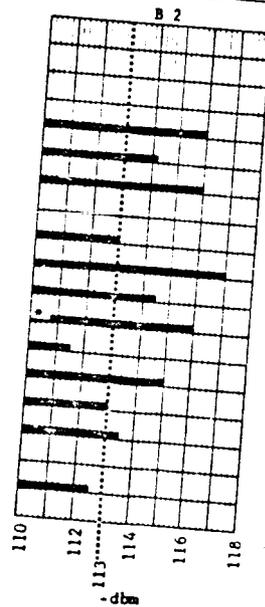
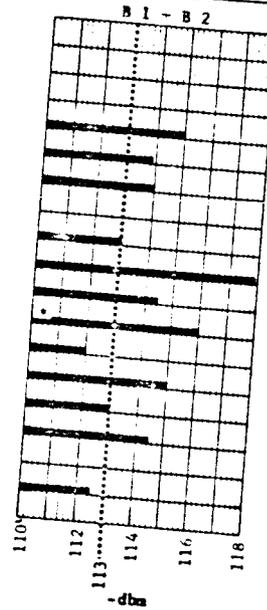
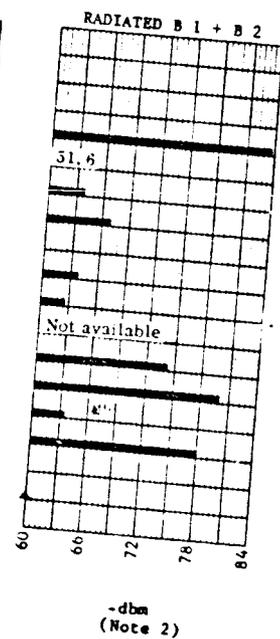
HARDWARE SYSTEM SENSITIVITY TESTS

1. Network average  
B1 -113.2 dbm  
B2 -114.8 dbm  
B1 & B2 -114.7 dbm
2. Space loss = Hardware minus radiated B1 + B2.
3. Minimum limit..... (not definitely established).

The presentation gives the relationship between the actual measured values and the established minimum or maximum limits given in the system test procedures. By using these charts, the overall network condition can be readily seen since all applicable sites are plotted on a single graph for a particular test.
