**MERCURY  
NETWORK PERFORMANCE ANALYSIS  
FOR MA-8**

MANNED SPACE FLIGHT SUPPORT DIVISION

OCTOBER 24, 1962

MERCURY NETWORK PERFORMANCE ANALYSIS

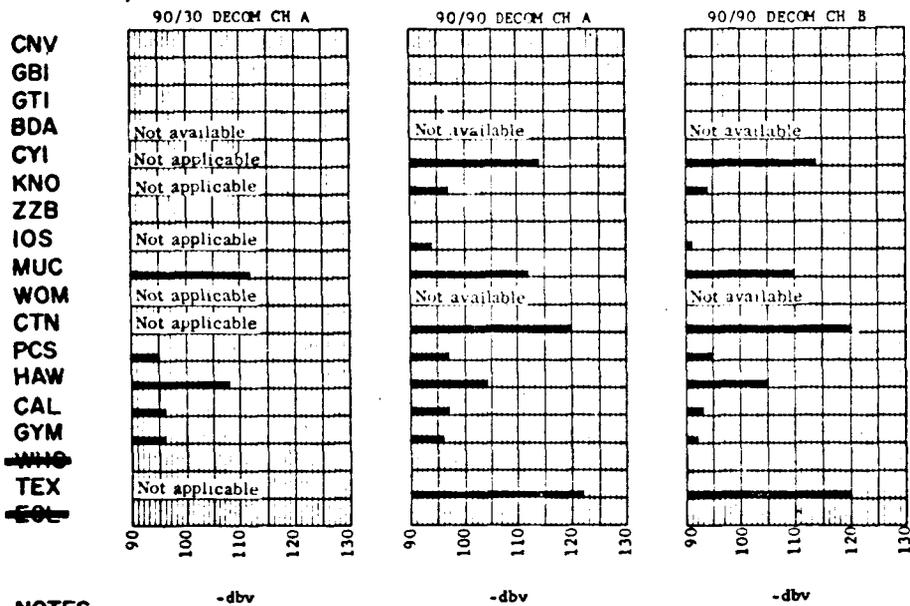
**DECOMMUTATOR-DISCRIMINATOR THRESHOLD**

**TELEMETRY**  
Detailed System Test (DST 106)  
MCG-462 Mission

1. Network average  
     90/30 Decom Ch A 103 -dbv  
     90/90 Decom Ch A 108 -dbv  
     90/90 Decom Ch B 106 -dbv
2. No established limits.

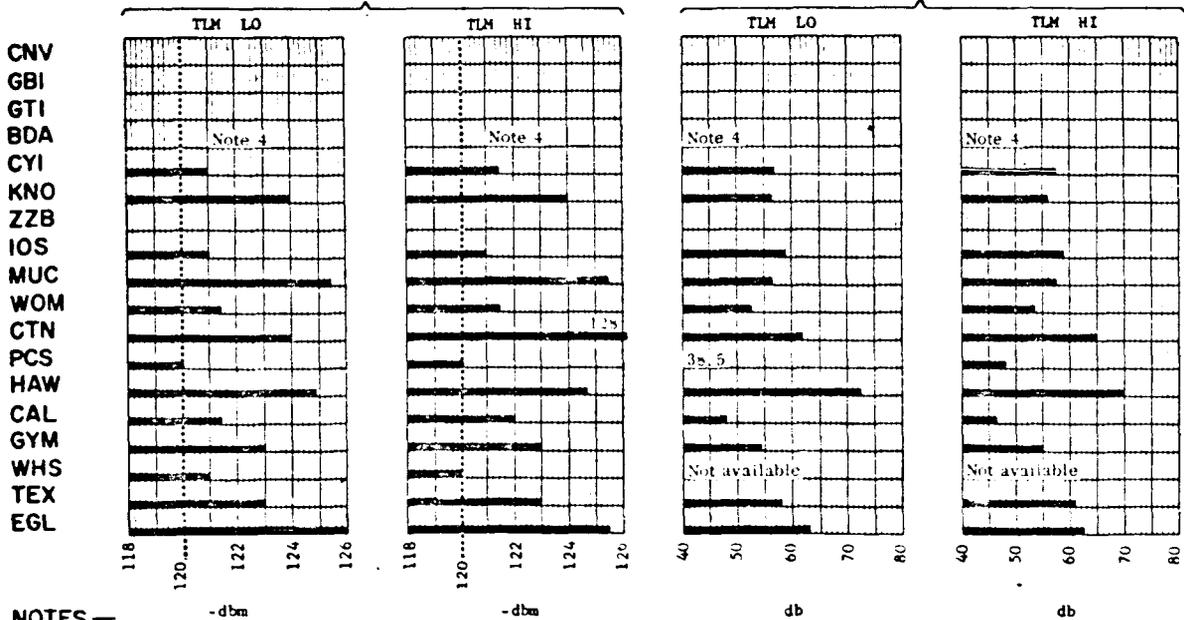
**SUM CHANNEL THRESHOLD**

**SPACE PATH LOSS (Note 3)**

1. Minimum limit .....
2. Network average  
     TLM HI -123.2 dbm  
     TLM LO -123.5 dbm
3. Values indicate characteristics of individual sites for reference only.
4. Test procedure does not conform to this presentation.

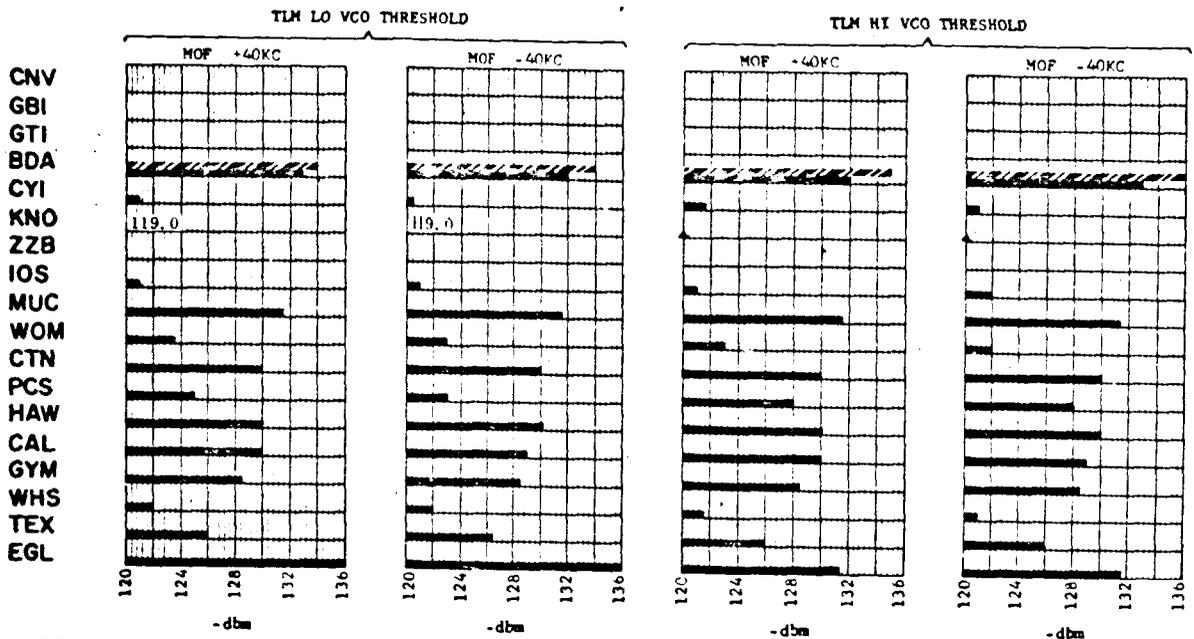
ACQUISITION  
Detailed System Test (DST 110)  
NCC-462 Mission

1. Maximum limits: MOF -40KC within  $\pm 1.0$  db of MOF +40KC.
2. Town Hill Coopers Island
3. Network averages provides no evaluation criteria.

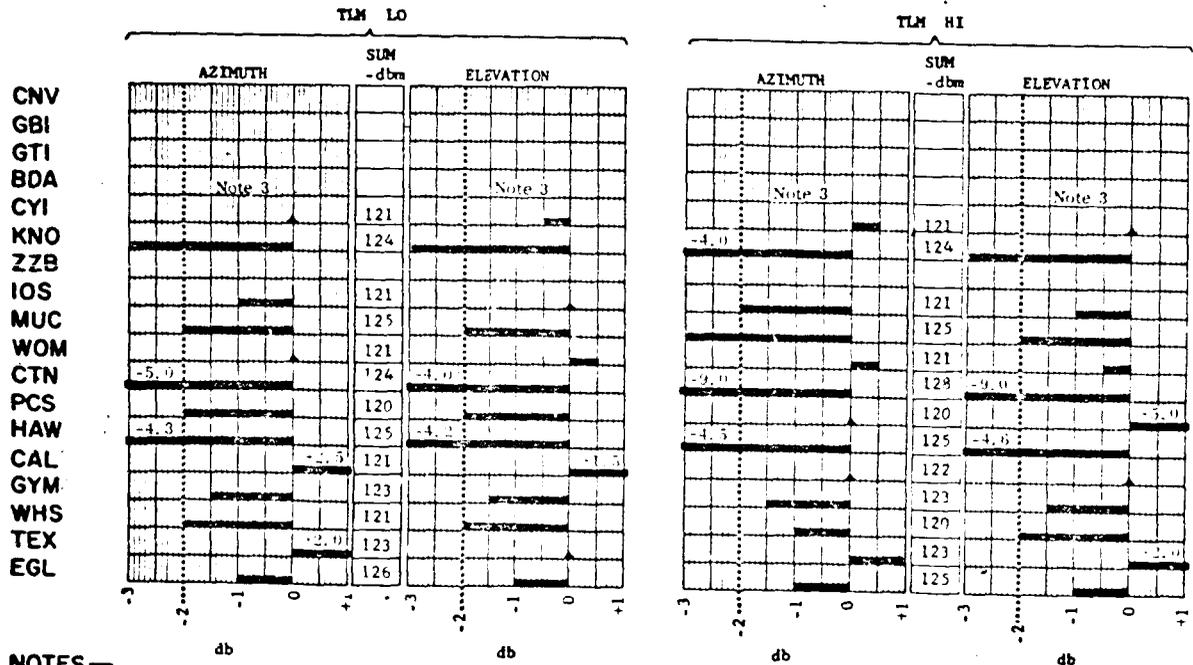
THRESHOLD OF ERROR CHANNELS

ACQUISITION  
Detailed System Test (DST 110)  
NCC-462 Mission

1. Minimum limit not more than -2.0 db of sum channel
2. Network average  
TLM LO -121.8 dbm Azimuth & Elevation  
TLM HI -121.4 dbm Azimuth & Elevation
3. Test Procedure does not conform to this presentation

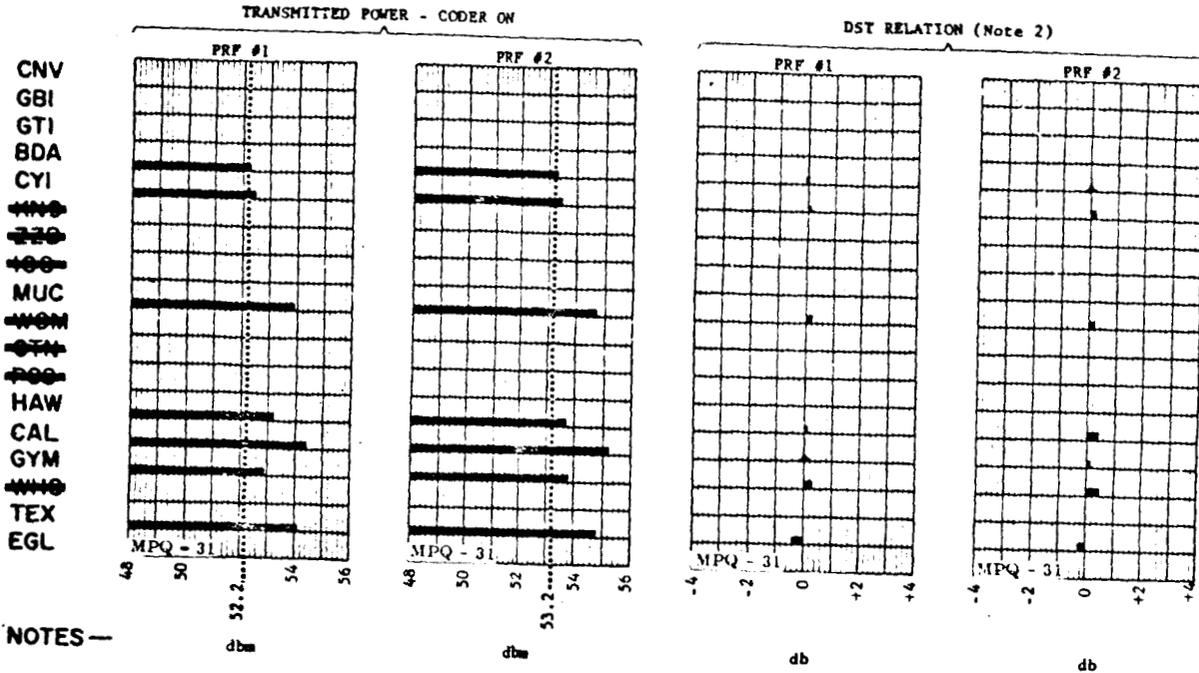
S-BAND RADAR  
Brief System Test (BST 101-1)  
NCG-462 Mission

1. Minimum limit .....
2. Values represent increase or decrease from measurements of the DST

The BST group shows the values obtained from checks conducted during the countdown period. A part of each chart is headed "DST RELATION", which indicates the amount of test improvement or deterioration that occurred since the DST check was made.

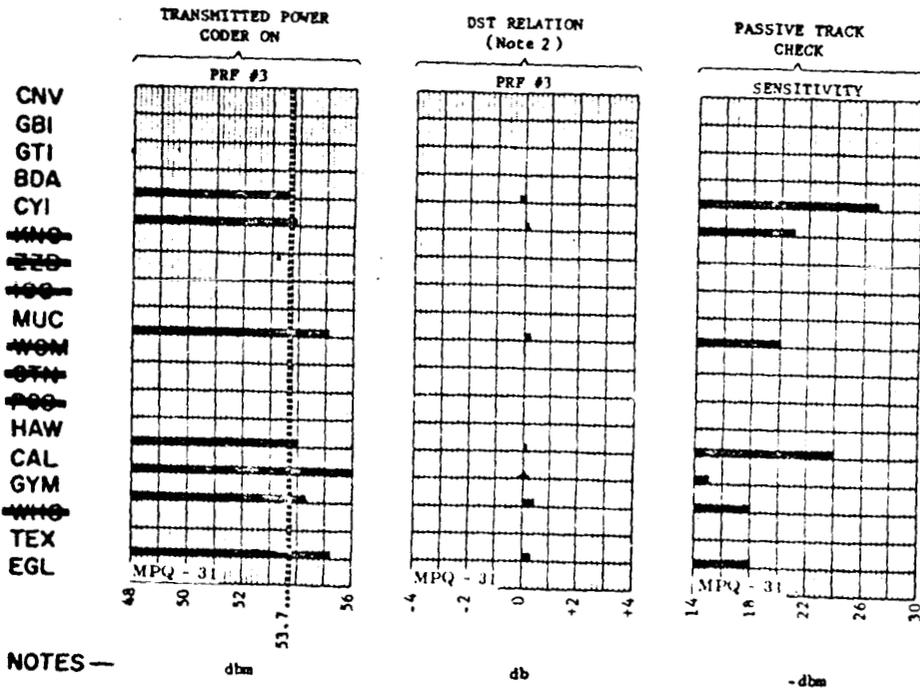
S-BAND RADAR  
Brief System Test (BST 101-1)  
NCG-462 Mission

1. Minimum limit .....
2. Values represent increase or decrease from measurements of the DST

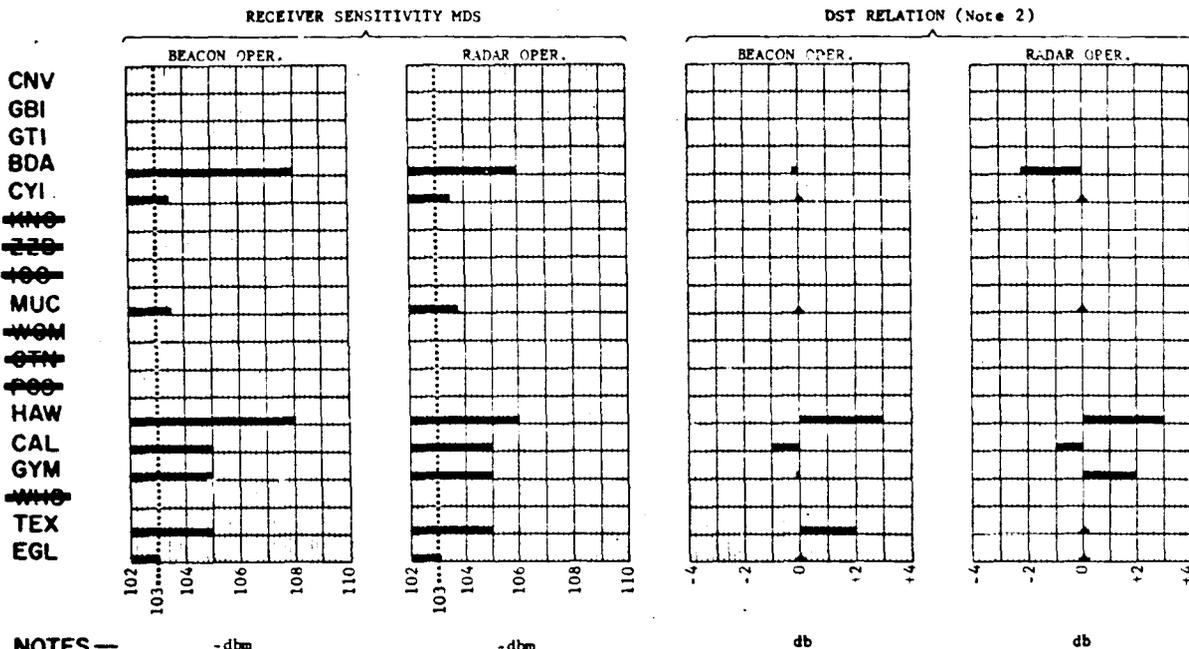
**S-BAND RADAR**  
Brief System Test (BST 101-1)  
NCC-462 Mission

1. Minimum limit .....
2. Values represent increase or decrease from measurements of the DST

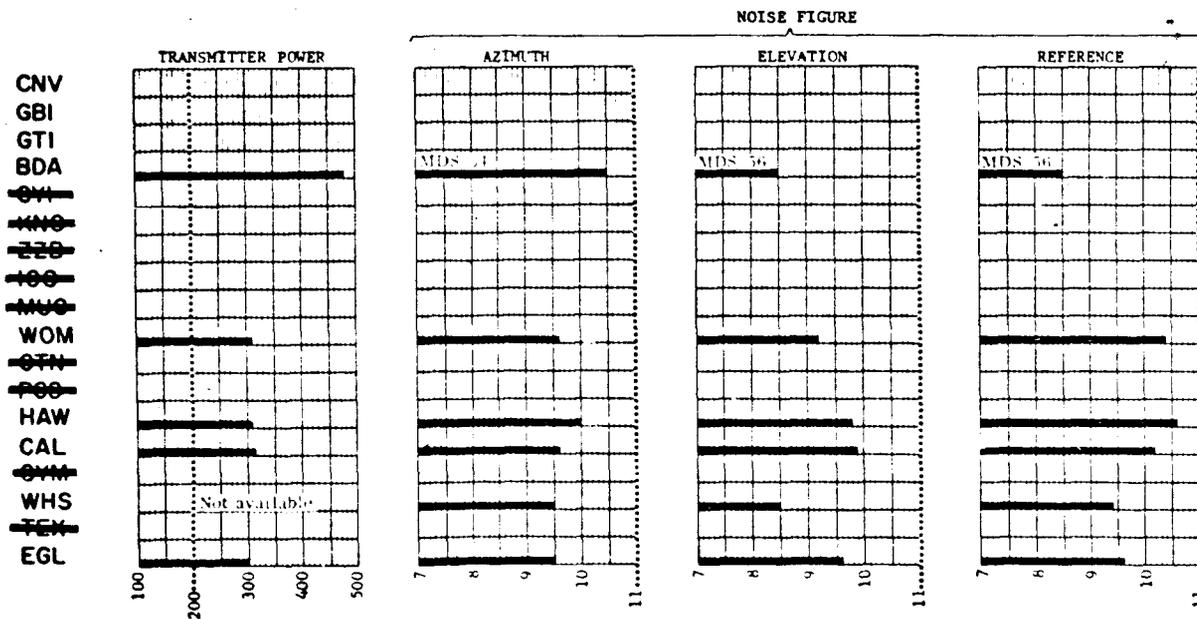
**C-BAND RADAR**  
Brief System Test (BST 101-2)  
NCC-462 Mission

1. Minimum level of Transmitter power .....
- Maximum level of Noise figure .....

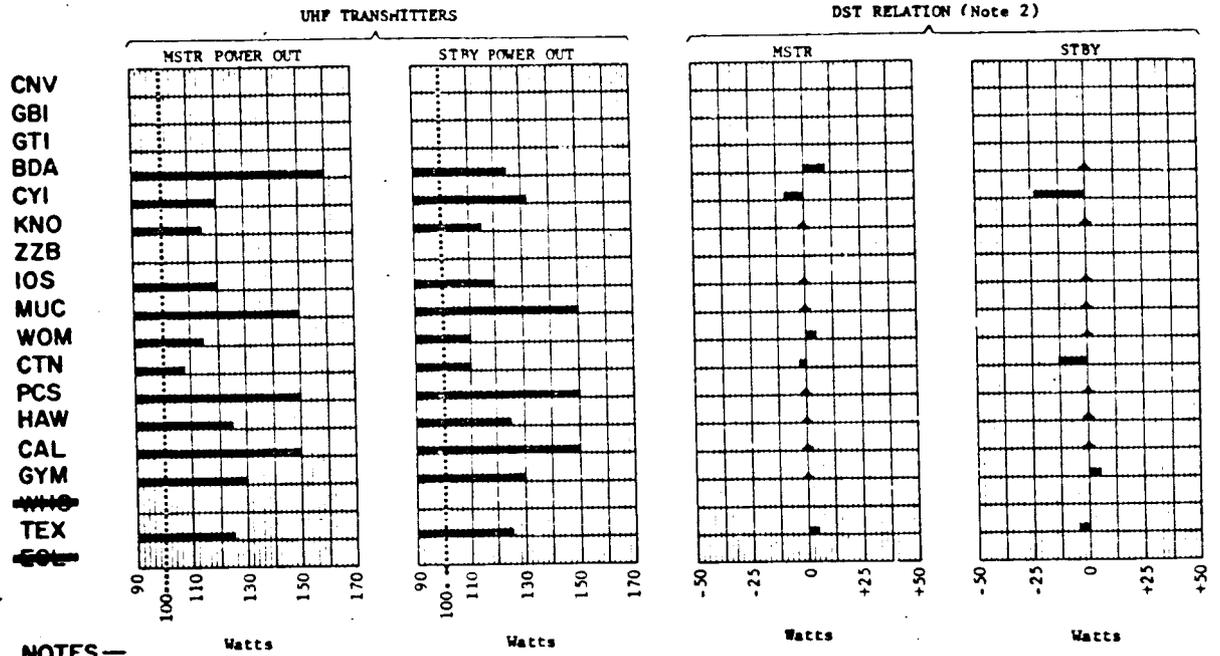
AIR/GROUND COMMUNICATIONS  
 Brief System Test (BST 102)  
 NCG-462 Mission

1. Minimum limit .....
2. Value represents increase or decrease from measurements of the DST

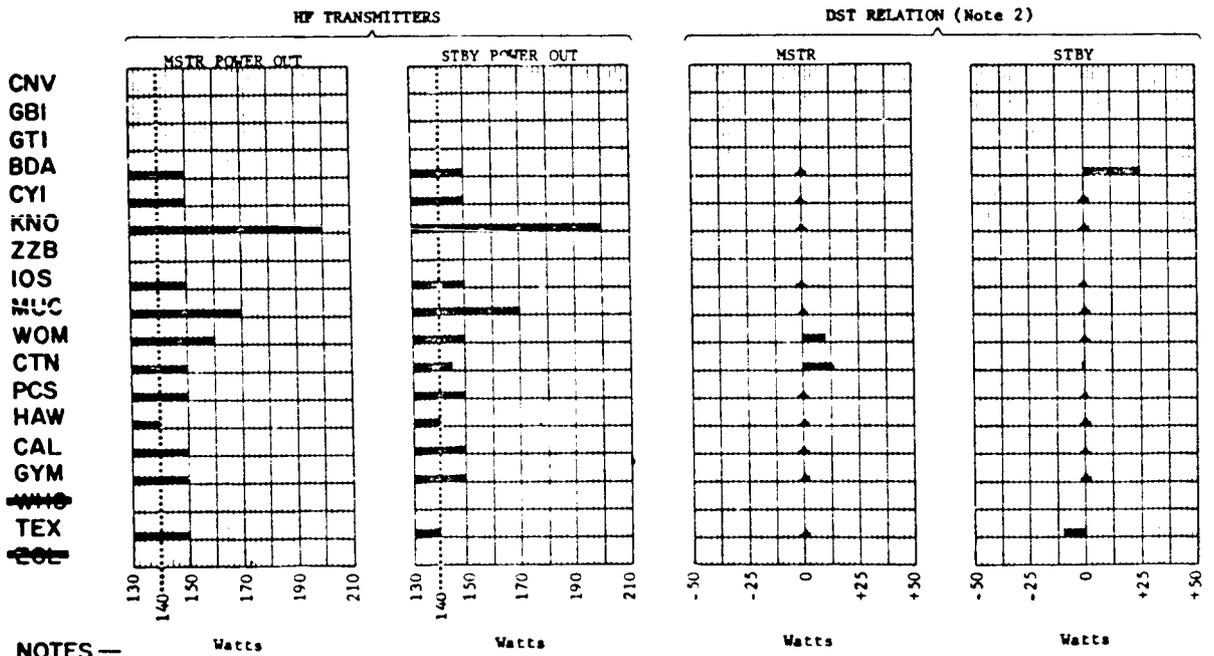
AIR/GROUND COMMUNICATIONS  
 Brief System Test (BST 102)  
 NCG-462 Mission

1. Minimum limit .....
2. Value represents increase or decrease from measurements of the DST

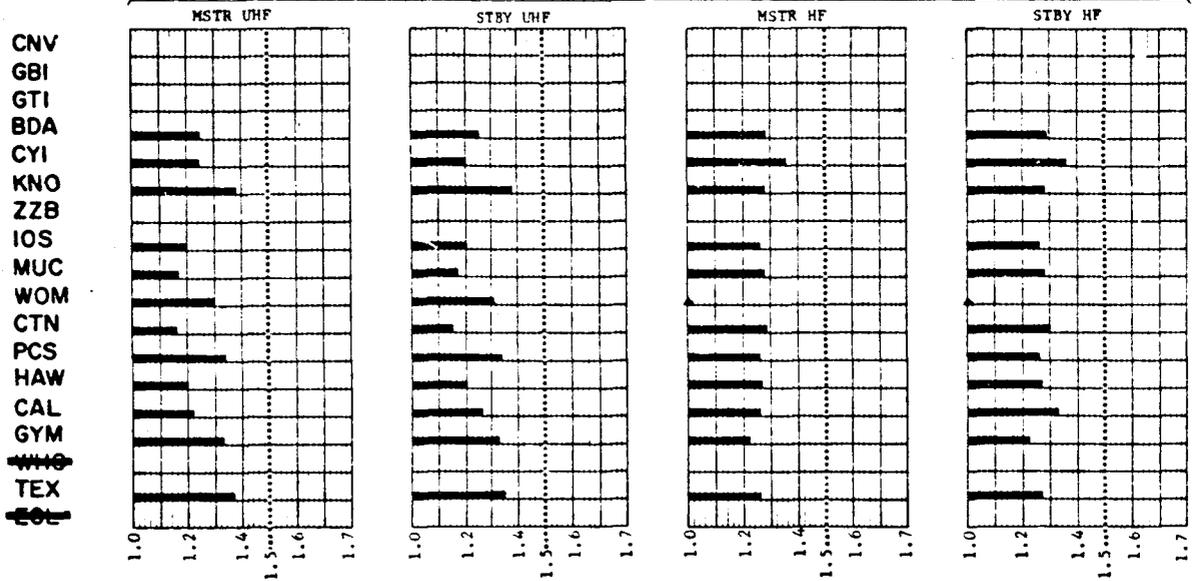
VSWR OF TRANSMITTERS

AIR/GROUND COMMUNICATIONS  
 Brief System Test (AST 102)  
 NCG-462 Mission

- NOTES—
1. Maximum limit -----
  2. All values referenced to unity

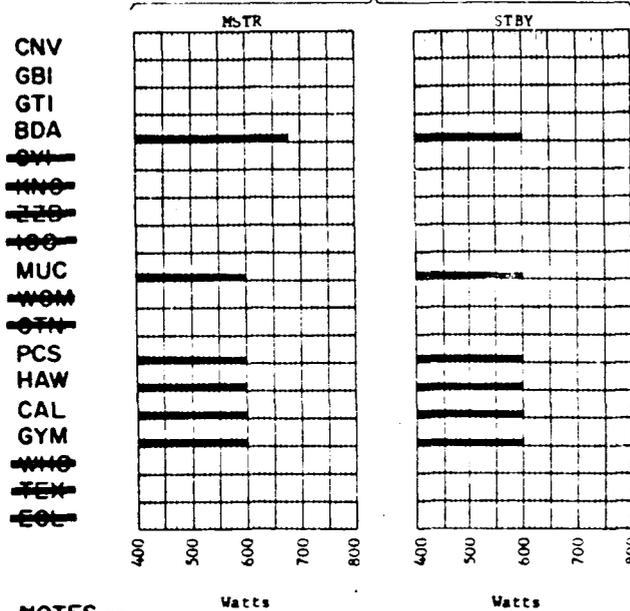
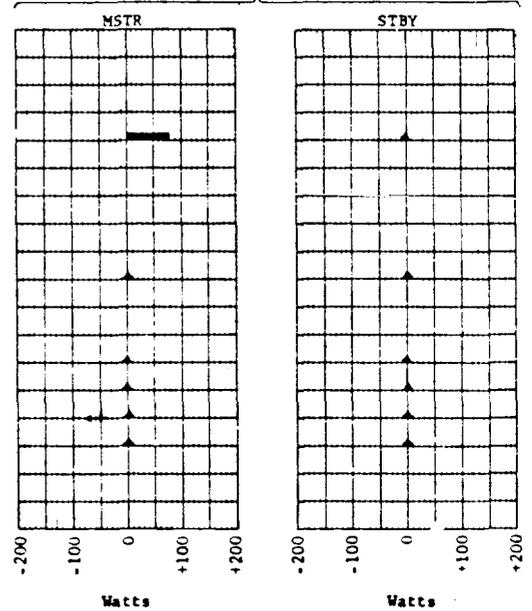
FRW-2 POWER OUTPUT

COMMAND CONTROL TRANSMITTERS  
 Brief System Test (BST 103)  
 NCG-462 Mission

DST RELATION (Note 1)

- NOTES—
1. Values represent increase or decrease from measurements of the DST

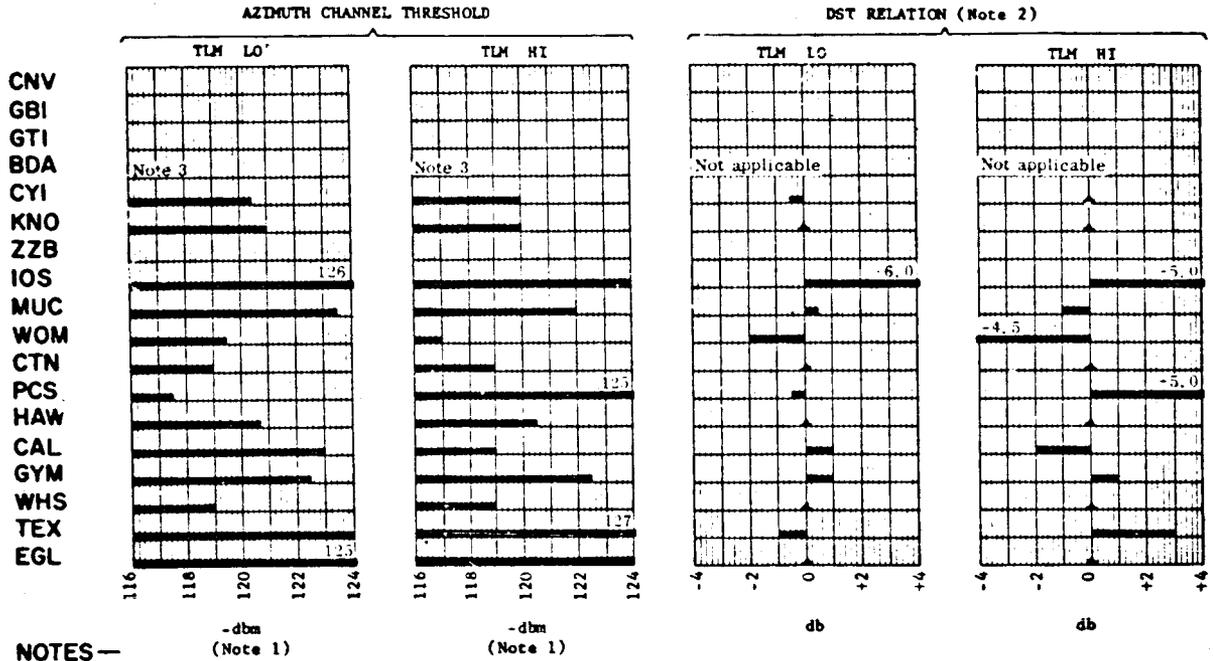
ACQUISITION  
Brief System Test (BST 110)  
MCG-462 Mission

1. Requirement: Not more than -2.0 db below sum channel
2. Values indicate BST difference from the previous DST measurement and should not exceed  $\pm 2.0$  db.
3. Test procedure does not conform to this presentation.

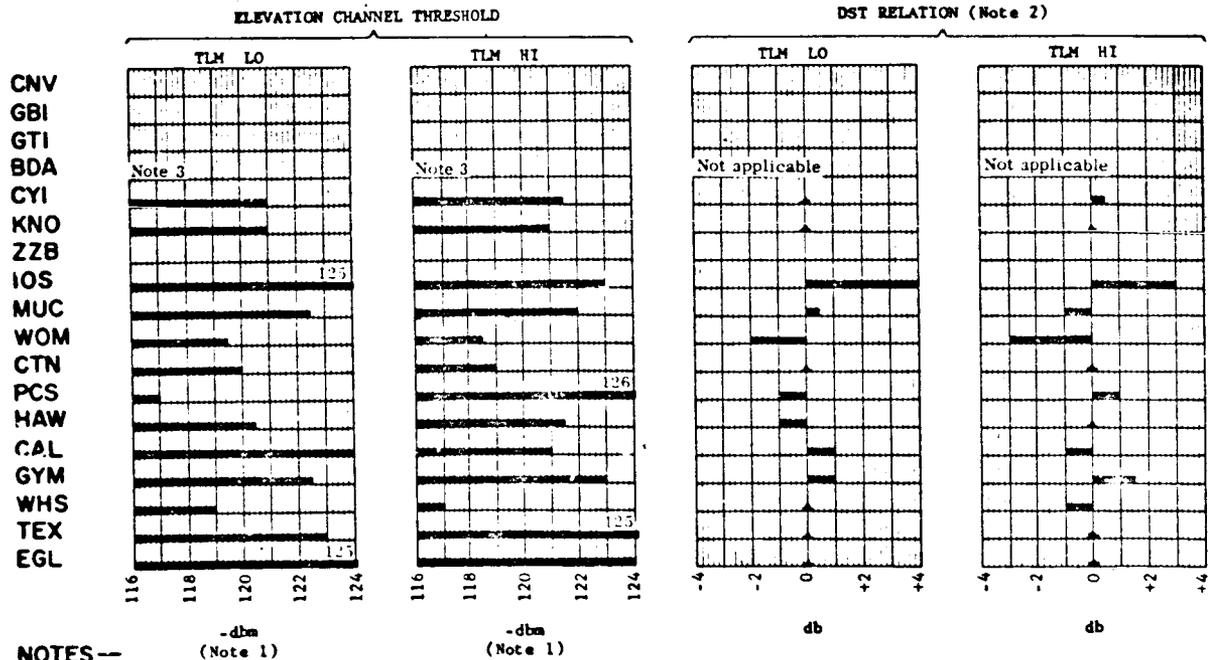
ACQUISITION  
Brief System Test (BST 110)  
MCG-462 Mission

1. Requirement: Not more than -2.0 db below sum channel
2. Values indicate BST difference from the previous DST measurement and should not exceed  $\pm 2.0$  db.
3. Test procedure does not conform to this presentation.

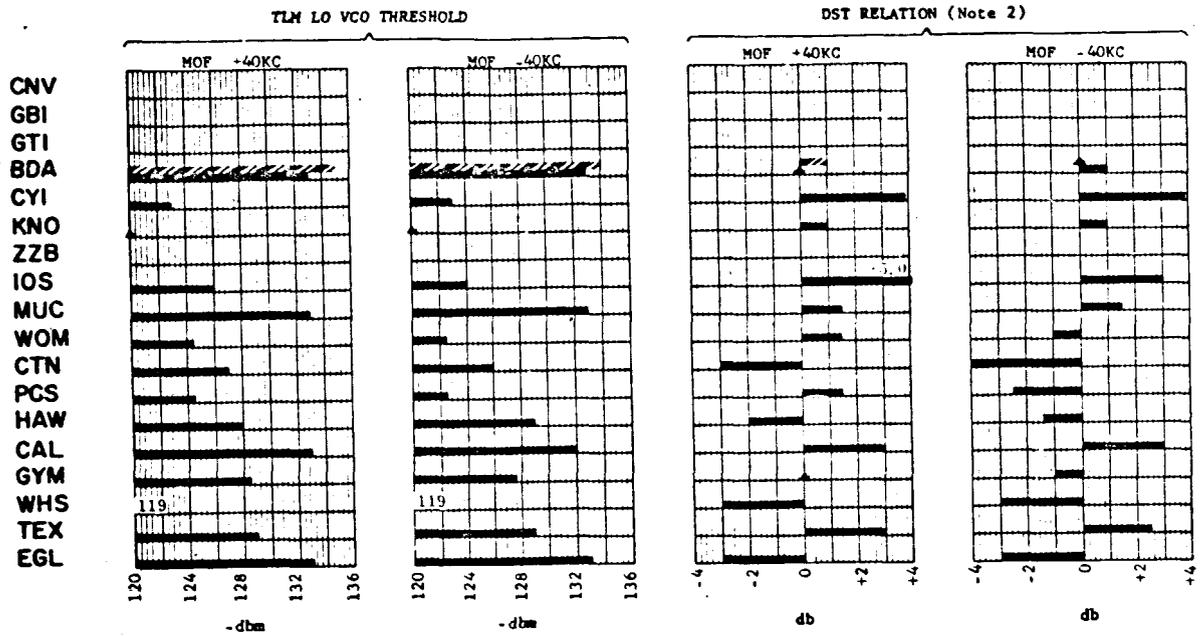
ACQUISITION  
 Brief System Test (BST 110)  
 WCG-462 Mission

1. Maximum limits: MOP +40KC within  $\pm 2.0$  db of MOP -40KC.
2. Values indicate BST difference from the previous DST measurement and should not exceed  $\pm 2.0$  db.
3. Town Hill Coopers Island
