ANALYSIS OF SPACECRAFT ANOMALIES

By Charles E. Bloomquist and Winifred C. Graham

PRC R-1833

Prepared under Contract No. NAS 2-9041

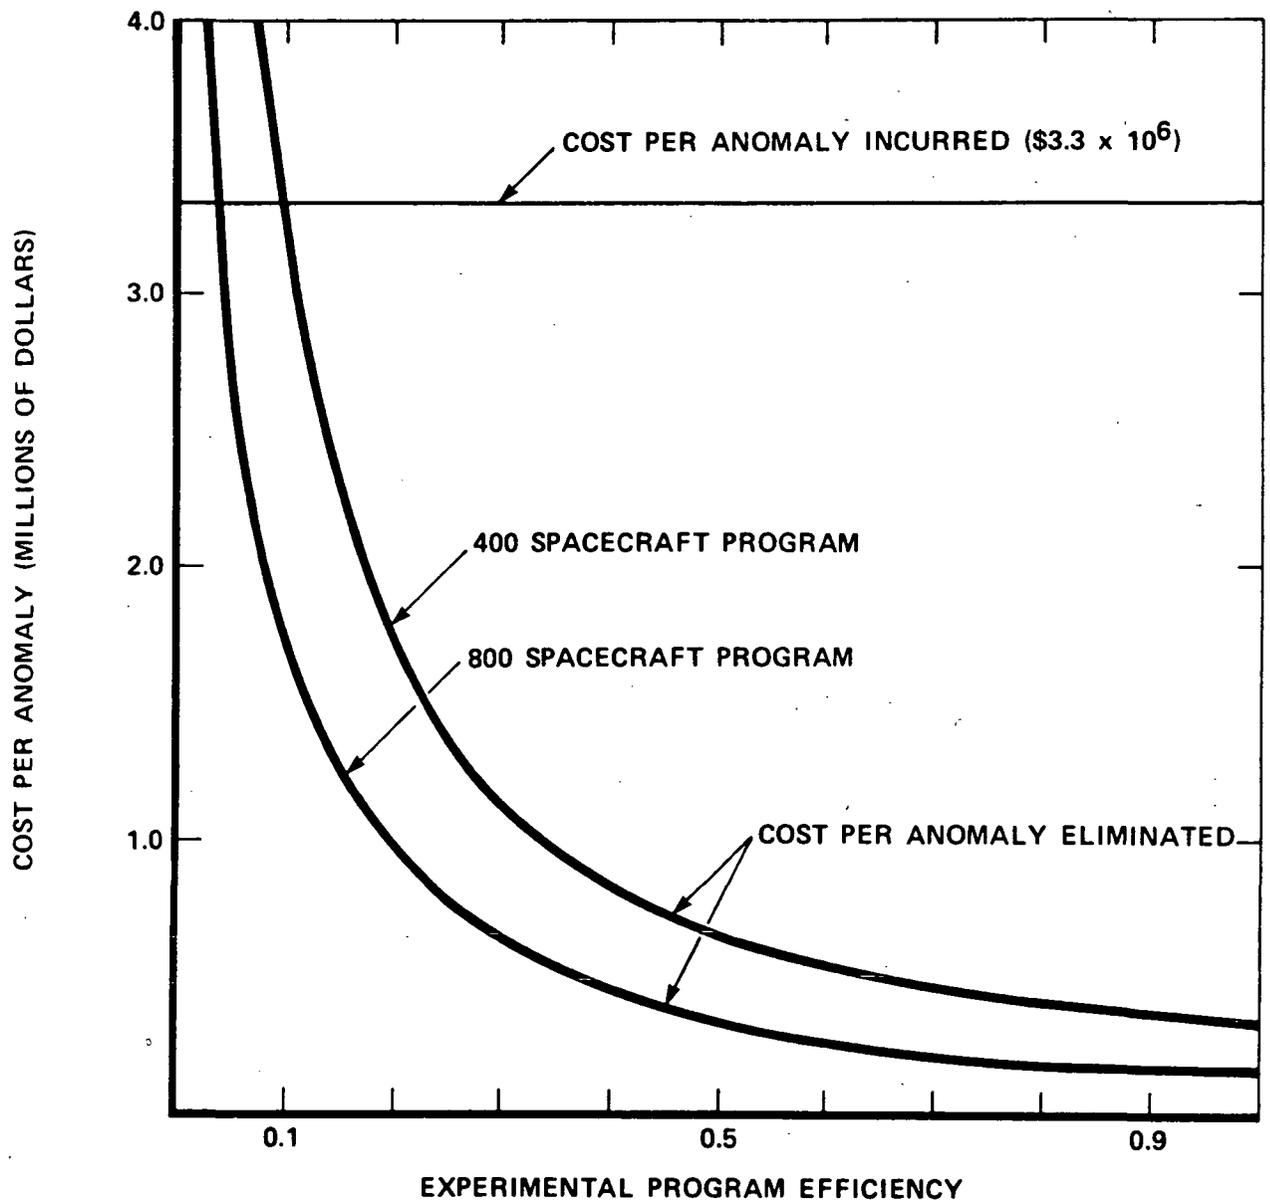
EXHIBIT V-1 - ECONOMIC VIABILITY OF RECOMMENDED EXPERIMENTAL PROGRAMS

The impact of the experimental program is shown graphically in Exhibit V-1. Without the program, there will be six anomalies per spacecraft, on the average, each of which will cost about \$3.3 million. This is represented by the horizontal line in Exhibit V-1. Implementation of the experimental program will result in the elimination of a certain number of anomalies from the Shuttle era spacecraft, depending on the number of spacecraft and the efficiency of the experimental program. From the tabulation above, which shows anomalies eliminated for two assumptions of program size and three levels of experimental program efficiency, it can be seen that the larger the space program or the more efficient the experimental program, the less the cost per anomaly eliminated. This is

represented by the two curves in Exhibit V-1. The program is justified wherever the horizontal line exceeds the curved line, i.e., for any efficiency greater than 10 percent for a 400 spacecraft program, and any experimental program efficiency greater than five percent for an 800-spacecraft program.
