PRE AND POST ANNEALING OF MECHANICAL DAMAGE IN SILICON WAFERS

G. H. Schwuttke

IBM East Fishkill Laboratories

ABSTRACT

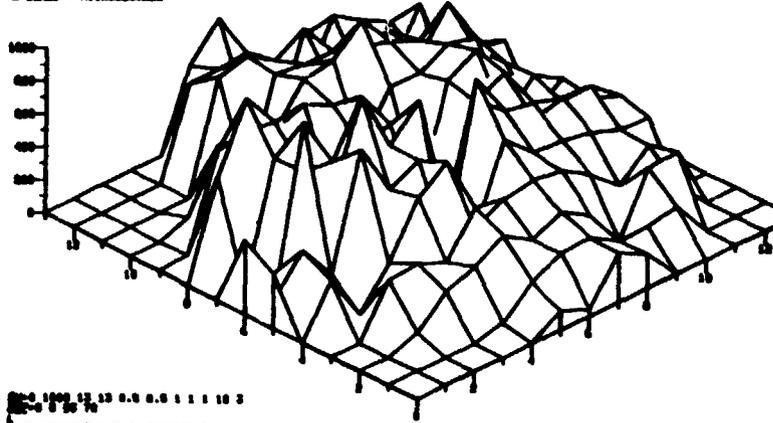
Fig. 1. Generation lifetime maps of silicon wafers. (a) Standard wafer after silicon dioxide polishing. (b) Same as (a) only one half of wafer surface contains residual mechanical damage. Note decrease of lifetime by 4 orders of magnitude in this part.

Mechanical damage on silicon surfaces has significant influence on minority carrier lifetime and surface recombination velocities of carriers. This is illustrated in Figs. 1a and 1b for minority carrier lifetime. Both figures represent MOS C-t generation lifetime maps of silicon wafers. Figure 1a shows generation lifetime distributions for a "state of the art" silicon dioxide polished wafer. Average lifetime for this wafer is 400 μ sec. The results shown in Fig. 1b were obtained by first

lightly abrading half of a polished wafer surface and subsequently removing 10 μm of the abraded surface by chemical etching before MOS processing. The average lifetime in the damaged wafer half is 0.07 μsec as compared to 300 μsec obtained in the undamaged part of the wafer. This 4 order of magnitude decrease in lifetime in the damaged part of the wafer is due to dislocations and stacking faults. Such defects are the annealing product of mechanical damage in silicon. This subject is discussed in the next section of this review.

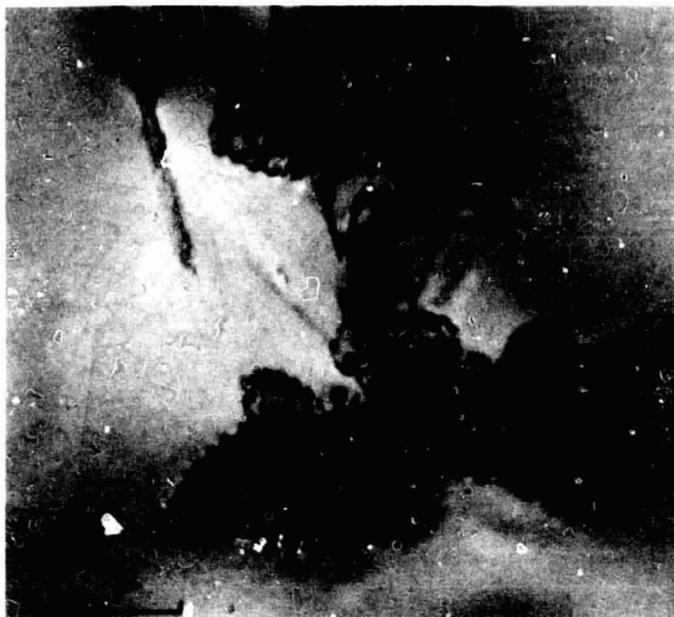
Fig. 2 Transmission electron micrograph of crack in silicon.

In general all three effects are present simultaneously. Thus the lattice distortions overlap and produce a rather complicated Moire pattern if observed in the transmission electron microscope (TEM). Simple patterns are seen for cracks lying in cleavage planes. Such Moires consists of pure translational fringes and the crack image looks very much like a stacking fault. This similarity is very striking if "closure" of the crack has taken place. This is always the case for areas close to the crack tip. Examples are given in the micrographs of Figs. 2.

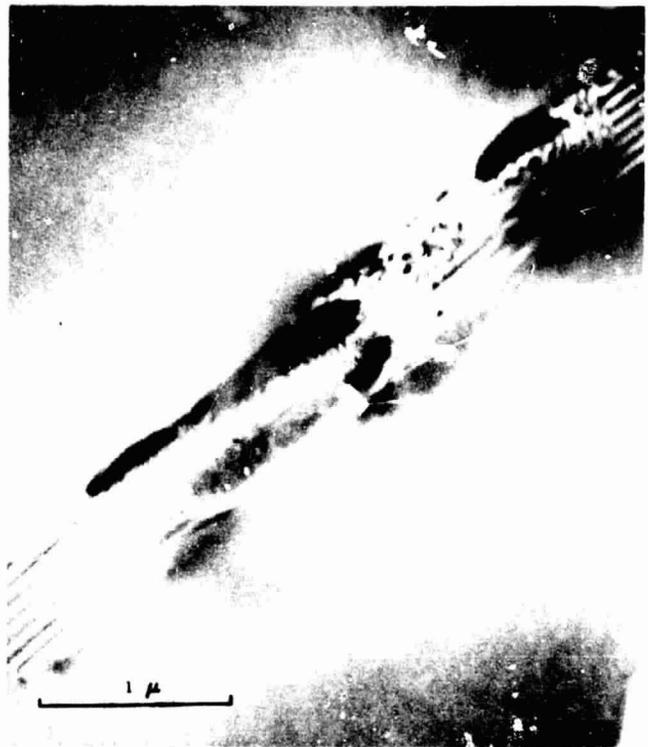
Fig. 5. Transmission electron micrograph of stacking fault nucleation through annealing of microcrack.

Microcracks can be annealed out, specifically, if such splits are located in $\{111\}$ planes. Assuming that "block slip"¹² governs crack formation it appears plausible that bonding between the silicon atoms in the vicinity of the crack tip is re-established through high temperature relaxation. Thus fairly large crack areas (micron range) can heal and 60° - and 90° - dislocations are the healing product of this process. Sub-micron cracks cause a much smaller displacement between the split crystal parts and stacking fault nucleation may occur directly through rebonding of the silicon atoms if the displacement "R" of the free crystal surfaces is of the right order of magnitude. This is shown very clearly in the TEM - micrograph of Fig. 5 and is an important mechanism for the annealing of abrasion damage as discussed in the next section.

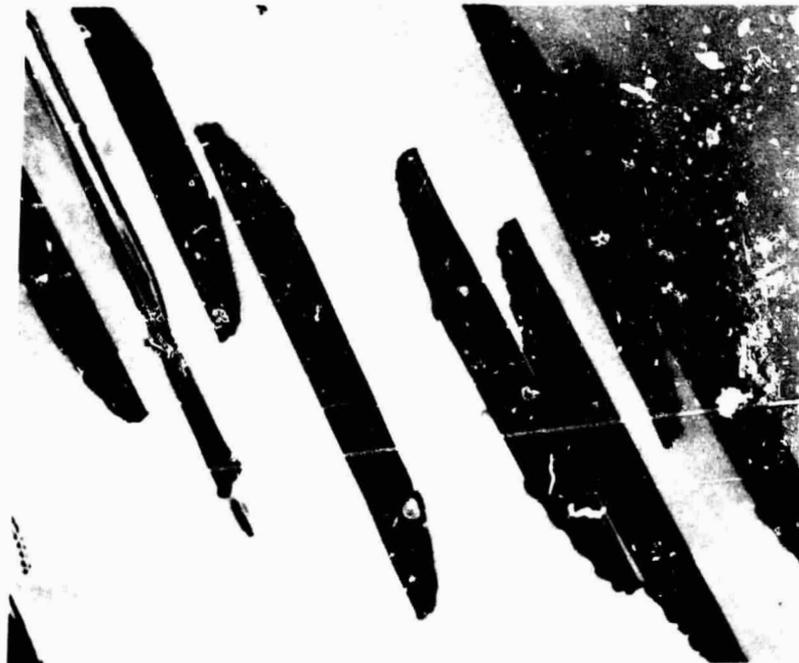
Fig. 7 Transmission electron micrograph of annealed abrasion damage showing stacking faults.

Experimental evidence indicates that annealing of abraded silicon surfaces generates stacking faults (Fig. 7). The most frequently studied nucleation model for stacking faults¹³ relies on a dislocation reaction first pointed out by Hirsch¹³ and assumes that mechanical damage produces prismatic dislocations which form stacking faults according to the reaction: $(a/2)$ $[\bar{1}\bar{1}0] \rightarrow (a/3)$ $[\bar{1}\bar{1}\bar{1}] + (a/6)$ $[\bar{1}\bar{1}\bar{2}]$. However, our measurements indicate that dislocation loops introduced through abrasive damage are shear loops. A shear loop cannot dissociate as required by the Hirsch reaction. Consequently, the generally accepted prismatic loop nucleation mechanism for oxidation induced stacking faults cannot explain stacking fault nucleation.
