A Repair Technology Program at NASA on Composite Materials

AUGUST 1982

Jerry W. Deaton
Langley Research Center
Hampton, Virginia

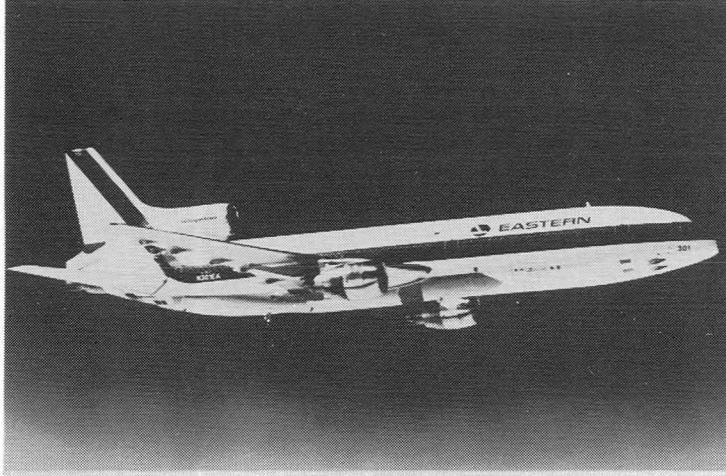
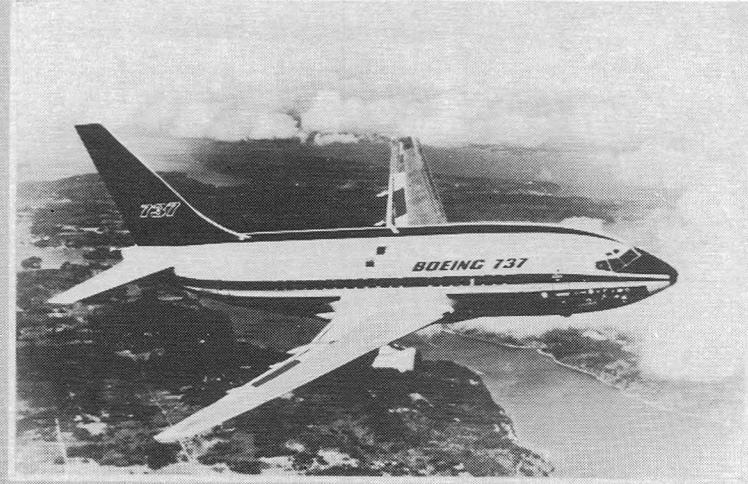
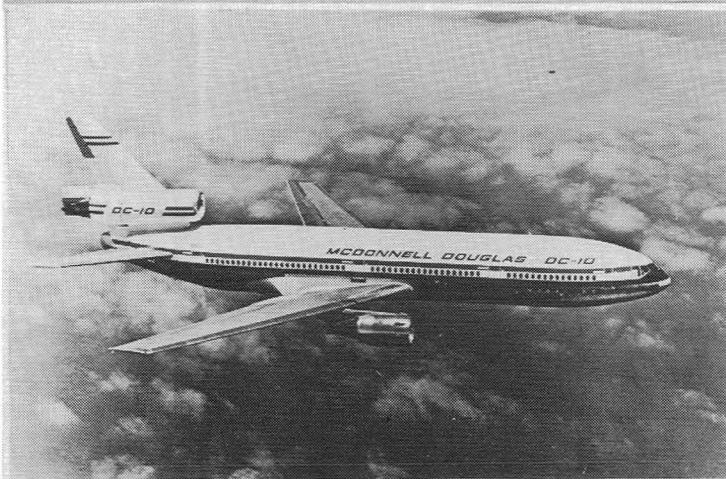
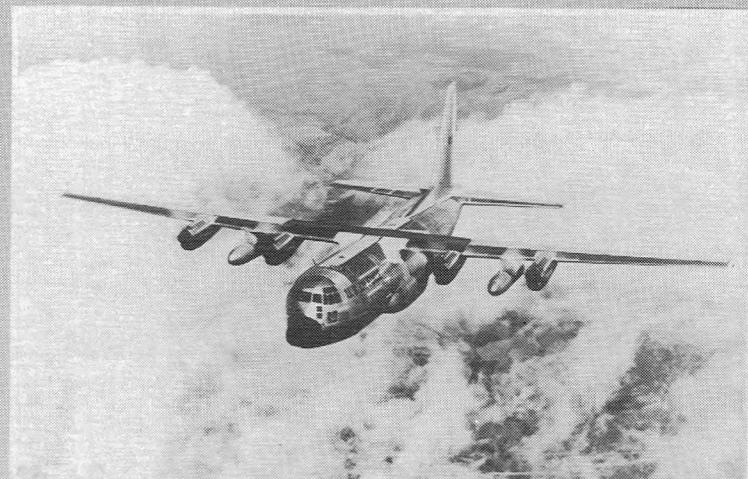
L-1011 fairing

737 spoiler

DC-10 rudder and aft pylon

C-130 wing box

Figure 1.- Flight-service composite components on transport aircraft.

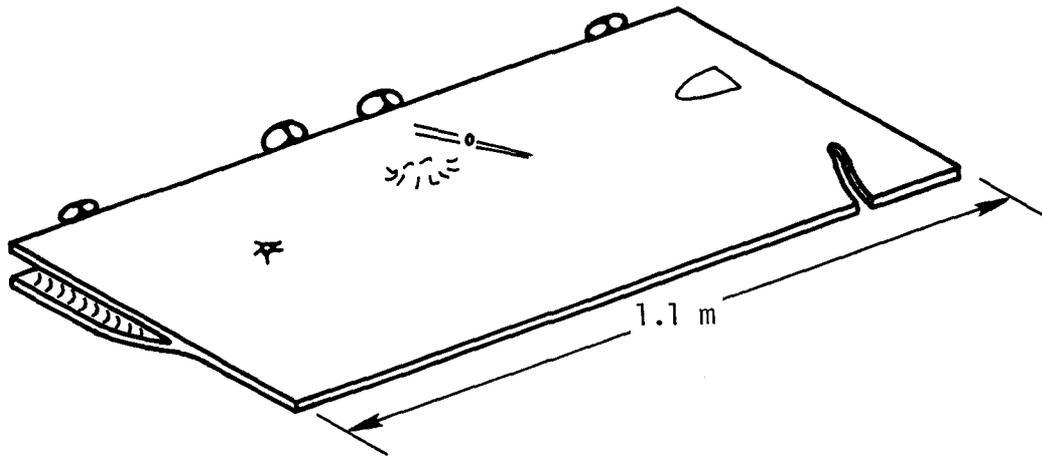
Figure 2.- Damage on graphite/epoxy 737 spoiler.

from table II indicate that some composite components from all the flight-service programs except the Lockheed C-130 center-wing box have experienced either damage or deterioration in the flight-service environment. Figure 2 illustrates some of the types of damage that have occurred on some of the Boeing 737 spoilers during 9 years of flight service. In one case, a cable cut through the trailing edge, and, in another case, sufficient clearance was not provided for an actuator-arm end fitting so that it punctured the upper-surface skin. Other types of damage include foreign-object impact. In all cases where repairs were necessary, the spoiler was removed and returned to the manufacturer for repair.

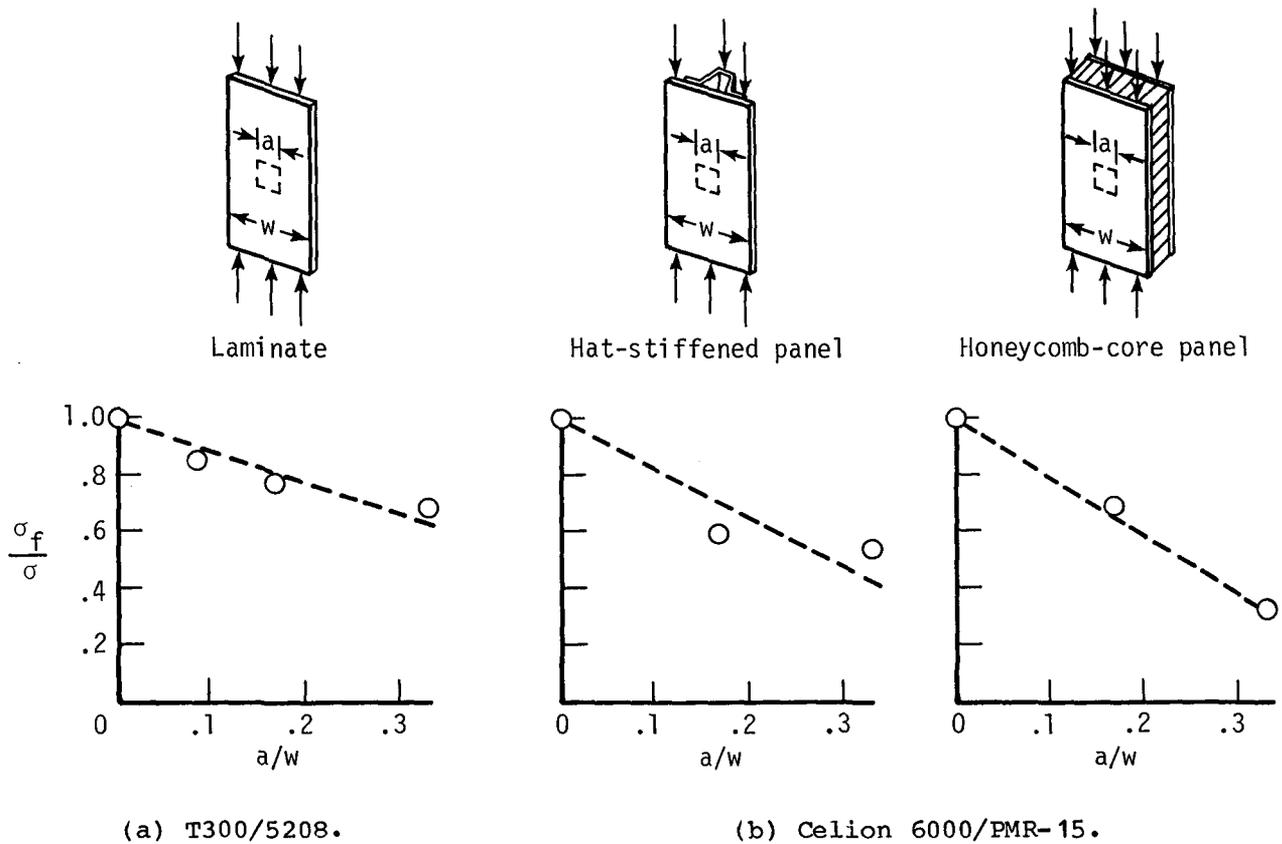
Figure 3.- Effects of delamination on performance of compression panels 0.15 m wide by 0.30 m long.

impact damage. These four flaw types were also used in the study to determine their effect on performance of stiffened elements and honeycomb-core panels representative of current and near-term aerospace applications. Figure 3 shows a typical set of data for a laminate, a hat-stiffened panel, and a honeycomb-core panel that has simulated delaminations and is subjected to compression. The delaminations were either 161, 645, or 2580 mm² in area and were made by placing one piece of 0.976-mm heat-treated Kapton¹ film on top of another during the fabrication process. All three specimens illustrated in the figure were 0.15 m wide by 0.30 m long. The data shown for the laminate are for the graphite/epoxy T300/5208, and data shown for the hat-stiffened and honeycomb-core panels are for the graphite/polyimide Celanese Celion 6000/PMR-15. The compression strength, normalized as a percent of unflawed strength, is plotted as a function of the ratio of delamination width to panel width. For a 5-cm delamination in the laminate, a 30-percent reduction in the compression strength was observed, whereas for the same size of delamination in the hat-stiffened and honeycomb-core panels, 40-percent and 60-percent reductions in the compression strength were observed, respectively.

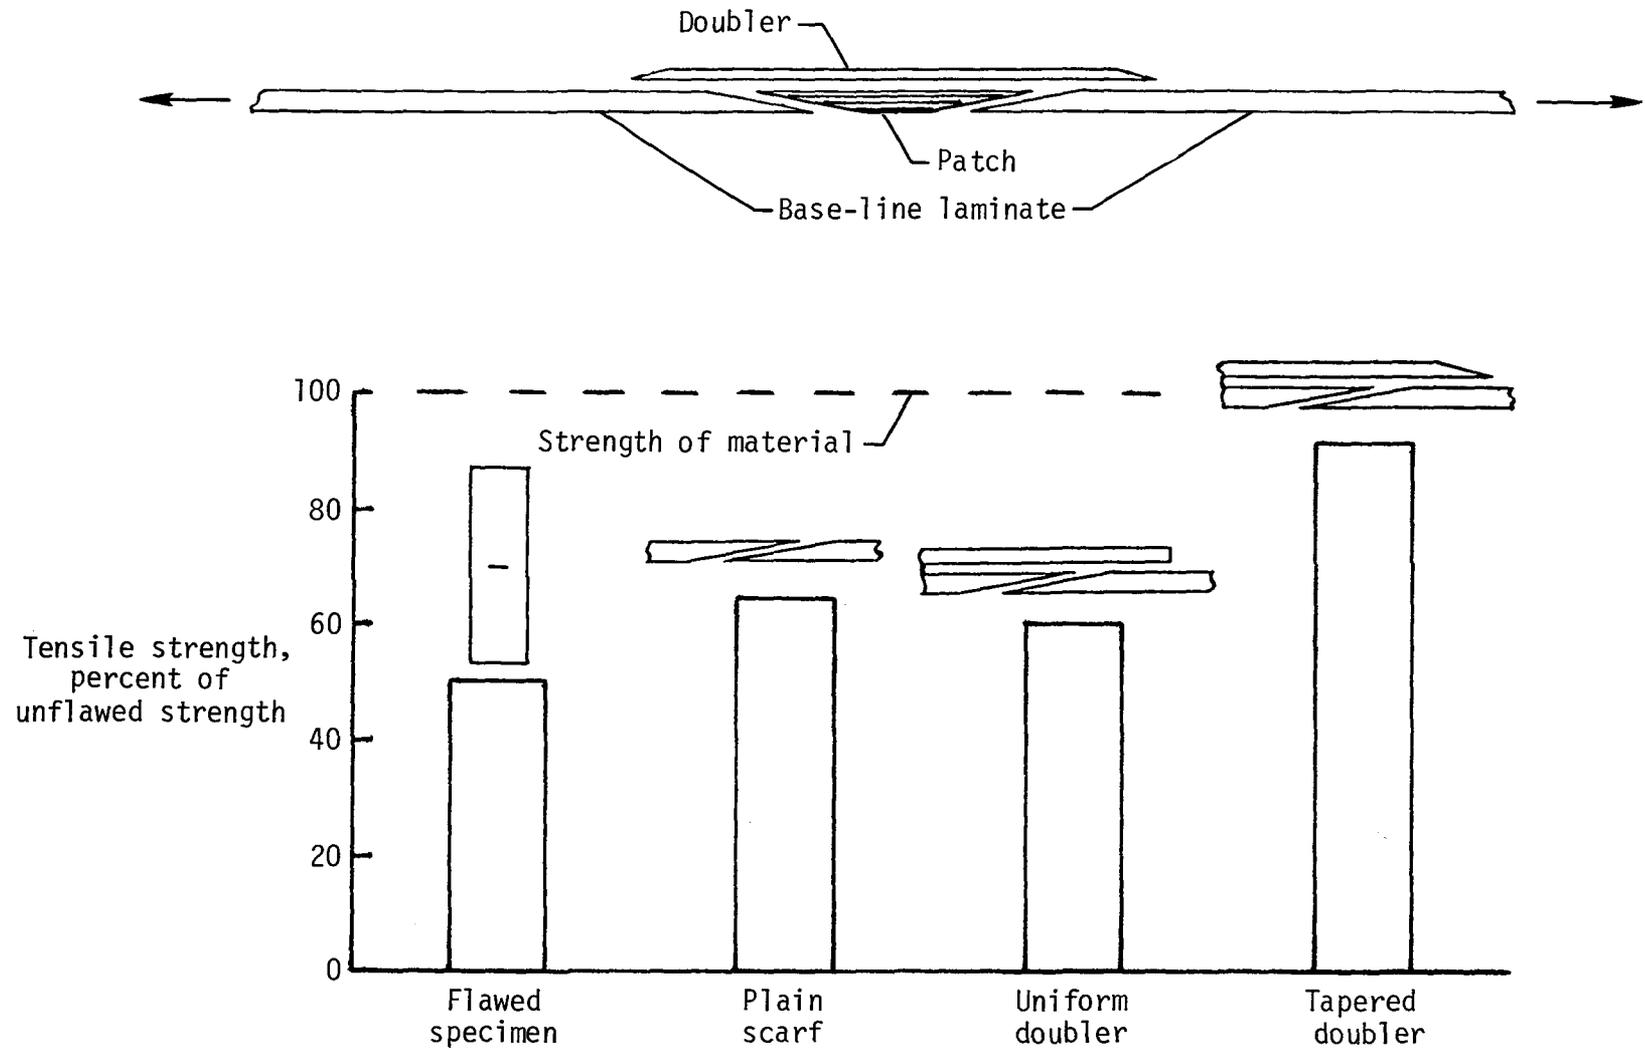
Figure 4.- Strength of repaired AS/3501-6 laminates.

After deciding that a detected flaw is detrimental to the use of the structural component, repair procedures must be developed and validated that are adaptable to current maintenance operations and that meet the basic criteria for restoring design strength and service life to the repaired component. Figure 4 gives results for three repair procedures being studied at the University of Delaware under NASA grant NSG-1304, "Damage Repair Technology in Composite Materials." (See ref. 14.) Shown at the top of the figure is a cross section of a scarf repair to a damaged laminate. The damaged area is first cleaned out by a machining operation. A machined precured patch is then adhesively bonded in the cleaned-out area and a doubler of the same material may or may not be added. The data shown are for a graphite/epoxy AS/3501-6 laminate having a ply orientation of $(0_2/\pm 45/90/\pm 45/0_2)_s$. The first bar shows a 50-percent reduction in tensile strength for a specimen that has a 1.3-cm slot. The next bar shows that a plain-scarf repair for a severed laminate restores 65 percent of the tensile strength. The next bar shows that the addition of a uniform doubler does not increase the tensile capability over the plain scarf. This is due to the existence of a large peeling stress at the end of the doubler which initiates failure. However, if the doubler is tapered as indicated in the last bar, then 90 per-

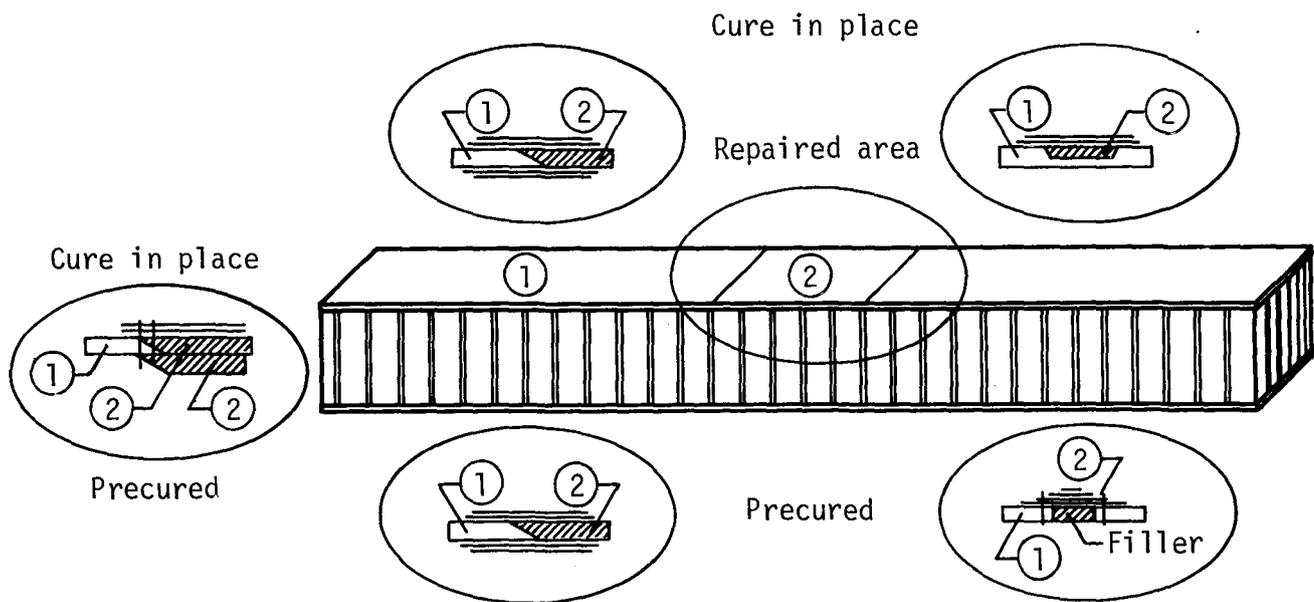
Figure 5.- Repair concepts and specimen for evaluation: ① indicates base-line laminate; ② indicates repaired area.

Under contract NAS1-15269, "Development, Demonstration, and Verification of Repair Techniques and Processes for Graphite/Epoxy Structures for Commercial Transport Aircraft," the Lockheed-California Company is developing and evaluating repair procedures for Gr/E composites. Figure 5 shows schematically some of the repair concepts evaluated. Two laminate configurations were used as the parent laminate: a 16-ply laminate, representative of current lightly loaded composite applications; and a 50-ply laminate, representative of highly loaded applications such as a wing cover. The significant variables evaluated in the program, illustrated in figure 5, include flush and external protruding repairs, precured bonded Gr/E patches, cure-in-place Gr/E patches, and a combination of cure-in-place and precured bonded repair. The test specimen used for the repair evaluation was a sandwich-beam specimen which is also shown schematically in figure 5. Damage was simulated as a cut across the laminate width which was rejoined by the repair. (See fig. 5.) All repairs were performed after the parent laminate had been conditioned to a 1-percent moisture content to simulate in-service conditions. In all cases, repairs were made with a 450 K structural adhesive and unaugmented vacuum-cure pressure. Specimens were tested from 218 K to 355 K in static tension and compression. Some fatigue specimens were also included. Figure 6 lists the repair efficiencies obtained for the concepts presented in figure 5 for 50-ply specimens tested at 355 K. The data indicate that the most effective repair concept was the flush, precured Gr/E repair, followed closely by the flush, cure-in-place Gr/E repair. The results indicate that unaugmented vacuum-cure pressure can provide satisfactory structural bonded and cure-in-place Gr/E repairs for laminates representative of highly loaded structures. Additional results from this investigation are given in reference 15.

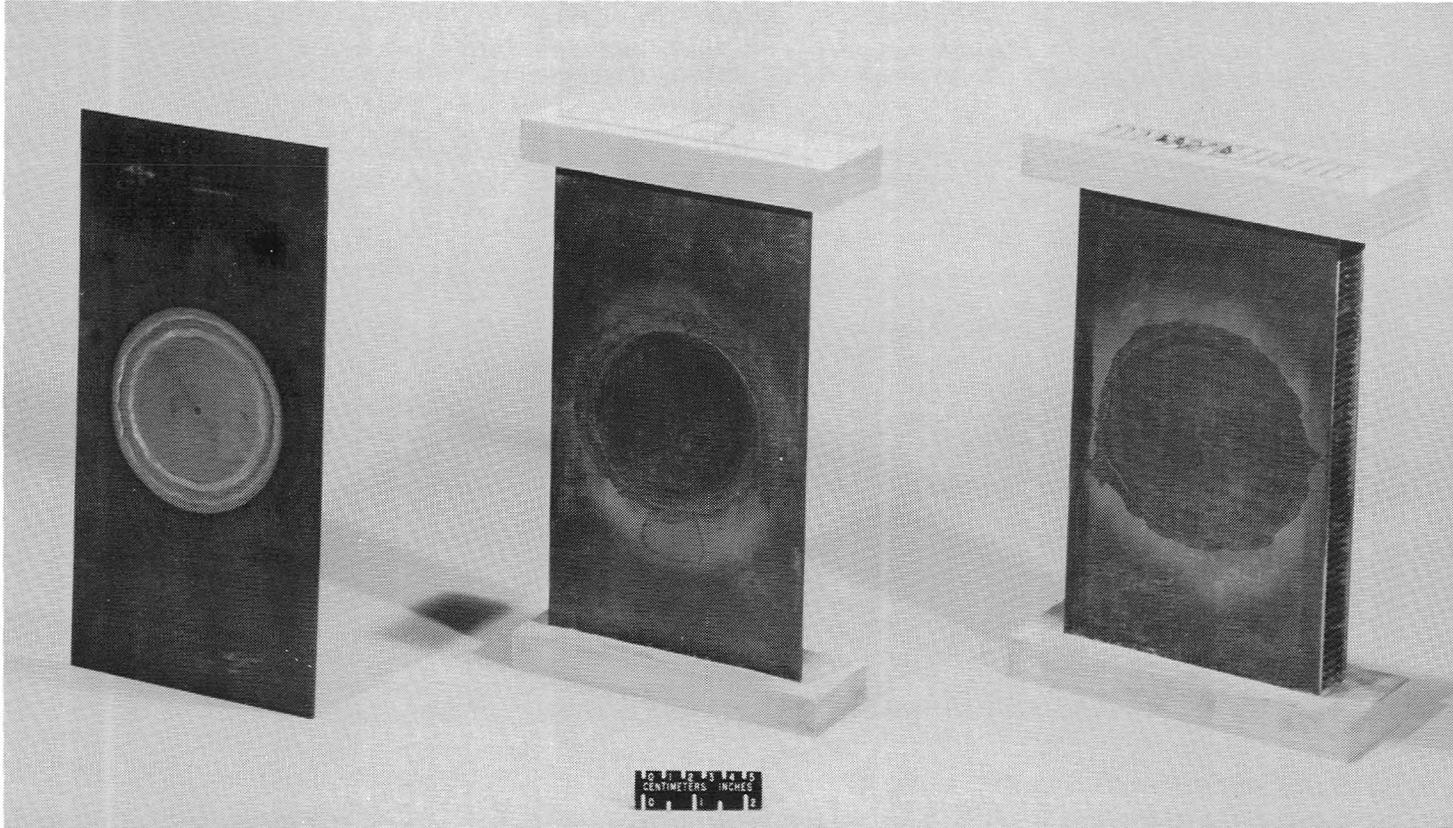
L-79-7897

Figure 8.- Repair of Gr/PI compression specimens.

The bonding of Gr/PI materials is not as well established as the bonding of Gr/E. Therefore, bonded repair techniques for Gr/PI structures are being evaluated through flexure and short-beam-shear tests on Celion 6000/PMR-15 and Celion 6000/LARC-160. The five bonding techniques being evaluated are: (1) cure in place, (2) cure in place with LARC-13 amide/imide (AI) adhesive, (3) secondary bonding with 1 ply of prepreg, (4) secondary bonding with LARC-13AI adhesive, and (5) secondary bonding with LARC-13AI adhesive on 1 ply of Type 104 E-glass carrier cloth. For the cure-in-place techniques, 5 plies of prepreg were cured onto 5-ply precured panels for preparation of the flexure specimens; and 10 plies of prepreg were cured onto 10-ply precured panels for preparation of the short-beam-shear specimens. For the secondary bonding techniques, two 5-ply precured panels were bonded together for preparation of the flexure specimens, and two 10-ply precured panels were bonded together for preparation of the short-beam-shear specimens. In all cases, the bonded panels were 25 cm square. Specimens were tested from control panels and panels bonded with the five techniques. Based on preliminary analysis of the test results, the cure-in-place and the secondary bonding with 1 ply of prepreg procedures offer the most promise for making repairs on both material systems. A typical set of results is presented in figure 7. The data shown are for unidirectional laminates. The short-beam-shear strength indicated for the control panel is the average of 10 tests, and for the cure-in-place bonding it is the average of 5 tests at each of the 5 test temperatures. Superior shear strengths are obtained for the cure-in-place panel at all test temperatures except 116 K. This trend was also observed for the flexure tests. Based on these results, cure-in-place repairs have been made on Celion 6000/PMR-15 compression specimens, as shown in figure 8, and are currently being evaluated.

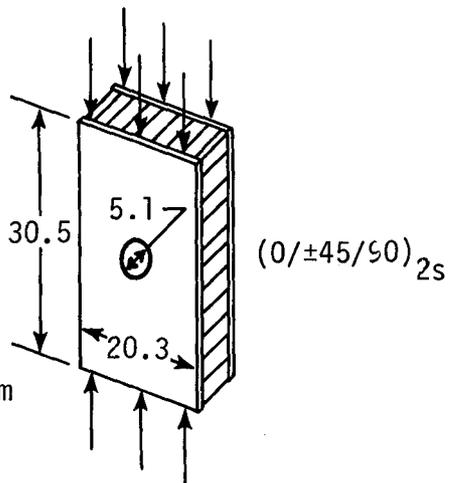
All dimensions are in cm

Specimen	Test results	
	Failure load, MN/m	Efficiency, percent
As fabricated, no hole	2.040	100
Damaged, 5.1-cm-diam. hole	1.007	49.4
Scarf repair of 5.1-cm-diam. hole	1.671	81.9

Figure 9.- Repair of Celion 6000/LARC-160 sandwich compression panels.

Additional repair specimens fabricated from Celion 6000/LARC-160 are being evaluated by Rockwell International under contract NAS1-16448, "Development, Demonstration, and Verification of Repair Techniques and Processes for Celion-6000/LARC-160 Graphite/Polyimide Composite Structures." The types of flaws that are being repaired are representative of manufacturing defects, in-service damage, and in-service deterioration. Test specimens include flat laminates, sandwich panels, and skin-stringer panels. Figure 9 presents some results for damaged and repaired Celion 6000/LARC-160 sandwich compression panels. A 5.1-cm-diameter hole in one of the face-sheet laminates reduces the compression strength more than 50 percent. A cure-in-place scarf repair for similar damage is found to increase the compression strength to within 20 percent of the no-damage condition. Although full-strength recovery was not achieved in this first test, the results are encouraging because failure occurred outside the repair location. (See fig. 10.)

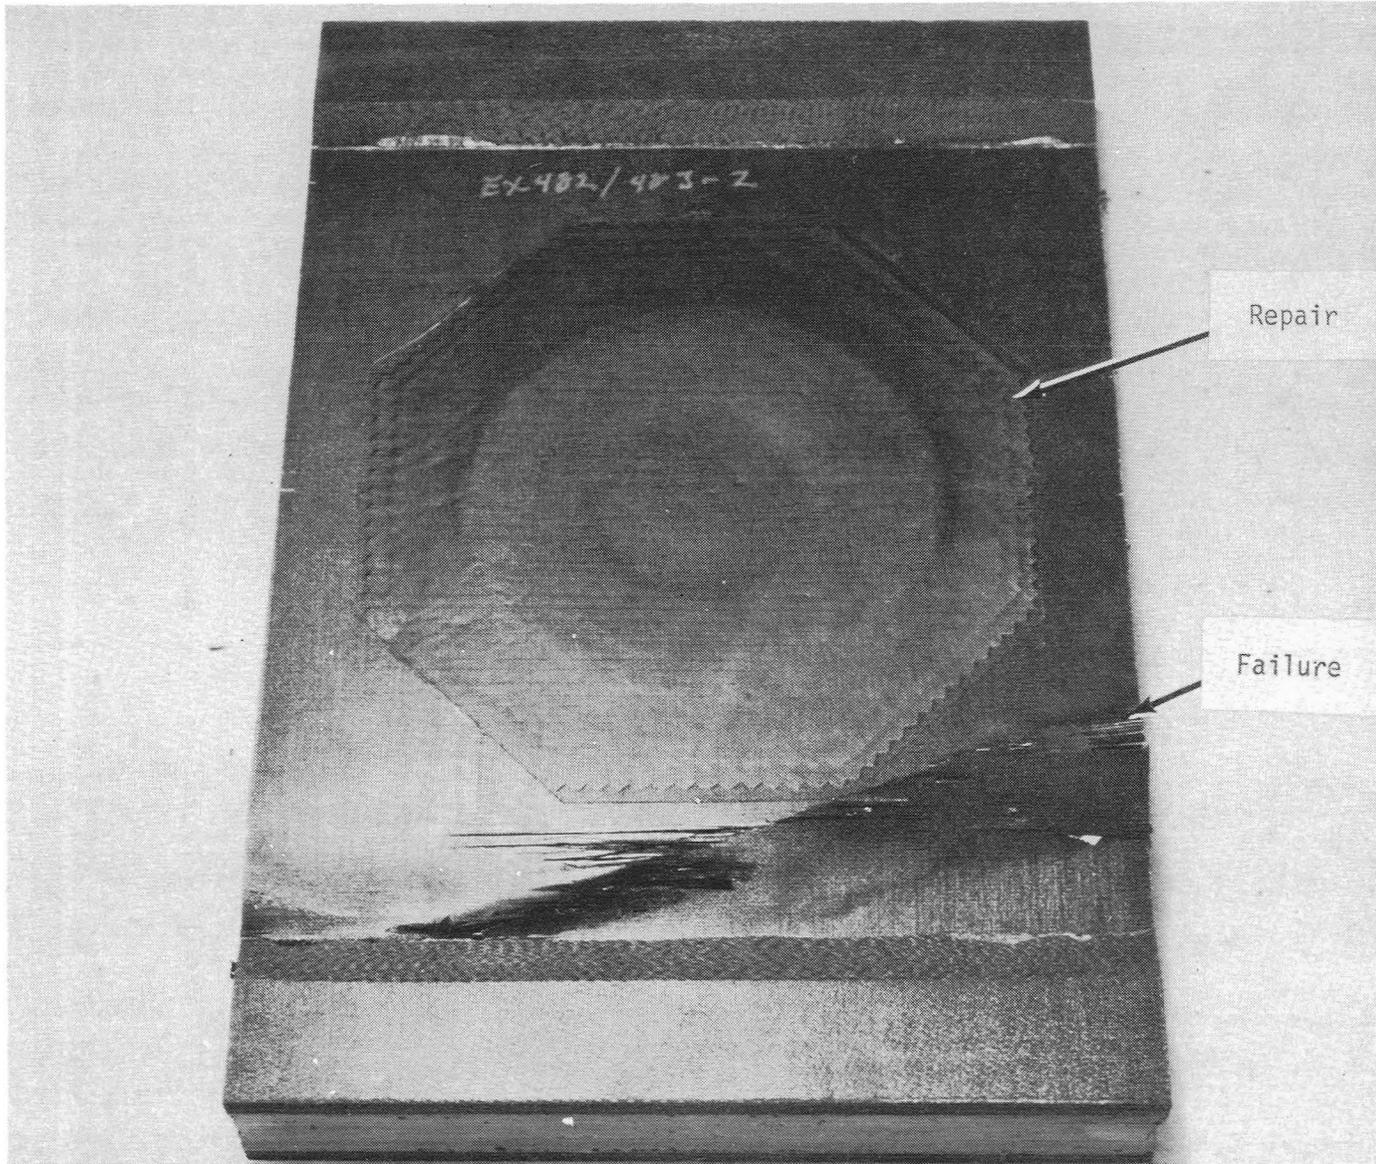
L-82-2747.1

Figure 10.- Failure location for repaired Celion 6000/LARC-160 sandwich panel tested in compression.

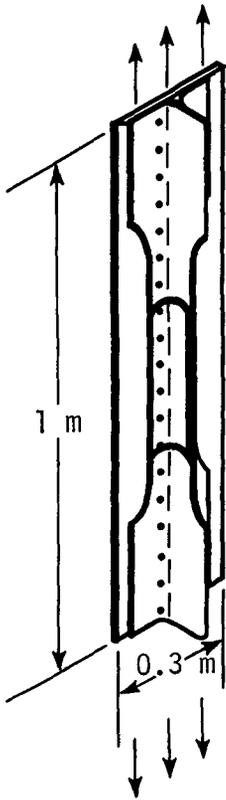
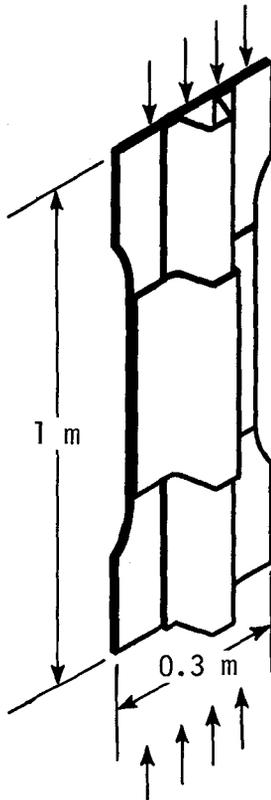
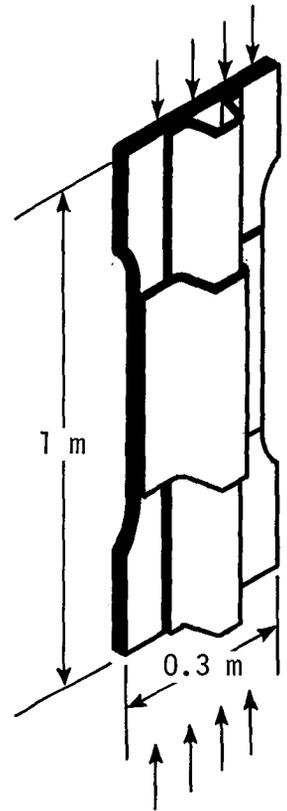
Spar segment

Repair efficiency,
92 percent

Fin cover

Wing cover

Repair efficiency,
79 percent

Figure 11.- Repair of Gr/E subelement specimens.

The strength of the repaired Gr/E coupon specimens has been shown to approach the undamaged strength of the specimen, and these concepts are being evaluated for the repair of Gr/PI coupon specimens. The next step in the development of repair technology was to apply these repair concepts to larger Gr/E subelement specimens. Large subelement specimens were made available for repair demonstration through the NASA-sponsored Aircraft Energy Efficiency (ACEE) program. In this program, each of the three major U.S. commercial transport manufacturers are under contract to NASA to design, fabricate, and test secondary and primary composite components. The use of advanced composites has the potential to reduce fuel consumption by 10 to 15 percent. One of these components is the L-1011 composite vertical fin that the Lockheed-California Company is building. Composite parts of the L-1011 vertical fin were used to demonstrate the repair of graphite/epoxy T300/5208 subelement specimens, and some results are shown in figure 11. Repairs were made on a L-1011 spar segment, a L-1011 stiffened cover, and a typical wing-cover subelement. In each case, as with the laminate specimens, damage was simulated as a complete cut across the specimen width representing a cleaned-out damage area rejoined by the repair. The spar-segment repair consisted of a metal doubler on each side of the web, as indicated in figure 11, as well as stepped metal doublers on the spar cap. Doublers were mechanically fastened, and film sealant was placed between metal and graphite parts. The repaired spar element was tested in tension and failed at 92 percent of the undamaged-spar-subelement tension strength. Repair of the L-1011 stiffened cover and the wing-cover subelements consisted of precuring a hat-shaped patch and bonding this patch along with a cure-in-place patch on the skin side of the specimens. The ends of the specimens were potted, and then the specimens were tested in compression. The repaired L-1011 stiffened-cover subelement failed at 92 percent of the control-specimen strength. Failure occurred when the end-potting compound separated from the specimen, thus allowing a fiber-brooming end failure. However, because such a large repair efficiency was obtained, the test was considered valid. The wing-cover subelement specimen obtained a 79-percent repair efficiency and failed through the repair. The precured hat patch for the wing-cover specimen was much stiffer than that for the stiffened fin cover and, as a result, was much harder to fit properly to the hat element for adequate bonding. Ultrasonic "C" scan inspection following bonding verified the inadequate fit of the patch. As a result, a cure-in-place repair on the hat element as well as on the skin is recommended.

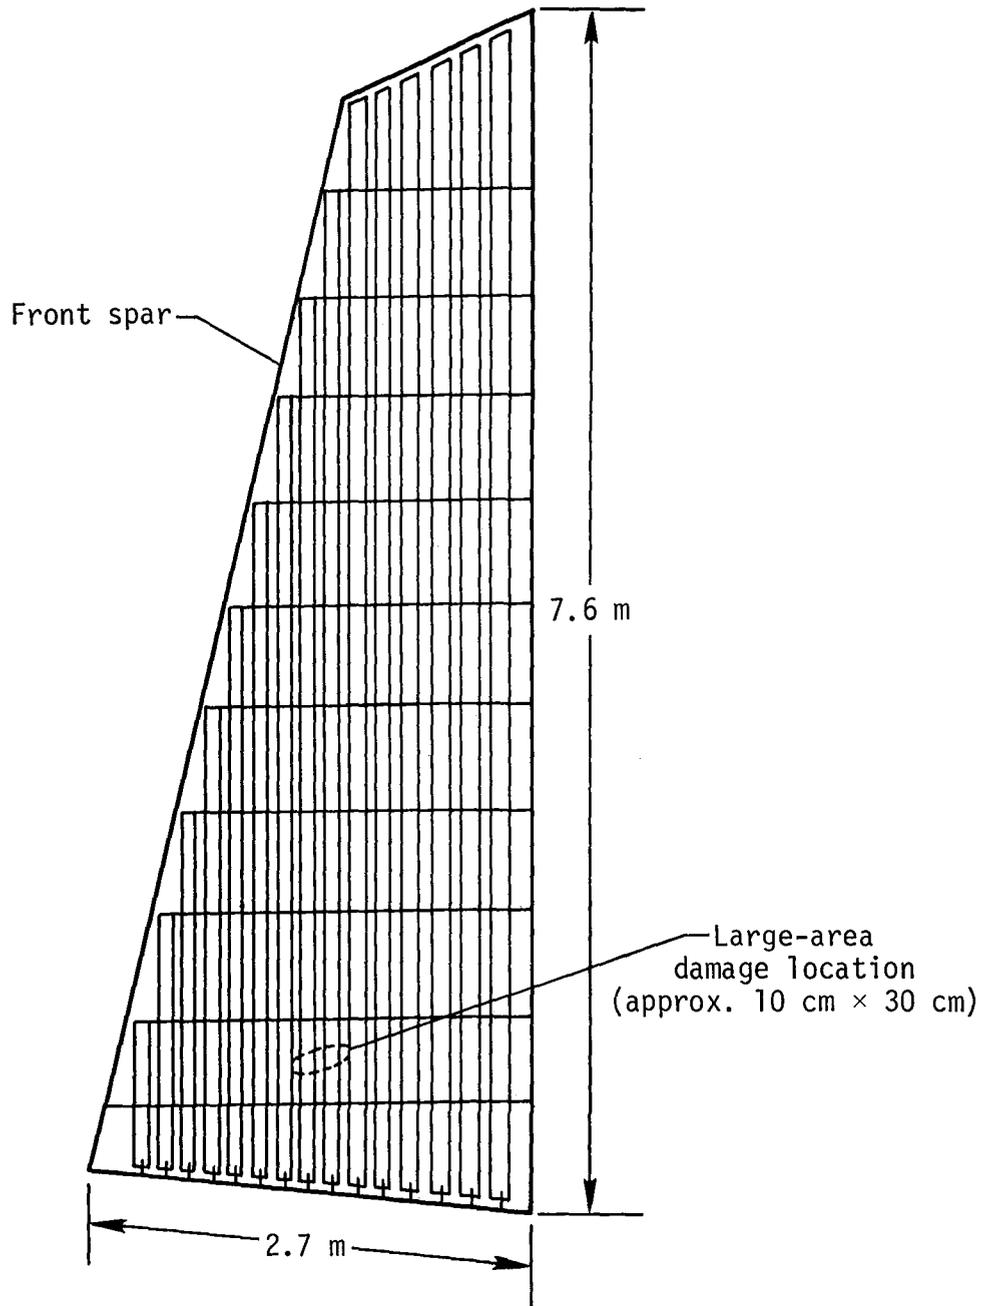
Figure 12.- Large-area damage location on composite vertical fin of L-1011 aircraft.

Repair techniques have been successfully demonstrated on small coupon specimens, and selected repair techniques have also been shown to be applicable to the repair of larger subelement specimens. However, it must be demonstrated that the methods developed are suitable for repair of large-area damage on full-sized structures and, as a result, the L-1011 composite vertical-fin ground-test article (GTA) has been selected for evaluation. The GTA is a full-sized production component and is a complete box structure, approximately 7.6 m by 2.7 m in area, with composite hat-stiffened covers and composite spars and ribs. (See fig. 12.) The damage to be inflicted will simulate a swept-stroke lightning strike near the bottom of the fin as shown in the figure. An area of approximately 10 cm by 30 cm will be delaminated; then the skin is punctured with a hot welding rod. The delaminated area will then be exposed to a high-temperature flame. The large-area repair planned for the vertical fin consists of a cure-in-place external Gr/E patch for repair of the skin damage and a cure-in-place Gr/E patch for repair of the damaged hats. After the GTA has been repaired, the service-life capability will be determined by performing spectrum fatigue cycling. Following the fatigue cycling of the GTA, the residual strength will be determined by static loading to failure.

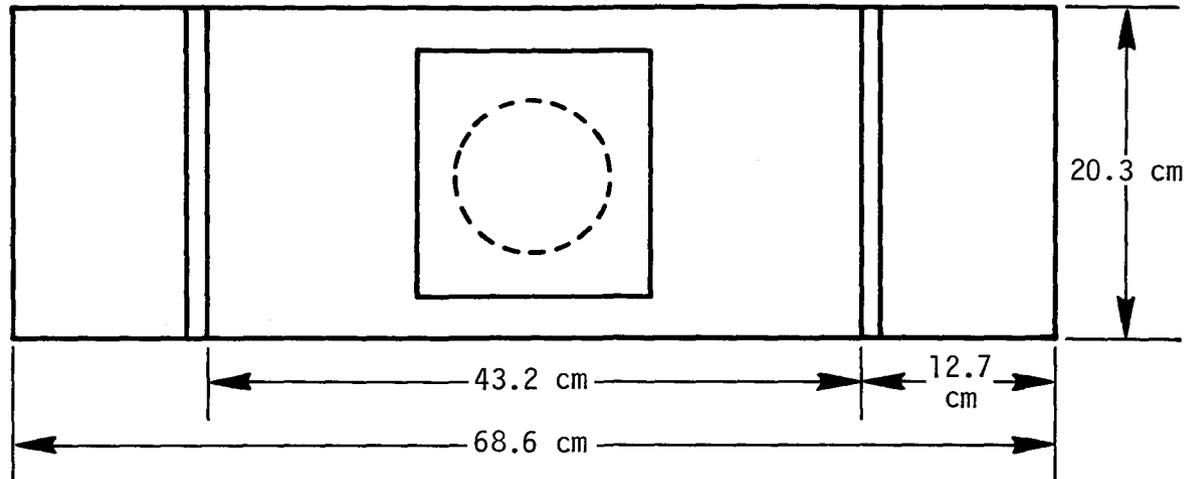
Exposure time, yr	Tabbed coupon specimens					
	Controls		Repair technique			
	Undamaged	Damaged, not repaired	Cure-in-place external graphite	Precured bonded graphite	Cure-in-place flush graphite	External bolted aluminum and adhesive
0	3	3	3	3	3	3
1	3	3	3	3	3	3
3	3	3	3	3	3	3
5	3	3	3	3	3	3
7	3	3	3	3	3	3
10	3	3	3	3	3	3

Figure 13.- Tabbed laminate specimens for composite-repair durability.

To address the long-term durability of repairs, a 10-year exposure program of repaired specimens will be initiated at the Langley Research Center. The specimen to be used for this program is shown schematically in figure 13 along with the proposed exposure matrix. The specimen is a tabbed 16-ply laminate specimen that is similar to specimens evaluated in tension in an earlier phase of contract NAS1-15269. The damage to be repaired will consist of a 9.5-cm-diameter hole. Four repair methods will be evaluated. These include: (1) cure-in-place external Gr/E, (2) precured bonded Gr/E, (3) cure-in-place flush Gr/E, and (4) external bolted aluminum-plus adhesive. Repaired specimens as well as undamaged and damaged unrepaired controls will be exposed outdoors for 1, 3, 5, 7, and 10 years. The exposure facility is shown in figure 14. One specimen from each group of three will be subjected to a sustained load for the entire exposure time, a second specimen will be a fatigue specimen, and the third specimen will be an unloaded specimen. This exposure program is scheduled to begin in September 1982.

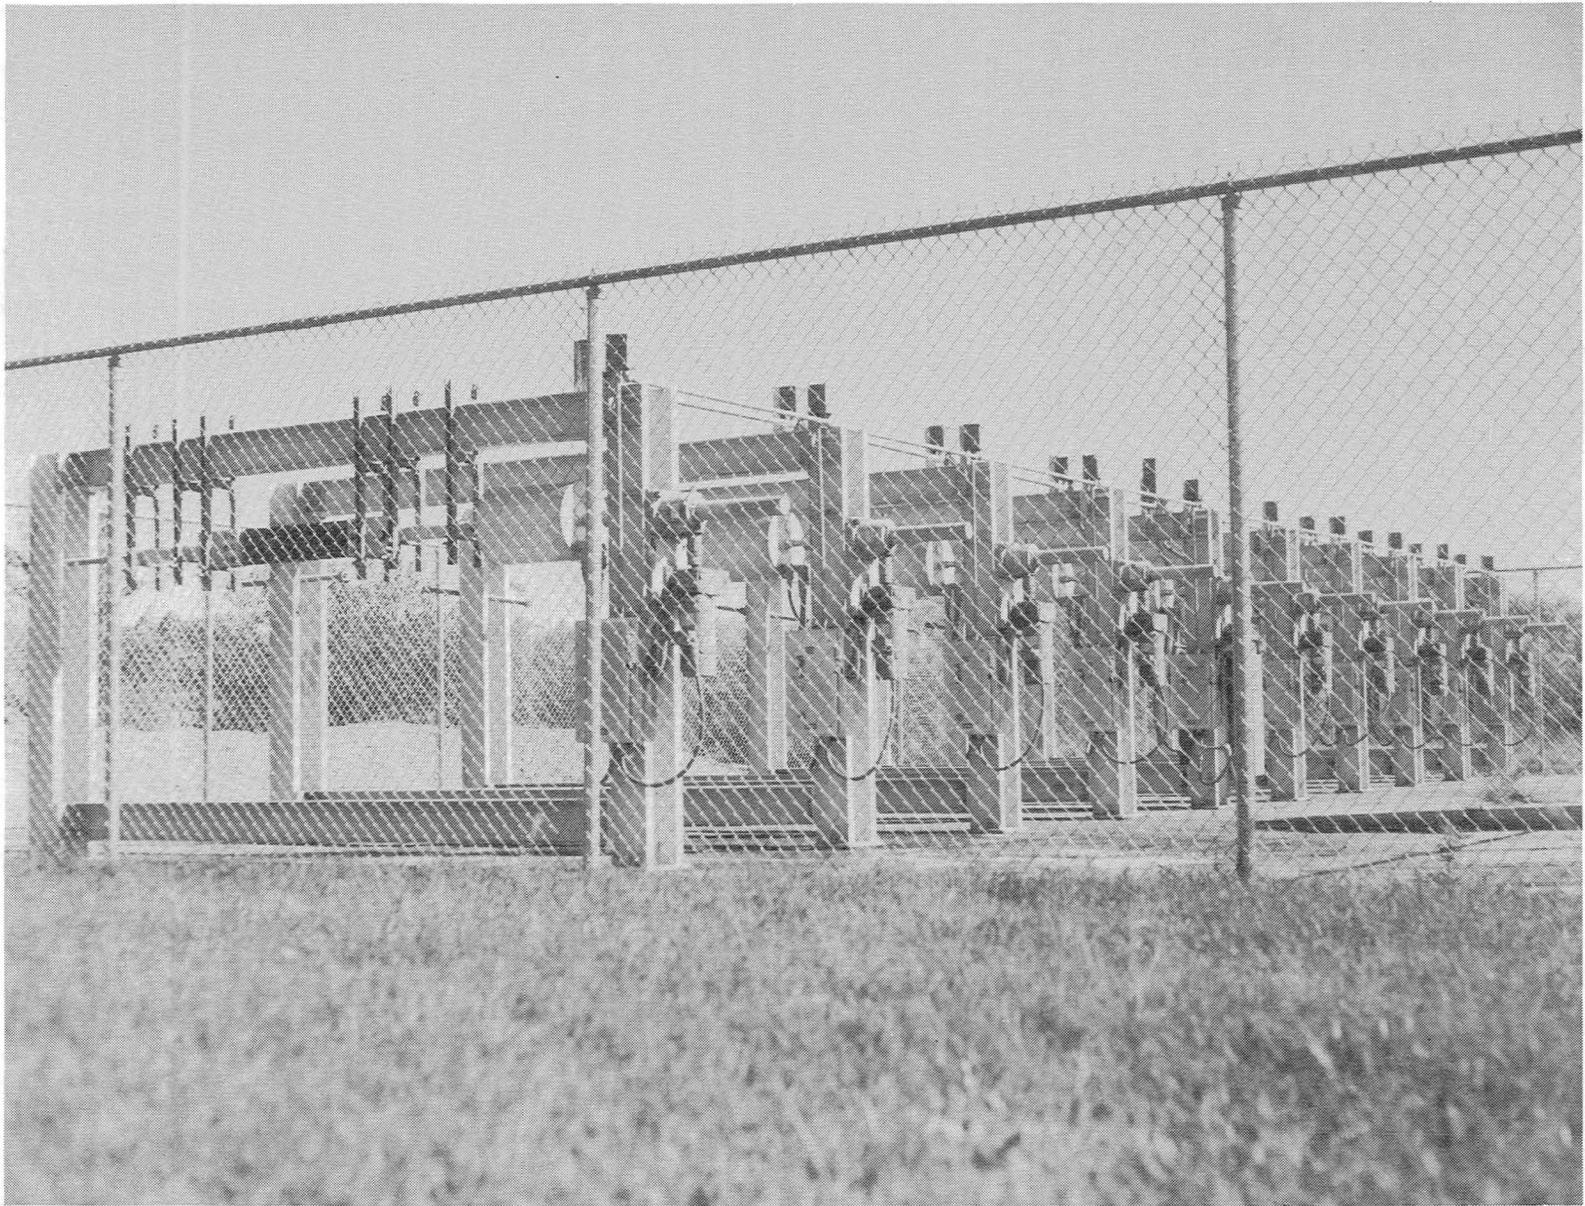
I-77-7358

Figure 14.- Outdoor environmental test facility.
