NASA Technical Memorandum 103095

# Fatigue Crack Growth in a Unidirectional SCS-6/Ti-15-3 Composite

Prepared for the  
Third Symposium on Composite Materials: Fatigue and Fracture  
sponsored by the American Society for Testing Materials  
Orlando, Florida, November 6-9, 1989

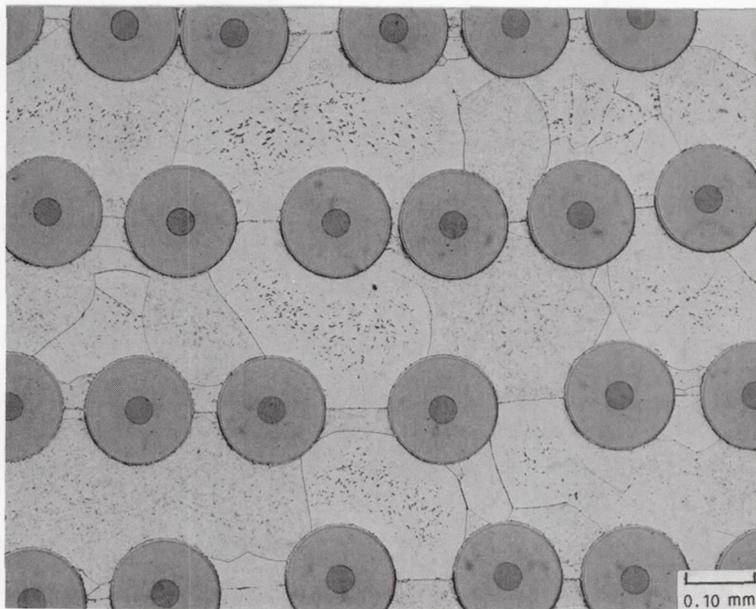
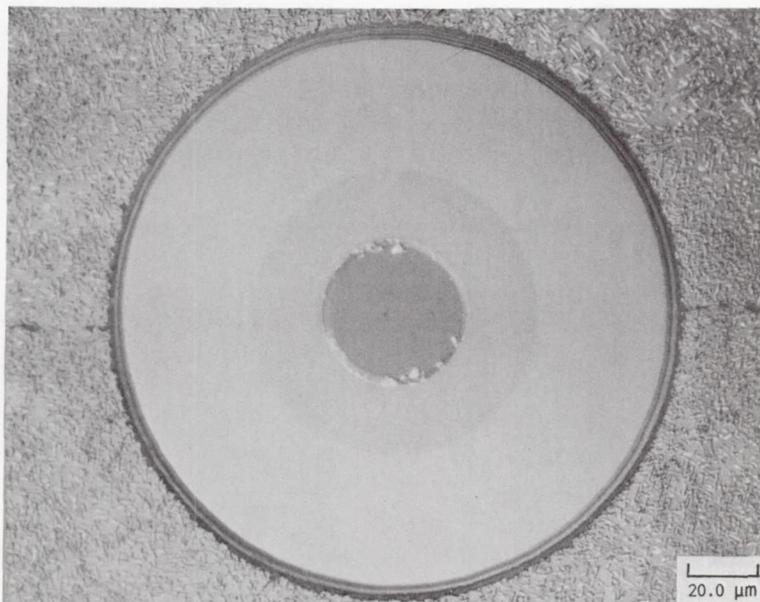
(a) AS RECEIVED-ETCHED TO REVEAL MICROSTRUCTURE.

(b) DETAILED VIEW OF SCS-6 FIBER-HEAT TREATED.

FIGURE 1. - SCS-6/Ti-15-3 COMPOSITE.

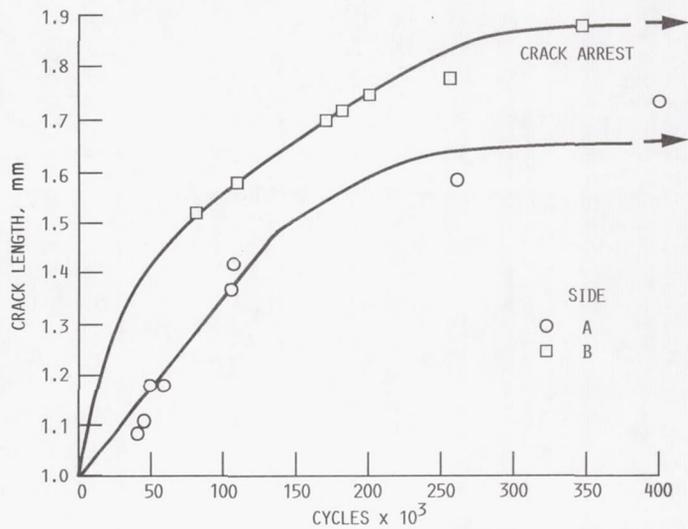
FIGURE 2. - CRACK LENGTH VERSUS CYCLES FOR THE  $[0]_8$  ORIENTED SEN SPECIMEN.

rates and finally lead to full crack arrest (Fig 2). The very efficient transfer of the load from the cracked matrix to the unbroken fibers resulted in no apparent change in compliance as measured by the extensometer mounted in the crack mouth. This points to the inadequacy of the far field measuring devices to characterize the fatigue crack growth behavior of a complex material such as this composite.

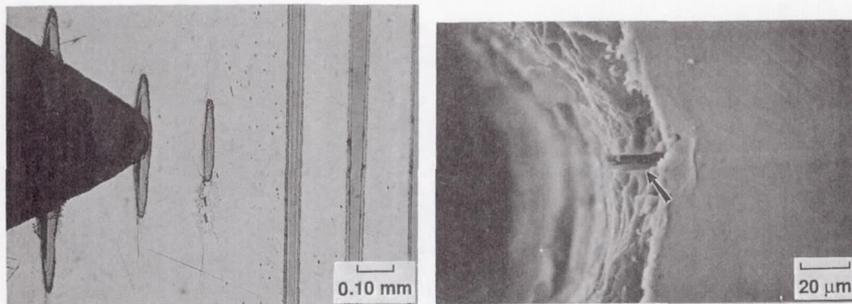
PRIOR TO TESTING

AFTER 150 CYCLES

FIGURE 3. - CRACK INITIATION IN THE  $[0]_8$  ORIENTED SEN SPECIMEN.

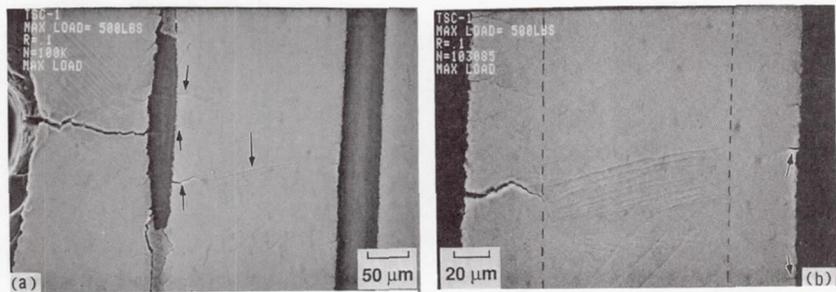
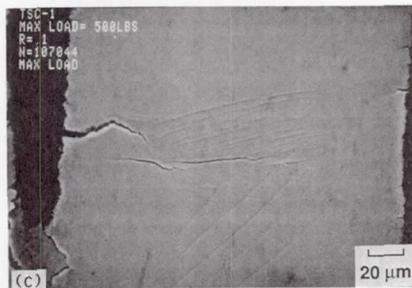
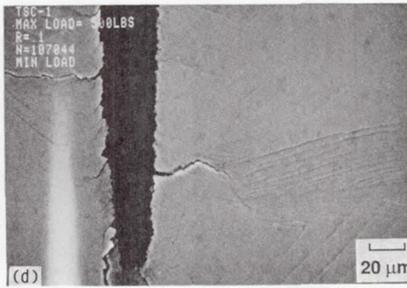
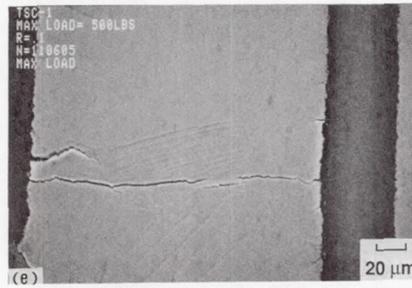
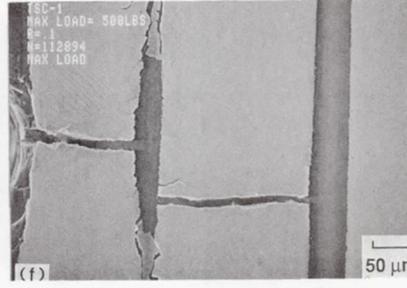
(a) AFTER 100 000 CYCLES      MAXIMUM LOAD      (b) AFTER 103 085 CYCLES      MAXIMUM LOAD

(c) 107 044 CYCLES      MAXIMUM LOAD

(d) 107 044 CYCLES      MINIMUM LOAD

(e) 110 605 CYCLES      MAXIMUM LOAD

(f) 112 894 CYCLES      MAXIMUM LOAD

FIGURE 4. - CRACK GROWTH SEQUENCE IN THE  $[0]_8$  SEN SPECIMEN RESULTING IN FIBER BRIDGING OF THE CRACK WAKE.

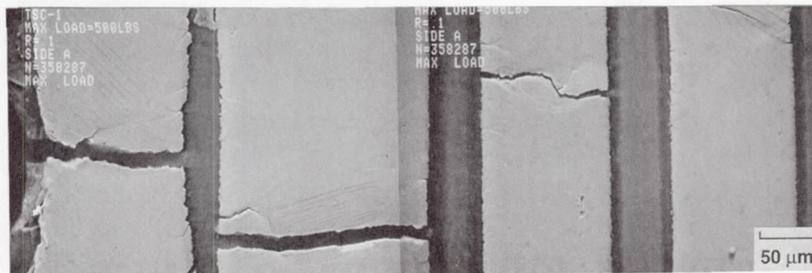
358 287 CYCLES      MAXIMUM LOAD

FIGURE 5. - GENERAL APPEARANCE OF THE FATIGUED  $[0]_8$  SEN SPECIMENS AS OBSERVED IN LOADING STAGE INSIDE AN SEM.

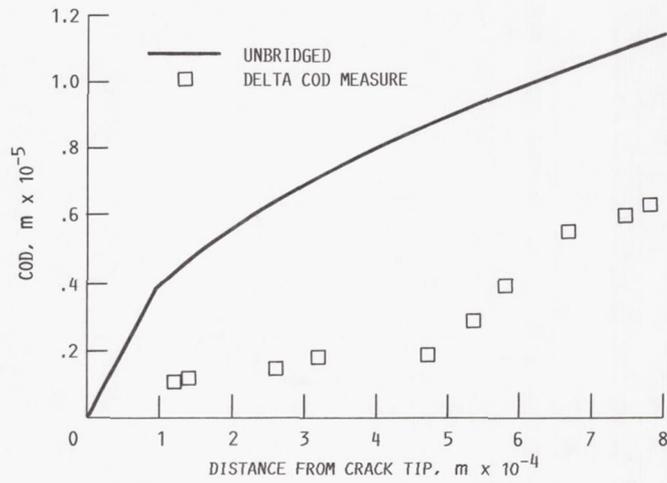
DISPLACEMENT PROFILE VERSUS DISTANCE FROM CRACK TIP

FIGURE 6. - COMPARISON OF THE MEASURED DELTA COD'S WITH ANALYTICALLY CALCULATED COD'S FOR AN UNBRIDGED SEN SPECIMEN.

Using high magnification micrographs of the near-crack tip region, crack opening displacements were measured as a function of the applied load and the distance behind the crack tip,  $t$ . One of the many data sets obtained is shown in Fig 6. Shown in the figure

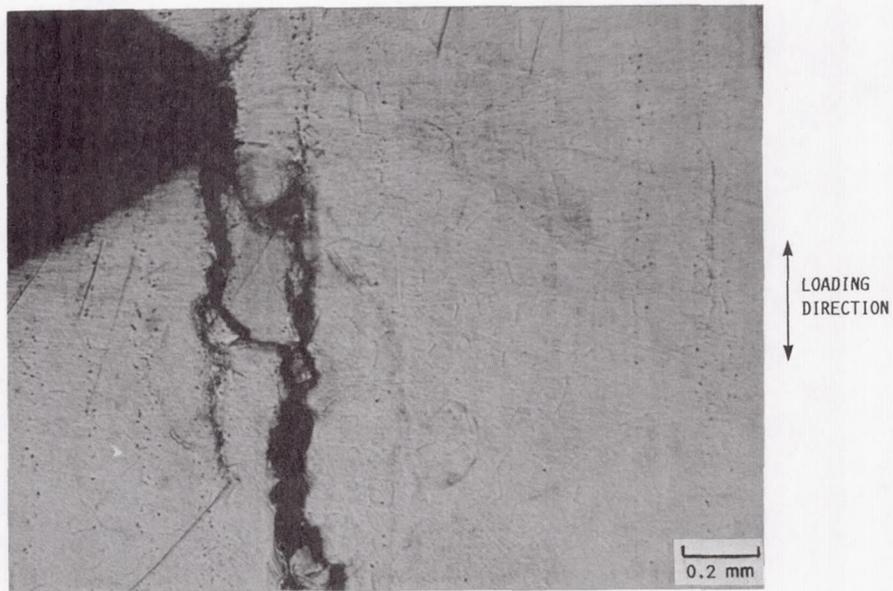
$[0]_8$  ORIENTATION.

FIGURE 7. - CRACK GROWTH PARALLEL TO THE LOADING DIRECTION FOR THE CT  $[0]_8$  ORIENTATION.

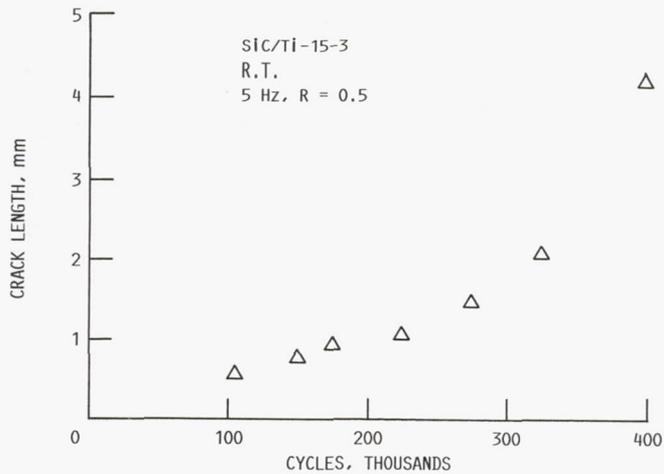
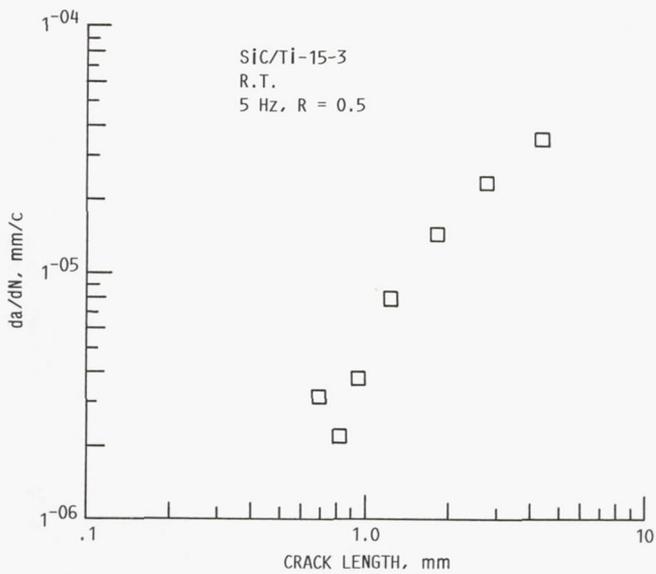
(a) CRACK LENGTH VERSUS CYCLES.

(b) CRACK GROWTH RATE VERSUS CRACK LENGTH.

FIGURE 8. - FATIGUE CRACK GROWTH RATE DATA FOR CT [0]<sub>g</sub> SPECIMENS.

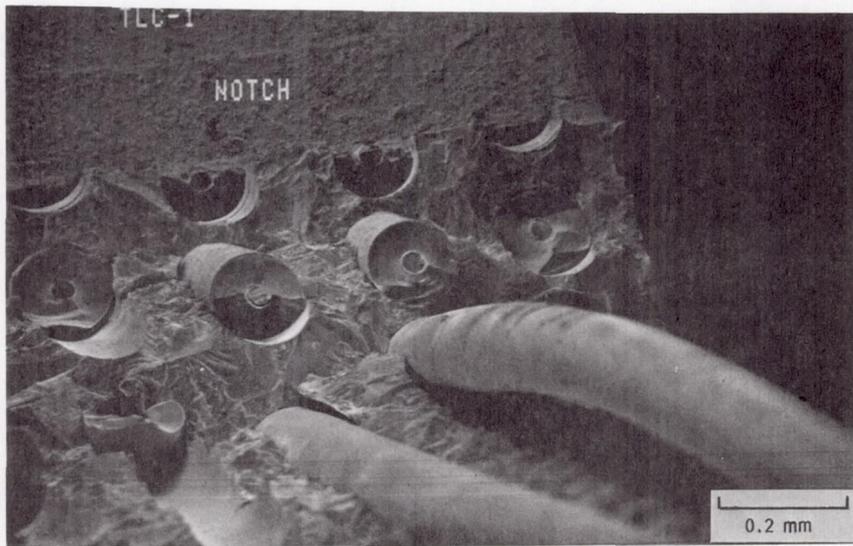
FIGURE 9. - CRACK GROWTH IN THE  $[0]_8$  CT SPECIMEN. DIRECTION OF LOADING PARALLEL TO FIBER DIRECTION.

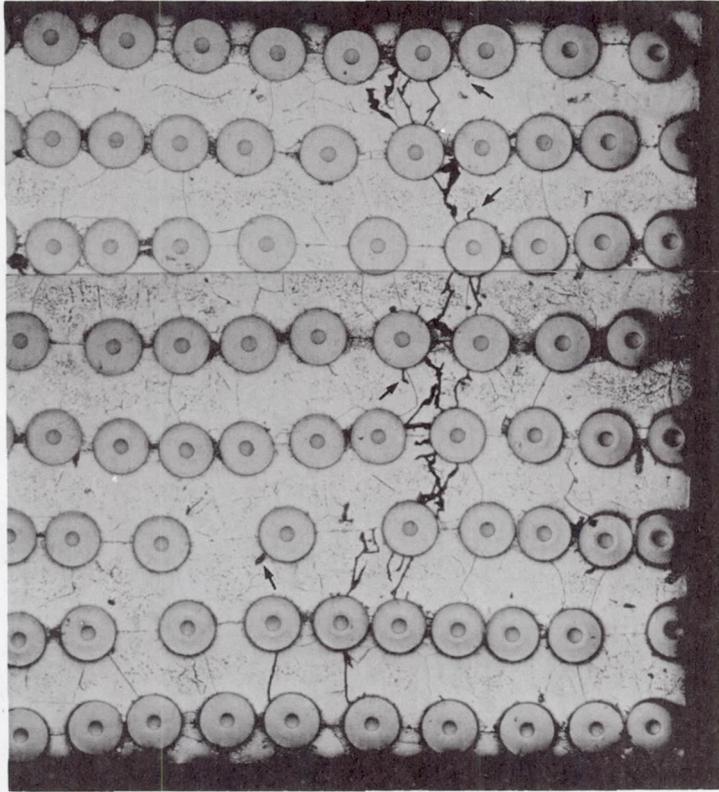
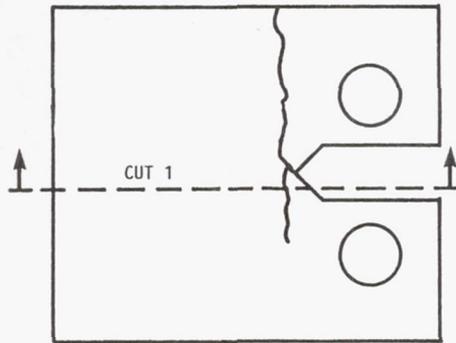
FIGURE 10. - MULTIPLE CRACK INITIATION AND COALESCENCE IN THE EARLY STAGES OF FATIGUE LIFE IN THE CT [0]<sub>8</sub> COMPOSITE. ARROWS MARK CRACKS INITIATING IN THE INTERFACE REGION.

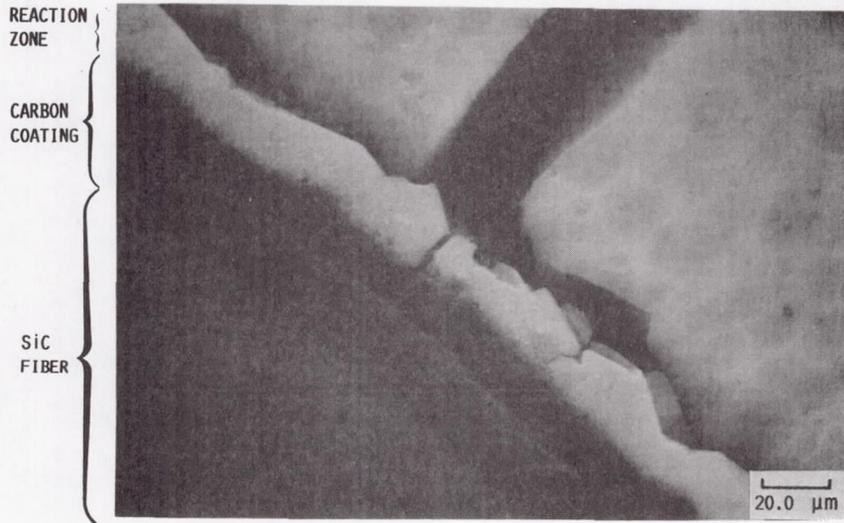
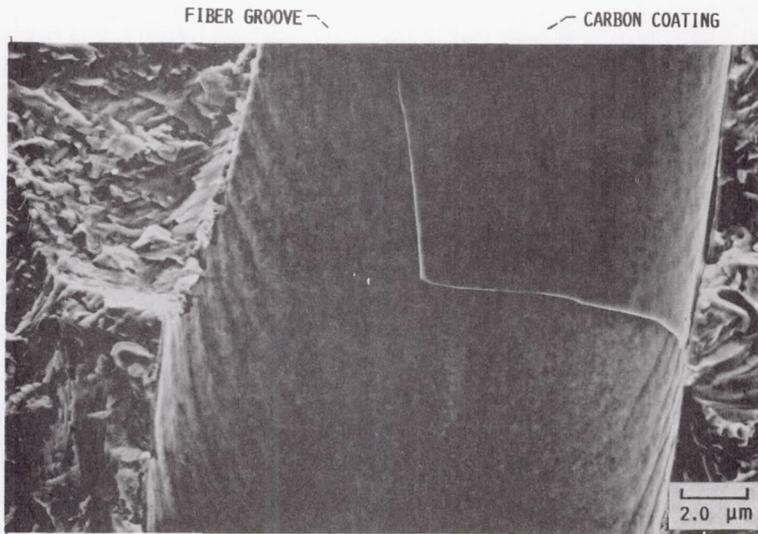
(a) CRACKING EMANATING FROM THE CARBON LAYER.

(b) CARBON LAYER SEPARATED FROM THE FIBER DURING FATIGUE.

FIGURE 11. - PREFERENTIAL CRACKING OF THE CARBON LAYER.

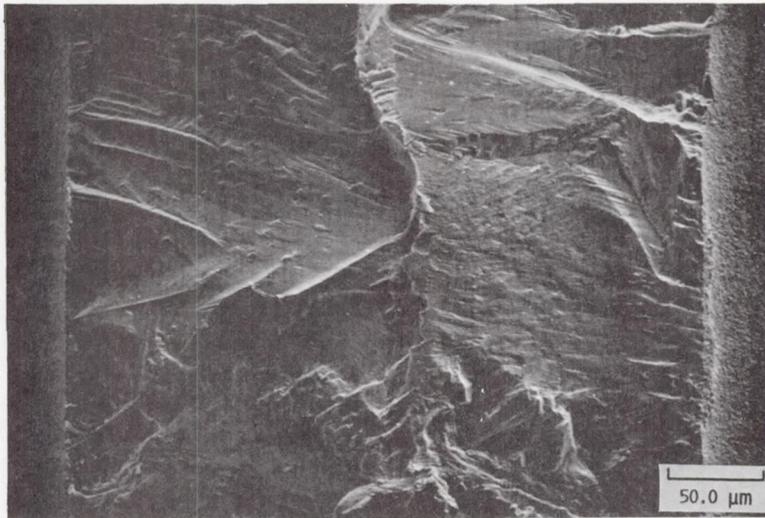
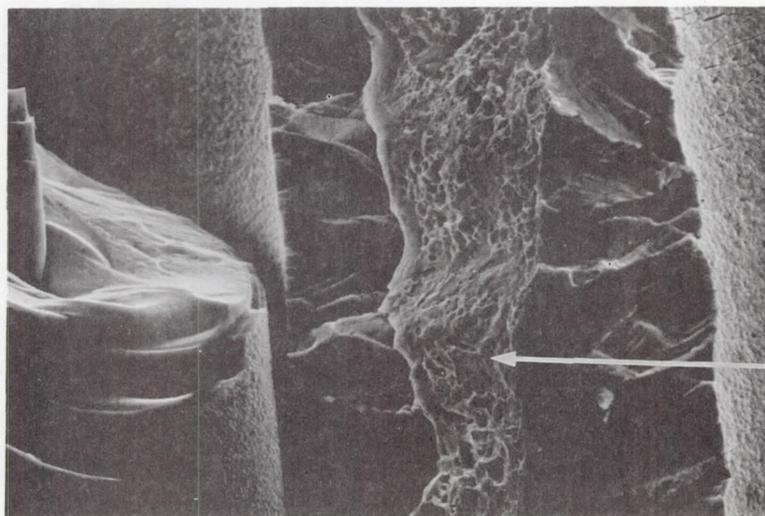
MICROSCOPIC GROWTH DIRECTION

(a) LOW  $da/dN$   $[0]_g$ .

↑ MACROSCOPIC  
GROWTH DIRECTION

(b) HIGH  $da/dN$   $[0]_g$ .

FIGURE 12. - MICROSCOPIC CRACK GROWTH DIRECTION FROM THE INTERFACE INTO THE MATRIX LIGAMENT IN THE  $[0]_g$  CT SPECIMENS.

The crack propagation within the matrix was transgranular in nature (Fig 12). The active fatigue failure mechanisms in the matrix included evidence of striation formation, slip band deformation and some cleavage. Some secondary cracking was present in the matrix foil laminate boundaries perpendicular to the main crack front.

One of the major findings of the study was the close similarity of the fatigue failure processes for the two different composite orientations tested using CT specimen geometry (compare Figs 12 and 15). The most important event which lead to this similarity in the fatigue behavior was the preferential cracking

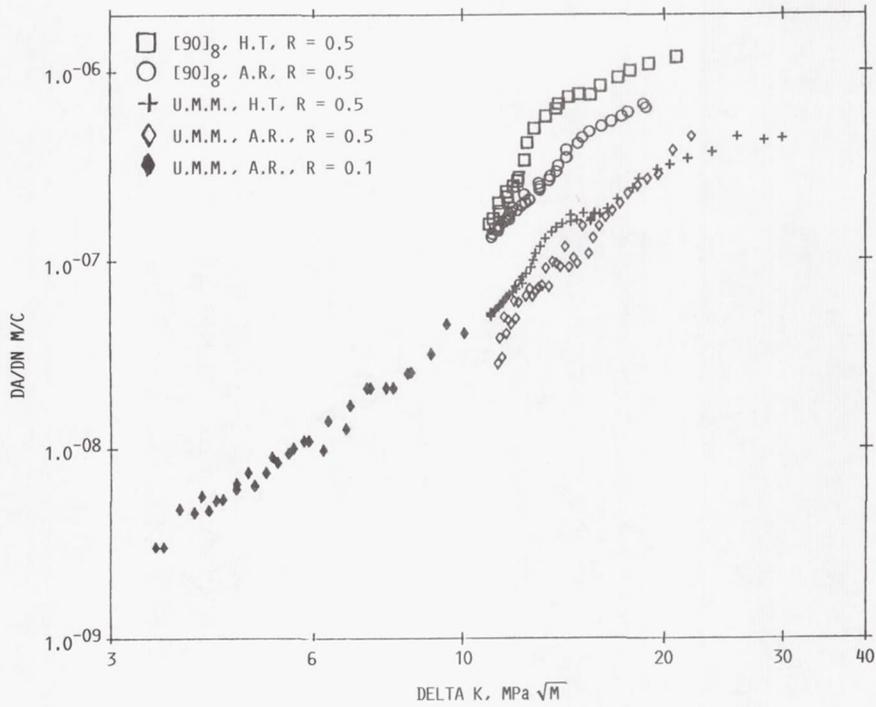
FIGURE 13. - COMPARISON OF FCG RATES FOR THE [90]<sub>8</sub> AND THE UNREINFORCED MATRIX MATERIAL IN THE AS-RECEIVED (A.R.) AND HEAT-TREATED (H.T.) CONDITION.

Contrary to the behavior of the CT  $[0]_s$  specimens, for both the  $[90]_s$  composite and the unreinforced matrix material CT specimens the crack growth direction was perpendicular to the applied load. The comparison of the FCG behavior for the two materials is shown in Fig 13. As shown for the  $\Delta K$  range tested, the crack growth rates for the  $[90]_s$  oriented composite are always considerably higher than those of the unreinforced material. Possible reasons for this type of behavior will be discussed later.

The FCG data in Fig 13 is shown for both the heat treated and as-received conditions. For the limited number of tests conducted, there appears to be no appreciable effect of heat treatment on the FCG behavior of the unreinforced material. However, in the  $[90]_s$  composite the heat treated material exhibits higher FCG rates in at least the high  $\Delta K$  region.

The FCG rate of the  $[90]_8$  CT specimens was considerably greater than that of the unreinforced matrix for a given stress intensity tested (Fig 13). The fatigue mechanisms within the matrix region (i.e. formation of striations, slip deformation etc) were very similar for both the  $[90]_8$  and the unreinforced material and thus probably did not contribute to the observed differences in the FCG rates. However, the ease of cracking of the interface region, in particular the carbon coating, is probably responsible for the increase in the crack growth rates. This is consistent with the hypothesis that the fiber/matrix interface has lower fatigue resistance than the matrix. This weak composite constituent therefore limited the fatigue cracking resistance of the  $[90]_8$  composite.

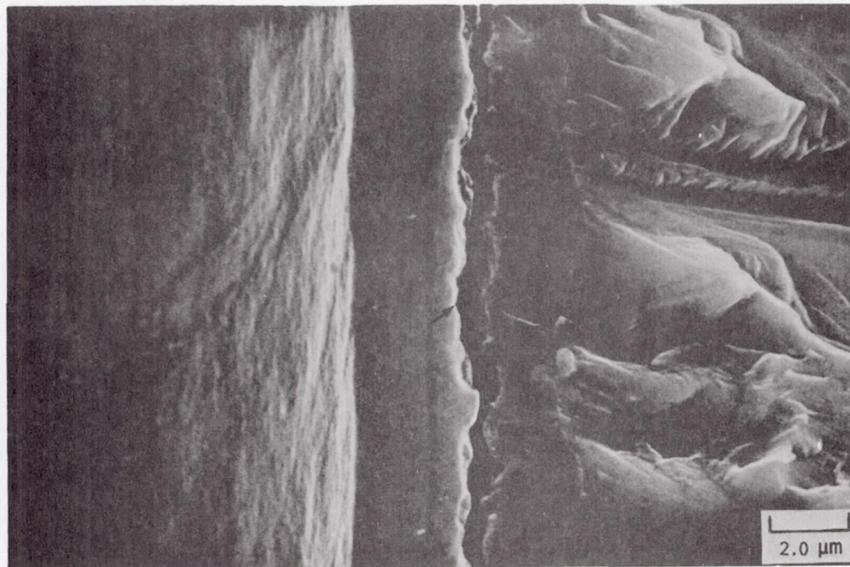
FIGURE 14. - SEPARATION OF CARBON COATING FROM THE FIBER IN [90]<sub>8</sub> CT SPECIMEN. IN THE CENTER OF THE FRACTOGRAPH NOTE A CRACK BETWEEN CARBON COATING AND THE INTERFACE.

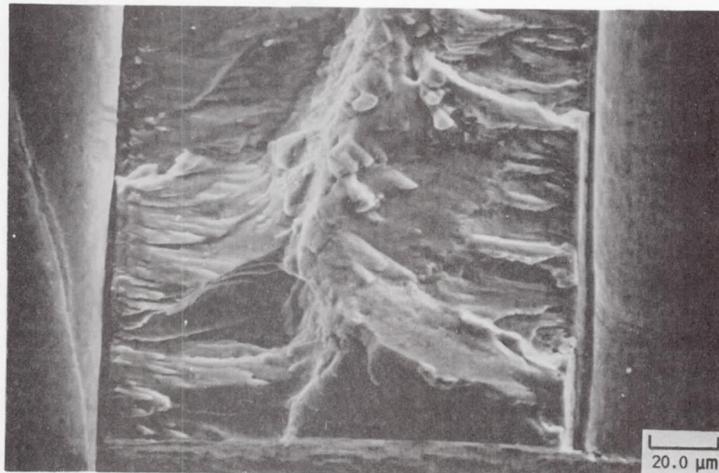
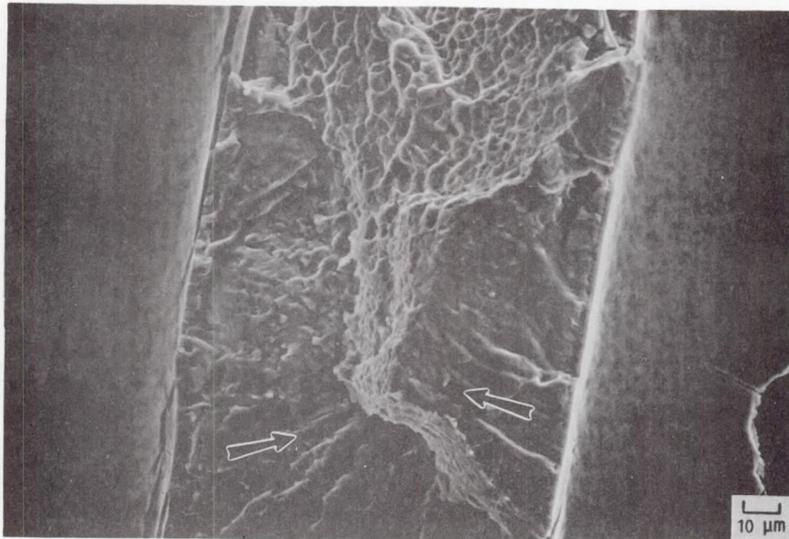
MICROSCOPIC GROWTH DIRECTION

(a) LOW  $da/dN$ .

(b) HIGH  $da/dN$ .

FIGURE 15. - MICROSCOPIC CRACK GROWTH FROM THE INTERFACE INTO THE MATRIX LIGAMENTS IN THE  $[90]_8$  SPECIMENS.

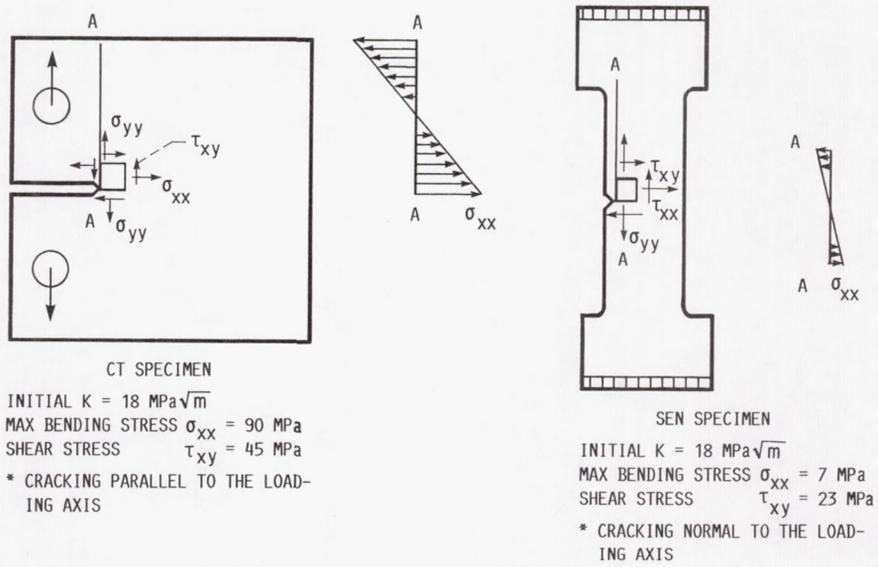
FIGURE 16. - COMPARISON OF BENDING AND SHEAR STRESSES FOR THE TWO SPECIMEN GEOMETRIES.

As mentioned earlier, the crack growth direction was parallel to the loading direction for the  $[0]_s$  CT specimens and normal to the loading direction in the  $[0]_s$  SEN specimens. A comparison of the simple bending and shear stresses at the notch root for the two specimen geometries may explain the difference in behavior. As shown in Fig 16 the bending and shear stresses were respectively 13 and 2 times greater for the CT specimens in comparison to the SEN specimens. These higher bending stresses were able to preferentially crack the interface region and drive the crack front in the direction parallel to the loading direction. In the case of the SEN specimens, the considerably lower bending stresses and somewhat lower shear stresses were inadequate to crack the fiber/matrix interface region. The result was that the crack growth in the SEN specimens was confined to the matrix and bypassed the fibers leaving them unbroken in the crack wake with little evidence of failure in the fiber/matrix interface. As the crack grew longer in the SEN specimens, fiber bridging acted to reduce the bending stresses at the crack tip and thus the crack growth direction remained normal to the loading crack.

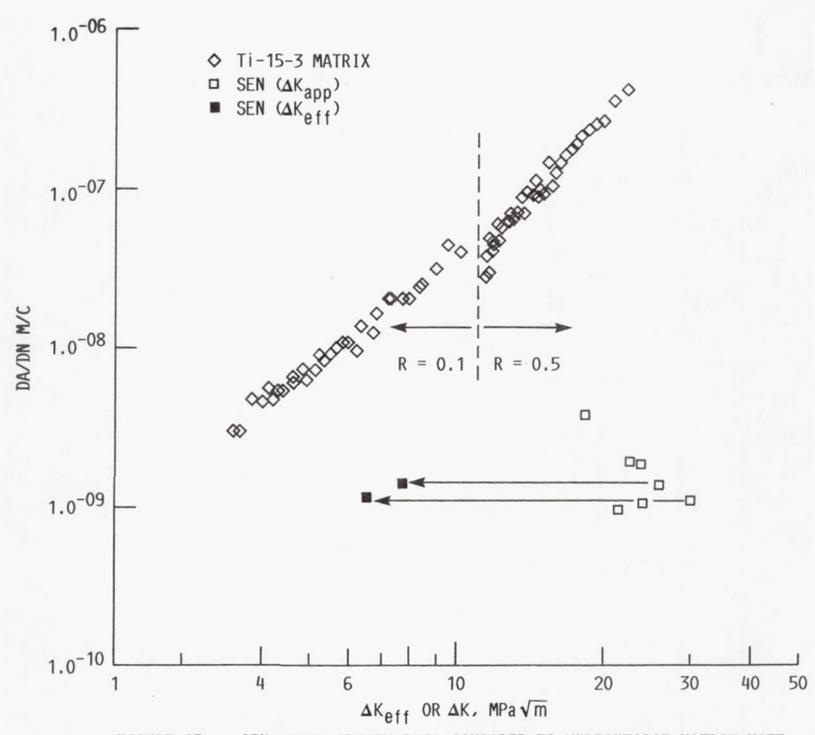
FIGURE 17. - SEN CRACK GROWTH DATA COMPARED TO UNREINFORCED MATRIX MATERIAL IN TERMS OF  $\Delta K_{app}$  AND THE PROPOSED  $\Delta K_{eff}$  PARAMETER.

In Fig 17 the fatigue crack growth rate data for a SEN specimen is plotted as a function of both the global  $\Delta K_{app}$  parameter and the calculated  $\Delta K_{eff}$  parameter. For comparison purposes also

shown in the figure is the FCG rate data obtained from unreinforced matrix CT specimens. The FCG rates for the  $[0]_s$  SEN specimens decreased as a function of the  $\Delta K_{app}$ . For the same  $\Delta K_{app}$ , the FCG rates were three orders of magnitude slower for the  $[0]_s$  composite than the unreinforced material. This large difference in the measured FCG rates is due almost entirely to the crack bridging experienced by the SEN specimens. Some of the SEN fatigue crack growth data was recalculated in terms of the  $\Delta K_{eff}$  parameter to account for crack bridging. As shown in Fig 17, the corrected  $[0]_s$  data is significantly closer to the data trends exhibited by the unreinforced matrix material. For the data points for which the  $\Delta K_{eff}$  parameter was calculated, the stress intensity shifted from approximately 30 MPa $\sqrt{m}$  to 6-8 MPa $\sqrt{m}$ . A stress intensity range of 3-4 MPa $\sqrt{m}$  produced comparable crack growth rates in the unreinforced matrix material. The remaining difference between the actual FCG rates in the unreinforced matrix material and the FCG rates of the  $[0]_s$  SEN specimens, measured in terms of  $\Delta K_{eff}$ , may in part be due to environmental effects. The unreinforced matrix material was tested in the ambient environment while the  $[0]_s$  composite was tested in vacuum. In the low crack growth region ambient environment has been shown to increase the FCG rates of titanium based alloys (7). Also, the COD measurements were obtained on the specimen surface and they may not fully represent crack tip opening displacements through the specimen thickness.

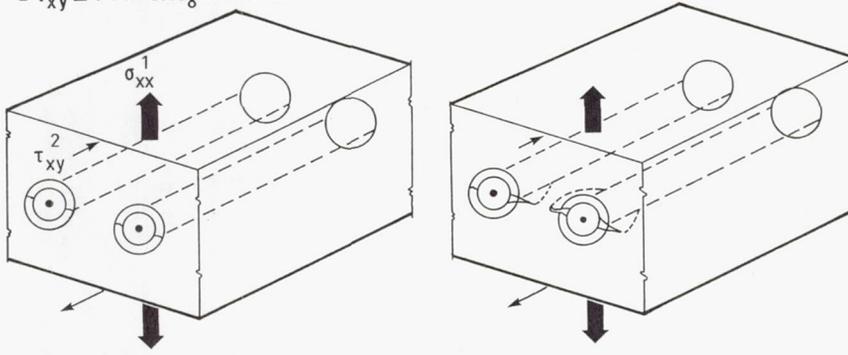
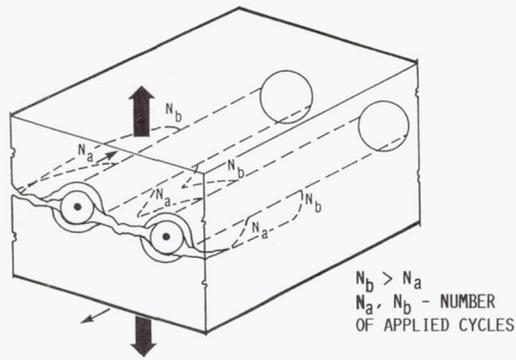
1  $\sigma_{yy}$  FOR  $[90]_8$  SPECIMENS  
 2  $\tau_{xy} \equiv 0$  FOR  $[90]_8$  SPECIMENS

(a) CRACK INITIATION IN THE INTERFACE.

(b) CRACK GROWTH AND LOCAL DEBONDING.

(c) CRACK COALESCENCE IN THE MATRIX.

FIGURE 18. - PROPOSED CRACK INITIATION AND CRACK PROPAGATION PROCESSES FOR THE CT SPECIMEN GEOMETRY.

A schematic illustration of the crack initiation and propagation processes discussed above, for both composite orientations, is proposed and shown in Fig 18. The process can be summarized as follows: 1) cracking of the interface region perpendicular to the resulting  $\sigma_{xx}$  stresses; 2) local debonding occurring in the failed interface region and growth of microcracks into the matrix; 3) linking of the cracks in the matrix ligaments. This is a continuing process requiring continuous cracking of the interface region layer at or ahead of the crack front.
