**MISSION SAFETY EVALUATION
REPORT FOR STS-37**

Postflight Edition

Office of Safety and Mission Quality

National Aeronautics and Space Administration

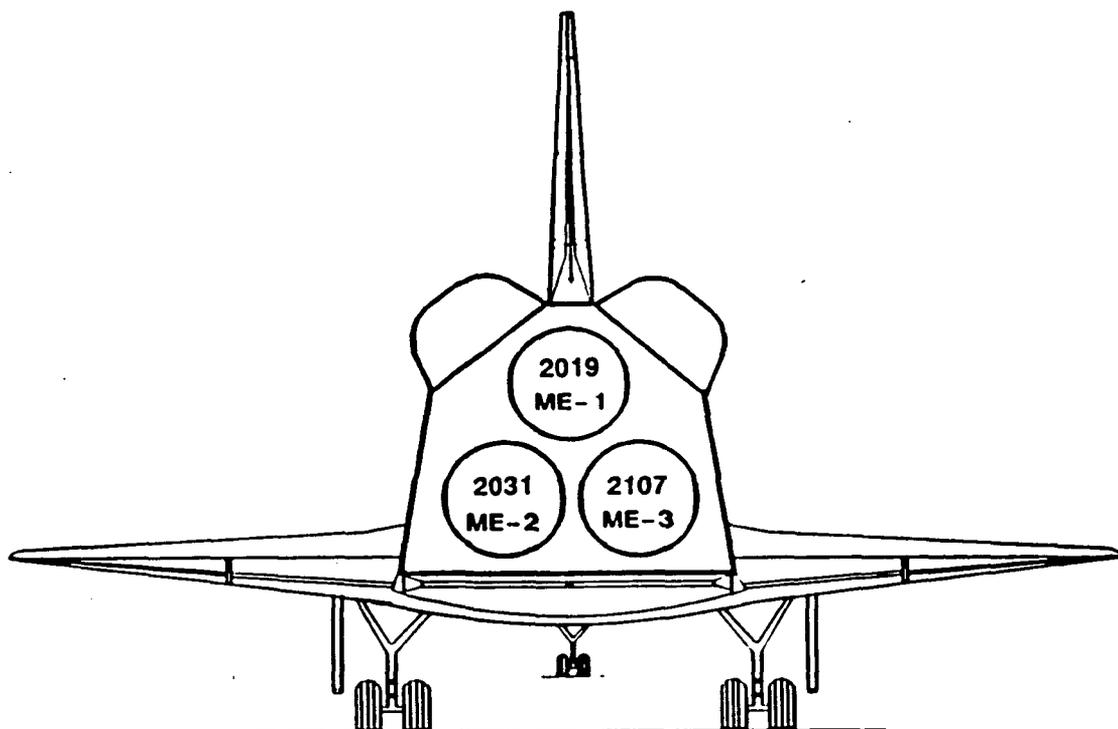
ENGINE	#2019	#2031	#2107
POWERHEAD	#2020	#2028	#2014
MCC*	#2023	#2019	#4002
NOZZLE	#2024	#4017	#4019
CONTROLLER	F4	F29	F25
FASCOS*	#23	#12	#29
HPFTP*	#6008	#4010R3	#6003R1
LPFTP*	#2022R1	#2120R1	#4007
HPOTP*	#9309R2	#2027R3	#2521R2
LPOTP*	#2025R1	#2120	#2216
