**Session XI. Regulation, Certification and System Standards**

**In-service Evaluation of Wind Shear Systems**  
**Capt. Sam Shirck, Continental Airlines**

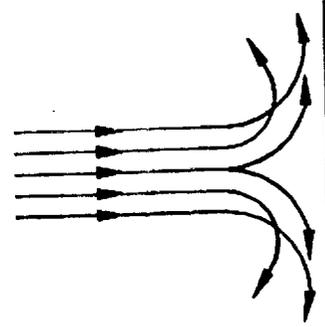
## -CONDITIONS-

- AIRCRAFT - BELOW 1500 FT. ON FINAL
- WX - WINDSHEAR WITHIN 1.5NM

- LAMP

- AURAL "WINDSHEAR AHEAD" 1 REPEAT
- DISPLAY WINDSHEAR ICON RED/BLACK  
POP UP IS OFF TO WS MODE

- GO AROUND
- REPORTS WS TO ATC

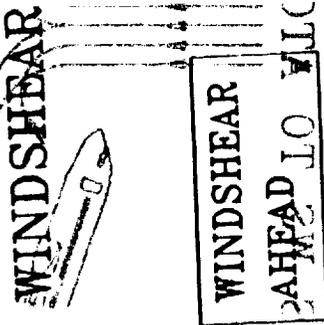
**CONDITIONS-**

- AIRCRAFT - END OF RUNWAY TO V.
- WX - WINDSHEAR WITHIN 5NM

**ALERTS-**

- LAMP
- AURAL "WINDSHEAR AHEAD" - 1 REPEAT
- DISHAW. WINDSHEAR ICON RED/BLACK POP UP IS OFF TO WS MODE

**PILOT ACTION**

- RTO
- REPORTS WS TO ATC

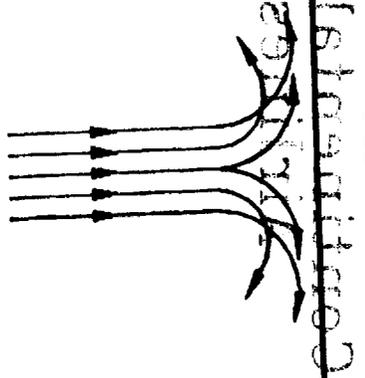
## -CONDITIONS-

- AIRCRAFT - BEYOND  $V_1$
- WX - ENCOUNTERED WINDSHEAR

- LAMP

- AURAL\* "WINDSHEAR AHEAD" 2 REPEATS \* AURAL INHIBITED 100 KNOTS TO ROTATION
- DISPLAY NONE

- WTARP
- REPORTS WS TO ATC

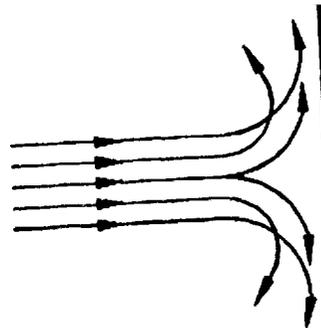
## --CONDITIONS--

- AIRCRAFT - TAKEOFF ROLL BEYOND V
- WX - WINDSHEAR BETWEEN 1.5NM AND 5NM

WINDSHEAR  
AHEAD

- LAMP

\* AURAL INHIBITED  
100 KNOTS TO ROTATION

- AURAL\* "WINDSHEAR AHEAD" 1 REPEAT
- DISPLAY WINDSHEAR ICON YELLOW/BLACK  
POP UP IS OFF TO WX/WS MODE

- TO MAX POWER
- NOTIFY ATC
- AVOID WS
