WARTIME REPORT

September 1944 as
Restricted Bulletin E4I07

A POSITIVE-REPLICA TECHNIQUE FOR EXAMINING FINISHED METAL
SURFACES AND ITS APPLICATION TO AIRCRAFT-ENGINE CYLINDERS

Aircraft Engine Research Laboratory
Cleveland, Ohio

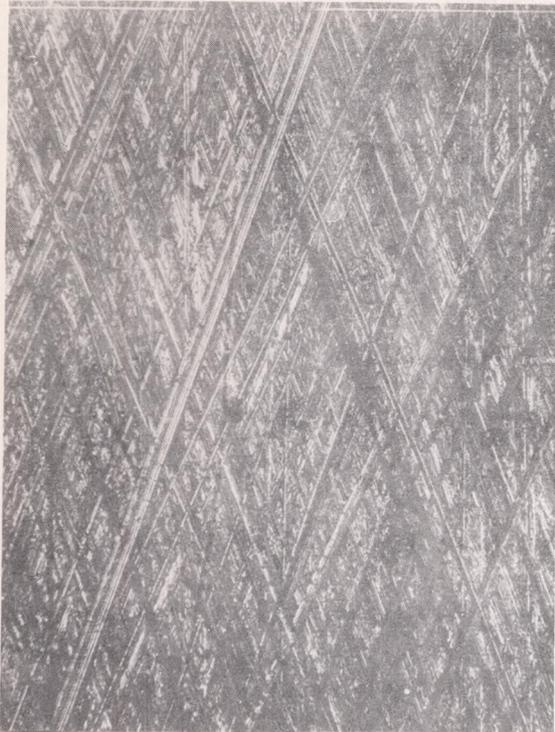
Figure 3. - A positive replica of a new coarsely honed Allison V-1710 cylinder barrel. X112.

Figures 3 to 7 are photomicrographs of positive replicas of various portions of the surface of the cylinder magnified 112 diameters. The coarsely honed surface finish of a new Allison cylinder

barrel is shown in figure 3. Figure 4 shows the comparatively finely honed finish given to the Allison cylinder barrel at AERL in the course of a general engine overhaul. The surface of the coarsely honed new cylinder after 48 hours of test running is shown in figure 5 and the surface of the finely honed cylinder barrel after 35 hours of test running is shown in figure 6. Figure 7 shows the surface of the coarsely honed cylinder after 100 hours of test operation. All these photomicrographs were taken along the middle portion of the major-thrust face of the barrel and represent the general surface appearance of the cylinder barrel.

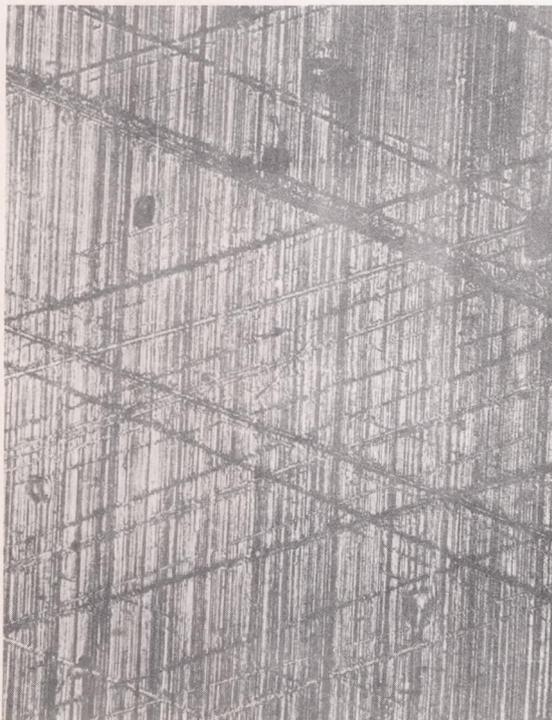
Figure 5. - A positive replica of the coarsely honed Allison V-1710 cylinder barrel after 48 hours of test running. X112.

A replica of a typical surface area in the center of the barrel slightly worn after 33 hours is shown in figure 11. This surface has not yet reached the appearance of the barrel shown in figure 5. Figure 12 shows the same general area in the barrel well-worn after 225 hours. An examination of the replicas of this area made from this cylinder during its running indicated that apparently no further surface-finish change occurred once this stage had been reached. (Cf. figs. 6, 7, and 12.)

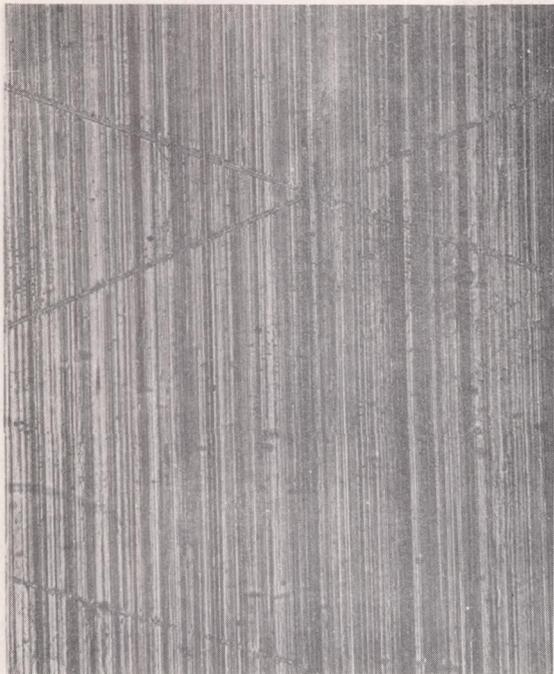
Figure 7. - A positive replica of the coarsely honed Allison V-1710 cylinder barrel after 100 hours of test running. X112.

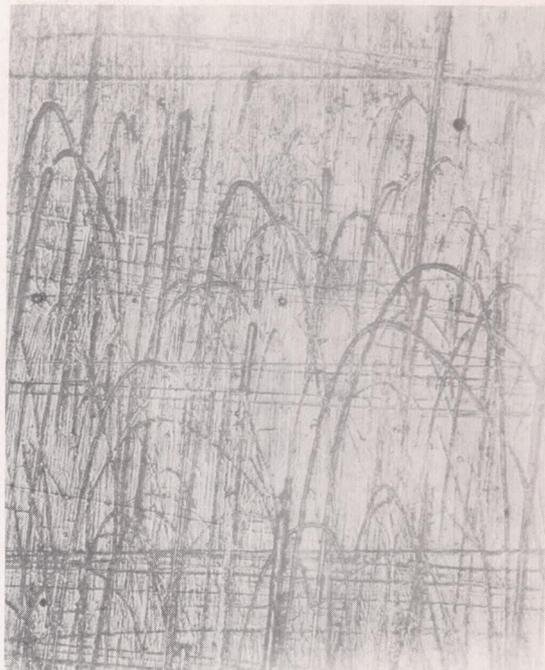
Figure 8. - A positive replica of the area at the top of ring travel in an Allison V-1710 cylinder barrel after 120 hours of test running. The top ring was free. X112.

had been run 33 hours, one 120 hours, and the other 225 hours on a test stand. These photomicrographs are shown in figures 8 to 14. The fact that the cylinders examined in this replica study were used for ring-sticking tests must be kept in mind in interpreting the figures. In the cylinders that had been run for 33 and 225 hours, the top ring was stuck in the ring groove causing a different pattern on the cylinder wall at the top of ring travel from that which is found at the same position in the barrel that had been run for 120 hours where all the rings were free.

Figure 8 shows the area within the top ring band in the cylinder in which the top ring did not stick. The looping scratches were presumably generated by the top compression ring as it rotated slightly at the top of the stroke. Figure 9 shows the area at the top of ring travel in the barrel run for 33 hours in which the top ring was stuck. The burnishing effect of the ring impact has removed the scratches in this barrel but has left the deeper cross-hatched grooves of the honing operation. Figure 10 shows a replica of the worn surface of the barrel run for 225 hours taken at approximately the same area shown in figure 9. The ring was stuck in this cylinder. This cylinder presents an excellent example of the surface found at the top of ring travel in a worn cylinder barrel. A characteristic burnished area with the fringe of smeared metal extending downward is clearly shown.

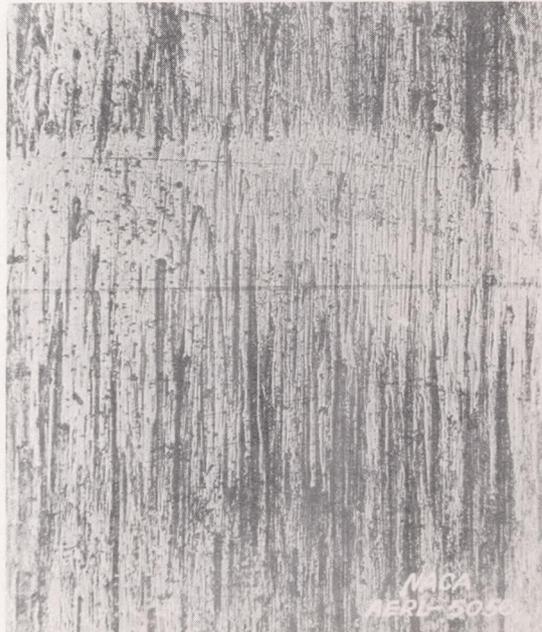
Figure 10. - A positive replica of the area at the top of ring travel in an Allison V-1710 cylinder barrel after 225 hours of test running. The top ring was stuck. X112.
