# High-Speed Observer: Automated Streak Detection in SSME Plumes

### HIGH-SPEED OBSERVER: AUTOMATED STREAK DETECTION IN SSME PLUMES

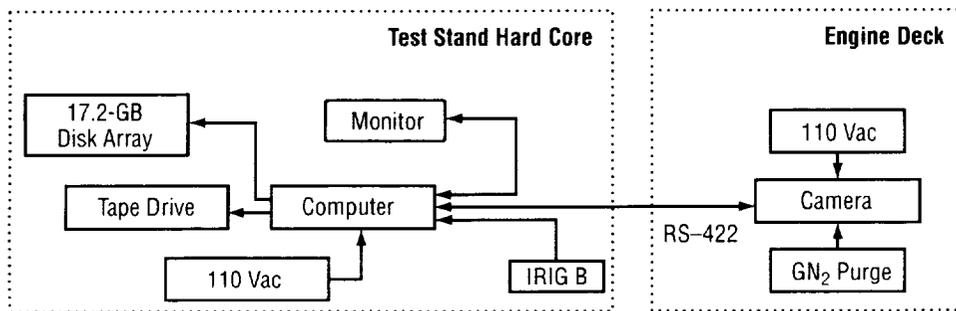
Figure 2. HSO system.

The HSO system, depicted in figure 2, uses a 200-fps,  $256 \times 256$  pixel, DALSA<sup>®</sup> charge-coupled device (CCD) array camera to generate 8-bit, gray-scale digital images. This camera is mounted inside a PELCO<sup>®</sup> EHX6-16 explosion-proof housing for protection against the rugged environment experienced during testing. The HSO camera position at SSC is shown in figure 3. The ideal camera position on the test stand is on or slightly above a plane, horizontal with the midpoint between the nozzle exit plane and the Mach disc. This position provides a single line of reference at the nozzle exit plane for the region of interest.

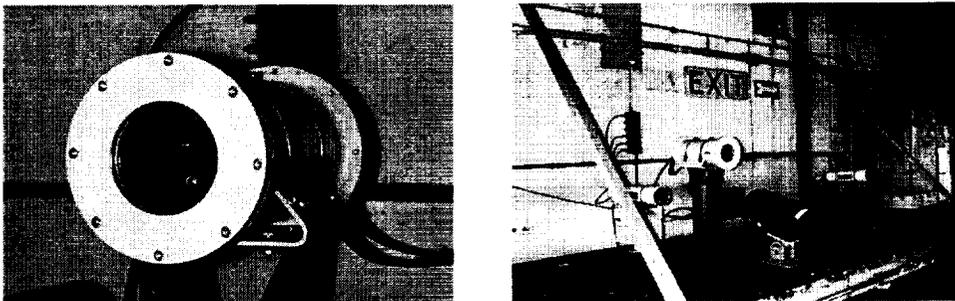
Figure 3. HSO installation at SSC.

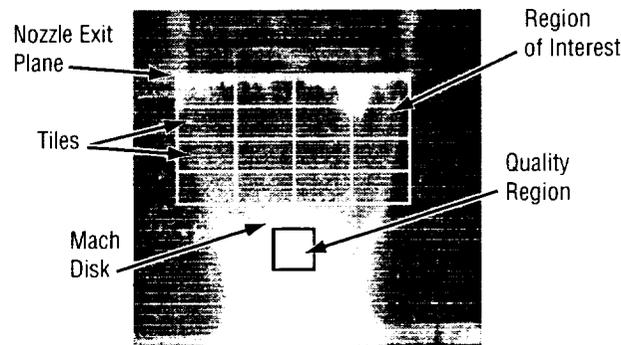
Figure 6. HSO image elements.

Image data validation consists of checking a quality region for a valid data signal and an obscured field of view as shown in figure 6. The quality region currently employed by the HSO system is a small, presently  $5 \times 5$  pixel, fixed array acting as a reference point for validation of the image. Since the intensity of the Mach disc is approximately the same as that of a streak, the quality region was selected in the Mach disc. The average intensity value of the quality region is called the quality region value. A valid data signal indicates that the hardware is functional, determined by checking for nonzero data in the quality region.

Plume streak detection utilizes a system based on a region of interest. The region of interest is a rectangular area extending from the nozzle exit plane to the Mach disc and bound by the width of the plume. This area, shown in figure 6, is divided into equal-sized, rectangular groups of pixels called tiles, figure 7(a). The number of pixels per tile varies with the size of the region of interest. In the current configuration, each tile is  $32 \times 32$  pixels.

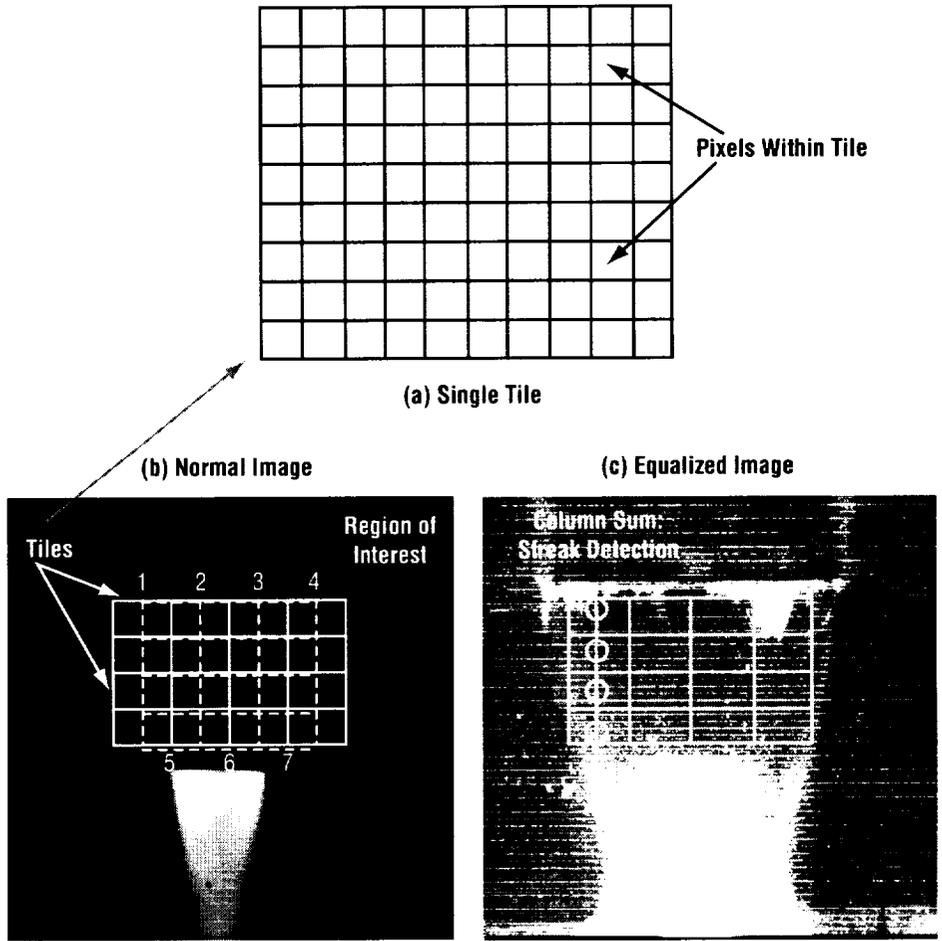
Figure 7. Streak detection elements.

In the present configuration, a system of seven overlapping columns of tiles, extending between the engine nozzle exit plane and the Mach disc, are used to determine whether a streak has occurred. Figure 7(b) shows this seven-column configuration with a normal HSO recorded image in which the Mach disc is exposed for the midrange of the camera. Four main columns of tiles cover the region of interest, as represented by the solid lines in figure 7(b) and (c). While a plume streak may occur on the boundary between two of these four main columns of tiles, it was empirically determined that the intensity change due to a streak along a tile boundary is not always sufficient to indicate an out-of-family tile. However, streaks recorded in the center of a tile do yield a sufficient intensity change to indicate an out-of-family tile. To avoid missing these boundary streaks, three additional columns of tiles are used—dashed lines in figure 7(b). The centers of these three additional columns cover the intersecting boundaries of the four main tile columns.

Processing of each column begins at the nozzle exit plane, moving toward the Mach disc, as shown in figure 7(c). Figure 7(c) is an equalized image that permits observation of the plume boundary and nozzle exit plane. The main columns are processed first, followed by the overlapping columns. If each tile in a column has tile value "1," the column is said to contain a streak. If there is at least one tile in a column whose tile value is "0," the column is said to not have a streak. If a tile is encountered that has a value of "0," processing stops on that column and begins on the next column. The column location, size (number of columns), number of frames, and the duration of each streak are recorded.

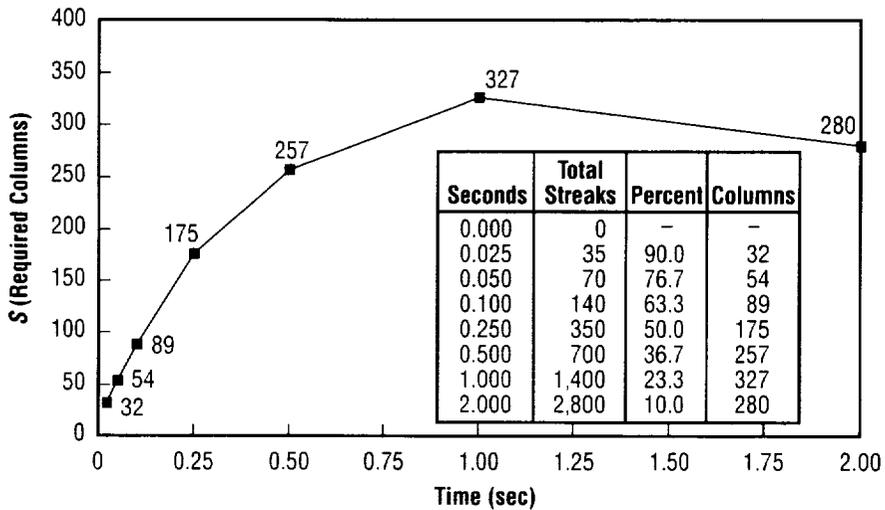
Figure 8. Number of required columns for redline violation with 200-fps camera.

The interpolated values for the number of columns required for redline violation versus time period are shown in figure 8.

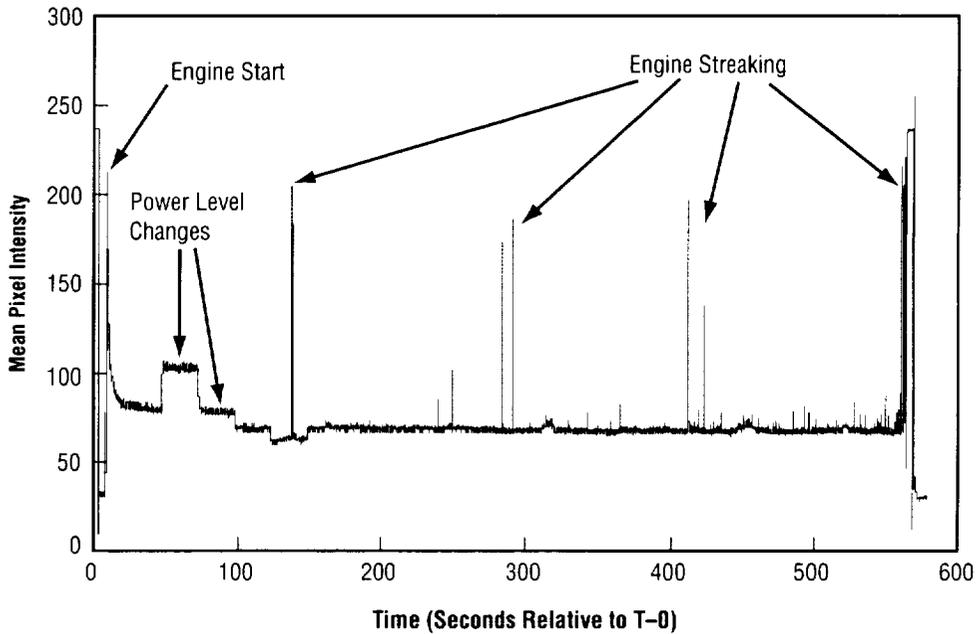
Figure 9. Test 901–853 mean plume intensity.

This SSME test was performed on January 25, 1996, at SSC on test stand A1. A number of large streaks were visible during this test. The test was cut off early by a human observer and the engine suffered damage. Videotape of this SSME test was used to develop the HSO expert system. Figure 9 shows the mean plume intensity during SSME test 901–853. Streaking induces a plume brightening and this greater intensity is noted as plume streaks in figure 9.

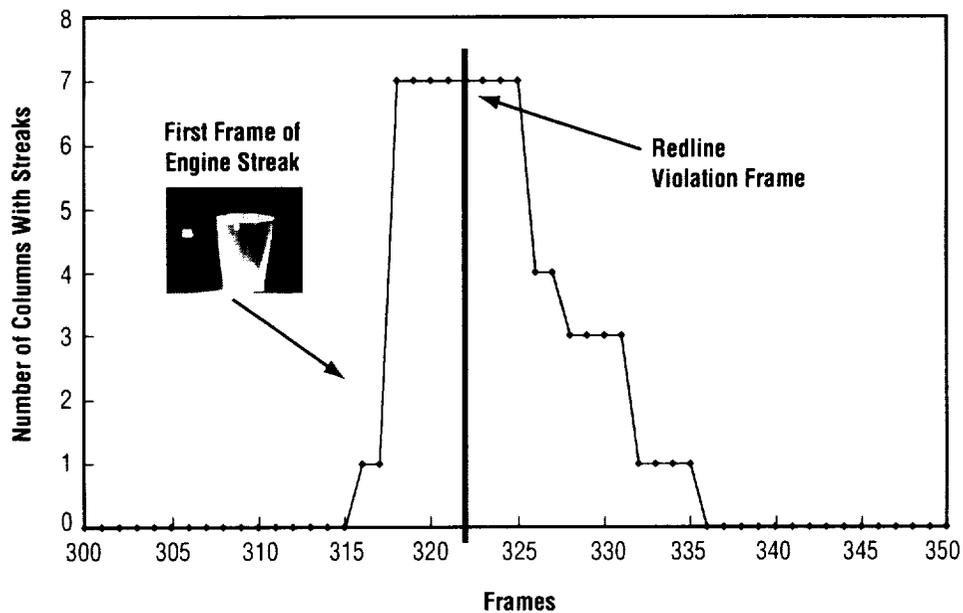
Figure 10. HSO analysis of first streak phenomenon for SSME test 901-853.

Figure 10 provides a magnified view of the HSO analysis for the first streak occurring at  $\approx 140$  sec. A redline violation occurs and was noted by the HSO expert system. The number of columns with streaks together with the continuing nature of the streaking during the five frames preceding the bold black line in the center of figure 10 produced a redline violation within 25 msec at frame 322.

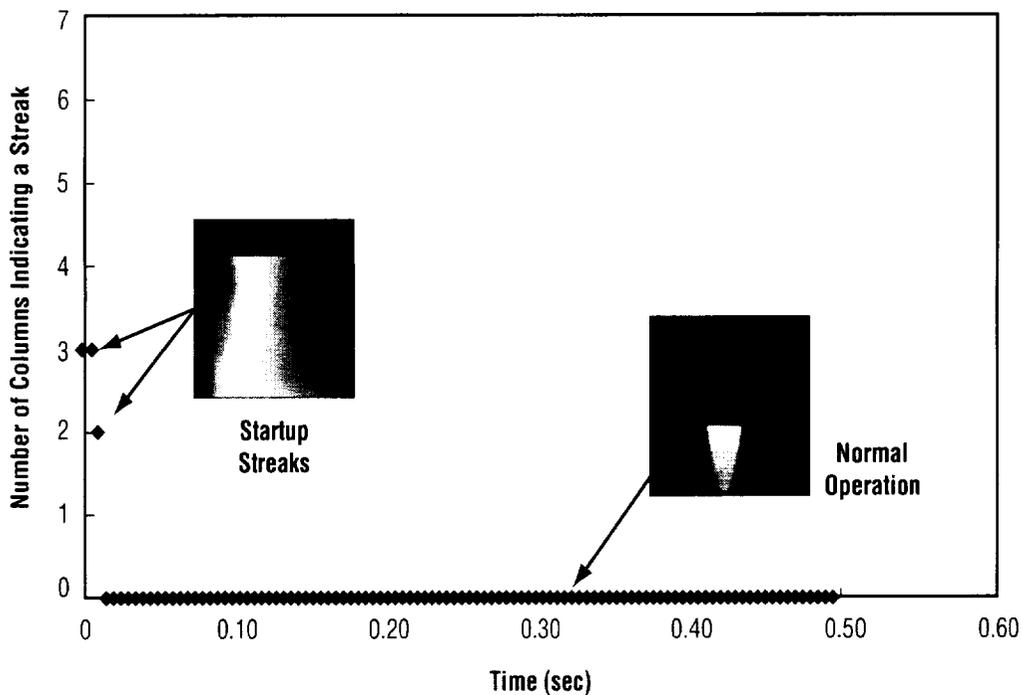
Figure 11. HSO analysis of SSME test 904-361 streak data from first 440 frames.

This SSME test occurred at the B1 test stand at SSC on September 3, 1998. Two streaks were detected in the early startup phase, but no streaks were detected after that, as shown in figure 11. Test duration was 750 sec.

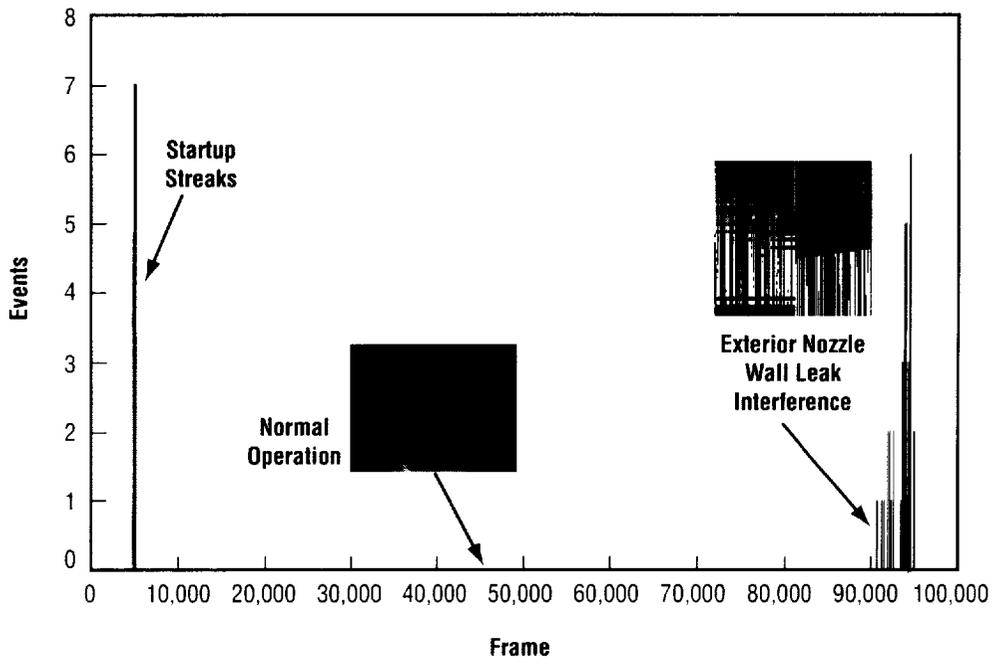
Figure 12. HSO analysis of engine test 901-932.

This SSME test occurred at the A1 test stand at SSC on August 23, 1997. As shown in figure 12, there were numerous streaks detected early in the startup phase but no anomalous streaks were detected. The camera was in the direct path of an exterior wall nozzle leak and the data were unusable after the camera malfunctioned due to overheating. Another problem experienced during the test was an incorrect exposure setting for the Mach disk. This overexposure caused the CCD array in the camera to bloom, a common phenomenon experienced in CCD array cameras when overexposed. To prevent this from creating false streaks, the camera is turned on the camera mount in such a way that the blooming effect is orthogonal to the direction of columns.
