Vacuum/Zero Net-Gravity Application for On-Orbit TPS Tile Repair

Gale A. Harvey, Donald H. Humes, and Emilie J. Siochi
NASA Langley Research Center

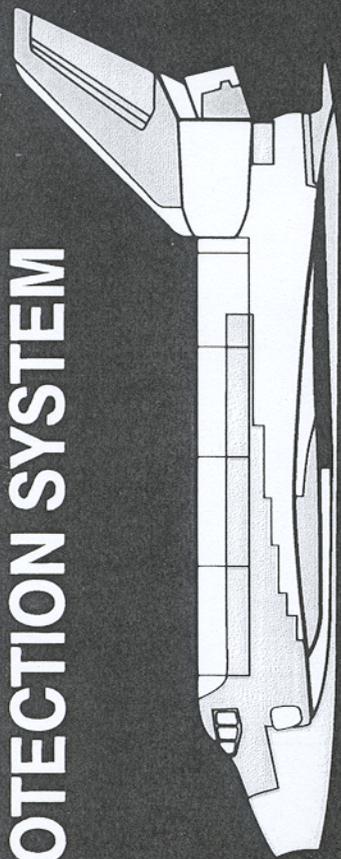
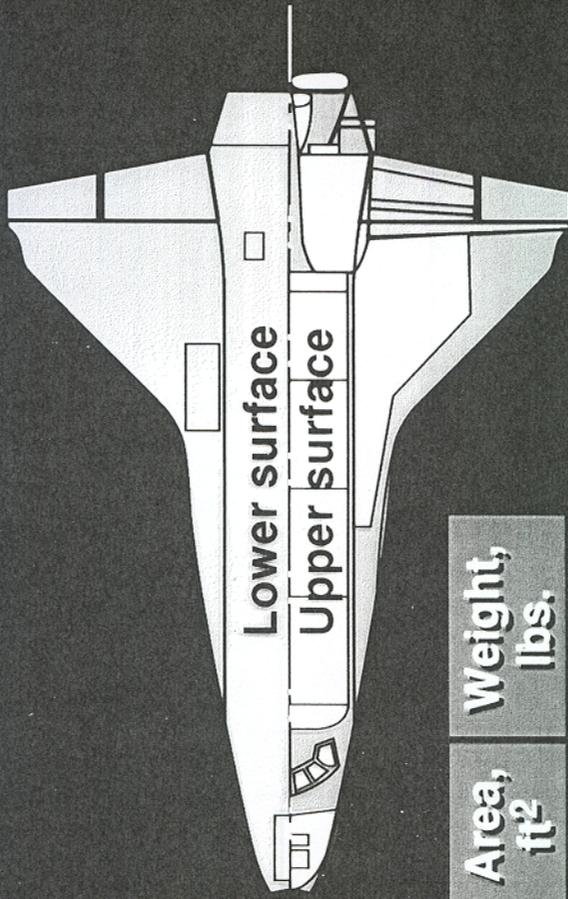
- Reinforced carbon carbon (RCC)
- High temperature, reusable surface insulation (HRSI)
- Low-temperature, reusable surface insulation (LRSI)
- Coated Nomex felt reusable surface insulation (FRSI)
- Metal or glass

1. Space Shuttle Orbiter Thermal Protection System.

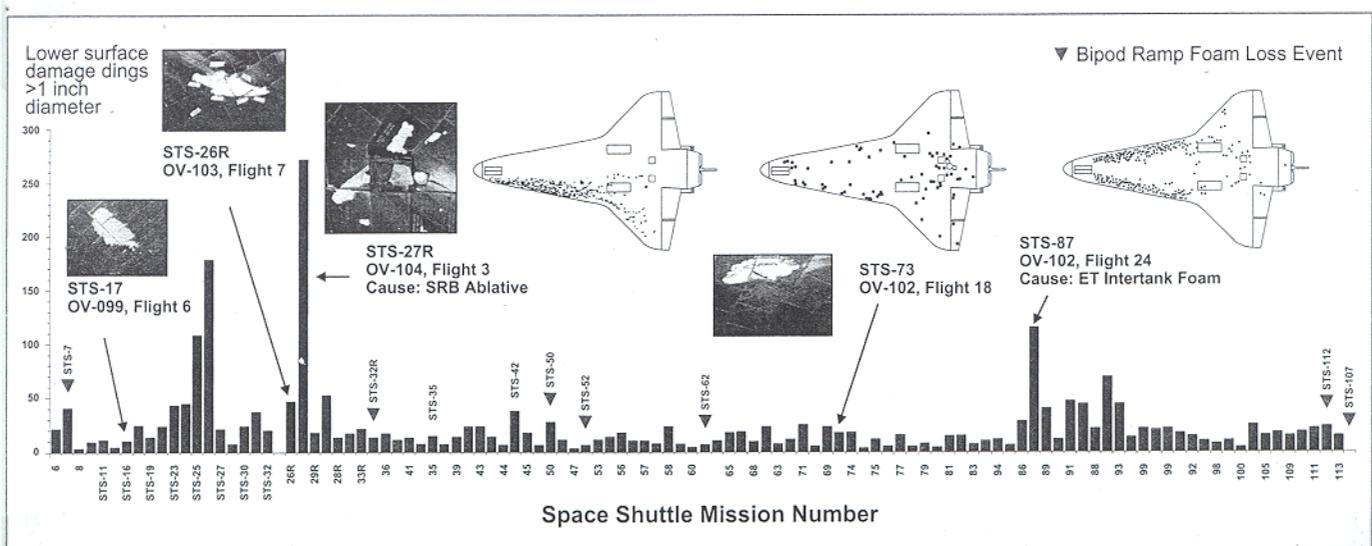
2. This chart shows the number of dings greater than one inch in diameter on the lower surface of the Orbiter after each mission from STS-6 through STS-113.

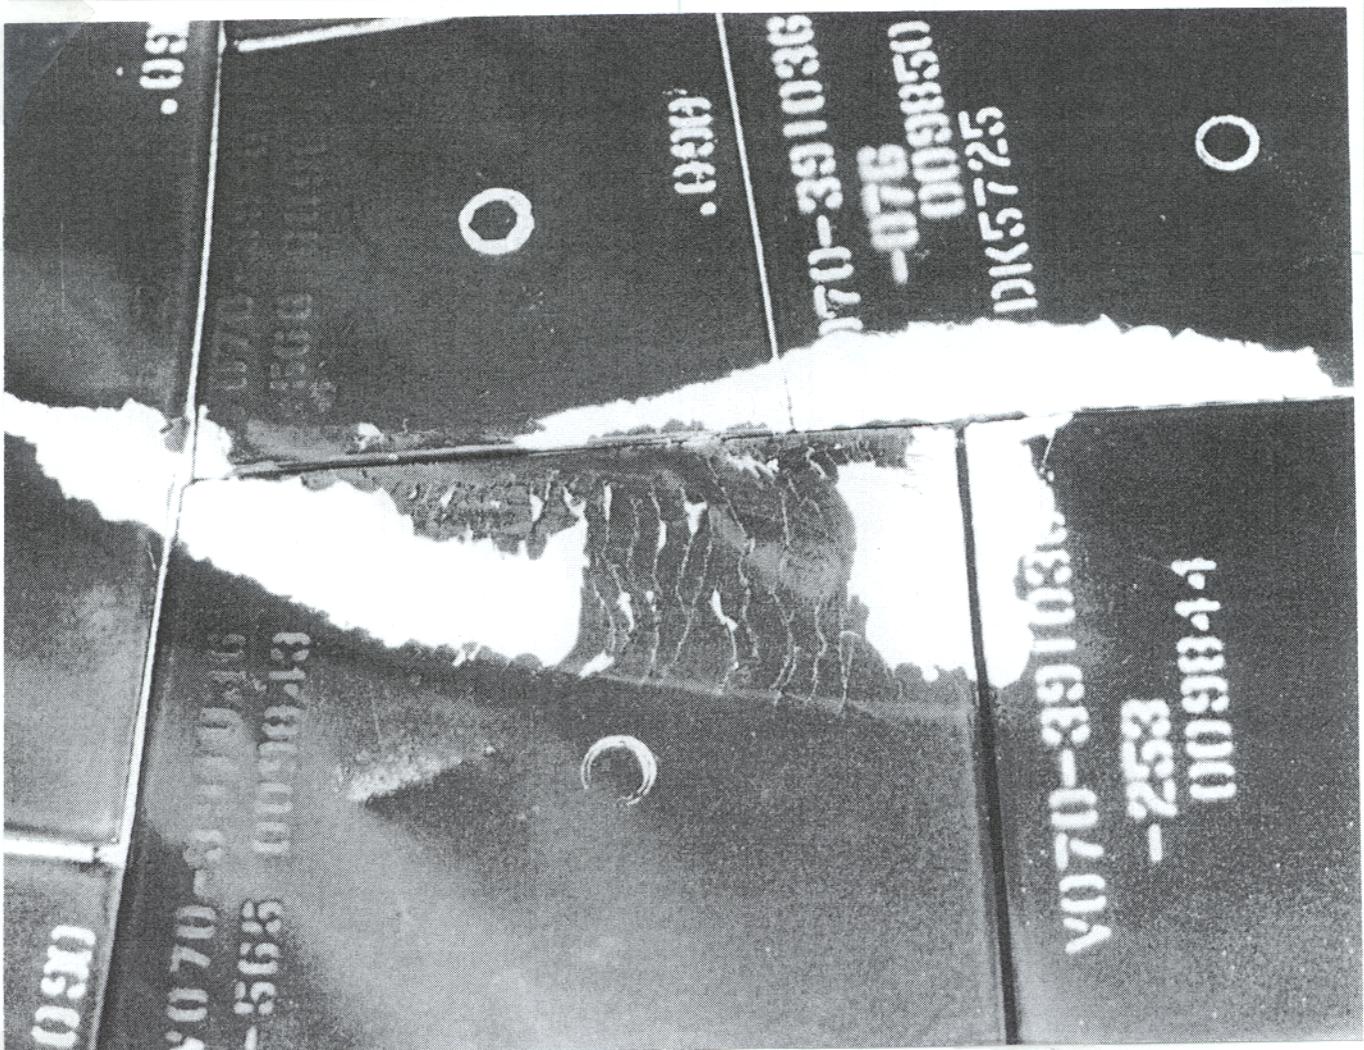
3. Impact damage in HRSI (TPS tile), right hand forward chine, STS 49.

3. Impact damage in HRSI (TPS tile), right hand forward chine, STS 49.
4. 1 m x 1m top loading vacuum chamber (top off).
5. Interior of 1 m x 1 m chamber with vertical turntable, manual feed-through for positioning the target, and manual feed-through for positioning the mixing-dispenser.

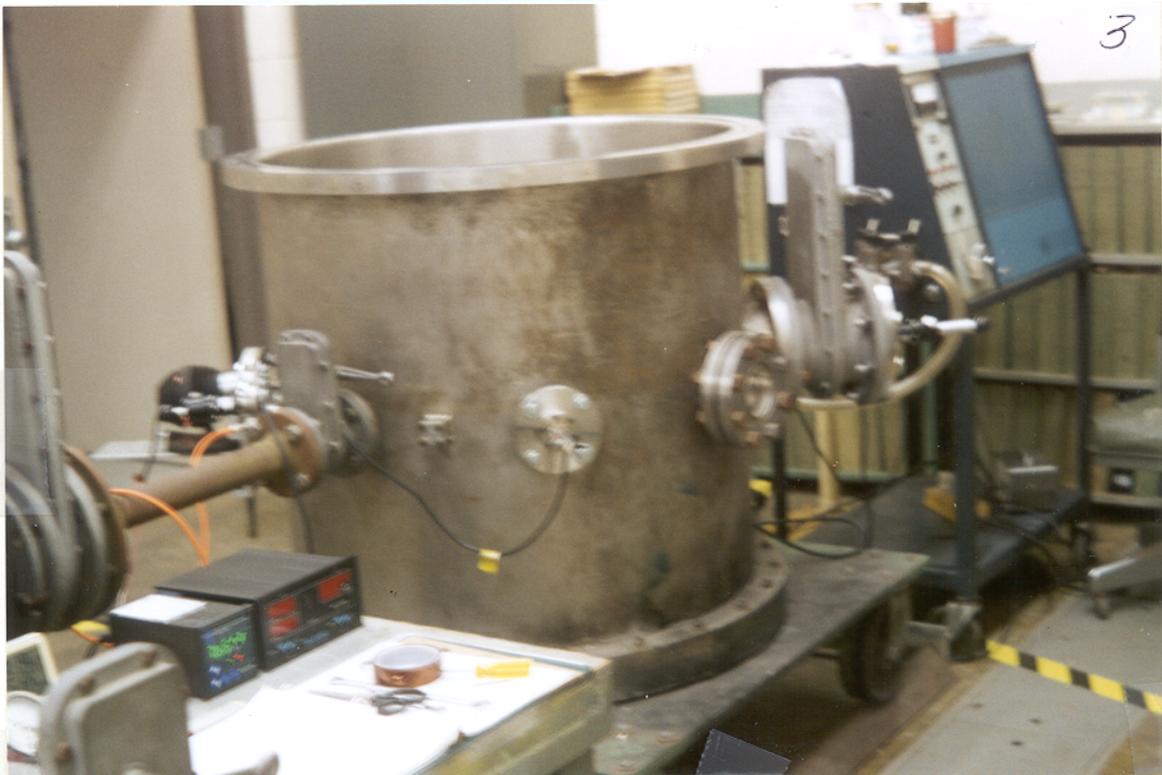
4. 1 m x 1m top loading vacuum chamber (top off).

A one meter by one meter top-loading chamber was available and amenable to modification for vacuum and zero-net gravity testing (figure 4). A one meter by one meter mockup chamber was fabricated in order to size and fit-check the apparatus to be placed in the chamber. The vacuum chamber was refitted with a new Pirani gauge and a new cold cathode gauge, and tests were run to establish the chamber's vacuum integrity and pumping characteristics. Two manual feed-through manipulators were installed on the chamber, one to provide ratcheted dispensing of test RTV repair material, and one to move the target (cavity-cup) to and from the dispenser nozzle. A photograph of these feed-through manipulators, mixing-dispenser gun, and a Crystobolite cavity-cup is shown in figure 5.

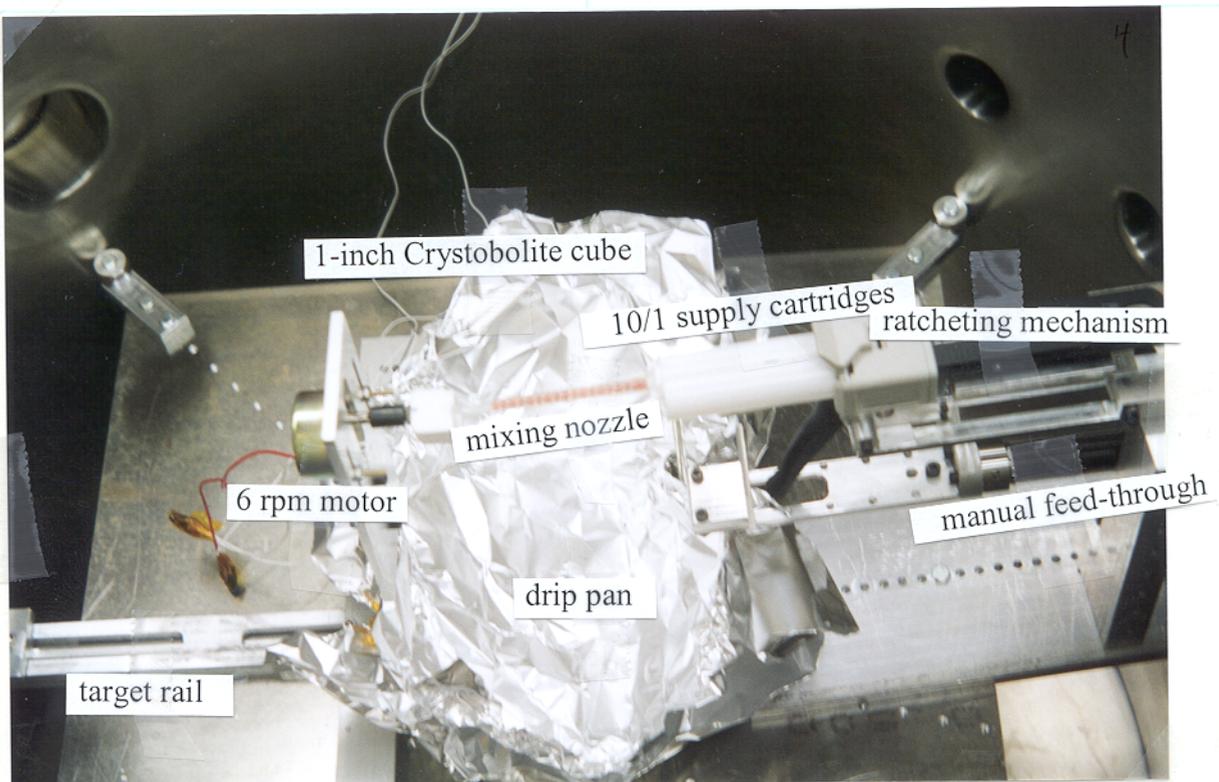
5. Interior of 1 m x 1 m chamber with vertical turntable, manual feed-through for positioning the target, and manual feed-through for positioning the mixing-dispenser.

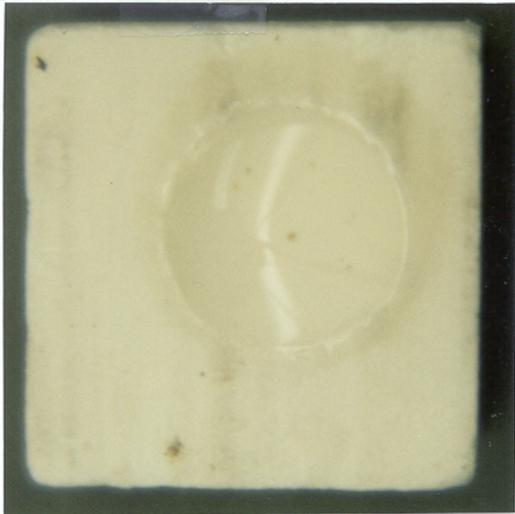
6. Photograph of phenyl methyl silicone mixed in air and dispensed in air into 1-inch pit in Crystobolite on zero net-gravity turntable.

The ethanol and entrained air bubbles will rise to the top of low and medium viscosity silicones and burst, leaving void-free material to cure (over cure times of several hours at STP). Zero net-gravity tests at STP of medium viscosity silicones (10 to 1000 Poise) injected into a one-inch diameter cavity showed that the silicones cured to be void-free and with a smooth meniscus surface. That is, the surface tension of the medium viscosity silicones caused the material to be self-smoothing under zero net-gravity. Photographs of the white, medium viscosity silicone cured under zero net-gravity at STP is shown in figure 6. A few small bubbles are at the surface of the cured silicone. No material dripped out of the cavity during the application and curing of the silicone.

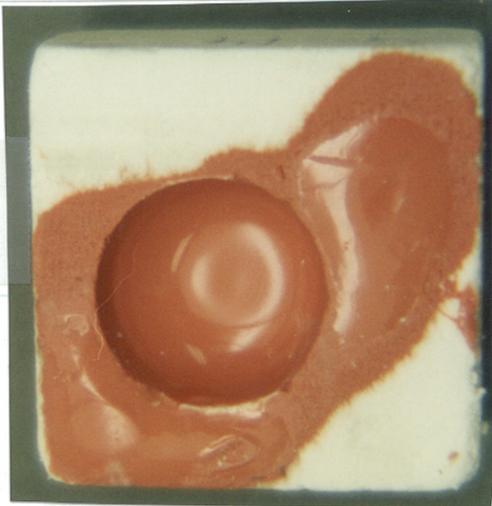
7. Photograph of color-enhanced phenyl methyl silicone mixed in air and dispensed into 1-inch pit in Crystobolite in vacuum zero net-gravity facility.

The first vacuum/zero net-gravity was performed September 14, 2004. The first four tests are listed in Table 1. The first test demonstrated the operability of the facility. The phenyl-methyl silicone based repair material was premixed and placed in the cartridge of a small caulking gun-like dispenser. The tin catalyst-cure liquid resin had been previously vacuum degassed, but was not degassed again after the catalyst had been mixed in. Large bubbles (air and ethanol) were observed forming and bursting in the silicone injected into the Crystobolite cavity-cup. A photograph of the cured silicone in the Crystobolite cavity-cup is shown in figure 7.

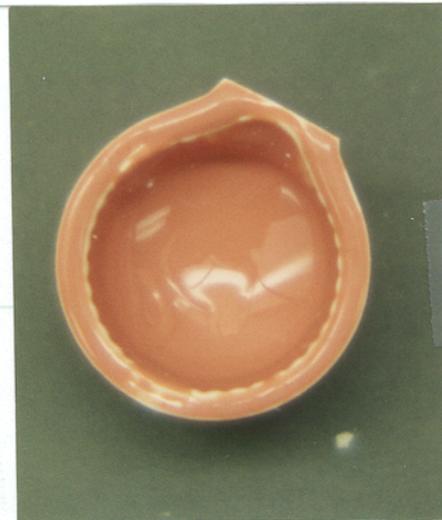
9. Photograph of color enhanced phenyl methyl silicone vacuum degassed after mixing in air and dispensed in vacuum/zero-net gravity facility.

The third vacuum/zero-net gravity test was performed September 29, 2004. The phenyl methyl silicone based repair material was premixed and vacuum degassed after mixing in the catalyst. Again the tip of the dispensing nozzle was inserted about ¼-inch into the cavity-cup. A few bubbles formed and burst during dispensing of the silicone into the cup. The silicone wicked into the cup, covering the floor of the cup. About half of the silicone remained in the cup and about half dripped onto the floor (and was collected in an aluminum foil pan). A photograph of the cured silicone in the cup is shown in figure 9.

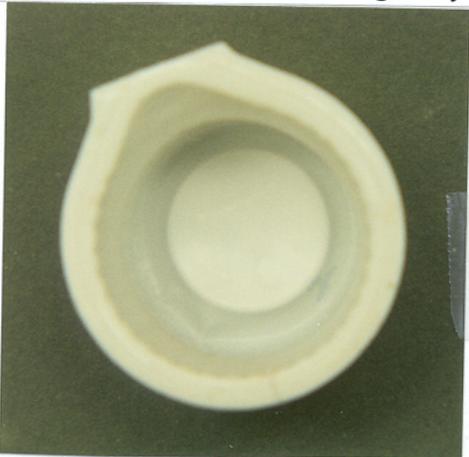
8. Photograph of vinyl silicone mixed in air and dispensed in 1-inch cup in vacuum/zero net-gravity facility.

The second vacuum/zero net-gravity test was performed September 28, 2004. The clear, vinyl silicone based repair material was not degassed, was premixed, and hence had many small air bubbles entrained in the material. The tip of the nozzle of the dispensing gun was positioned ¼-inch into the plastic cavity-cup. The vinyl based silicone started foaming during the chamber pump-down below 100 Torr. The froth formed a cover over the top of the cavity-cup, preventing the silicone from wicking into the bottom of the rotating cup. Most of the silicone dripped out of the cup (Table 2). A photograph of the cured silicone in the cup is shown in figure 8.

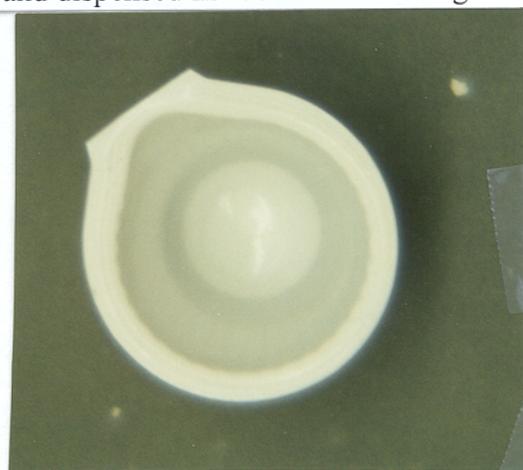
10. Photograph of vinyl silicone mixed and dispensed into 1-inch cup in vacuum/zero net gravity facility.

The fourth vacuum/zero-net gravity test was performed October 6, 2004. The vinyl silicone based repair material was not degassed and was not premixed. That is the resin and catalyst were mixed in the mixing nozzle during the dispensing of the material into the cavity cup. The tip of the nozzle was inserted about ¾-inch into the cavity-cup. A very few bubbles formed at the tip of the nozzle at the beginning of the dispensing of the silicone, and then no bubbles were observed for the remainder of the dispensing. 3.8 gm of silicone wicked into the bottom of the cup, and formed a deep meniscus within the cup. About 6.3 gm of the silicone dripped out of the cup. The vinyl silicone is a low viscosity material immediately after mixing. A photograph of the cured silicone in the cup is shown in figure 10.
