# FOREIGN OBJECT DAMAGE RESISTANCE OF UNCOATED SiC/SiC COMPOSITES

R.T. Bhatt, S. R. Choi, L.M. Cosgriff, D.S. Fox, and K.N. Lee  
NASA Glenn Research Center,  
Cleveland, Ohio 44135

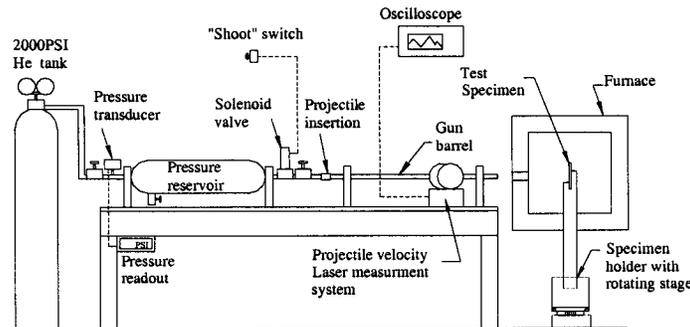
Figure 1. Impact testing apparatus with a specimen holder and a high-temperature furnace.

For impact testing of flexural specimens at room temperature and 1316<sup>0</sup>C in air an experimental apparatus as shown in Fig. 1 was used. Detailed descriptions of the apparatus and the testing procedure for impact testing can be found elsewhere [8, 9]. The specimens were partially supported at the specimen ends in the specimen holder. For impact testing of dog-bone shaped tensile specimens, an impact gun unit similar to that shown in Fig. 1 was used, but the specimens were held at their ends in a “C” shaped clamp and the gage section was heated by an atmospheric pressure burner rig mounted parallel to the specimen holder. In both test configurations, the specimens were impacted with hardened (HRC≥60) chrome steel-balls (~1.59-mm diameter) at velocity ranging from 110m/s to 400m/s.

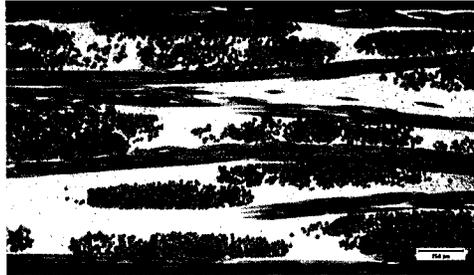
Figure 2. SEM photograph of a cross-section of an as-fabricated SiC/SiC composite showing distribution of SiC fiber tows in the SiC matrix

Figure 2 shows a SEM micrograph of the cross section of an as-fabricated SiC/SiC composite. The composite is essentially a layered structure consisting of woven fiber plies interspersed with SiC matrix which is composed of SiC particles and silicon. The gray region in the photograph is the SiC fiber tows coated with CVI BN and SiC coatings. The white region is the SiC matrix. Dark regions in the tow indicate closed porosity.

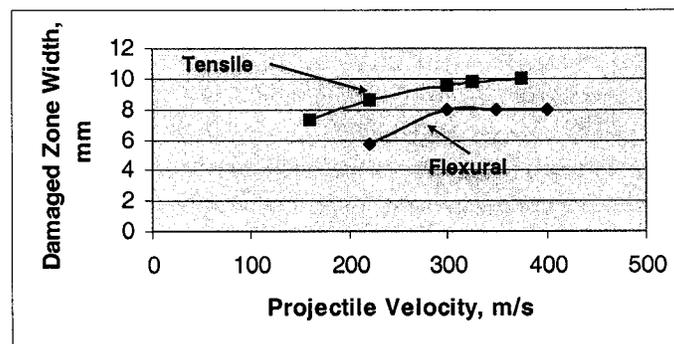
Figure 3. Variation of damaged zone width with projectile velocity for SiC/SiC composites tested at room temperature

Figure 3 shows the width of the impact damage zone as a function of projectile velocity for flexural and tensile specimens impact tested at room temperature. The width of damaged zone was measured by thermal wave imaging. The data indicated that as the projectile velocity increases, width of the damage zone increases initially and then reaches a plateau corresponding to the width of the specimen. This suggests that back side tensile stresses and edge effects cause delamination to start and propagate to the edge of the specimen beyond certain impact velocities. Delamination is probably caused by poor interlaminar tension between fiber plies and the SiC matrix.

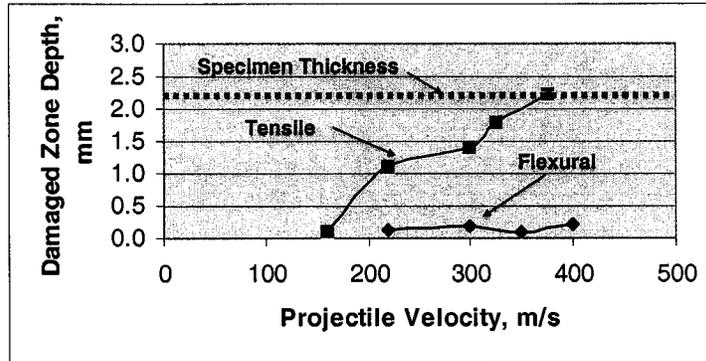
Figure 4. Variation of damaged zone depth with projectile velocity for SiC/SiC composites tested at room temperature.

Figure 4 shows the depth of the impact damage zone as a function of projectile velocity for SiC/SiC composite specimens impact tested at room temperature. The through-the-thickness damage was measured by CT. The dotted line in the figure indicates nominal thickness of the impacted specimens. For tensile specimens, as the projectile velocity increased, the depth of damage also increased. At projectile velocities  $> 300\text{m/s}$  the damage zone extends across the thickness of the specimen. In other words, the projectile perforated the specimen. On the other hand, flexural specimens showed considerably lower through-the-thickness damage with increasing projectile velocity. The reason for this behavior is not clearly understood. However CT images indicate increasing amount of delamination with increasing projectile velocity. Although not shown in this paper, the damaged zone depth was much greater for specimens tested at  $1316^{\circ}$  than at  $25^{\circ}\text{C}$ , possibly due to plasticity of the matrix at high temperature [10].

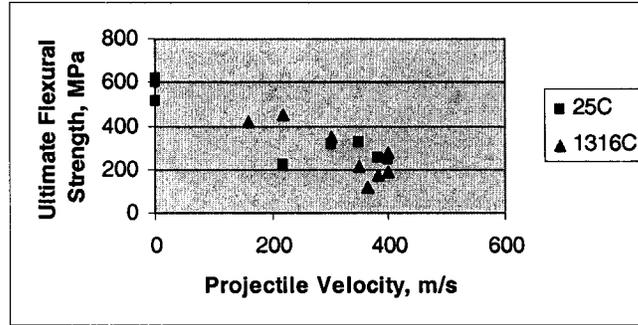
Figure 5. Variation of room temperature ultimate flexural strength with projectile velocity for SiC/SiC composites impact tested at room temperature and 1316<sup>0</sup>C in air.

Variation of room temperature ultimate flexural strength with increasing projectile velocity for the flexural specimens tested at room and  $1316^{\circ}\text{C}$  in air is shown in Fig. 5 Included in the figure for comparison are the ultimate flexural strength values for the as-received SiC/SiC composites. One specimen at each temperature impacted at the lowest velocity (i.e.,  $160\text{ m/s}$  at  $25^{\circ}\text{C}$  and  $115\text{ m/s}$  at  $1316^{\circ}\text{C}$ ) did not fracture at the impact site because of negligible impact damage, and its resulting strength was close to the as-received strength. As seen in the figure, post-impact strength decreased with increase in impact velocity at both temperatures which is attributed to increased impact damage. The impact damage resulted from both frontal contact and backside bending stresses, resulting in more significant strength degradation.

Comparison of data indicates that loss in ultimate flexural strength for specimens tested at a given projectile velocity at 25 and 1316<sup>0</sup>C is nearly the same. However, the observed size of frontal damage zone at 1316<sup>0</sup>C was greater than that at 25<sup>0</sup>C [10]. This implies that the overall combined damage (fiber-matrix debonding, delamination, shearing of matrix, and matrix/fiber cracking etc.) that control strength would remain almost similar in severity at both temperatures.

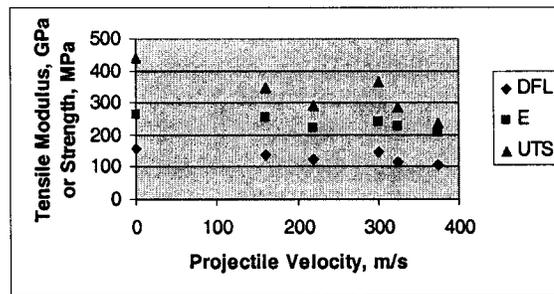
Figure 6. Variation of room temperature tensile properties with projectile velocity for SiC/SiC composites impact tested at room temperature in air.

Figures 6 and 7 show room temperature tensile data for SiC/SiC composites impact tested at room temperature and 1316<sup>0</sup>C, respectively. In the figures, the symbols DFL, E, and UTS refer to stress corresponding to deviation from linearity, Young's modulus, and ultimate tensile strength, respectively. For comparison purposes included in both figures are DFL, E and UTS values for the as-produced SiC/SiC composites. It is clear from the figures that as the projectile

velocity increases, E and DFL decreases slowly compared to UTS. The fact that impacted specimens display UTS value greater than the DFL stress value suggests strain capability beyond matrix fracture.

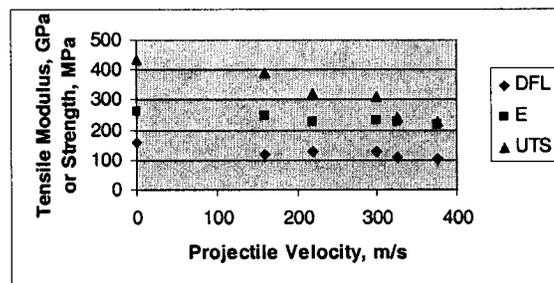
Figure 7. Variation of room temperature tensile properties with projectile velocity for SiC/SiC composites impact tested at 1316<sup>0</sup>C in air.
