On-Orbit Repair of RCC Structures

M. Singh
QSS Group, Inc.
NASA Glenn Research Center
Cleveland, OH 44135

On-orbit repair technologies for reinforced carbon-carbon composite (RCC) structures are critically needed for space shuttle return to flight (RTF) efforts. These technologies are also critically needed for the repair and refurbishment of thermal protection system of future Crew Entry Vehicles (CEV) of space exploration programs. GRABER (Glenn Adhesive Refractory for Bonding and Exterior Repair) has shown multiuse capability for in-space repair of both large repairs and small cracks in space shuttle Reinforced Carbon Carbon (RCC) leading edge material. The concept consists of preparing an adhesive paste and then applying the paste to the damaged/cracked area of the RCC composites with caulking gun. The adhesive paste cures at 100-120 C and transforms into a high temperature ceramic during vehicle re-entry conditions. Further development and testing are underway to optimize the materials properties and extend the application temperature.

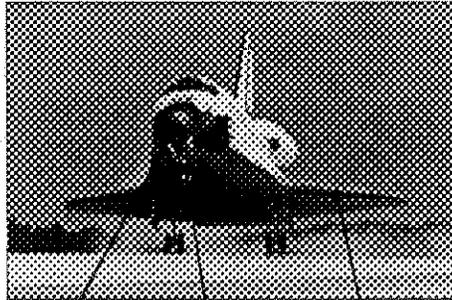
Leading Edge Structural Subsystem (LESS) RCC Components Overview

Nose Cap, Chin
Panel, and Seals

Forward External
Tank Attachment
"Arrowhead"
Plate

Wing Leading Edge
Panels and Seals

Orbiter

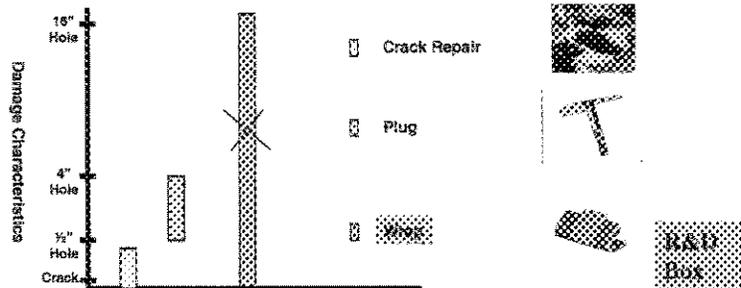
Repair Concept for WLE Damage and Location Limitations

Panel Location Limitations

- Crack Repair can accommodate cracks in the RCC acreage, but may have some restrictions on edges
- Plug can accommodate small scale holes provided adequate clearance behind damage to accommodate bolt length (expect restrictions on panel edges and wherever insulation is tight against the panel)

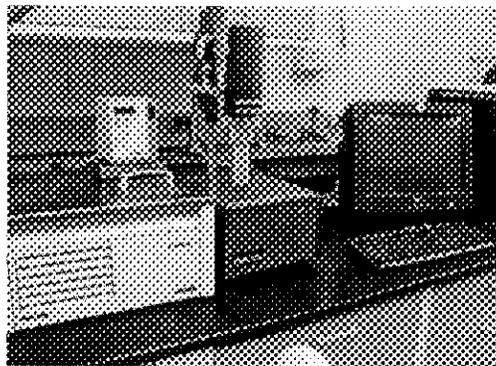
Brookfield PVS Rheometer Used for the Viscosity Measurements

*The temperature control bath has capability from
- 20°C (- 4 F) to 180°C (356 F)*

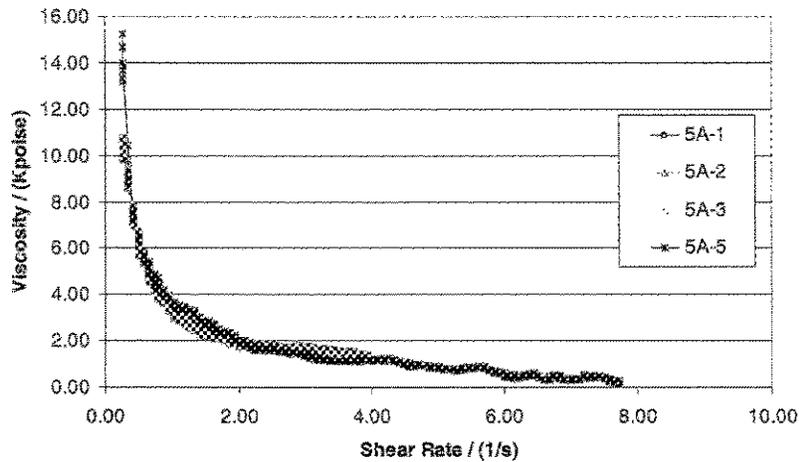
Reproducibility of GRABER 5A

Materials made at different times and in varying amounts show consistent viscosity

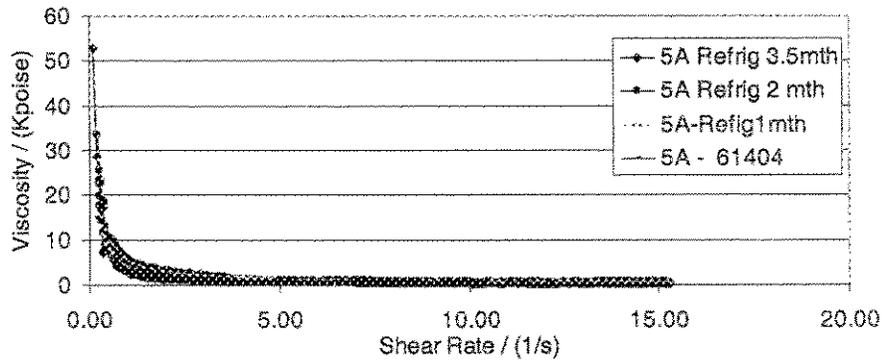
Storage Temperature Effects on GRABER 5A

Material Stored in a Refrigerator at 0 C

Materials stored for different times (1-3 months) had similar type of viscosity behavior as freshly prepared materials

Material was Tested under Vacuum

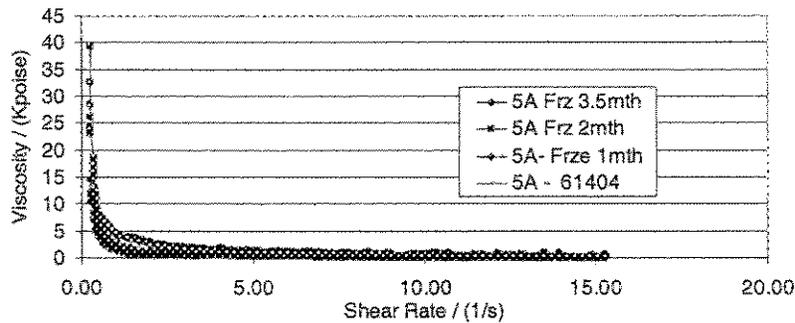
Storage Effects on GRABER 5A

Material Stored in a Freezer at -15 C

Materials stored for different times (1-3 months) had similar type of viscosity behavior as freshly prepared materials

Material was Tested under Vacuum

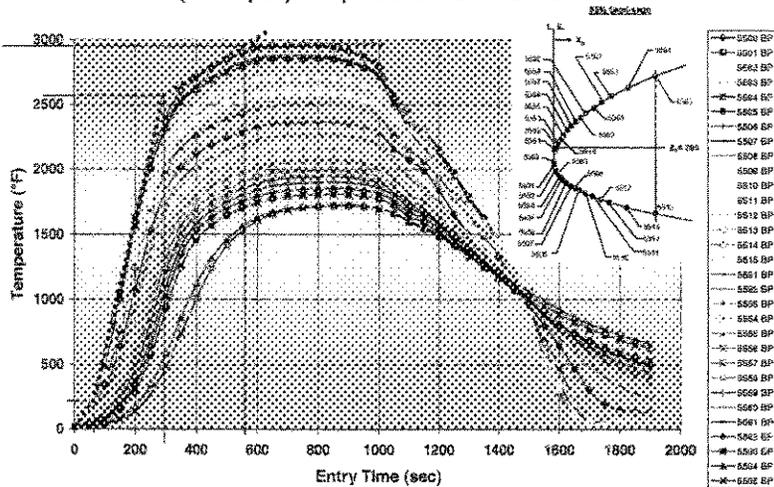
WLE Entry Temperature Profiles

Panel 9 (55% Span) Temperature Profile for Nom ISS EOM

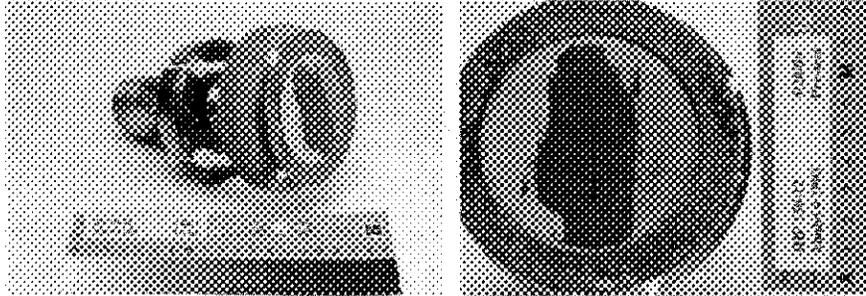
**ArcJet Testing of Repaired Specimens at ARC
Run 12 – Model 1993**

Percent Area = 10% of total condition
 Area at = 1.1 x 10⁻⁴ cm²
 Assembly was leak from externally, which allowed water vapor to the assembly

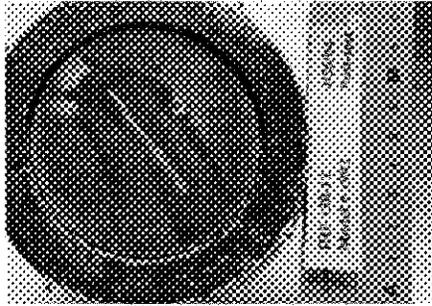
ArcJet Testing of Repaired Specimens at ARC
Run 12 – Model 1993

Post Test- Front Side

Post Test- Back Side

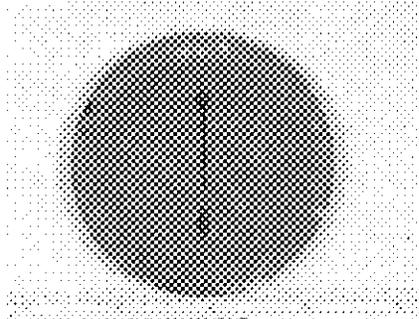
ArcJet Sample 1993, Graber 5A, 0.035" Crack Width

Front side

Back side

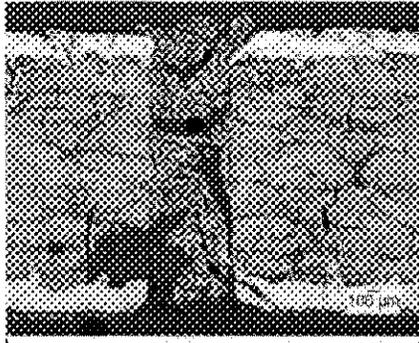
**ArcJet Sample 1993 (150-12), Graber 5A,
0.035" Crack Width**

Front Side

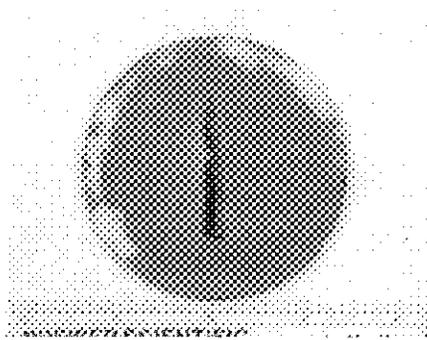
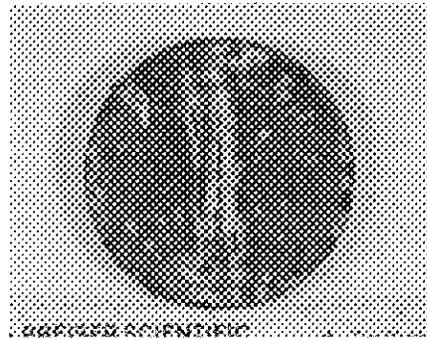
**ArcJet Sample 150-14, RCC-8, GRABER 12A,
0.062" Crack Width**

Back side

Front side

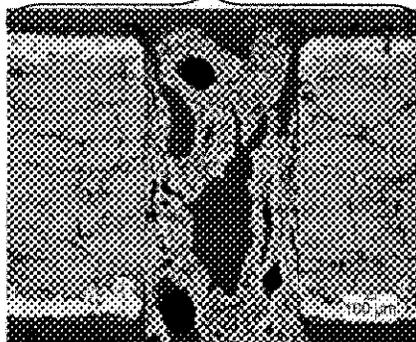
**ArcJet Sample 150-14, RCC-8, GRABER 12A,
0.062" Crack Width**

Front Side

There are large voids within the Graber material. The bonding between the Graber material and the L.T. substrate looks good as seen on the right.

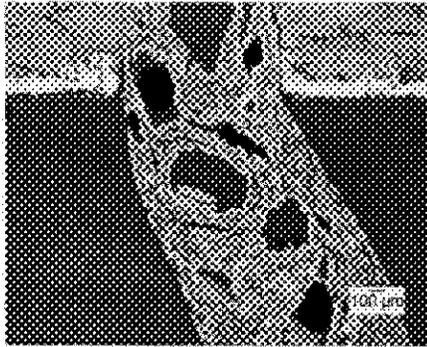
**ArcJet Sample 150-14, RCC-8, GRABER 12A,
0.062" Crack**

Backside

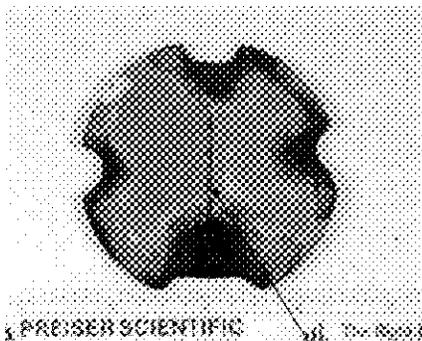
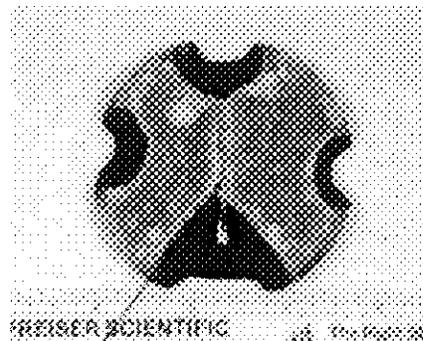
**ArcJet Sample 150-11, RCC-1, GRABER 5,
0.062" Crack Width**

Back side

Front side

Crack filled with Graber material

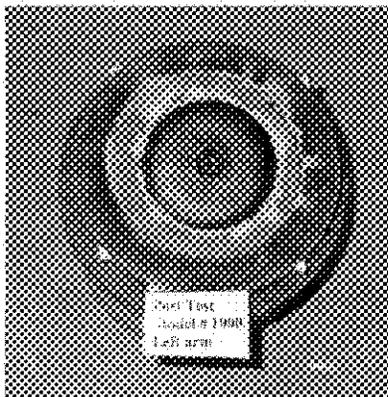
Sealants for Plug Repair Development

- Analogue RCC Plug Sealed with GRABER 5A Crack Sealant
- Survived the ArcJet Testing at JSC

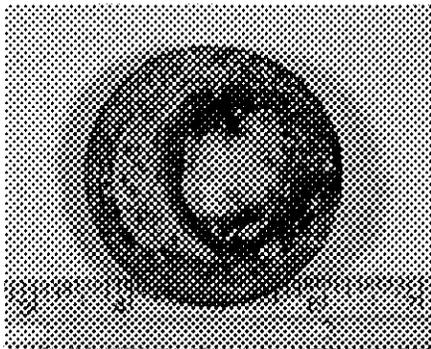
Post Test Analysis of GRABER 5 (Model 1908)

Macrographs of 1908 after ArcJet Testing

Front Side
