Aircraft Emergencies: Challenge and Response

Barbara Burian, Ph.D., FRAeS
Human Systems Integration Division
NASA Ames Research Center

**9th International Symposium of the Australian
Aviation Psychology Association**

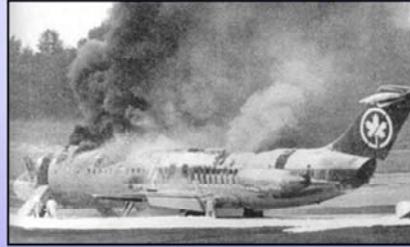
Air Canada 797 - DC-9 In-flight Fire, Covington, Kentucky June 2, 1983

- 1907:41 Emergency AC and DC busses lost power, CA & FO attitude indicators tumbled
- ATC offered landing at Cincinnati-Covington Airport
- CA accepted; heading 060° and 20 miles
- Declared emergency, squawked 7700 but transponder inoperative due to power loss
- 1909:33 Handoff from Indy Center to TRACON
- TRACON unaware of 797's electrical problems identified the wrong target on radar scope
- ATC planned for landing rwy 36; aircraft not positioned well for rwy 36 when identified as correct target; eventually landed rwy 27L

- ATC asked for "fuel and souls" twice, FO declined
- Though not required by procedure, FO turned off the air conditioning & pressurization packs "because the smoke was getting bad at that point and my reasoning was I have to do something..."
- Toxic fumes and gases built up, a flash fire occurred soon after landing and opening doors for evacuation; 23 passengers died.

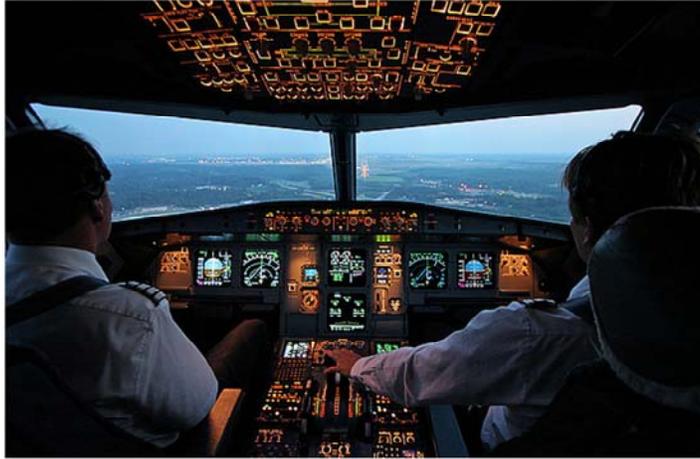
Pack Trip

- Master Caution Alert sounds
- Crew Identifies that Pack has tripped off
- Crew completes 4 step procedure
- Flight proceeds normally

Illustration of range of situations – a pack trip is generally pretty benign and easily handled – not much increase in stress or workload – some pack trip checklists may have more than 4 items

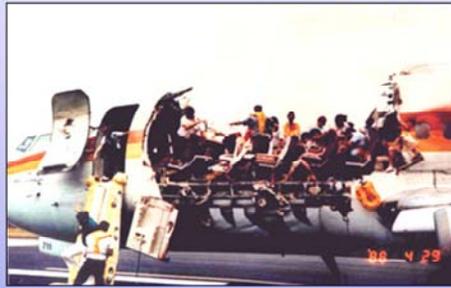
*Aloha 243 - B737 Rapid Decompression, Maui, Hawaii
April 28, 1988*

- **FO estimates all or parts of 17 different checklists completed in 13 min. almost all from memory. QRH consulted only for flaps 5 landing speed and passenger evacuation**

- Hilo to Honolulu, HI – 5 crew members and 41 passengers – leveling off at 24,000 ft. when decompression occurred
- FO reached for oxygen mask and it wasn't there – had been pulled out of storage compartment by decompression and was flopping in the wind behind her seat, still attached by its tubing to the oxygen system
- FO and CA could see blue sky and tail of the aircraft through the open cockpit door
- One flight attendant lost, one knocked unconscious, the third was crawling up and down the aisle on hands and knees assisting passengers put on life vests
- Multiple serious injuries for passengers
- FO and CA helped passengers evacuate, some were so bloody that they slipped through hands of FO, CA and ARFF when trying to help them up

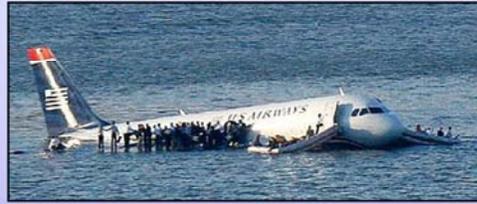
*US Airways 1549 - A320 Dual Engine Failure, Hudson River, NY
January 15, 2009*

- During climb out from LGA the aircraft hit a flock of geese and lost the thrust in both engine
- CA took over as PF and called for the ENG DUAL FAILURE checklist
- This is a paper checklist (ECAM Exception)
- FO tries several time to start the engines - unsuccessful
- Approx. 3 min. after hitting the birds, CA performs a forced landing into the Hudson River

- Daylight, good visibility, crew saw the birds right before hitting them
- Assessment: Knew immediately what their problem was and why, amount of time
- Division of workload clear – CA took over as PF and called for checklist
- FO recently completed training, recognized the checklist as an ECAM exception and knew to go to QRH for the checklist

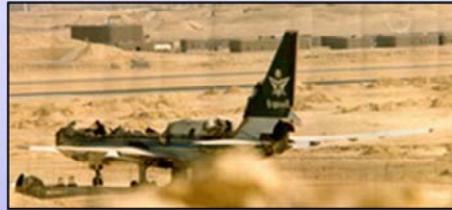
*Saudi Arabian 163 - L1011 Cargo Fire, Riyadh, Saudi Arabia
August 19, 1980*

- 7 minutes after takeoff, climbing through 15,000 ft. crew given visual and aural alerts of smoke in aft cargo compartment
- 4 minutes spent trying to confirm warnings & locate procedure in QRH – never found
- CA attempted to fly aircraft, assess situation, and remedy problem himself
- FO inexperienced, did not assist with radio communication or monitoring systems; SO spent most of event looking through AOM repeating “No Problem” to himself; FAs not informed
- No. 2 engine thrust level became stuck during return to airport, engine shut down
- Aircraft stopped on taxiway 2 min. 40 sec. after touchdown, 3 min. 15 seconds later engines shut down, evacuation never initiated, doors remained closed, all 301 on board perished

- Night flight, crew unsure if alerts were accurate or false alarms
- Very poor CRM and distribution of workload, CA attempted to do it all
- Crew were looking for checklist in “Abnormal” section of QRH, it was located in the “Emergency” section
