# The Evolution of Utilizing Manual Throttles to Avoid Excessively Low LH<sub>2</sub> NPSP at the SSME Inlet

Rick Henfling<sup>1</sup>

*National Aeronautics and Space Administration, Houston, Texas, 77058*

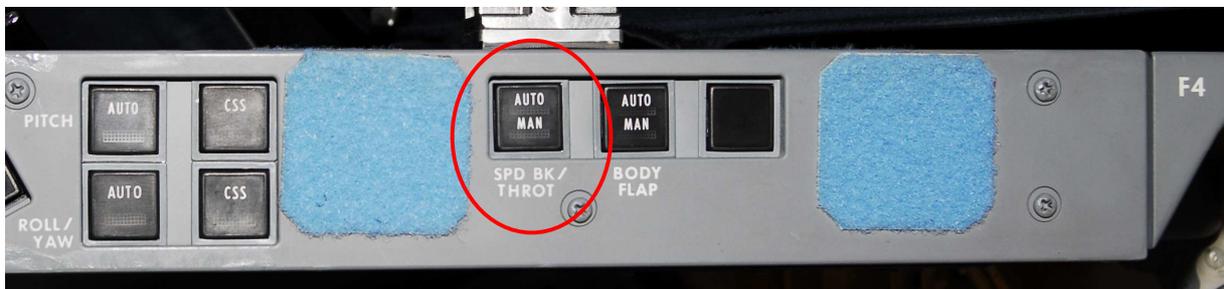
**Figure 2. Space Shuttle Orbiter Panel F4 (Speedbrake/Throttle light circled)**

The Pilot (who sits in the starboard front seat on the Orbiter flight deck) is the crew member who would be performing the manual throttling actions. To take manual throttling control of the SSMEs, he would depress a button on the Speedbrake/Throttle Controller (SBTC), which is located next to his left leg (see Fig. 5). The "AUTO" light (indicating the SSME throttles were being controlled by the GPCs) located on Panel F4 to the right of the Pilot's Heads-Up-Display and seen in Fig. 2 below would extinguish as a visual confirmation that the Pilot had pressed the button. When Manual Throttles were activated, a "MAN" light would illuminate just below where the AUTO light was located. With the "MAN" light illuminated, the Pilot could then manually throttle the SSMEs by moving the SBTC forward or aft. Early in the Space Shuttle Program, the SSMEs could be throttled between 65% and 107% Power Level (for contingency situations). The SBTC controls the throttle setting for all three SSMEs at once, and the full forward position is nominally 104.5% Power Level but can be increased to 109% Power Level for contingency situations, while full aft is 67% Power Level (current minimum power level).

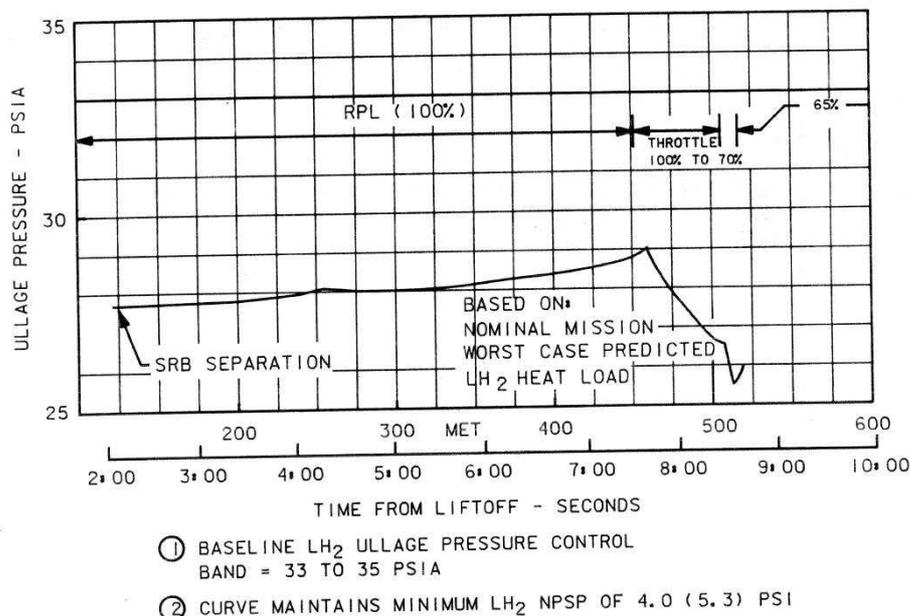
#### B. MINIMUM ALLOWABLE LH<sub>2</sub> ULLAGE PRESSURE

Figure 3. Ullage Pressure curve as approved for the STS-5 Flight Rules

STS-2 was also the first flight where an ullage pressure plot, as seen in Fig. 3 below, was added to the Flight Rule as a backup cue in the event the MCC computation failed to work properly. The curve was designed to protect the same minimum NPSPs as the MCC computation. This curve was included in the Flight Rules for STS-2 through STS-5 and changed somewhat each mission. It allowed progressively lower and lower ullage pressures, which shows the knowledge about the interaction between ullage pressure and NPSP granted the operations team more time operating the SSMEs at 100% Power Level before having to manually throttle the SSMEs to 65%. More time at 100% Power Level was desirable, because it decreased the possibility of having to perform an RTLS abort because it could possibly move the throttle-down threshold past the Negative Return boundary.

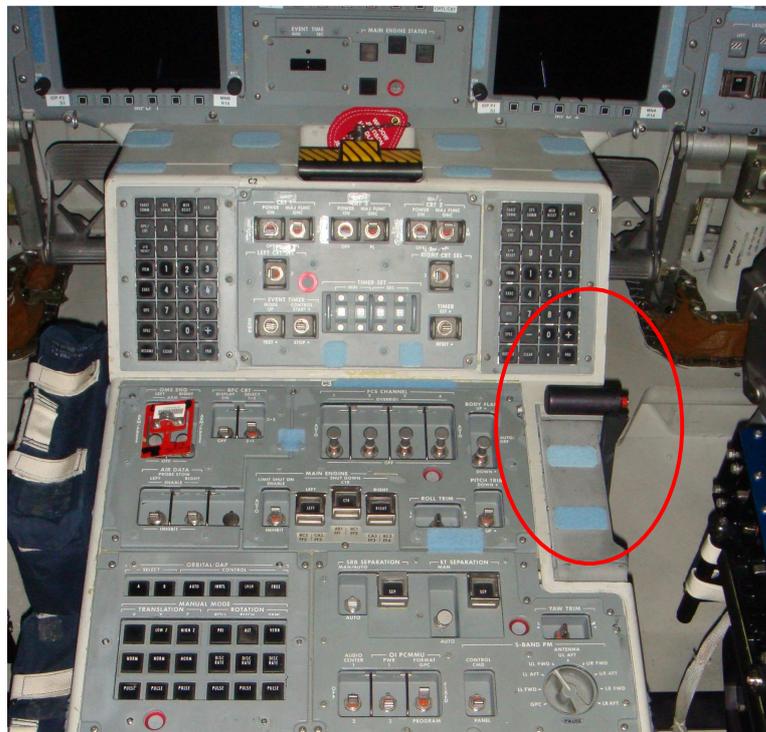
Figure 5. Space Shuttle Orbiter Center Console (Speedbrake/Throttle Controller circled)

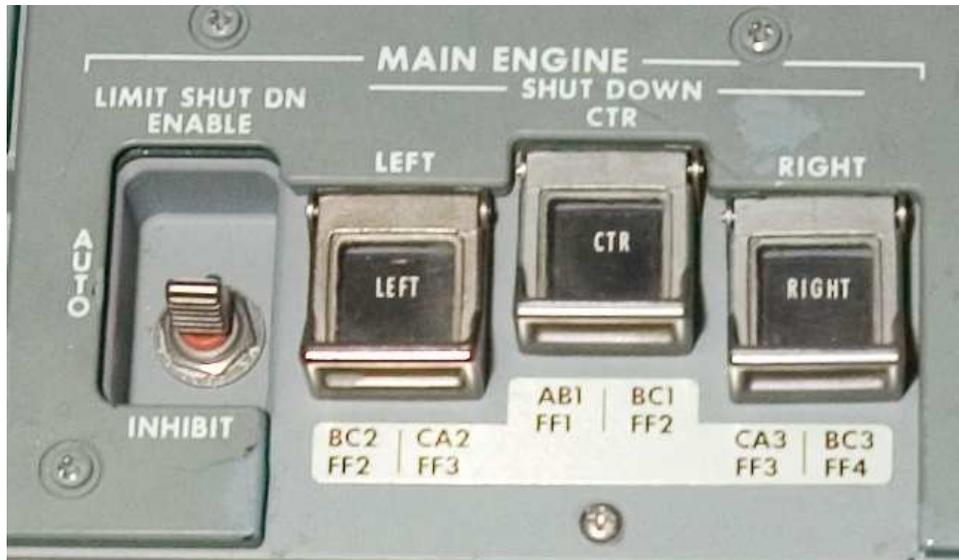
**Figure 6. SSME Limit Shutdown Control Switch on Space Shuttle Orbiter Panel C3**

A further addition to the Flight Rule for STS-26R was an action for the crew to take the Main Engine Limit Shutdown switch located on Panel C3, as seen in Fig. 6, to the “Enable” position once the SSMEs had been throttled down to 95%. This was added to allow multiple SSME shutdowns (on the HPFTP TDT redline) to occur automatically if a failure caused the NPSP to drop too quickly for the flight control team and crew to respond with manual throttling. Further discussion of the operation of the switch is outside the scope of this paper, but the Main Engine Limit switch has three positions (Enable, Inhibit, and Auto) and with the switch in the Auto position (as it is for launch) only the first automatic SSME redline shutdown is permitted.

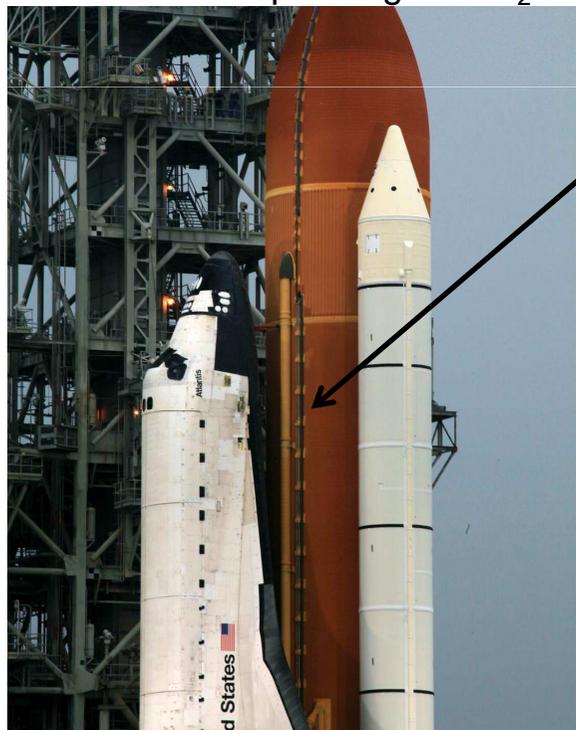
GH<sub>2</sub> pressurization line to top of ET LH<sub>2</sub> tank, enters through ET Intertank

GH<sub>2</sub> pressurization line exiting Orbiter

After the  $\text{GH}_2$  from each SSME flows through its respective flow control valve, the three flow paths are combined into one and plumbed out of the Orbiter through the  $\text{LH}_2$  ET/Orbiter 2" disconnect located on the Orbiter's underside. The  $\text{GH}_2$  then travels up the side of the External Tank and through an access hole in the ET Intertank (the ribbed area on the ET between the  $\text{LO}_2$  and  $\text{LH}_2$  tanks). Finally, the flow passes into the top of the  $\text{LH}_2$  tank and through a diffuser.

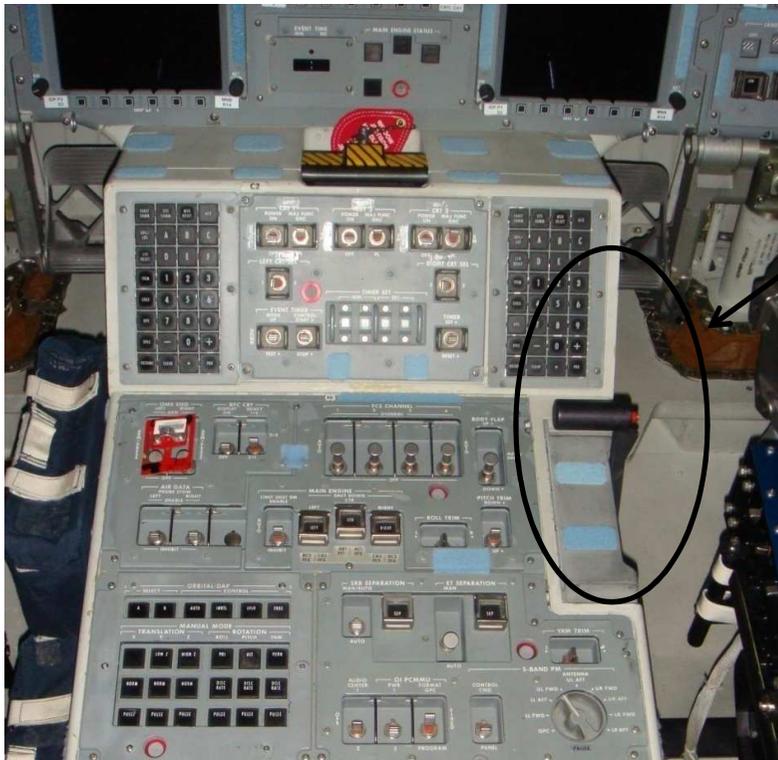
## SBTC:

- Full Forward – 104.5%/109% PL
- Full Aft – 67% PL
- Same PL command to all 3 SSMEs

- **Pilot (Right Front seat) depresses the red button on the Speedbrake/Throttle Controller (SBTC)**
  - “AUTO” light on SPD BK/THROT pushbutton indicator (pbi) extinguishes
    - Located at eye-level on a forward panel (F4) in front of the Pilot
- **When the throttle command coming from SBTC matches the current SSME throttle setting within a certain tolerance, manual throttling of the SSMEs is enabled**
  - “MAN” light on SPD BK/THROT pbi illuminates

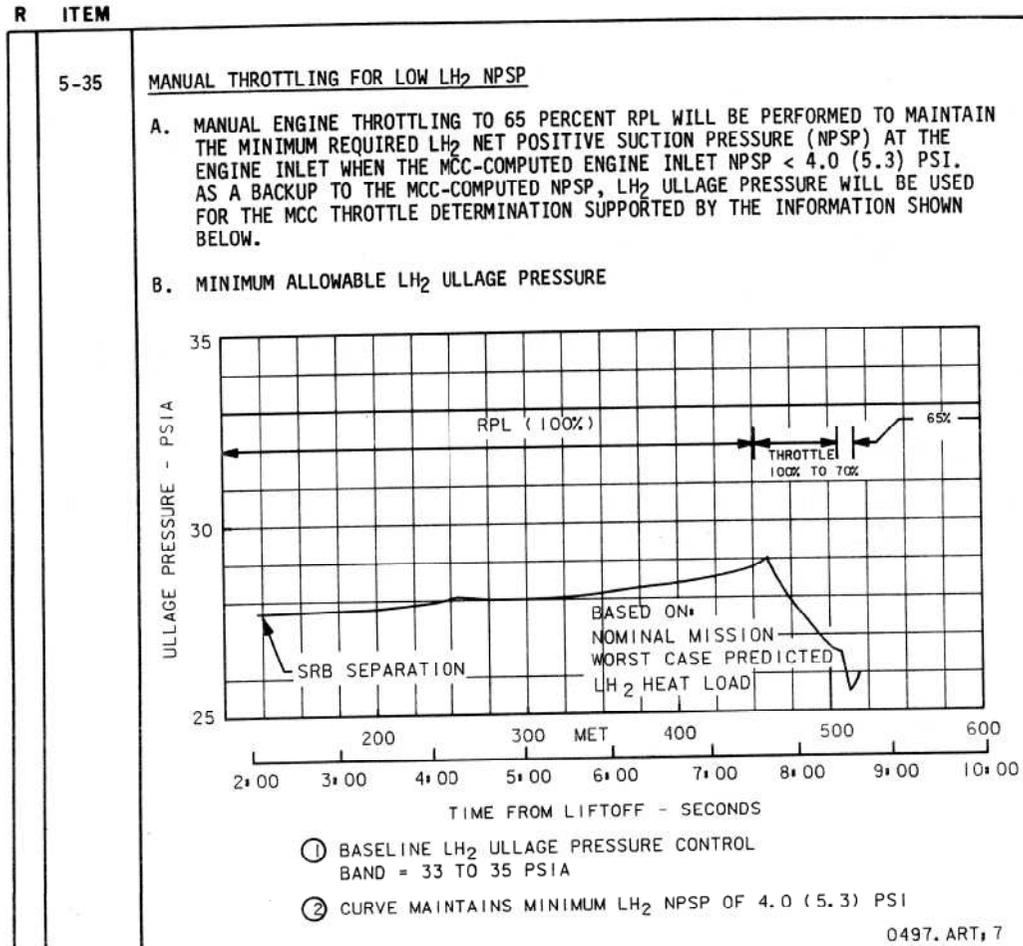
# Ullage Pressure Backup Table

Reference: NSTS 12820, Space Shuttle Operational Flights Rules for STS-5

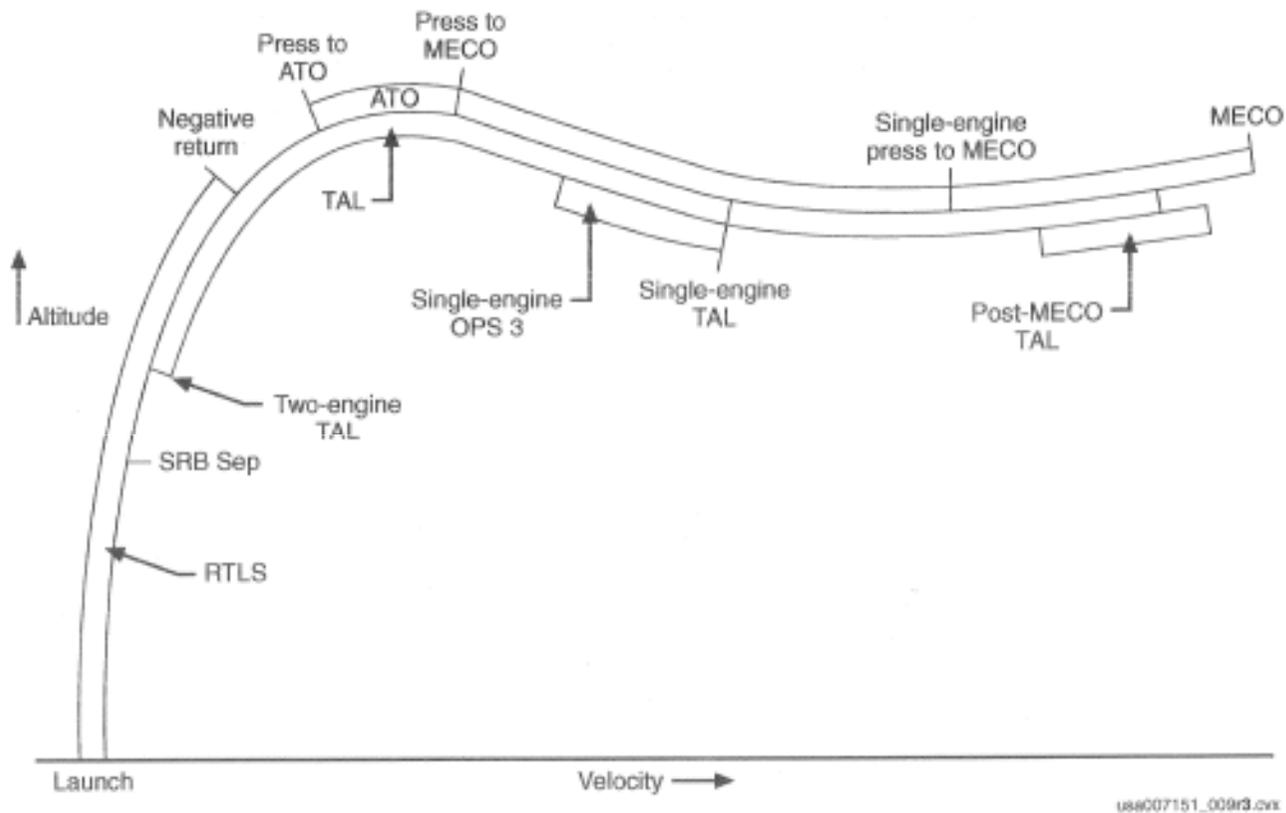
# Space Shuttle Abort Boundaries

Figure 2-1. Abort calls as a function of velocity and altitude
