# **Full-Scale Crash Tests and Analyses of Three High-Wing Single Engine Aircraft**

The NASA Emergency Locator Transmitter Survivability and Reliability (ELTSAR) project was initiated in 2013 to assess the crash performance standards for the next generation of emergency locator transmitter (ELT) systems. Three Cessna-172 aircraft were acquired to conduct crash testing at NASA Langley Research Center's Landing and Impact Research Facility. Testing was conducted in the summer of 2015 that represented three crash conditions; a flare to stall during emergency landing, and two controlled flight into terrain scenarios. Instrumentation and video coverage, both onboard and external, provided valuable data of airframe response. Full-scale finite element analyses were performed using two separate commercial explicit solvers. Sample comparisons of simulation results with test data will be shown here.

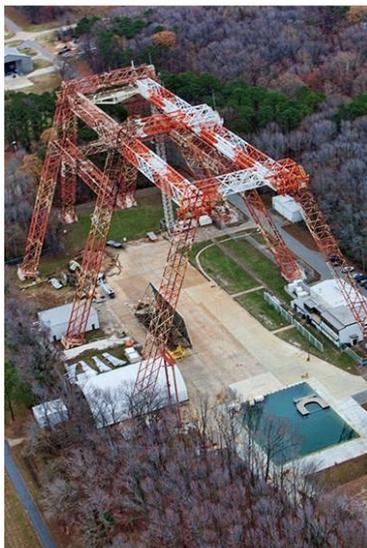
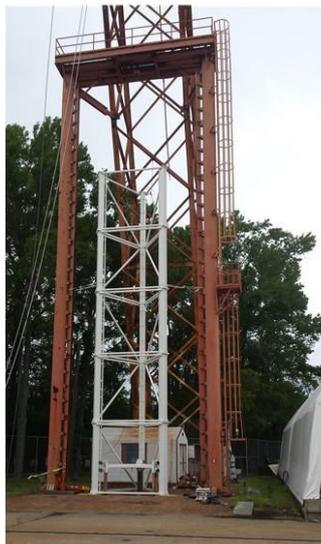
Figure 1. NASA Landing and Impact Research Facility

LandIR is a unique facility designed to perform crash and landing tests of full-scale aircraft, rotorcraft, and spacecraft by lifting and swinging test articles using a single or double pair of cables [1]. The swing cables are connected to one end of LandIR and at hard-points on the test article. A pullback cable is connected to a movable bridge located on the opposite end and hard points on the test article. As the pullback cabling is retracted with a winch system, the aircraft is lifted to a pre-determined drop height. A pyrotechnic system severs the pullback cabling, and the test article swings along a pendulum-like flight path onto a pre-determined impact location. Just prior to impact, the swing cables are also pyrotechnically severed. The attitude and velocity at impact is determined by swing cable length, impact location, and drop height. A photo of the LandIR is shown in Figure 1.

**240-ft Gantry**

**50-ft Drop Tower**

**20-ft Deep Basin**

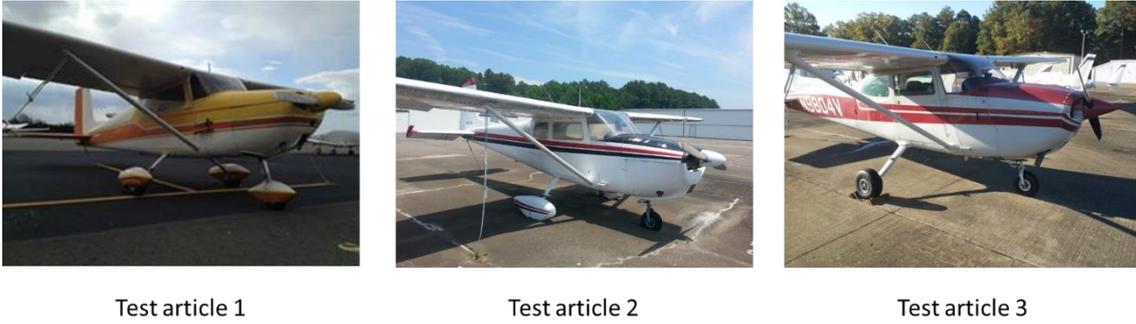
Figure 2. ELTSAR Crash Test Articles

Three Cessna high-wing, four seat, GA airplanes were purchased specifically for the test series. They are pictured in Figure 2. Test article 1 was a 1958 172 with a valid airworthiness certificate. Test article 2 was a 1958 175, which uses the 172 airframe, but contains a different engine and gearbox. The third test article was a 1975 172M with a valid airworthiness certificate. Test articles 1 and 3 were operational until the winter of 2014.

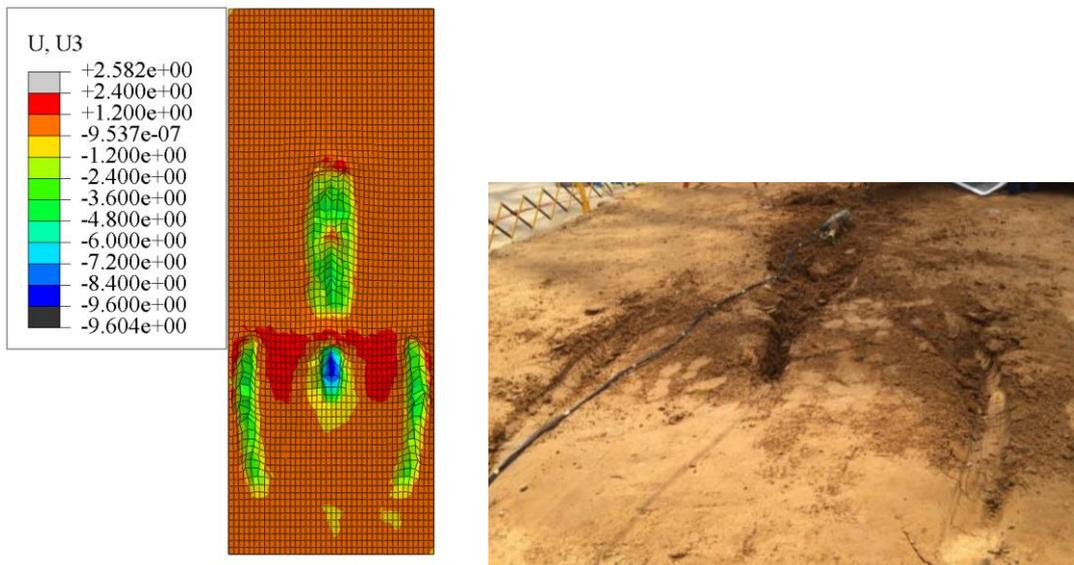
Figure 33. Test 2 ABAQUS/Test Soil Deformation

A fringe plot of the predicted vertical displacement of the soil is shown in Figure 33(a), compared with a post-test photograph showing the soil deformation pattern in Figure 33(b). The model matches the overall shape of the deformation pattern. The main gear furrows were 96-inches long, and the analysis predicted 92-inches. Similarly, the nose gear furrow was 38-inches long and the analysis predicted 44-inches. The predicted location of maximum soil displacement matches the test data, as well; however, the maximum displacement of the model (9.60-inches.) is lower than the measured maximum of 11-inches. This finding is an indication that the soil model may be too stiff.

(a) Fringe plot of soil vertical deformation (b) Post-test photograph of soil
