# Hubble Space Telescope

## 2004 Battery Update

2004 NASA Aerospace Battery Workshop

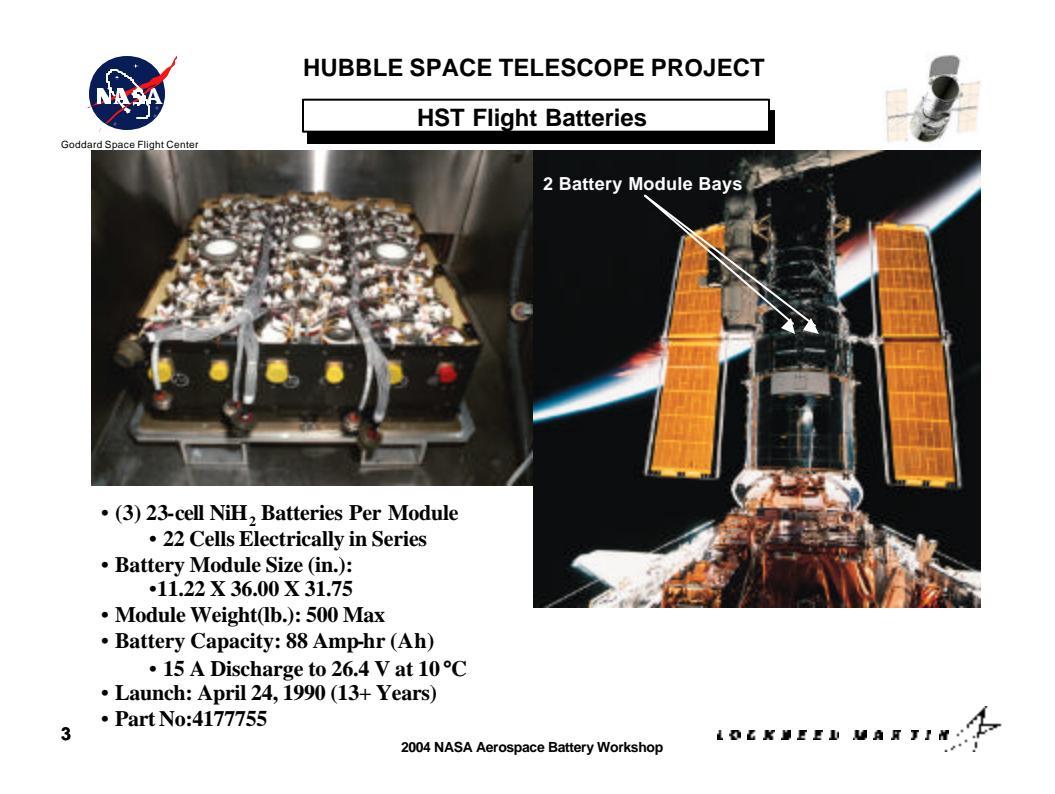
A total of 16 batteries were manufactured for the HST Program -3 Flight Modules, 2 Test Modules, and a Flight Spare Battery. The 23-cell batteries only used 22 cells connected electrically in series. The 23<sup>rd</sup> cell was determined as driving the system voltage outside the voltage limits of some electronic boxes. The six on-orbit batteries are enclosed in 2 modules, like the one shown on the left here, each module has 3 batteries. Flight Module 2 (FM2) is mounted inside Equipment Bay Door #3, and the Flight Spare Module (FSM) is mounted inside Equipment Bay Door #2. Flight Module 1 (FMI) was re-designated as the "spare".

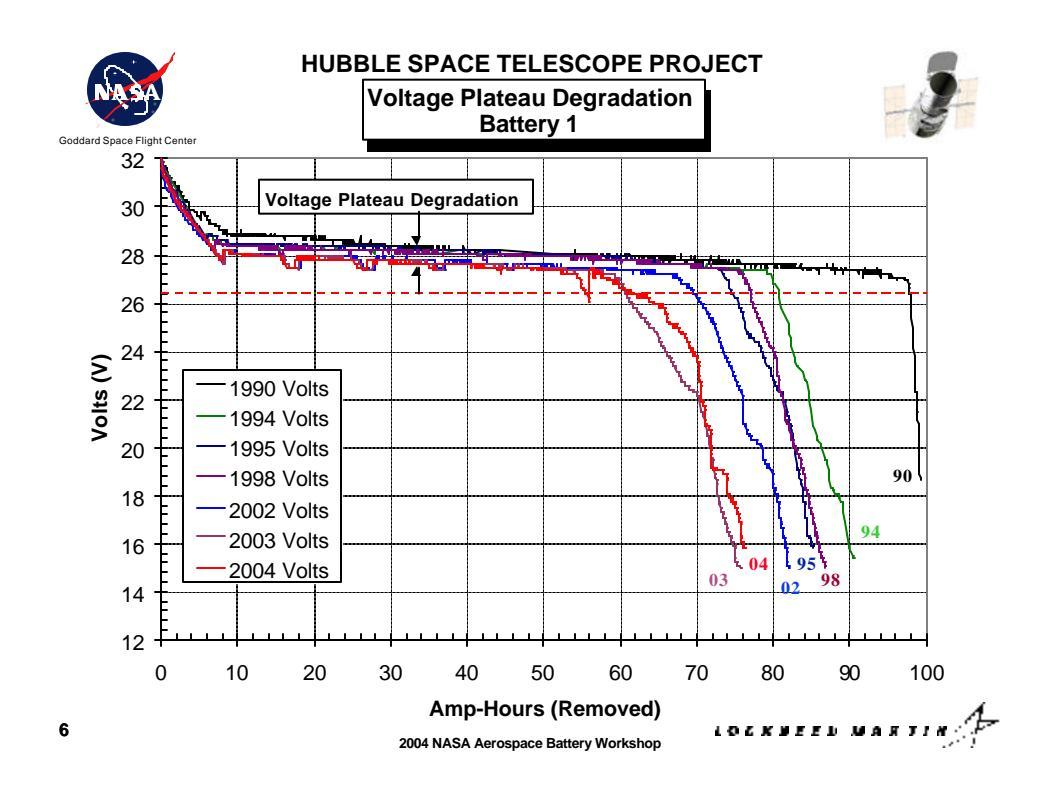
HST has experienced a depressed voltage plateau which was first observed after the SM3B servicing mission. This chart shows the capacity checks performed on HST Orbital Battery 1 since launch, as plotted versus the amp-hours removed from the battery. The depressed voltage at the midpoint of the discharge curve, as indicated, is of some concern.

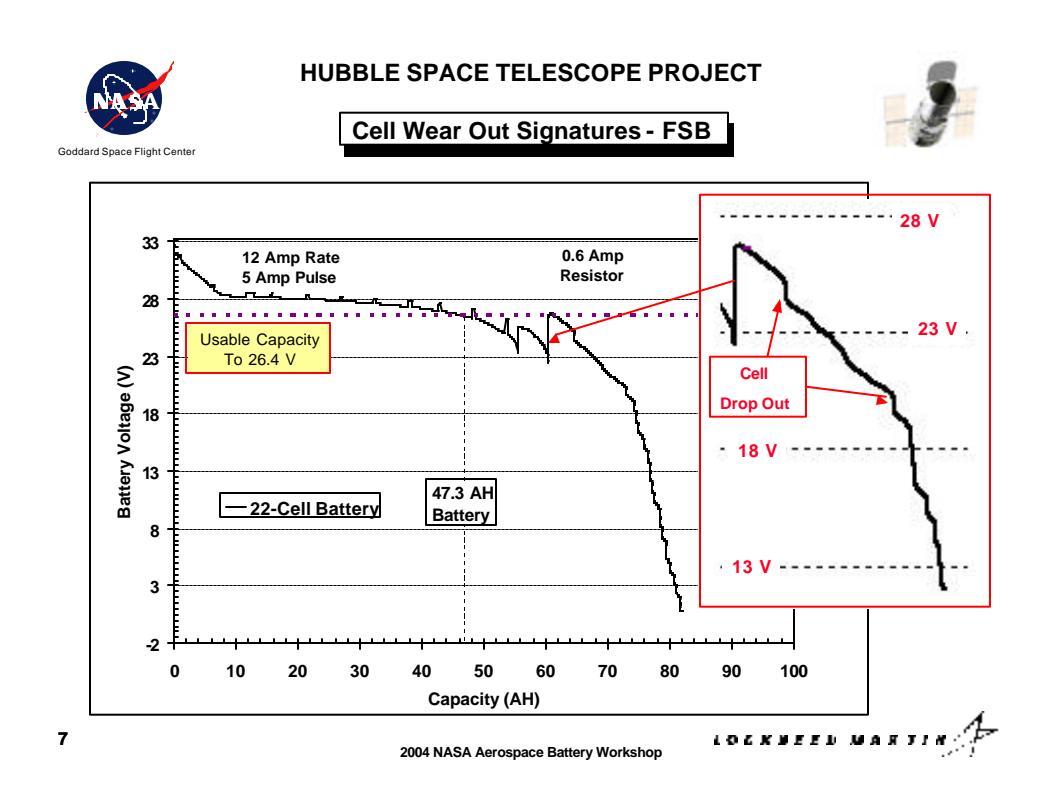
This is the battery voltage profile during a capacity discharge test conducted upon the Flight Spare Battery at MSFC. A 12 Amp discharge was modified to include 5 Amp pulses at 15 minute intervals, which provides dual discharge curves, which are then used for cell modeling of impedance and Electromotive Force (EMF) as a function of State of Charge (SOC).

Note that this battery exhibits a usable capacity (to 26.4 V) of 47.3 Ah. Additionally there are several sharp deflections in the discharge curve beyond 64 Ah with delta-V in excess of 0.5 V, which have previously been identified as being individual cell reversals. With HST hydrogen pre-charge cells, this cell reversal voltage is around 0 to -0.100 V depending upon the current.

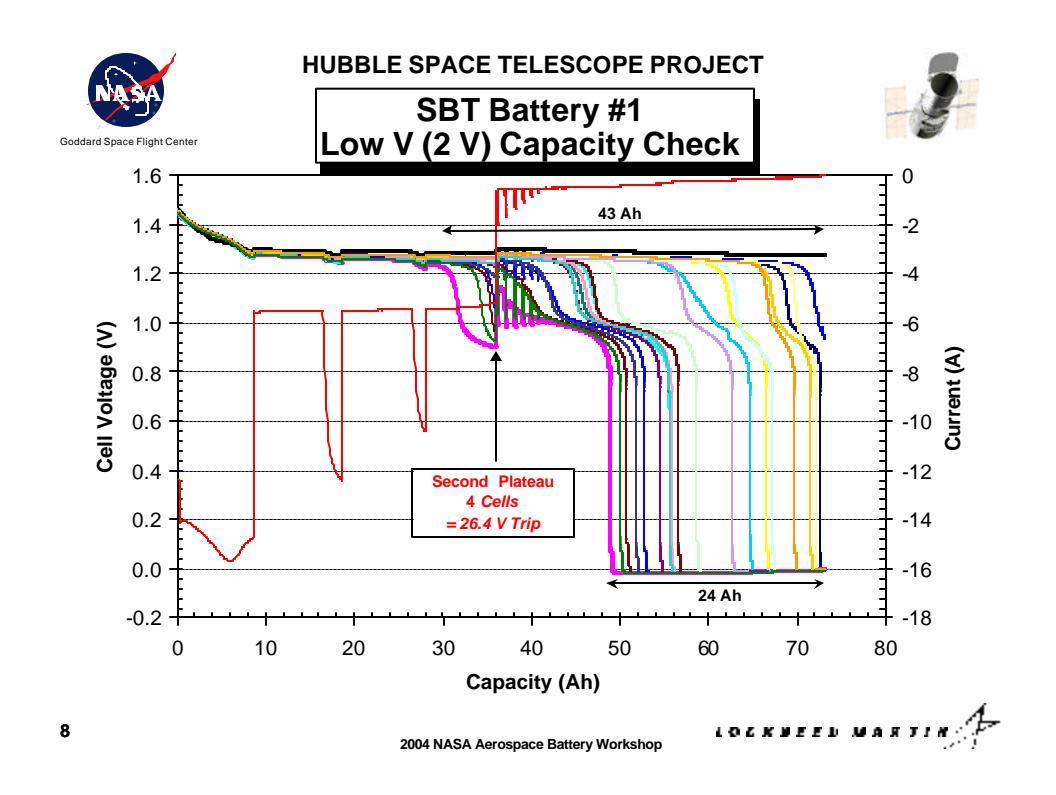
Battery cell wear out mechanisms and signatures are shown here for Battery 1 of the Six Battery Test Bed. Note that when the battery voltage declines to less than the 26.4 V battery minimum at about 36 Ah the individual cell monitoring indicates that only 4 cells have dropped down to the second discharge plateau. Second plateau is one limiting mechanism, with a second being cell reversal. Note also that there is a capacity imbalance of 43 Ah between when the first cell goes down to the second plateau and when the test is terminated with one cell still above 1.3 V. Similarly the cell imbalance, between when the first cell goes into reversal and when the test is terminated with 2 cells not in reversal, is 24 Ah.

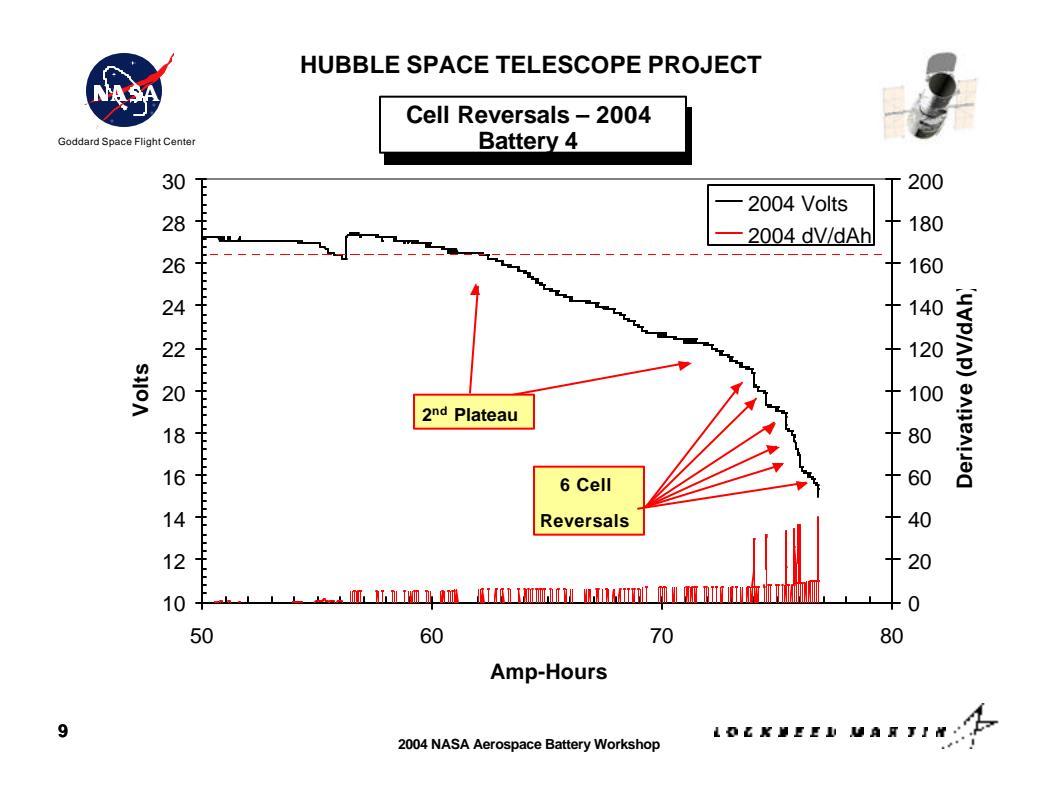
This chart details the voltage telemetry from the 2004 HST Orbital battery capacity check, plotted against the integrated Ah capacity. When the derivative of the Voltage/Ah capacity data is examined, as shown by the bottom trace here, it becomes apparent that 6 cells drop out, or go into reversal, between 74 Ah and 77 Ah. The slow decline in the battery voltage, starting at 60 Ah, is indicative of cells experiencing second plateau formation.

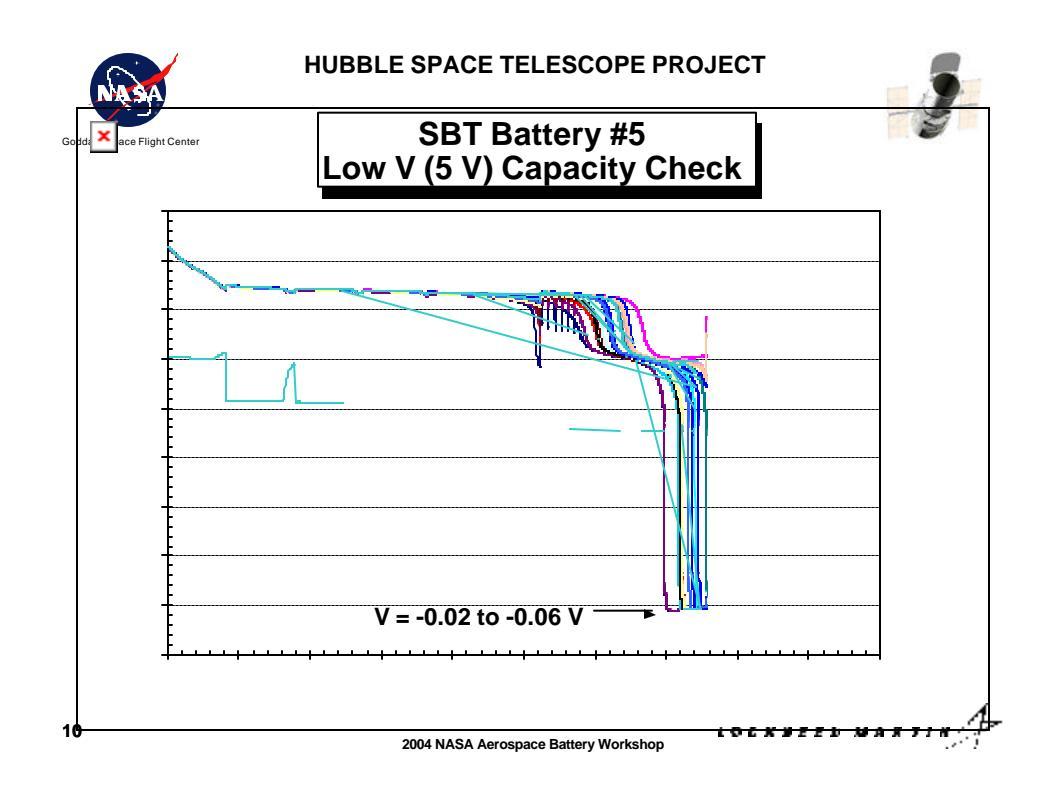
The individual cell voltages during a capacity check performed on Battery #5 of the Six Battery Test Bed shows significant second plateau formation, followed by cell reversals to voltages around -0.04 V. This reversal voltage is at the low rate resistor (50 ohm) discharge rate and the voltage is a function of the current. Other cell reversals on the Flight Spare Battery, with currents of 15 A, have shown reversal voltages of -0.08 V. The observed reversal voltage is a function of the electrochemical reactions occurring within the cell and this can help define the capacity fade mechanism.

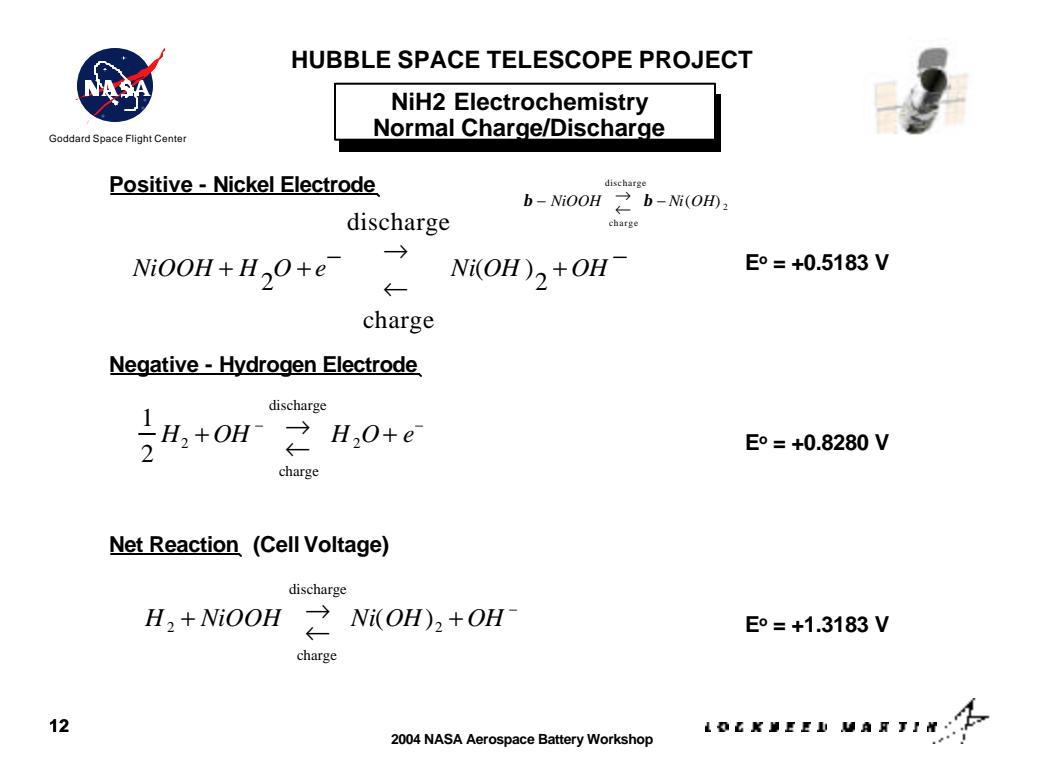
The reactions occurring during discharge are shown here with the half-cell reactions on the individual electrodes shown by the first two equations. The sum of these equations is shown next, with the sum of the electrochemical voltages being 1.318 V, which equates to the cell standard potential. The actual observed voltage is this standard potential plus a correction for the reactant/product activities (concentrations) and the temperature (Nernst Equation).

The second set of reactions define the cell reversal when there is still hydrogen present, and nickel is depleted, i.e., nickel limited. The reactions occurring here are reversible on both electrodes and represent no net change of reactants, and a potential close to 0 V.

This is the case for the HST capacity fade mechanism, namely loss of electrochemically active nickel oxyhydroxide (**NiOOH**) due to charge limitations.

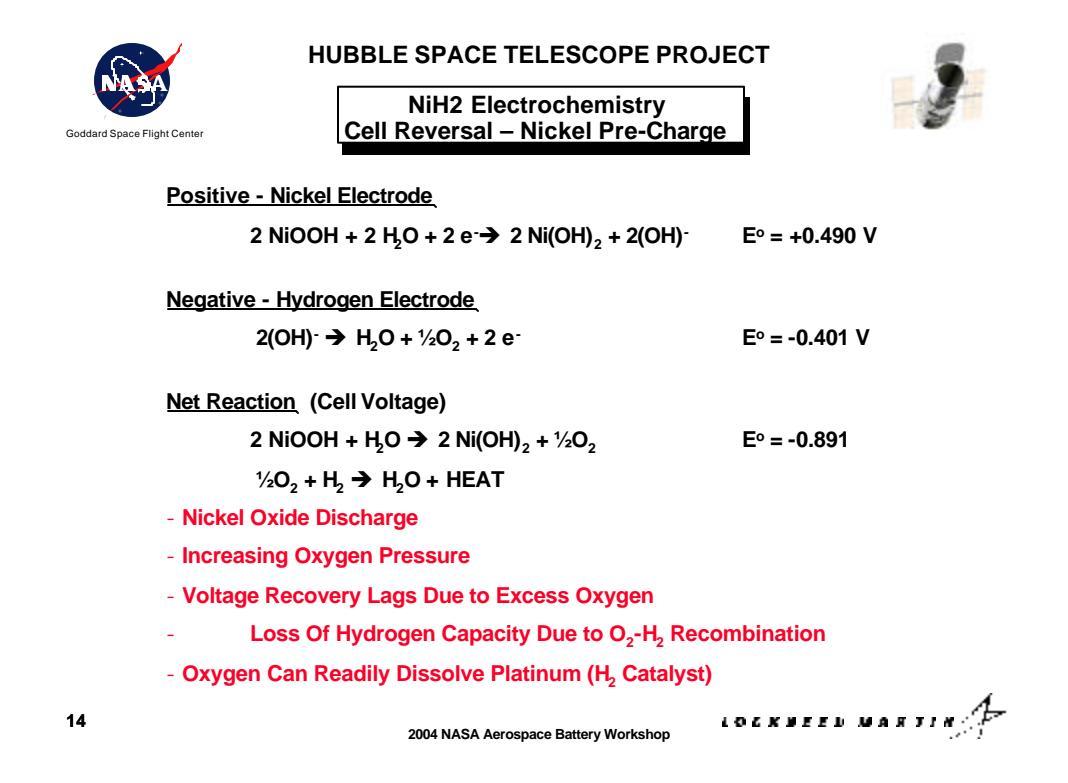
Cell reversal due to loss of active hydrogen gas occurs with nickel pre-charge cells, with excess nickel oxyhydroxide, via the chemical reactions shown above, which define the cell voltage observed during cell reversal. The current during cell reversal *must* be kept low to limit the heat due to catalytic recombination and thus possible cell electrode popping.

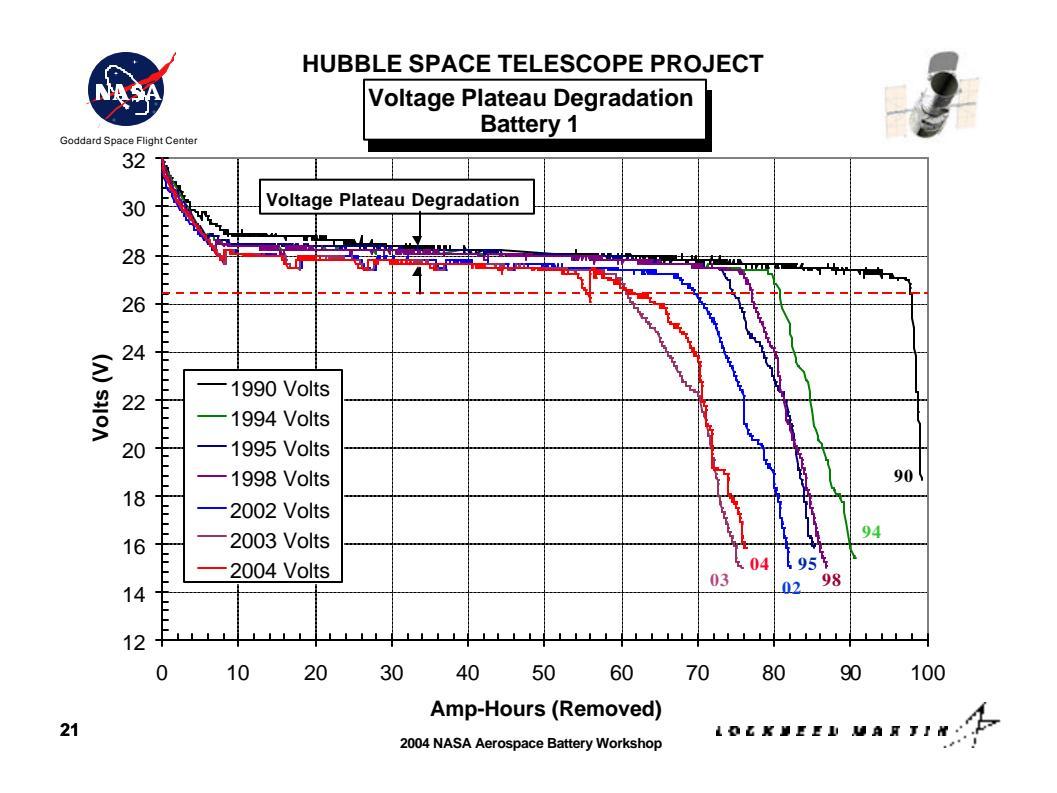
This chart shows the capacity checks performed on HST Orbital Battery 1 since launch, as plotted versus the amp-hours removed from the battery. The depressed voltage at the midpoint of the discharge curve, as indicated, is of some concern. The following charts will provide an explanation for this phenomenon.

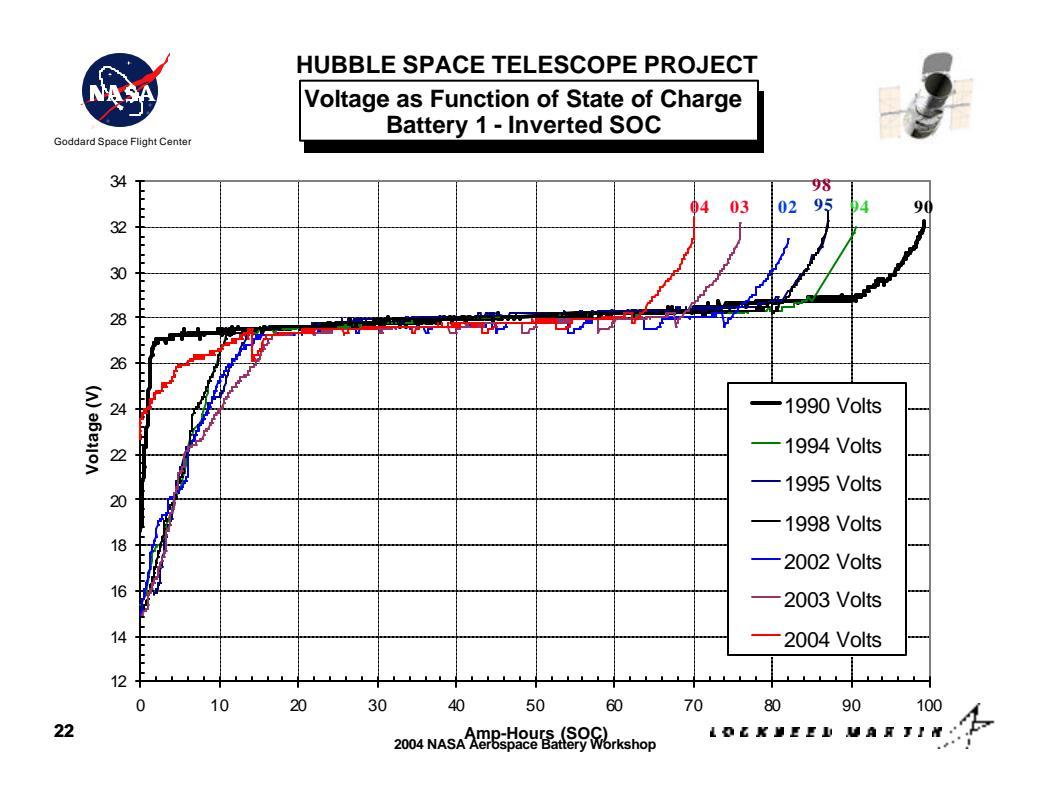
When the capacity check curves shown in the last chart are re-plotted based upon State-of-Charge (SOC), with all the End-of-Discharge-Voltages (EODV) referenced as the starting point, then it becomes clear that the voltage plateau is really a function of the initial SOC, when the capacity check began rather than a new ageing signature. This chart suggests that the capacity decline observed with HST is a function of the system undercharge of the batteries. This also suggests that getting more charge into the battery would raise the available capacity. This chart also explains why Hari Vaidyanathan reports high capacity numbers on 13 & 14 year old Flight Spare Battery cycled cells during electrical testing in the DPA process, when he submited them to recharge ratios of 1.5, which charges the cells to full capacity, similar to ATP Levels at BOL.

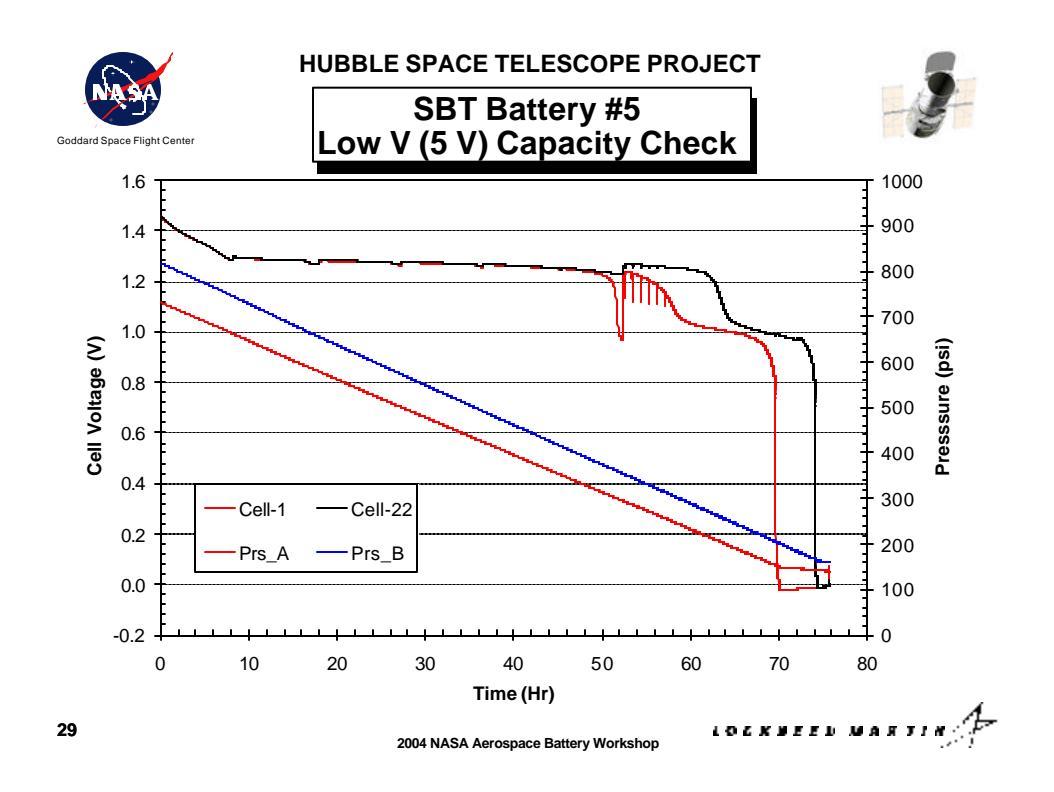
The ground test results from the Six Battery Test-Bed and the Flight Spare Battery show in every case that when the strain gauge pressure flat-lines during a capacity check, it indicates that the strain gauge cell becomes nickel limited and the cell is in reversal. The pressure plateaus at around 150 psi and the cell voltage is at around –0.04 V.

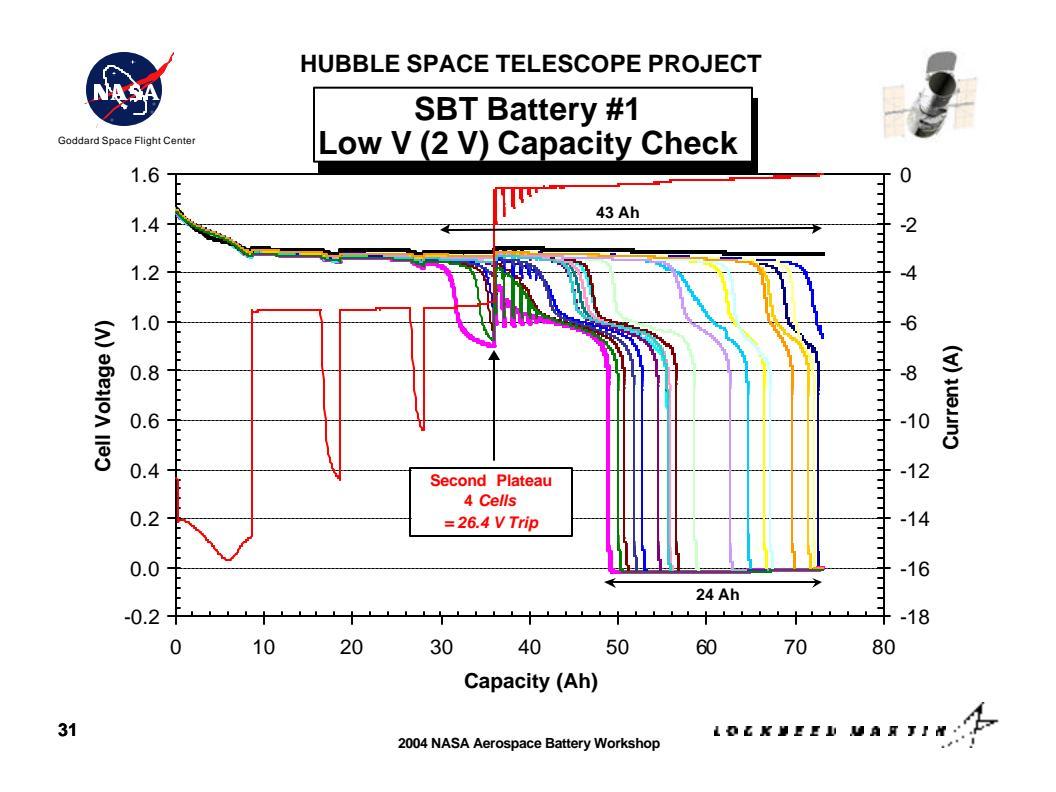
Strain Gauge Drift is indicative of the capacity imbalance between cells, as shown by this chart where the difference in second plateau capacity is at least 43 Ah, while the cell reversal capacity is at least 24 Ah. The strain gauge pressure indicated will depend upon which cell is being monitoring – weak, average, strong, etc.

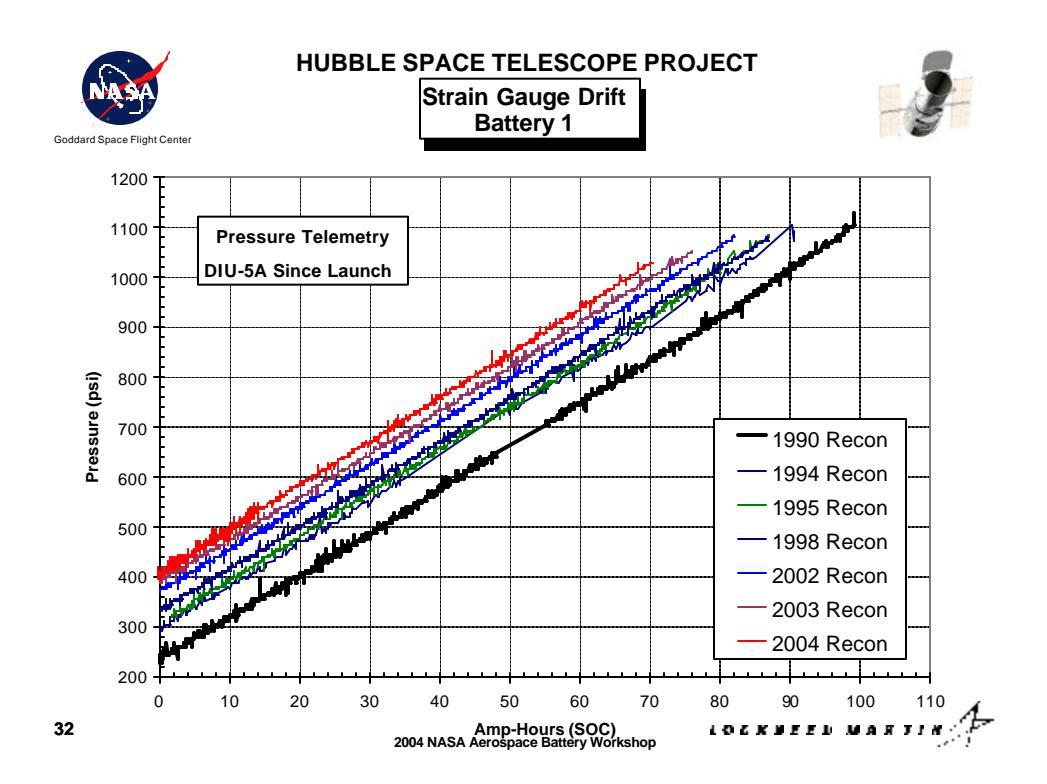
The orbital pressure telemetry only monitors either the A-side or B-Side pressure, which means only one of 22 cells is monitored. This chart shows a typical drift of the strain gauge pressure to higher pressures with time. This could be due to either nickel corrosion producing more hydrogen, or it could indicate that the strain gauge cell is a stronger cell within the battery. The stronger cells would have higher states of charge and thus capacity.

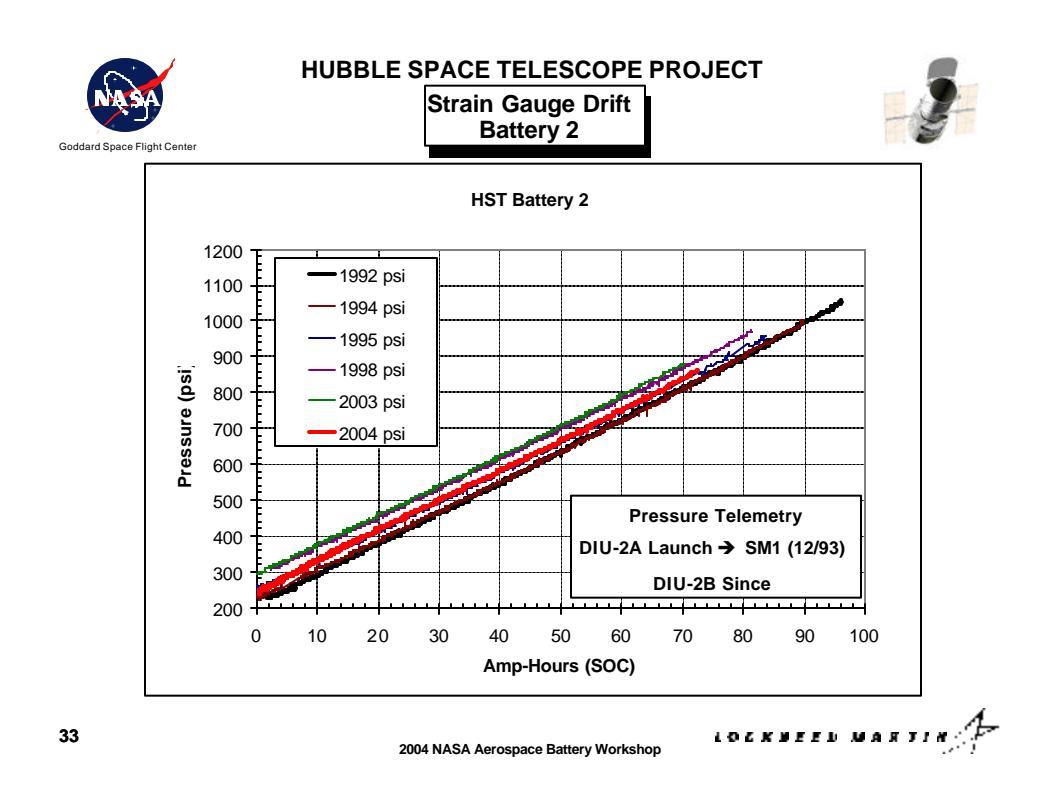
This chart shows a typical drift of the strain gauge pressure to higher pressures with time in 1998 ands 2003. This could be due to either nickel corrosion producing more hydrogen, or it could indicate that the strain gauge cell is a stronger cell within the battery.

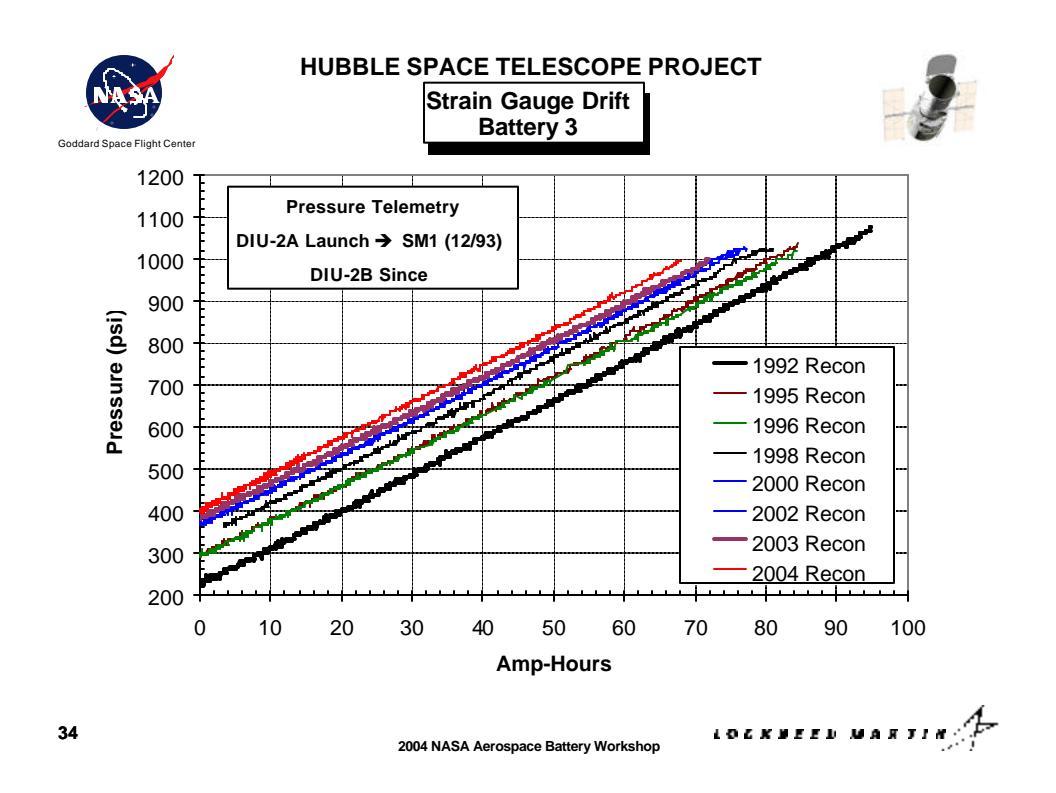
This chart shows a typical drift of the strain gauge pressure to higher pressures with time. This could be due to either nickel corrosion producing more hydrogen, or it could indicate that the strain gauge cell is a stronger cell within the battery. The stronger cells would have higher states of charge and thus capacity.

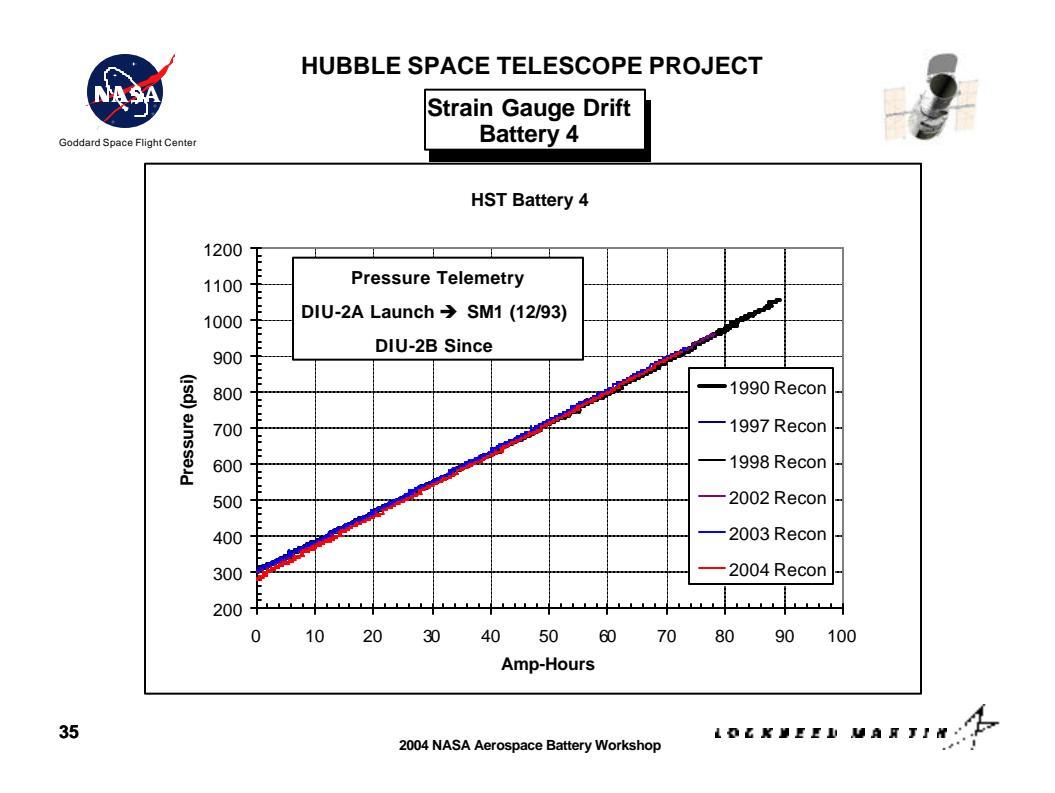
This chart shows no change of the strain gauge response with time which suggests no nickel corrosion. The stable operation also suggests no physical or electronic issues. The strain gauge cell probably is a very average cell within the battery, with an average capacity.

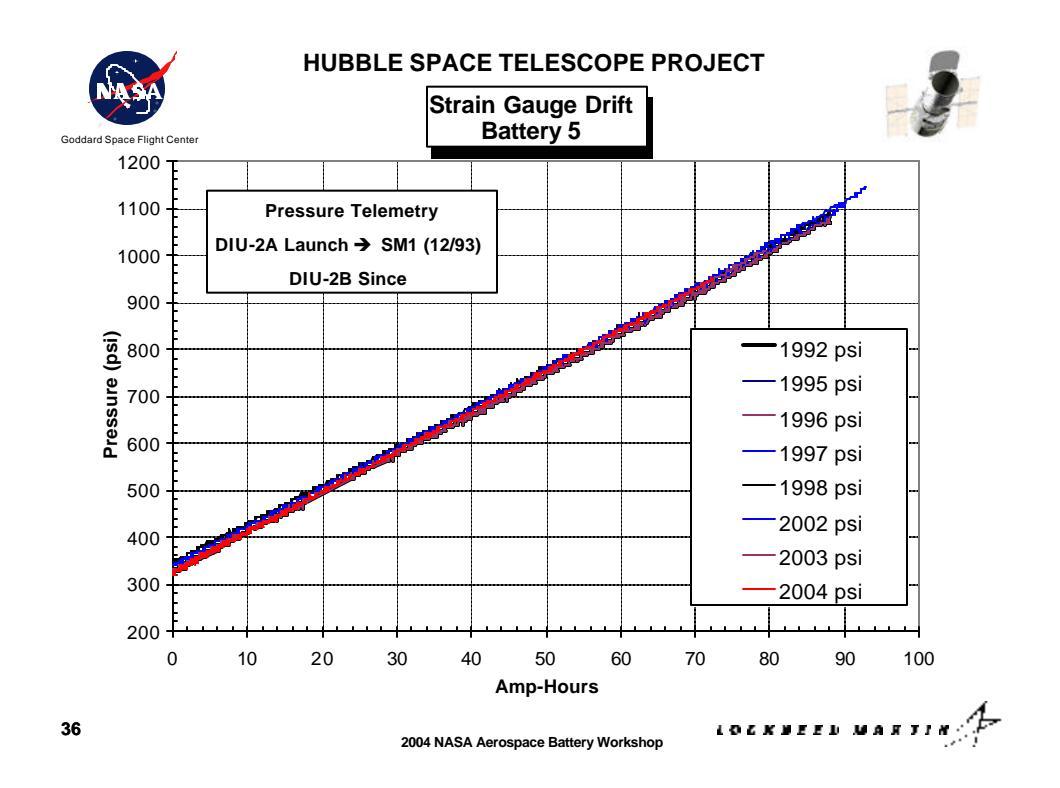
This chart shows a slight drift of the strain gauge pressure to higher pressures with time. This could be due to either nickel corrosion producing more hydrogen, or it could indicate that the strain gauge cell is a stronger cell within the battery. The stronger cells would have higher states of charge and thus capacity.

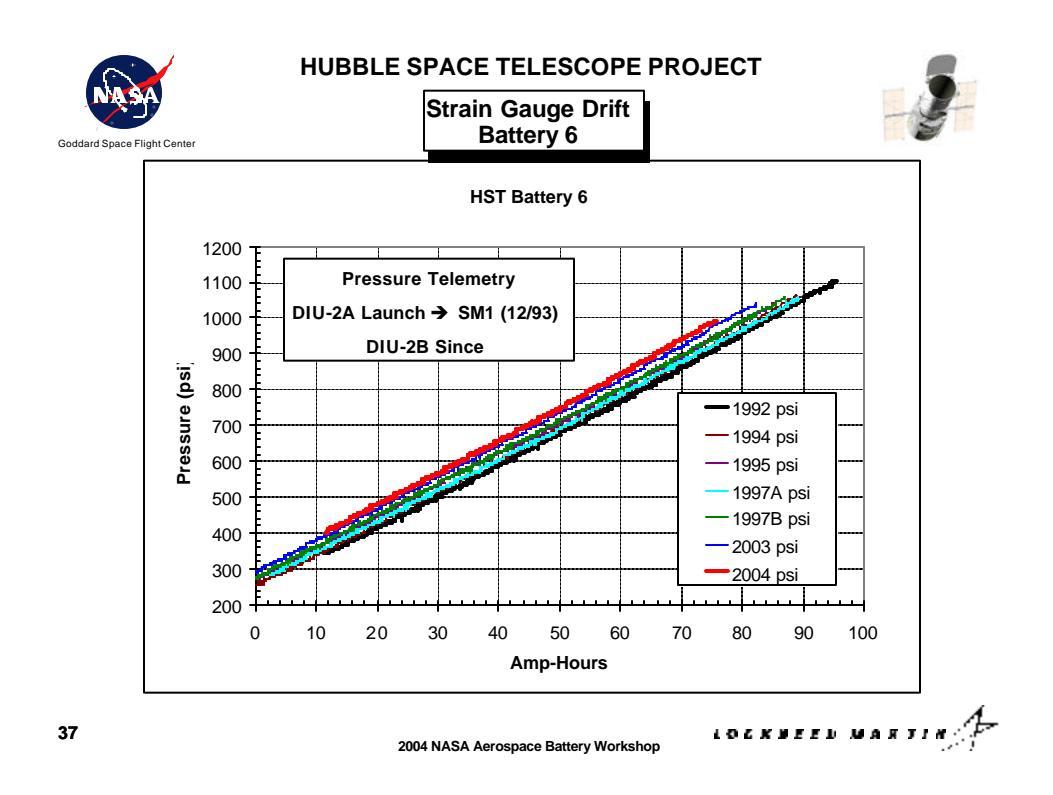
This chart shows a slight drift of the strain gauge pressure to higher pressures with time. This could be due to either nickel corrosion producing more hydrogen, or it could indicate that the strain gauge cell is a stronger cell within the battery. The stronger cells would have higher states of charge and thus capacity.

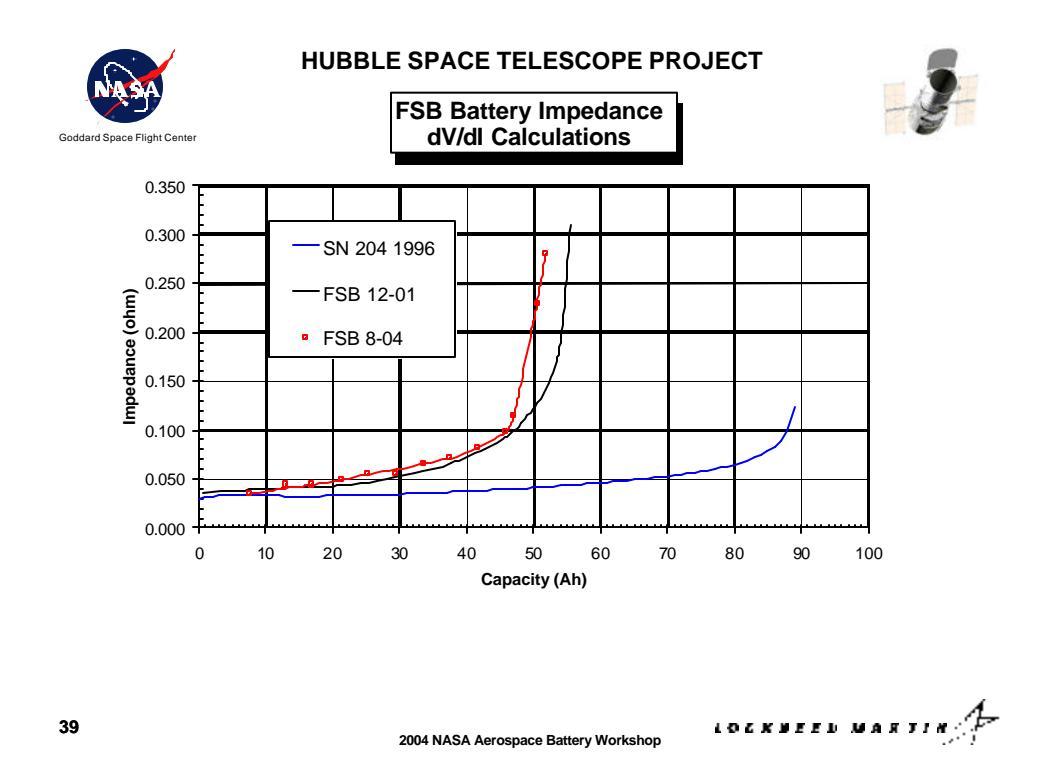
This details the impedance of the HST cells at various points in age. The S/N 204 impedance data is from the modeling of separate 40 A and a 18/9 A discharges conducted in 1996 as part of the HST Mini-Characterization Studies conducted at MSFC and Eagle Picher. This study compared the HST dry sinter cells with the SM4 wet slurry cells. The Flight Spare Battery (FSB) impedance data is from pulse discharge studies conducted at MSFC in 2001 and 2004. All this data is plotted versus the capacity delivered by the battery.

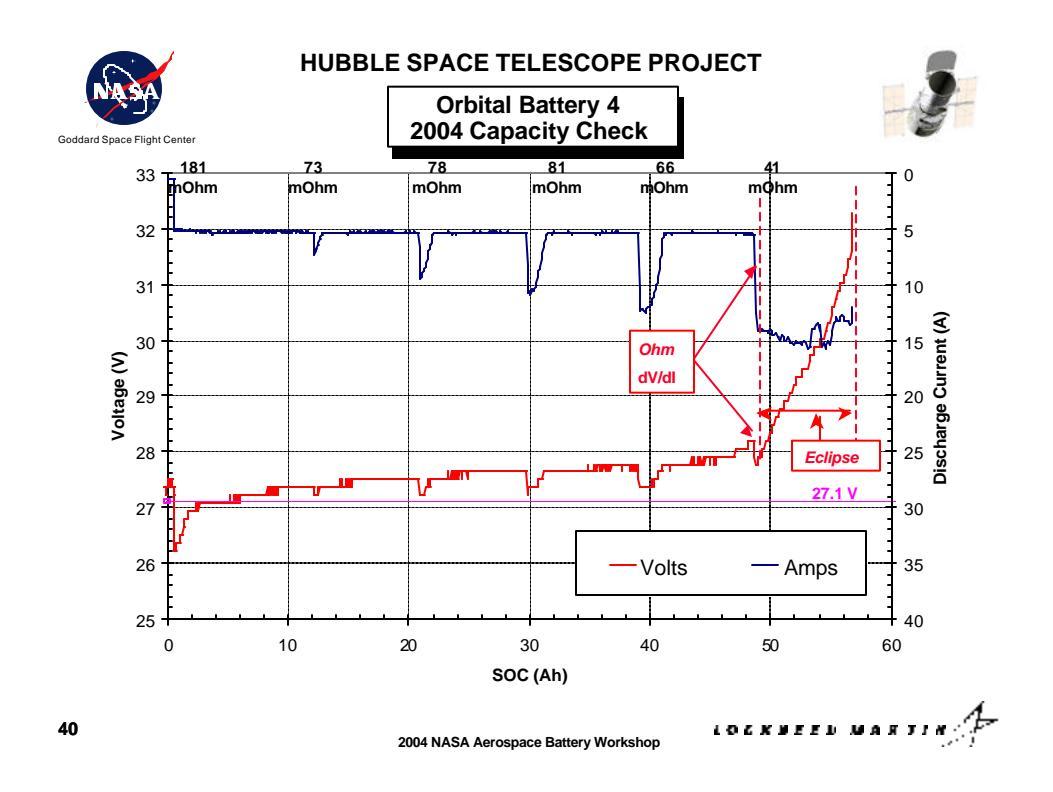
This is the 2004 capacity check plot for Battery #4, which had periods of load share with the other five orbital batteries, as shown by periods of current in excess of 5 A. The transition from load share to high rate resistor (5 A) can be used to calculate a battery impedance as a function of state of charge.

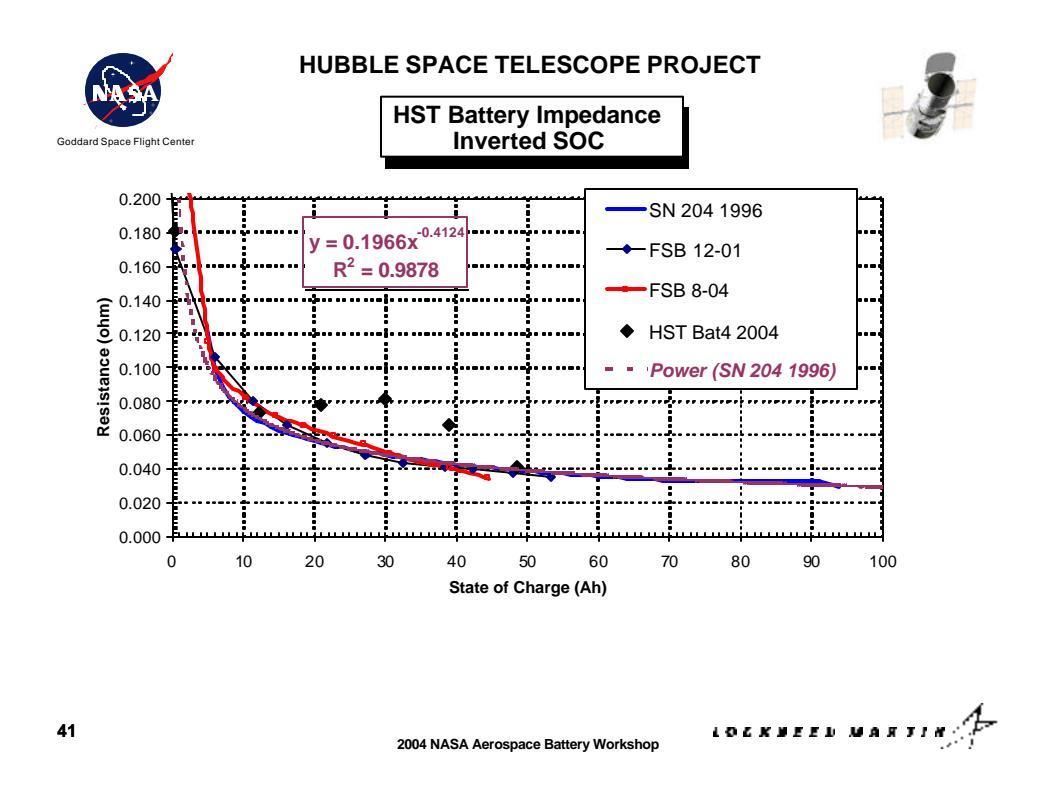
Standardizing this data to a common point, namely a discharged battery or cell, where all cells are at a similar State-of-Charge (SOC), is shown. Here it can be seen that the impedance versus SOC curves for the above ground testing, and the impedance data derived from the Orbital Battery #4 (Slide 4), are very similar. The outliers of the Battery 4 data can be explained by the nature of the coarse telemetry data, with different data rates for voltage and current.

Fitting the 1996 S/N 204 data yields the power formula (insert).

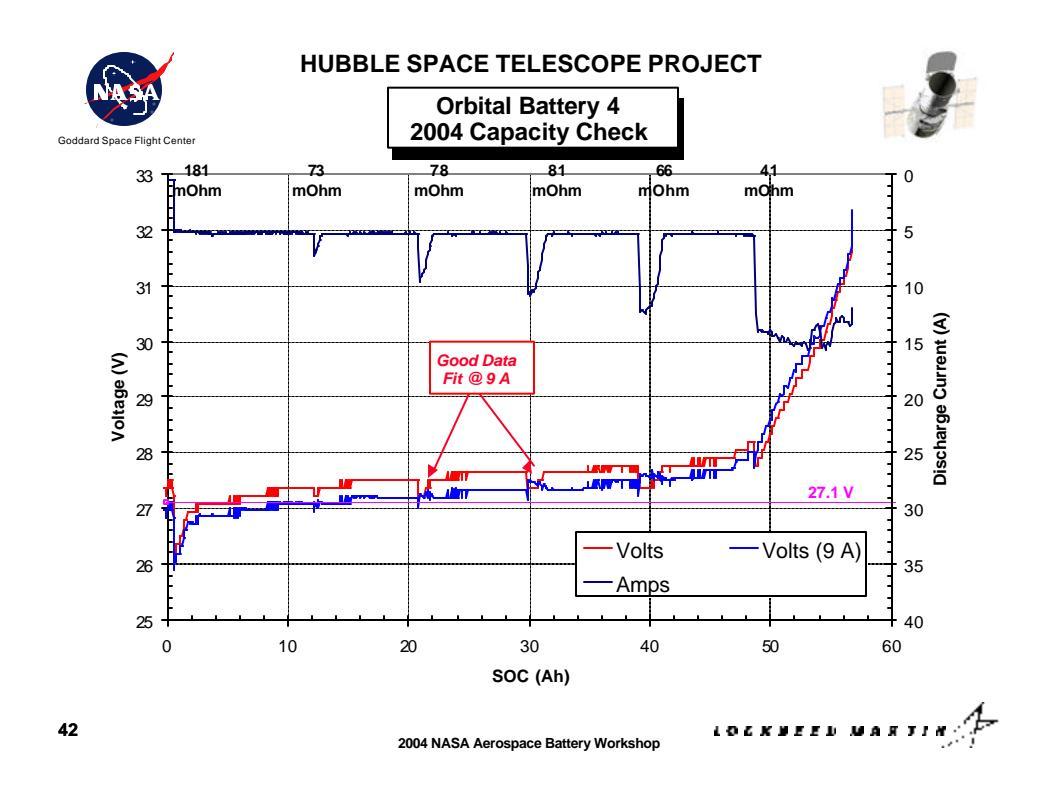
This equation was then used to calculate a battery impedance as a function of the SOC, and that impedance applied to the Battery 4 voltage/current data to project what a 9 A discharge would look like, as show above. Note that when the orbital data is load sharing with currents close to 9 A (22 & 30 Ah) that the 9 A projected curve is a close approximation of the voltage actually observed during those periods. This is a strong validation of this technique. It should be noted that the battery voltage shown here during the load share periods is representative of all 6 batteries because HST has a parallel 6battery bus.

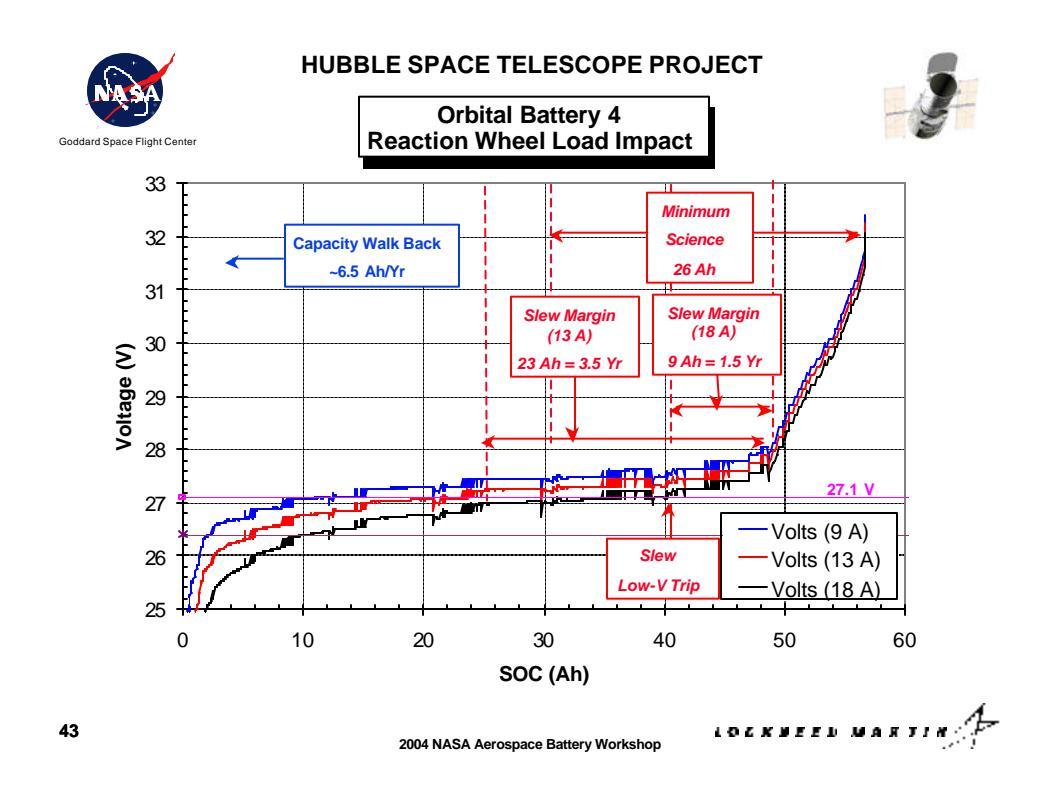
This slide shows the projected 9 A, 13 A, and 18 A discharge curves, as applied to the Battery 4 2004 Capacity Check. This slide enables one to examine how close to the minimum science voltage of 27.1 V the battery voltage approaches, during the 18 A/battery discharge curve expected due to reaction wheel, used for HST pointing, spin up. The projected discharge curve for 18 A shows that the 27.1 V minimum science voltage would be encountered within 9 Ah of the exit of the current eclipse period, on a per battery basis. This represents the margin currently available for extreme reaction wheel slew loads of 18 A, during eclipse periods. With a capacity fade rate of 6.55 Ah/year/battery, this minimum will be encountered within 1-2 years; the defined Science Minimum Capacity was 26 Ah. If the vehicle slews can be modified to reduce the reaction wheel current loads to below 13 A, then science operations could possibly be extended another 3-4 years. When reconditioning is performed the battery voltage will be several hundred millivolts greater.
