# Hubble Space Telescope

## 2004 Battery Update

2004 NASA Aerospace Battery Workshop

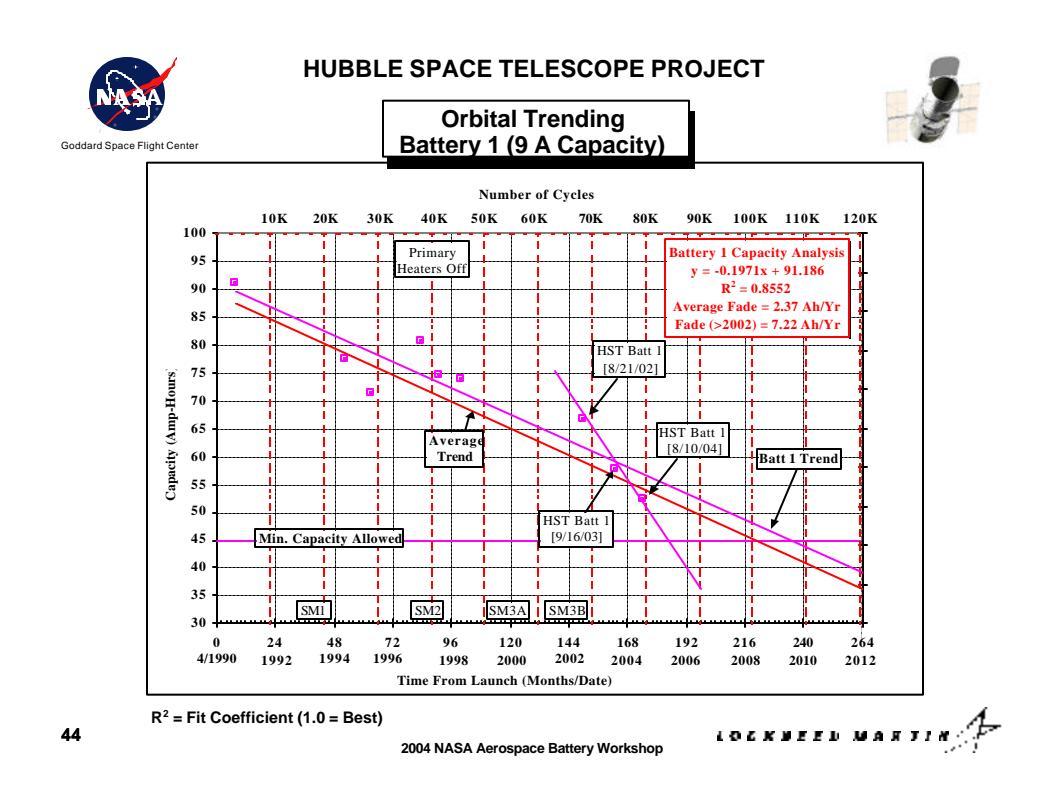
Battery capacity fade, corrected for 9 A capacity, trend suggests a Battery 1 replacement in 2009 (assuming 45 Ah/battery) if the general trend (with a  $\mathbb{R}^2$  fit coefficient of 0.86) is used or 2005 if the trend from the last two reconditioning cycles were to continue. With the increased DOD since SMBB, it is anticipated that the capacity degradation will be slightly higher to that prior to SMBB.

The capacities shown here have been corrected to reflect a 9 A load.
