IMPACT BEHAVIOR OF COMPOSITE FAN BLADE LEADING EDGE SUBCOMPONENT WITH THERMOPLASTIC POLYURETHANE INTERLEAVE

Sandi G. Miller¹, Gary D. Roberts¹, Lee W. Kohlman¹, Paula J. Heimann², J. Michael Pereira¹, Charles R. Ruggeri¹, Richard E. Martin³, Linda S. McCorkle²

¹NASA Glenn Research Center, Cleveland, OH 44135

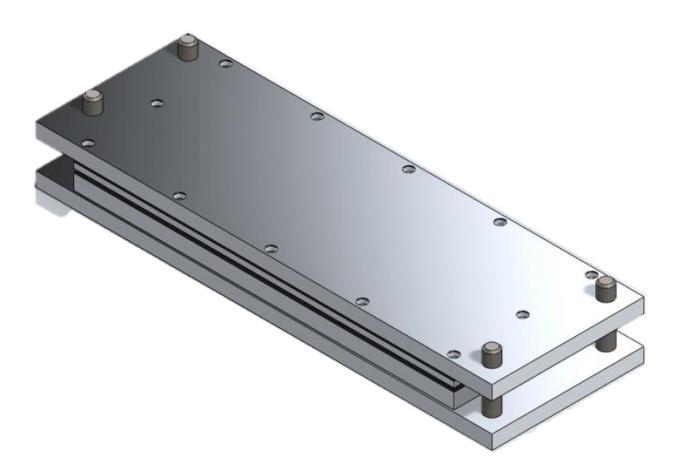
Figure 1. 3-D model of mated die mold

A simple subcomponent impact test article was designed to represent the leading edge of a fan blade as documented in Reference 15. The IM7/8551-7 pre-impregnated tape was cut according to the ply lay-up and configuration specifications for the subcomponent. An aluminum tool was custom designed to fabricate the leading edge specimen described in this paper. The mold was a mated 7075 Aluminum die, which was fitted with a vacuum pump venting attachment and a channel to capture excess resin flow (Fig. 1). All blade coupons were processed in an autoclave and followed the vendor recommended cure cycle. Cured blades dimensions were 15.24 cm (6 in) wide by 45.7 cm (18 in) long and, following removal from the tool, were machined on the 45.7 cm (18 in) sides for a smooth surface to secure in the impact test fixture.

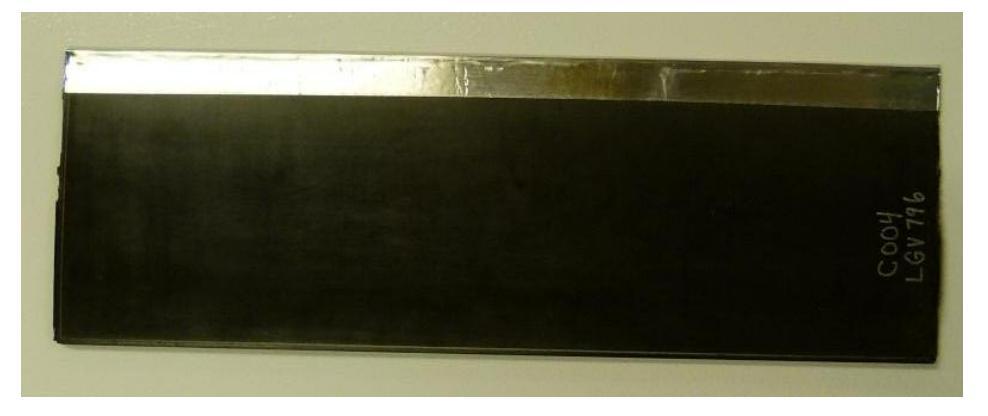
Figure 2: Prepared leading edge test article

In an effort to protect the leading edge from extensive break-out damage during impact, leading edge protection was applied in the form of an industrial aluminum foil adhesive tape. The aluminum foil tape was 0.25 mm (0.01 in) thick and 5.1 cm (2 in) wide and added approximately 20 g of mass to the edge of the blade. The adhesive tape was placed 2.5 cm (1 in) from the leading edge on the concave side of the blade, rolled over onto the convex side, then smoothed and flattened. A fully prepared test article is shown (Fig. 2).

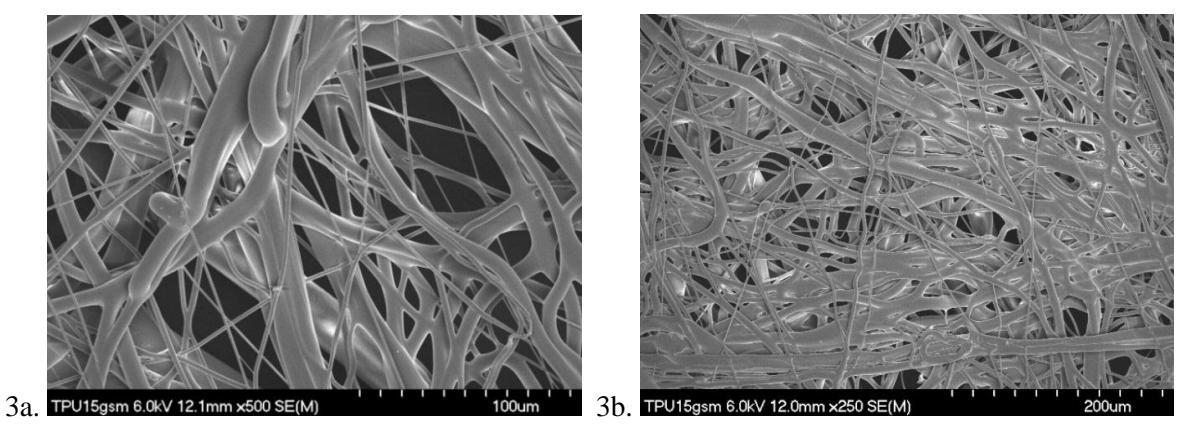
Figures 3a-b illustrate the variation in fiber diameter and packing within the 15 gsm veil.

Two separate veil areal weights, 15gsm and 45gsm, were evaluated. Representative SEM images (Figs 3, 4), show variation in fiber packing within regions of the 15 gsm (Figs 3a-3b) and the 45 gsm material (Figs 4a-4b). Literature has reported an increase in fracture toughness with increasing interleave thickness[16], however, tension and compression strength tended to decrease with increased areal weight, i.e., thickness. Thus, moving forward with fracture toughness and blade subcomponent work only the 15 gsm material was used.

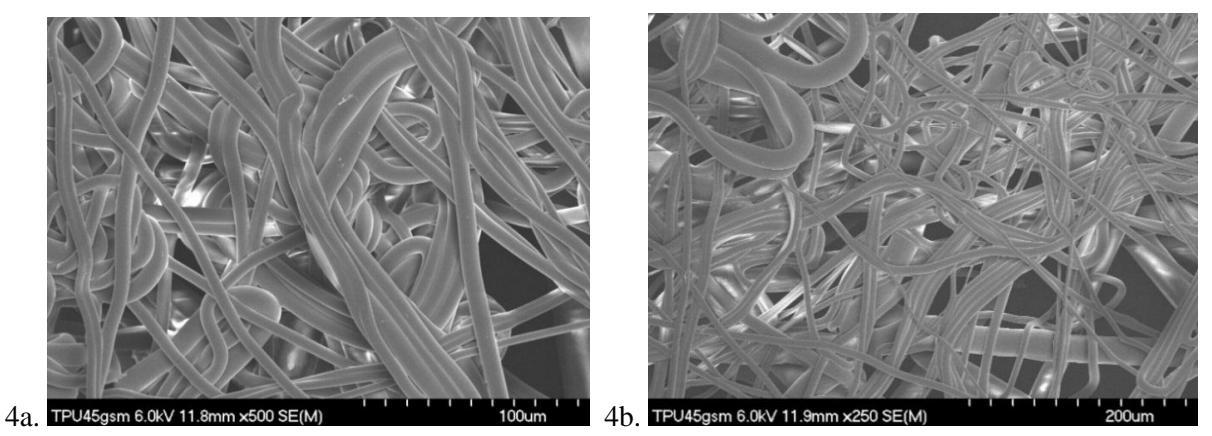
Figures 4a and 4b illustrate the variation in fiber diameter and packing within the 45 gsm veil.

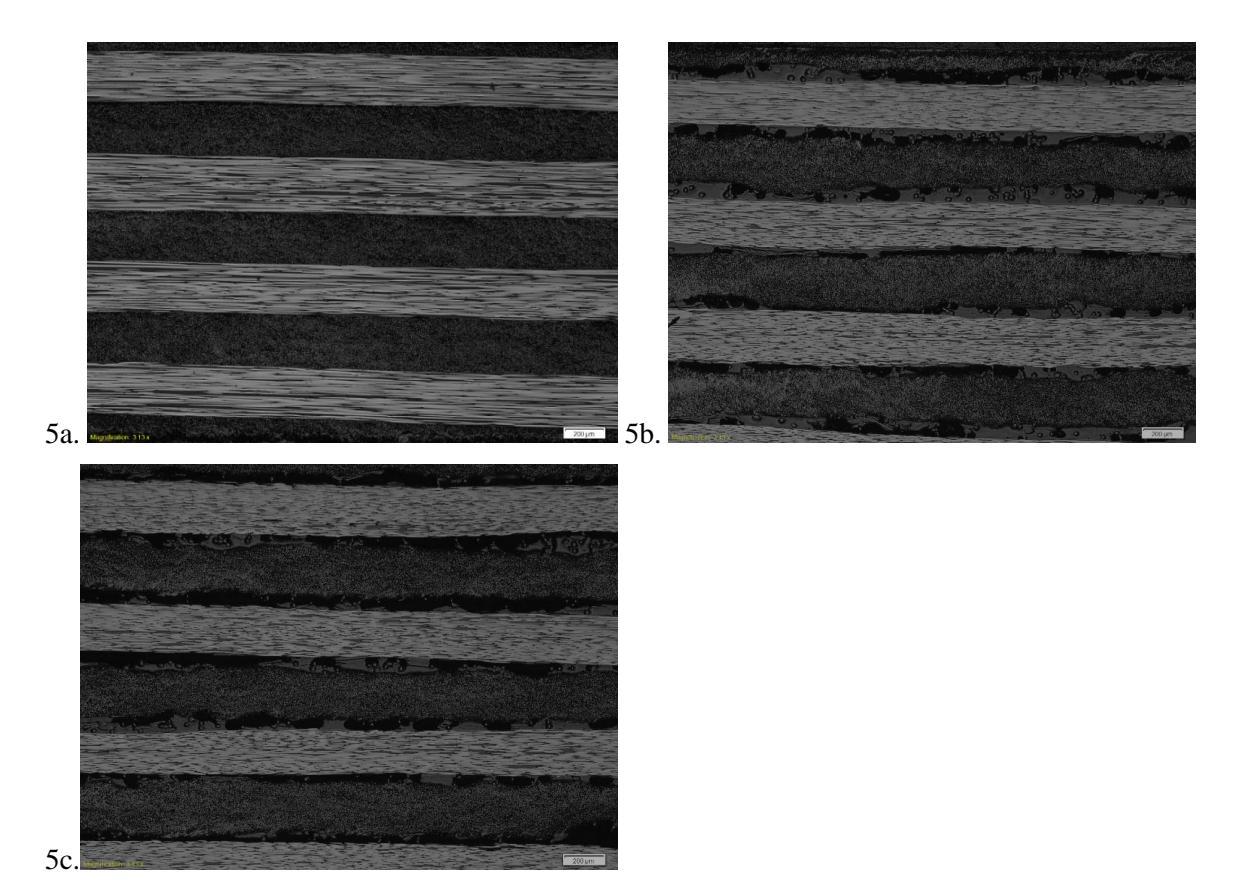
Figures 5a-5c: Optical Microscopy of the cross-section of a- baseline composite, b- 15 gsm interleave, and c- 45 gsm interleave coupon.

The process to cure the material was not modified following incorporation of the veil within the laminate. Optical microscopy of the cured panel cross-section (Figs 5a-5c) showed excessive voids at the interface, due to the added porous material, (Figs 5b and 5c). Voids are seen as the black areas at the ply interfaces. Future cure studies are recommended to mitigate consolidation issues such as void formation. A distinct increase of interlaminar interface thickness was also observed, from ~ 5 μ m in the baseline composite, to 10-70 μ m in the 15 gsm veil coupon, and 30-70 μ m in the 45 gsm veil coupon.

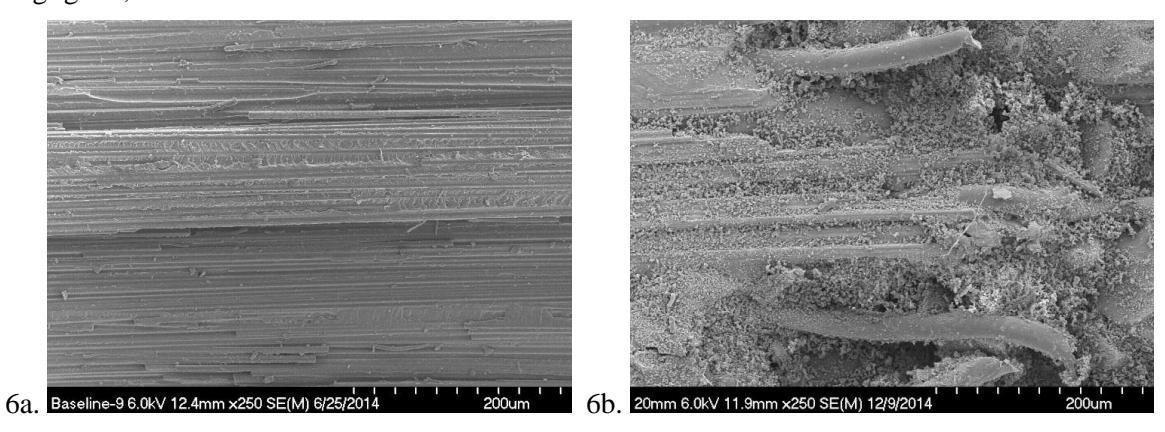
Figures 6a-b: Mode I fracture surface of 6a- baseline panel, 6b- 15 gsm interleave.

Mode I fracture toughness tests showed a 40% increase in G_{IC} following addition of the TPU veil. The mechanism of improvement has been attributed to crack deflection, where the veil increases the path length of crack propagation. This is illustrated in the images of the fracture surfaces Figs (6a and 6b). Figure 6a show matrix failure in the baseline material, and a clean fracture surface. The failure of the toughened panels, Figure 6b, is obscured from the debris left from the interleave, but an increased amount of fiber pull out is observed. The benefit to Mode II fracture toughness was negligible; 5%.

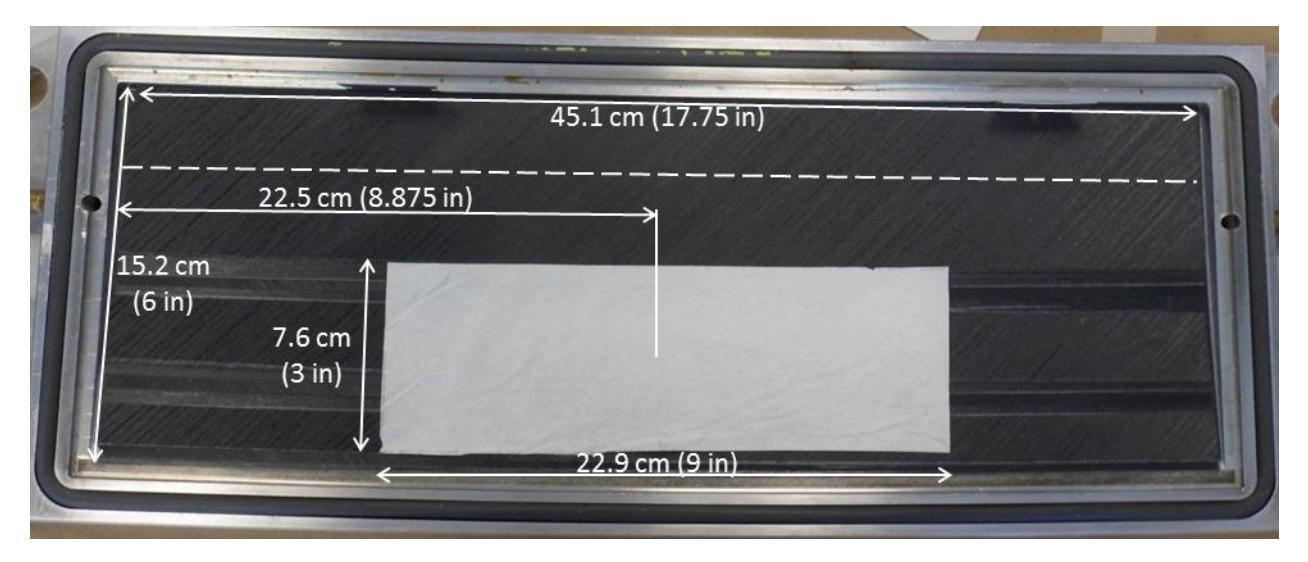
Figure 7. Location of 7.6 cm (3in) polyurethane veil layer.

Baseline and thermoplastic polyurethane (TPU) veil toughened blades were prepared to evaluate the effects of increased interlaminar strain-release capability of the structure on impact resistance. The toughening veil was 22.9 cm (9 in) long and placed in the midsection of the blade length (Fig 7). Three layers of TPU were added to the blade in the locations labeled in Fig. 8. Two of the layers were 7.6 cm (3 in) wide and the other was 5.1 cm (2 in) wide. The veil placement was chosen to cover a significant portion of ply terminations; reducing free edge stresses.

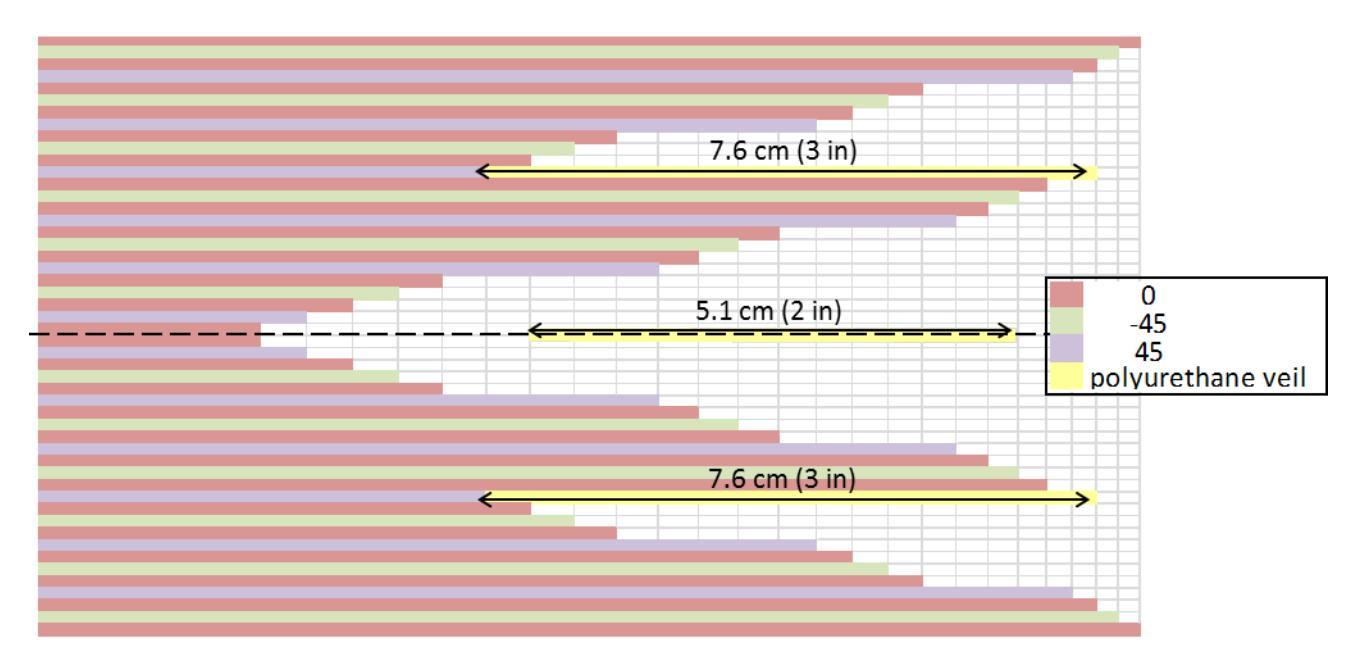
Figure 8. Polyurethane veil toughened specimen.

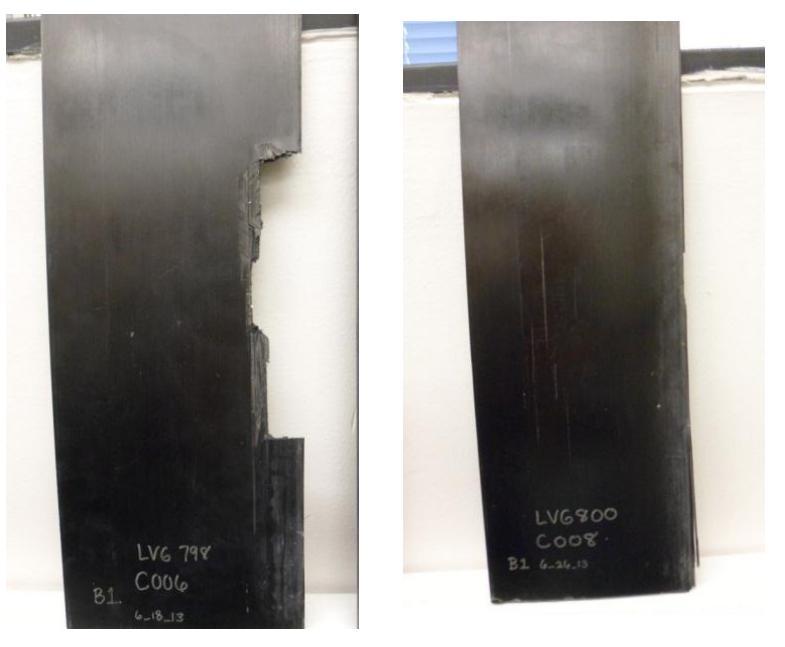
Figure 9. Photos of baseline (left) and toughened (right) panels after impact

The results of the impact test are shown (Fig. 9). Impact of the baseline blade (C006) led to considerable damage at the leading edge, with complete break-out at the impact location. There was no break-out of material for the veil toughened blades (C008) and no delamination at the leading edge was noted; in the interleave region. In both tests, a small delamination was observed near one end of the leading edge in an unmodified region due to flexural wave reflection. This failure mode was observed in other leading edge tests and is considered an artifact of boundary conditions, occurring

after the initial impact. Permanent deformation at the leading edge of the blade tip in actual fan blades is common in bird strike events.

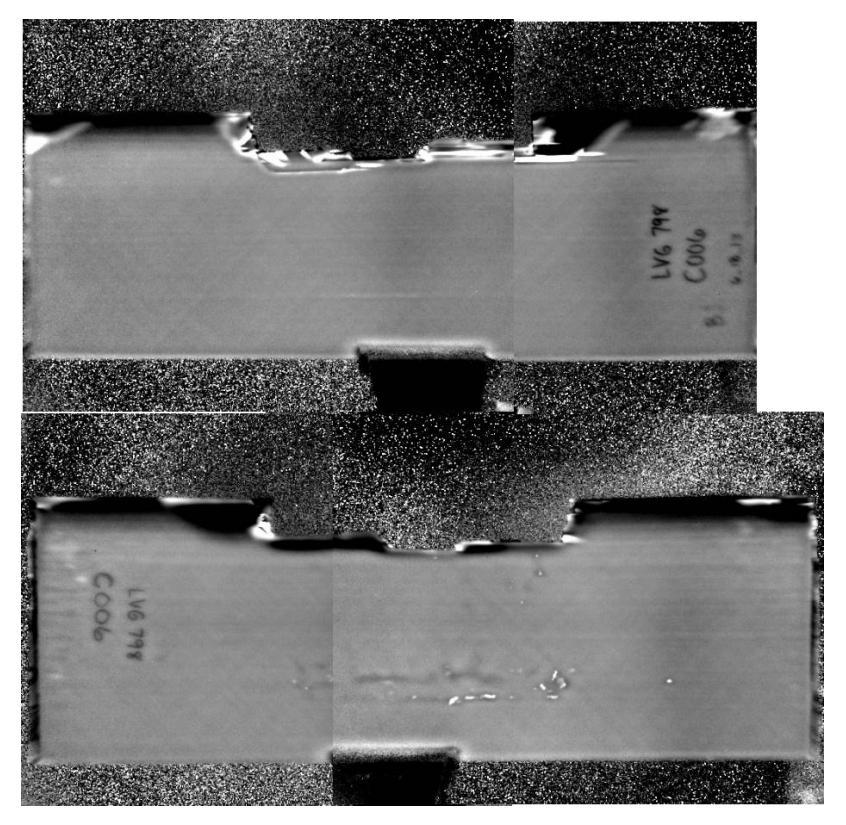
Figure 10a. Thermography images of the baseline composite blade. Upper image corresponds to the back surface and the lower image corresponds to the front surface.

Thermography images were used to characterize the impact-induced damage to the blade, (Figs 10a - 10b). The thermal image in Figure 10a indicates that damage to the baseline blade was limited to break-out at the impact site. The dark area along the leading edge is an artifact of the test, due to the thinness of the blade at the leading edge. In the toughened blade the leading edge maintained its integrity, allowing a greater amount of energy to be transferred into the blade, resulting in increased overall deformation in the form of large oscillatory flexing. The increased bending of the blade appeared to result in some delamination just beyond the placement of the toughening veil, as evidenced by the thermal image of the toughened blade (Fig. 10b). Increased flexing and bending was observed in the toughened blade, relative to the baseline, in high speed videos of the experiments. As a result, the mid-blade delamination appeared to only occur in the 'toughened' blade.

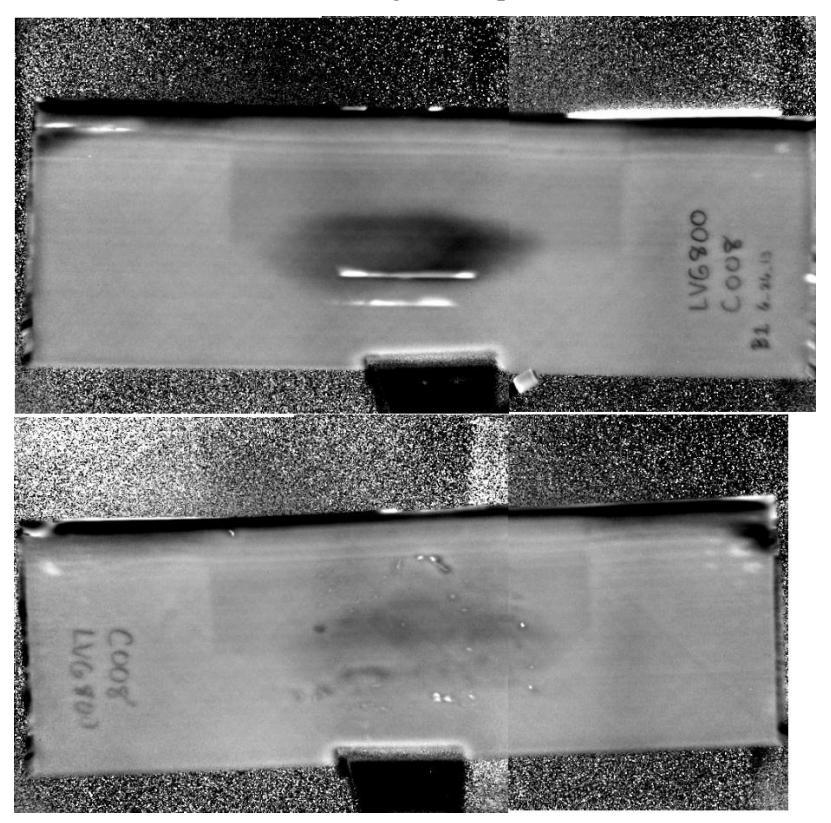
Figure 10b. Thermography images of the thermoplastic veil incorporated blade. Upper image corresponds to the back surface and the lower image corresponds to the front surface.
