# NATIONAL ADVISORY COMMITTEE FOR AERONAUTICS

#### RESEARCH MEMORANDUM

### VIBRATION AND ICING INVESTIGATION OF CAA TYPE V-109

#### VERY-HIGH-FREQUENCY AIRCRAFT ANTENNA

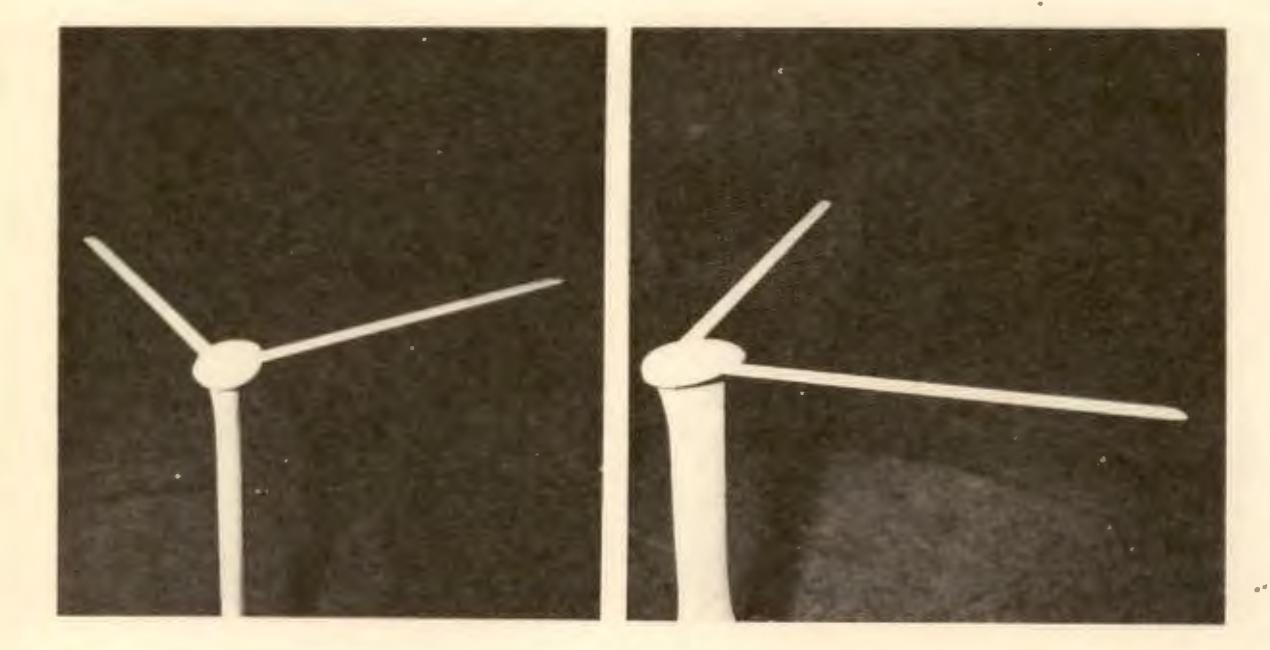
(a) Antenna without ice accretion.

Figure 1. - Omnidirectional aircraft antenna subjected to conditions of icing in icing research tunnel.

The antenna under icing and nonicing conditions is shown in figure 1.

During the nonicing vibration experiments at tunnel-air velocities of 100, 200, and 300 miles per hour, the amplitude of vibration at the antenna-element tips steadily increased as the tunnelair velocity increased. An amplitude of approximately 1/4 inch was reached at the element tip at a tunnel-air velocity of 300 miles per hour with a periodic surge of approximately 1/2-inch amplitude.

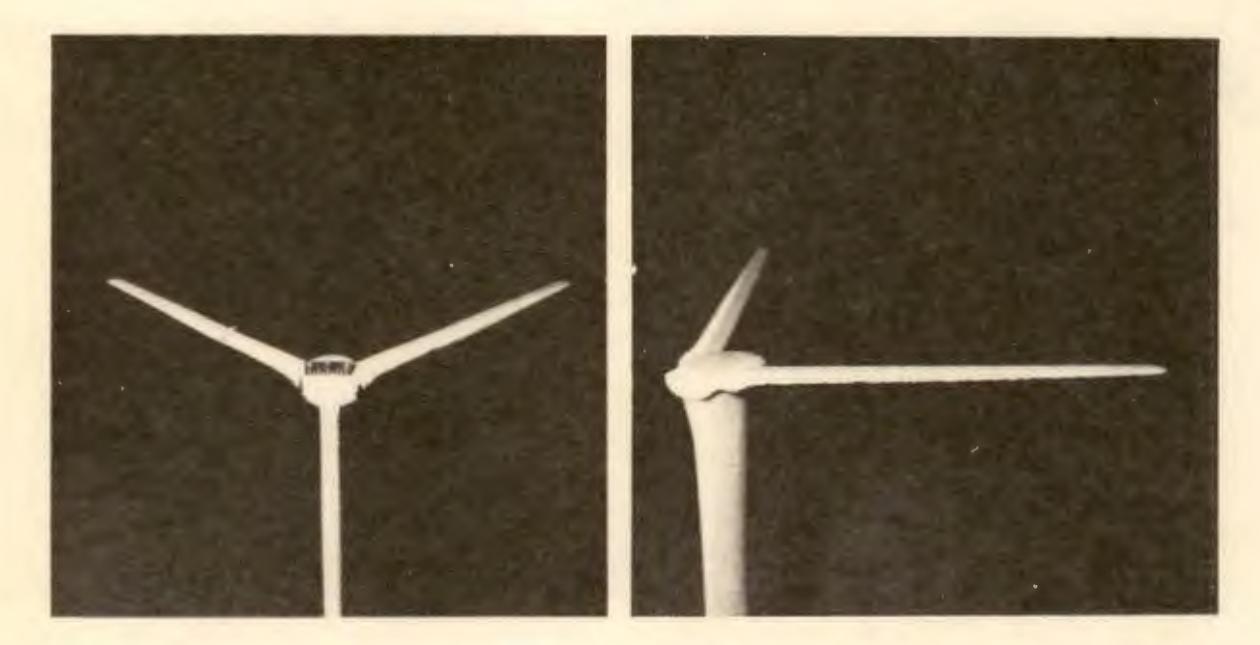
(b) Tunnel-air temperature, 16<sup>o</sup> F; tunnel-air velocity, 100 miles per hour; liquid-water content, approximately 1.50 grams per cubic meter; icing time, 20 minutes.

The first part of the icing investigation was conducted at a tunnel-air velocity of 100 miles per hour and a tunnel-air temperature of 16° F. Vibration of the antenna elements began immediately after even very small amounts of ice began to form and reached a maximum total amplitude of approximately 2 inches within 15 minutes. The antenna after 20 minutes of icing is shown in figure 1(b). At a tunnel-air velocity of 160 miles per hour and a tunnel-air temperature of 20° F, vibration became progressively worse during icing until a total amplitude as great as 6 inches at the element tips was observed within 8 minutes of icing (fig. 1(c)). When the tunnelair velocity was increased to 250 miles per hour with a tunnel-air temperature of 20° F, the total amplitude was observed to reach approximately 6 inches during the first 3 minutes of icing. Further icing for an additional 4 minutes had little or no effect on the amplitude, which stabilized at approximately 7 inches. After 7 minutes of icing, however, one antenna element experienced a vibratory failure at the end point of the steel insert (figs. 1(d) and 2).

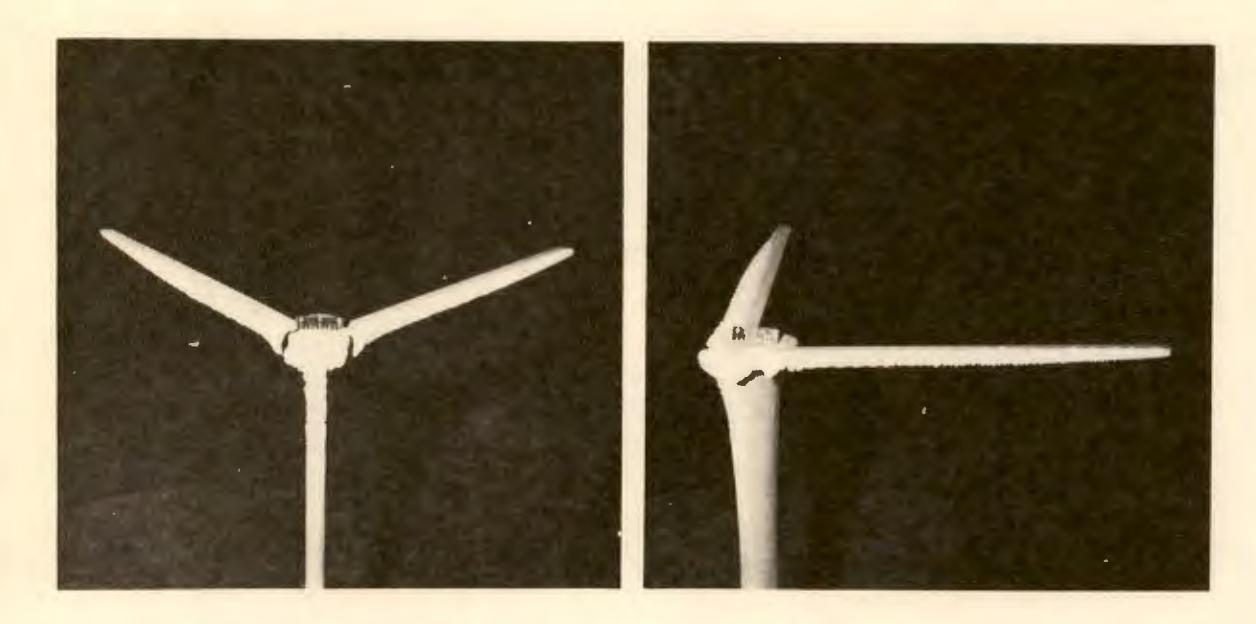
(c) Tunnel-air temperature, 20° F; tunnel-air velocity, 160 miles per hour; liquid-water content, approximately 0.95 gram per cubic meter; icing time, 16 minutes.

Figure 1. - Continued. Omnidirectional aircraft antenna subjected to conditions of icing in icing research tunnel.

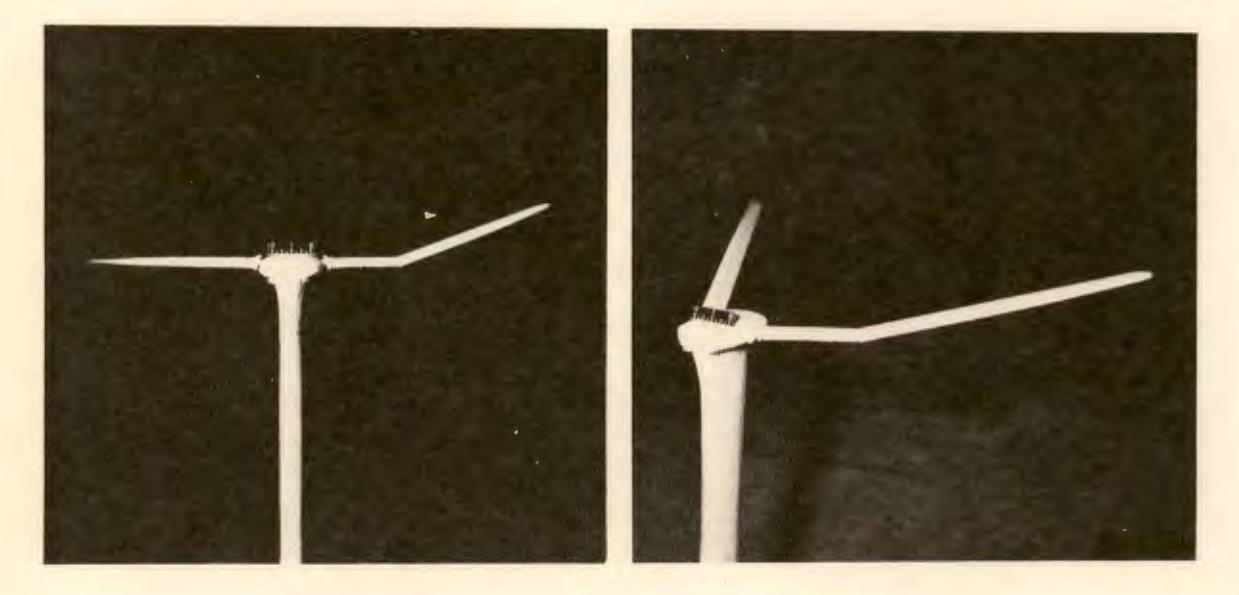
(d) Tunnel-air temperature, 20° F; tunnel-air velocity, 250 miles per hour; liquid-water content, approximately 0.60 gram per cubic meter; icing time, 7 minutes. (Right element, as viewed from front, fractured.)

3. Failure of an antenna element occurred after a 7-minute icing period at a tunnel-air velocity of 250 miles per hour and a tunnel-air temperature of 20° F. At the time of failure, tip amplitudes of approximately 7 inches were observed.

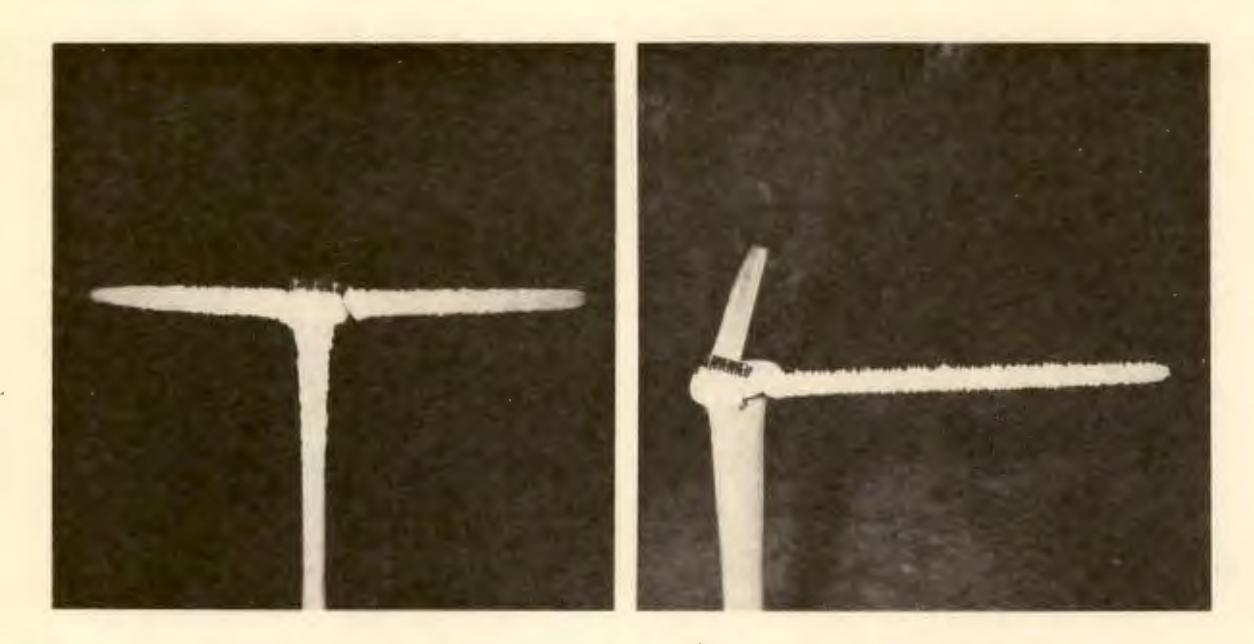
(e) Tunnel-air temperature, 28° F; tunnel-air velocity, 160 miles per hour; liquid-water content, approximately 0.95 gram per cubic meter; icing time, 7 minutes.

Figure 1. - Continued. Omnidirectional aircraft antenna subjected to conditions of icing in icing research tunnel.

A duplicate investigation was made with a second antenna having a transparent plastic head to compare its behavior with that of the first antenna. For a nonicing condition, the vibration of the elements was of the same magnitude as for the original. The antenna was subjected to more severe icing at a tunnel-air velocity of 160 miles per hour and a tunnel-air temperature of  $28^{\circ}$  F. An element-tip amplitude of approximately 6 inches was reached after 4 minutes of icing, but, after 5 minutes of icing, the ice accretion on the antenna elements became so heavy that the damping effect reduced the amplitude to approximately 1/4 inch and further icing for a total of 7 minutes (fig. 1(e)) had no additional effect.

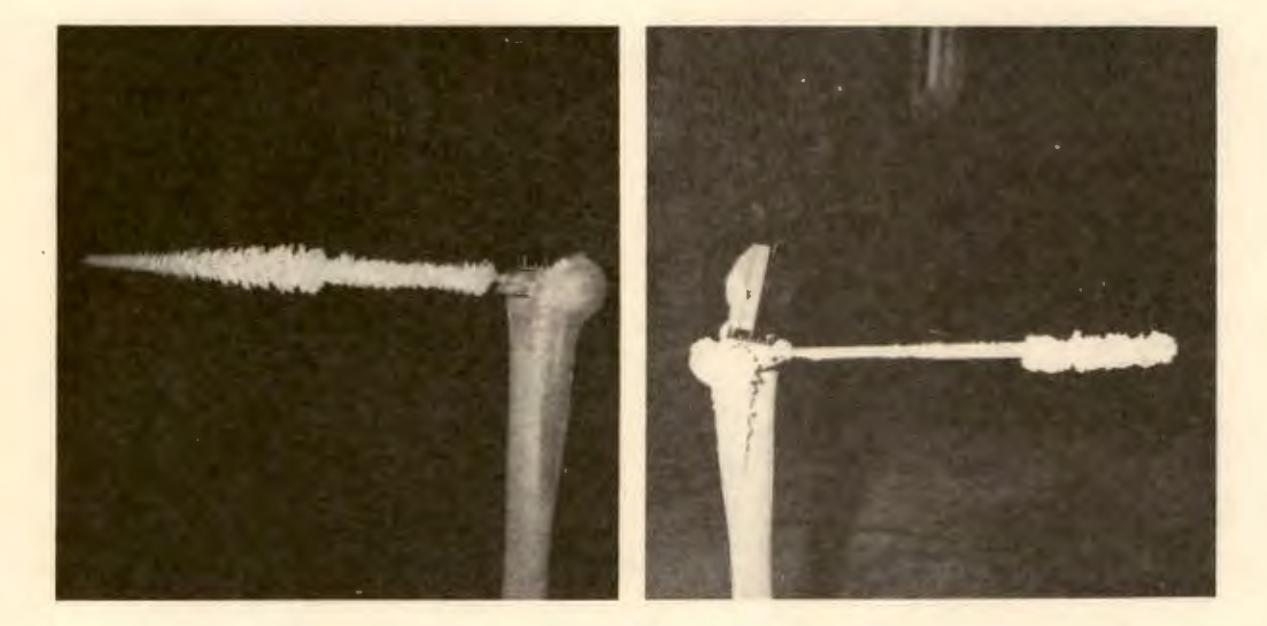
(f) Tunnel-air temperature, 26° F; tunnel-air velocity, 160 miles per hour; liquid-water content, approximately 0.95 gram per cubic meter; icing time, 15 minutes.

Observations were made at 250 and 300 miles per hour with a very heavy ice accretion obtained at 160 miles per hour and  $26^{\circ}$  F for 15 minutes. The elements with part of the ice shed from the inner sections are shown in figure 1(f). The subsequent observations made at 250 and 300 miles per hour without further icing indicated that vibration (maximum, 1/4 in.) was not serious at these speeds with heavy icing.

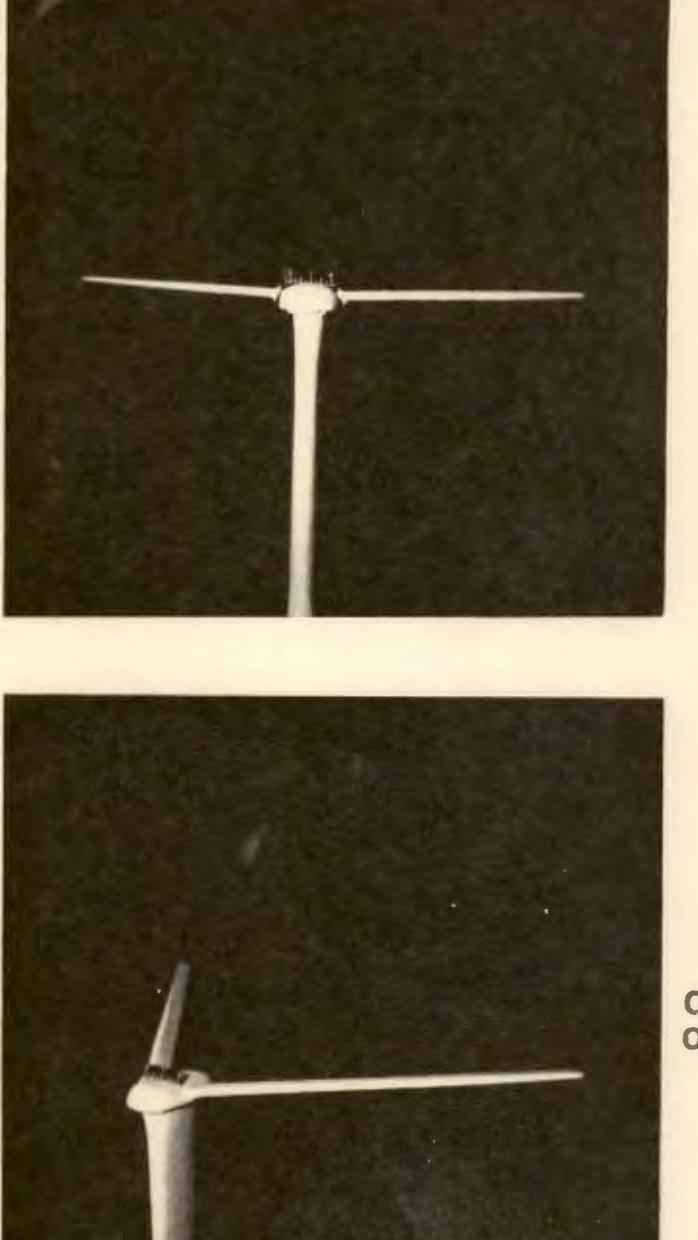
(g) Tunnel-air temperature, 0° F; tunnel-air velocity, 250 miles per hour; liquid-water content, approximately 0.60 gram per cubic meter; icing time, 5 minutes.

Figure 1. - Concluded. Omnidirectional aircraft antenna subjected to conditions of . icing in icing research tunnel. Ł

At a tunnel-air temperature of  $0^{\circ}$  F and a tunnel-air velocity of 250 miles per hour, icing was much less severe aerodynamically (fig. 1(g)) and the element-tip vibration amplitude reached approximately 4 inches after 5 minutes of icing.

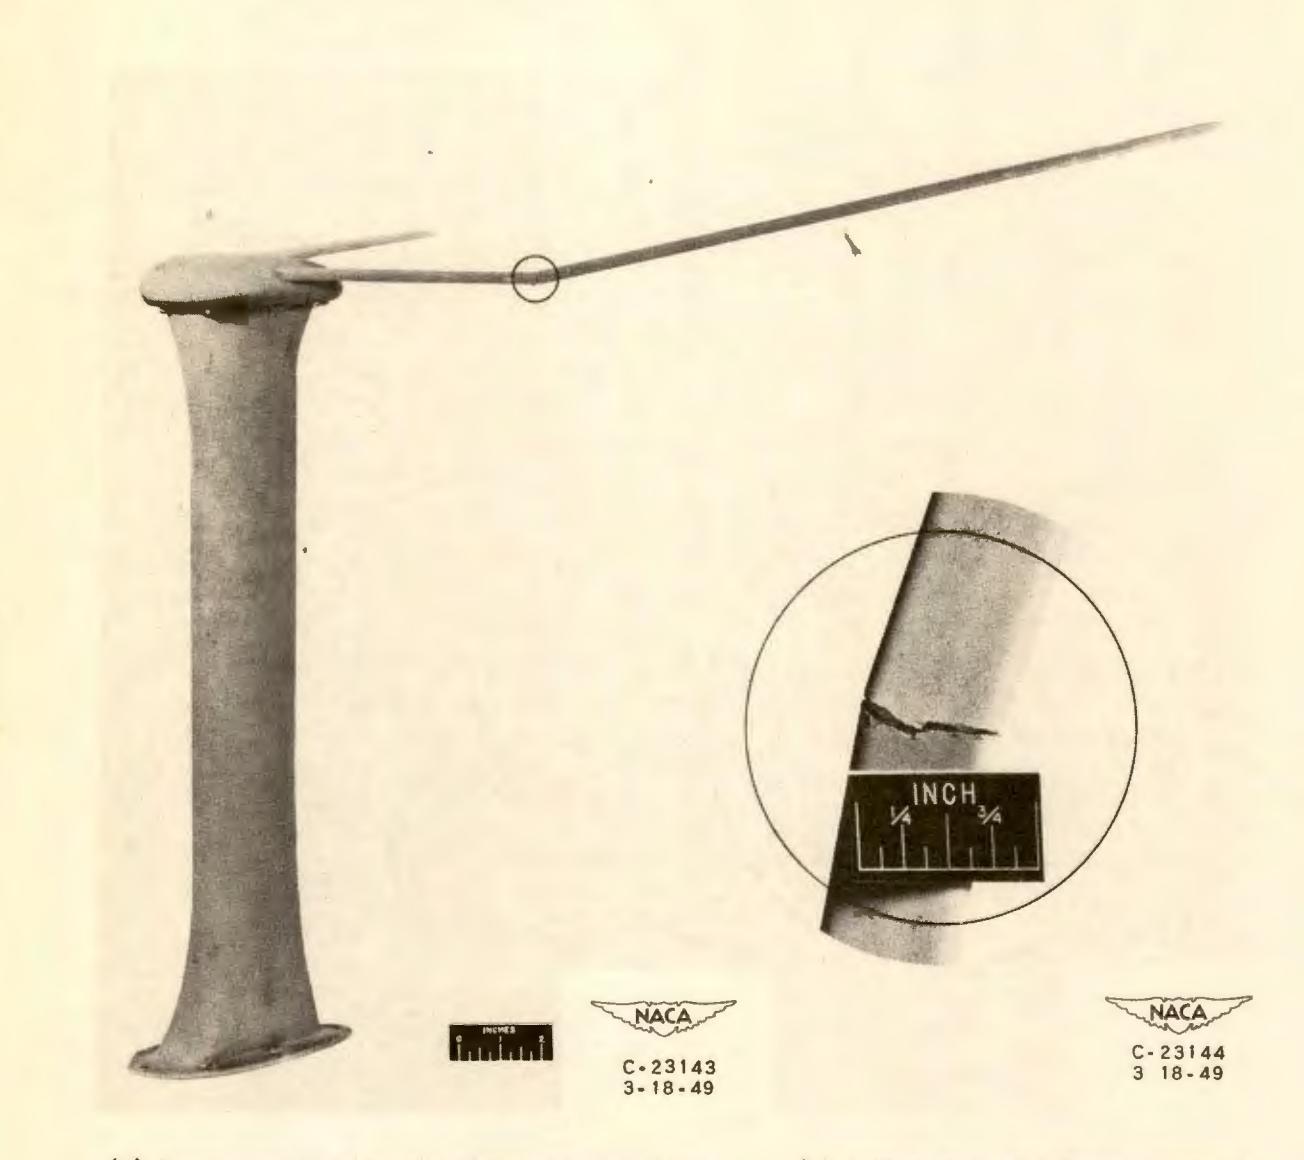
(a) Three-quarter view of antenna after failure.

(b) Bottom view of antenna fracture.

Figure 2. - Failure of omnidirectional aircraft antenna resulting from vibration under . icing conditions.
