NASA Technical Memorandum 110269

Texture Modification of the Shuttle Landing Facility Runway at the NASA Kennedy Space Center

Robert H. Daugherty and Thomas J. Yager Langley Research Center, Hampton, Virginia

July 1996

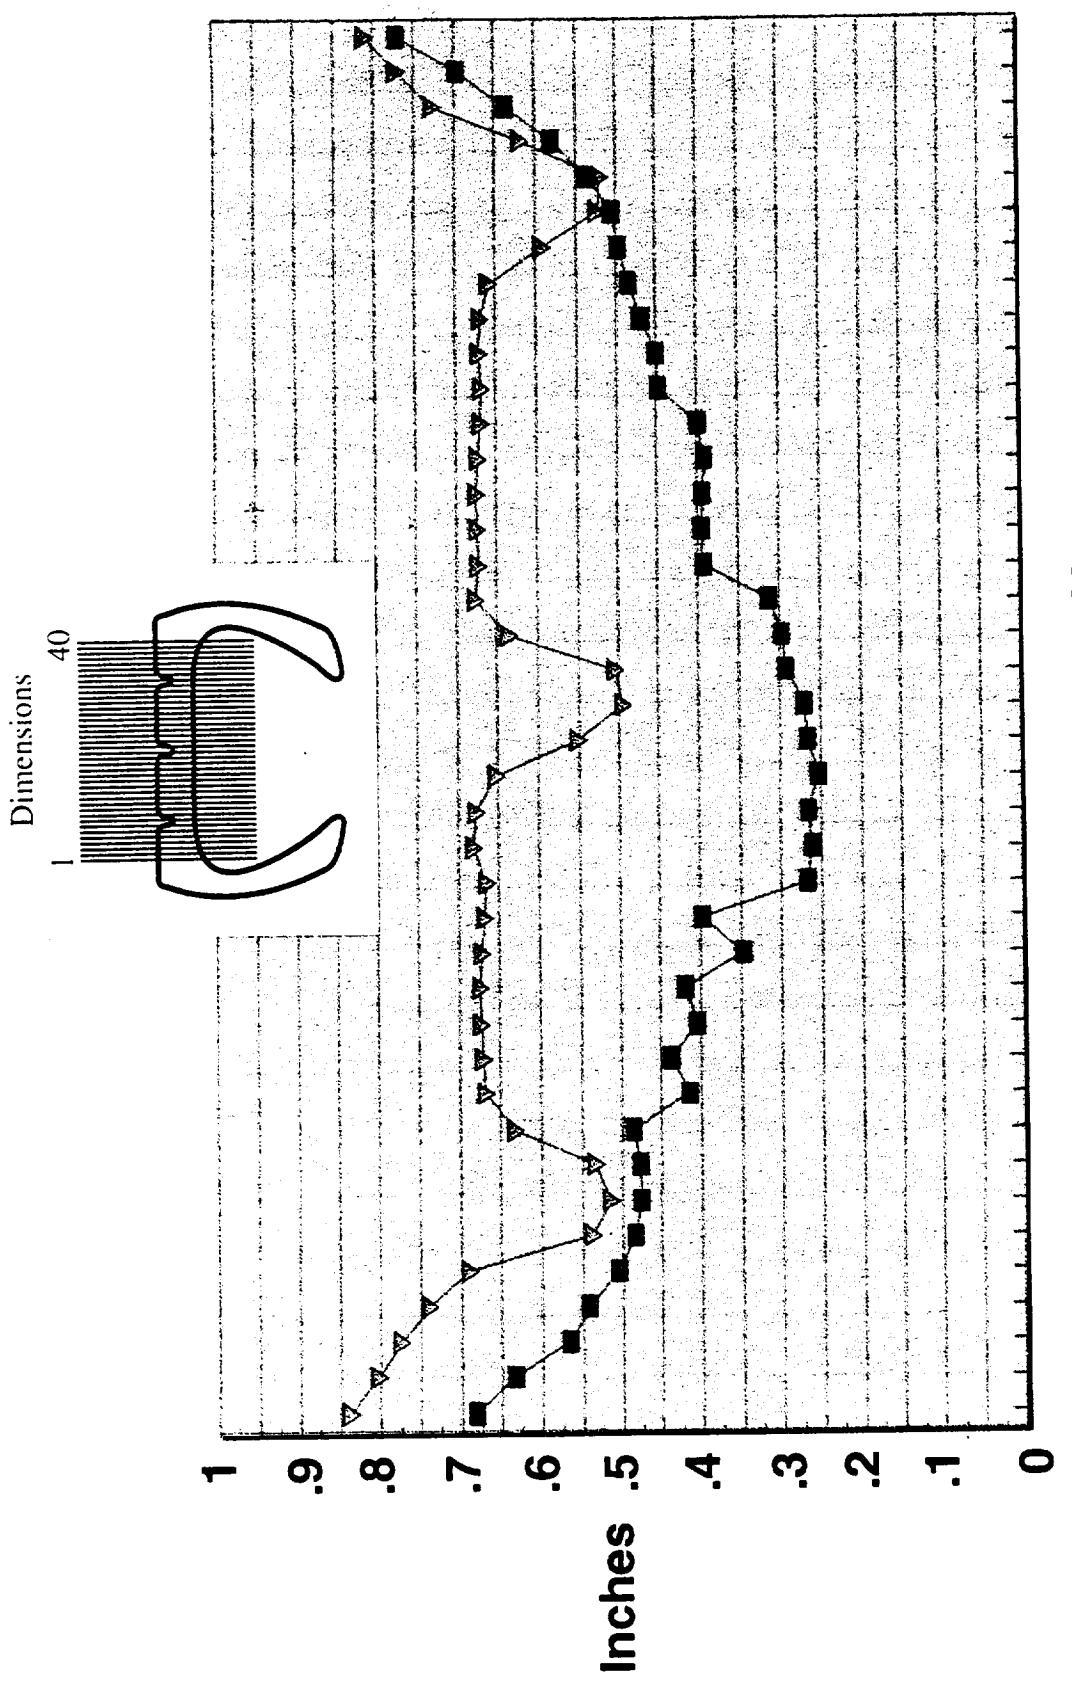
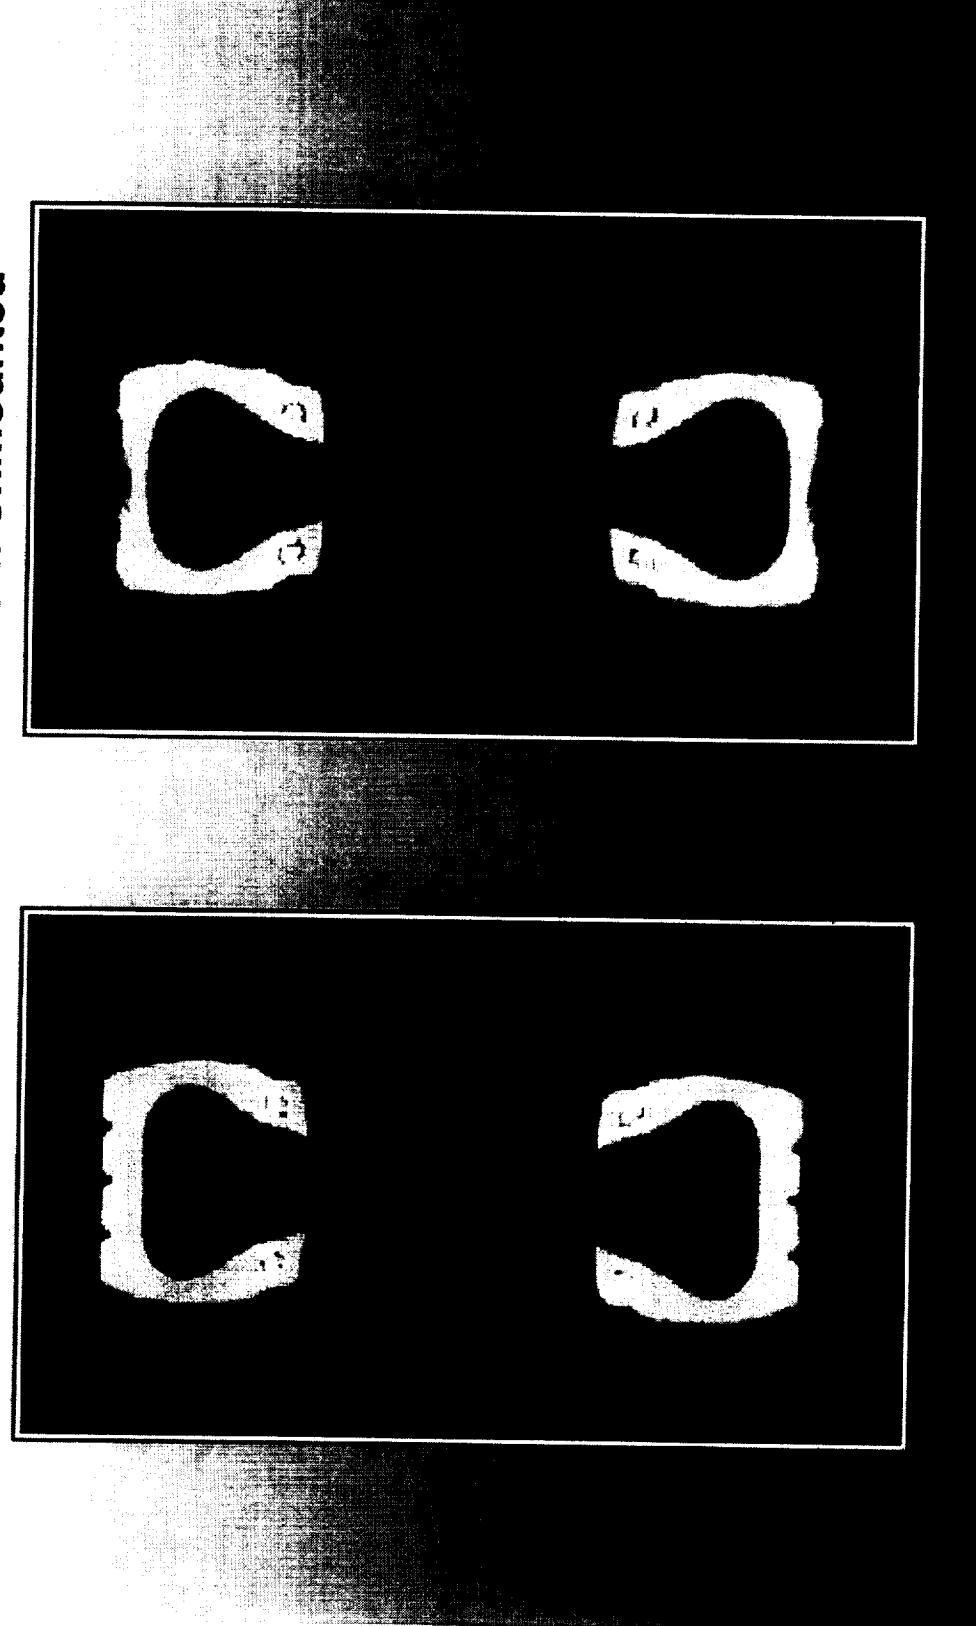
Figure 12. Computer tomography examples.

a. New versus worn tire profile comparison.

COMPUTED TOMOGRAPHY COMPARISON OF NEW AND WORN UNMOUNTED (LOOSE) T-38 TEST TIRE

of the tire. By placing a calibrated block of known size in the scan with the tire, a digital measurement program can be used to measure the tire width or thickness before and after wear testing. An example of the tire profile dimensions before and after testing is shown in figure 12(a). In the figure, dimensions 1-40 represent scans parallel to the rotational plane of the tire thus providing 40 data points from the left towards the right shoulder of the tire to characterize the tire tread area wear. Figure 12(b) provides a representation of the tire cross-section before and after testing. The change in thickness can then be correlated with other measurements of tire wear. The advantage of this kind of examination is that many more "individual" or discrete measurements can be performed automatically in a non-destructive manner. More information on this technique can be found in reference 13.
