# LOLA Radiator NS43C

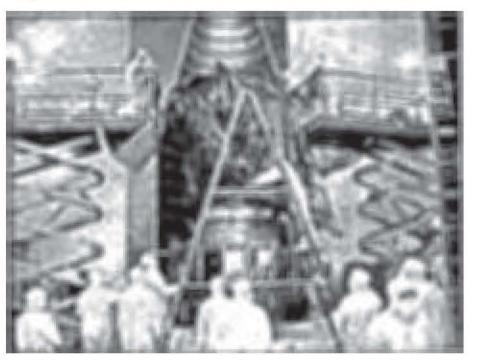
•Bag removal prior to encapsulation was performed in the middle of the night to limit the exposure of the observatory to contaminants

•Removal of the bag was again challenging due to the stack of two payloads

•Access was very limited due to risk of contact with either payload or the stand on which the faining would be placed

Scheme was designed again using parachute cord to lift the bag vertically off the spacecraft
There were many meetings to address concerns about removing the bag with the limitations
Bag removal occurred with minimal difficulties in less than 1 hour
