In-Plane Tensile Properties, Creep Behavior and Failure Mechanisms of CVI and PIP SiC/SiC Composites at Temperatures to 1,650 °C in Air

R.T. Bhatt HX5, LLC, Brook Park, Ohio

J.D. Kiser Glenn Research Center, Cleveland, Ohio

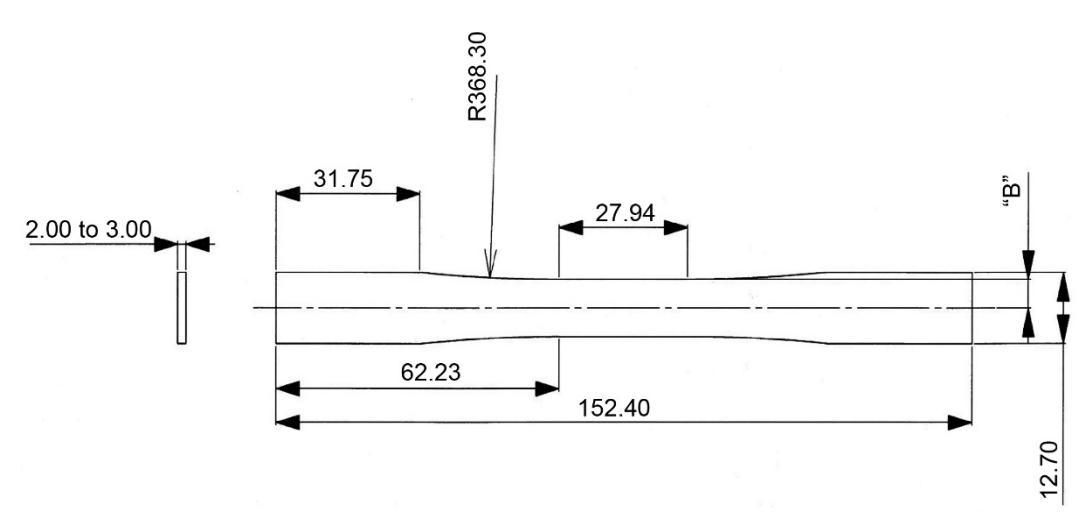
Figure 1.—Geometry and dimensions of specimen used for tensile and creep testing. (All dimensions are in mm).

The as-processed composite panels were first cut into 153 mm (L) by 13 mm (W) rectangular strips using a diamond tipped cut-off wheel. Each rectangular blank was machined into a dog-bone specimen using a diamond impregnated metal grinder. The CVI SiC/SiC dog-boned specimens were CVI-SiC seal coated following machining, to cover the machined edges with a thin protective layer of SiC. The PIP SiC/SiC dog-boned specimens were re-infiltrated with the pre-ceramic polymer and pyrolyzed to seal the machined edges. The dimensions of the dog-boned specimen are shown in Figure 1. Some CVI SiC/SiC(II) composite specimens were also heat treated at 1,600 °C for 1 hr in flowing argon to examine the influence of heat treatment on in-plane tensile and creep properties of the composites.

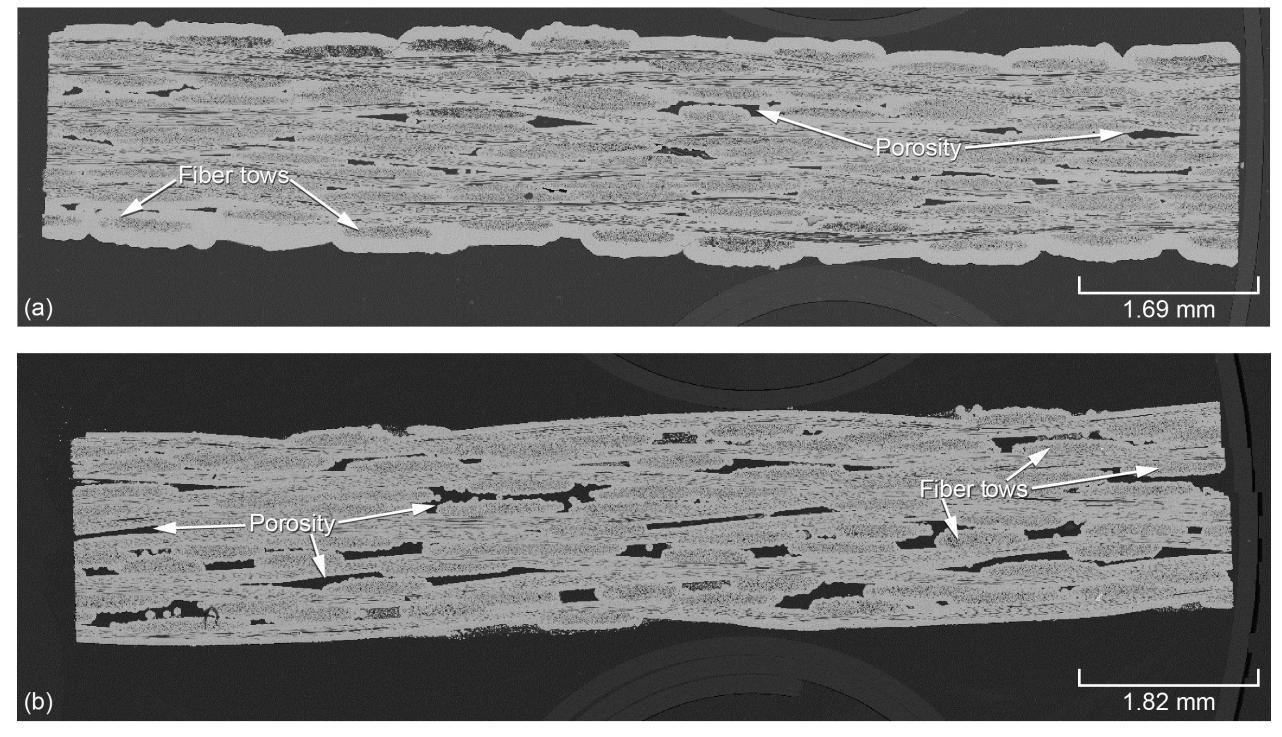
Figure 2.—Optical photographs of the cross-sections of 2D woven CVI SiC/SiC composites fabricated by different vendors showing fabric layup, porosity variation, and aspect ratio of fiber tows: (a) CVI SiC/SiC (I), (b) CVI SiC/SiC (II).

Figure 2 to Figure 4 show representative cross-sectional microstructures of CVI SiC/SiC (I) and (II), and PIP SiC/SiC composites, indicating fiber layup, matrix porosity distribution and typical BN interface and CVI SiC coating thickness on SiC fibers. The CVI SiC/SiC (I) composites (Figure 2(a)) appear to be slightly denser compared to the CVI SiC/SiC (II) composites (Figure 2(b)), and they also have a thicker layer of CVI SiC on the surface. A high-magnification photograph of the fiber tow shows the uniformity of the CVI BN interface coating, and the thickness variations of the CVI SiC coating on top of the SiC fibers (Figure 3). The dark ring around the fibers in Figure 3 is the CVI BN coating whose thickness is ~ 0.4 µm. In general, the thickness of CVI SiC coating on top of BN coating within a fiber tow varies and decreases from the outer periphery to the central region of the tow. Comparison of the cross-sectional microstructures within a batch as well as between batches of CVI SiC/SiC composites fabricated by different vendors indicates significant variation in porosity within fiber tows, between fiber tows, and between fiber plies, in addition to variations in thickness of CVI SiC coating. This variation in porosity and nonuniform distribution of CVI SiC within the panel occurs partly due to the randomness of the packing or nesting of the fabric during tooling for CVI fabrication, and partly due to canning of CVI SiC matrix at the surface of the panel and in the interior during the deposition process. On the other hand, the PIP SiC/SiC composite appears to be uniformly dense with micron-scale porosity and matrix microcracks distributed throughout the microstructure (Figure 4(a)). In some regions, fractured fiber tows were also observed, especially in regions where two parallel tows were touching each other. Detailed examination of a SiC fiber/PIP SiC matrix interface region indicates a thin layer (~<0.2 µm) of BN/Si₃N₄ interface coating on top of the fibers (Figure 4(b)).

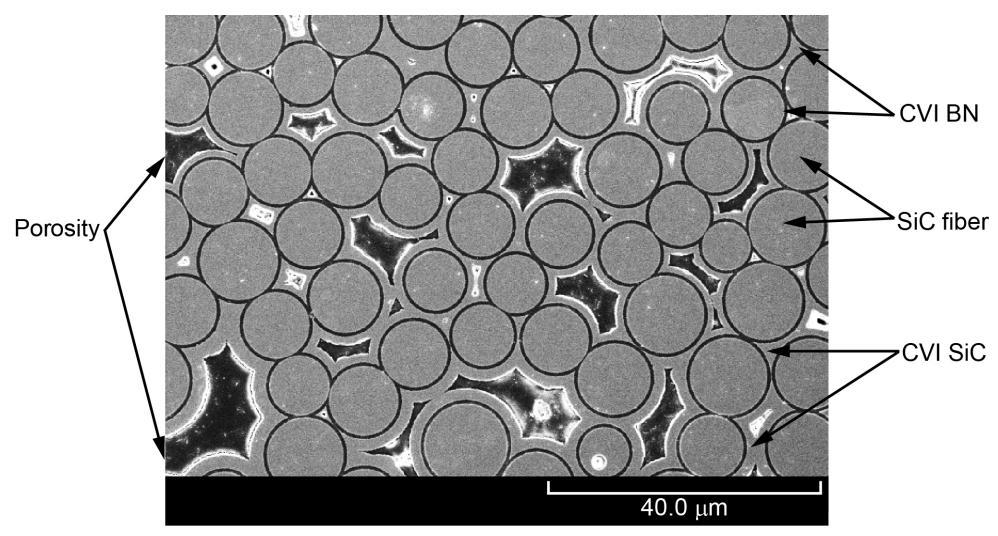
Figure 3.—High magnification SEM photograph of a cross-section of a 2D woven CVI SiC/SiC composite (I) showing fiber diameter, porosity, CVI BN interface, and CVI SiC coating thickness variation within the fiber tow.

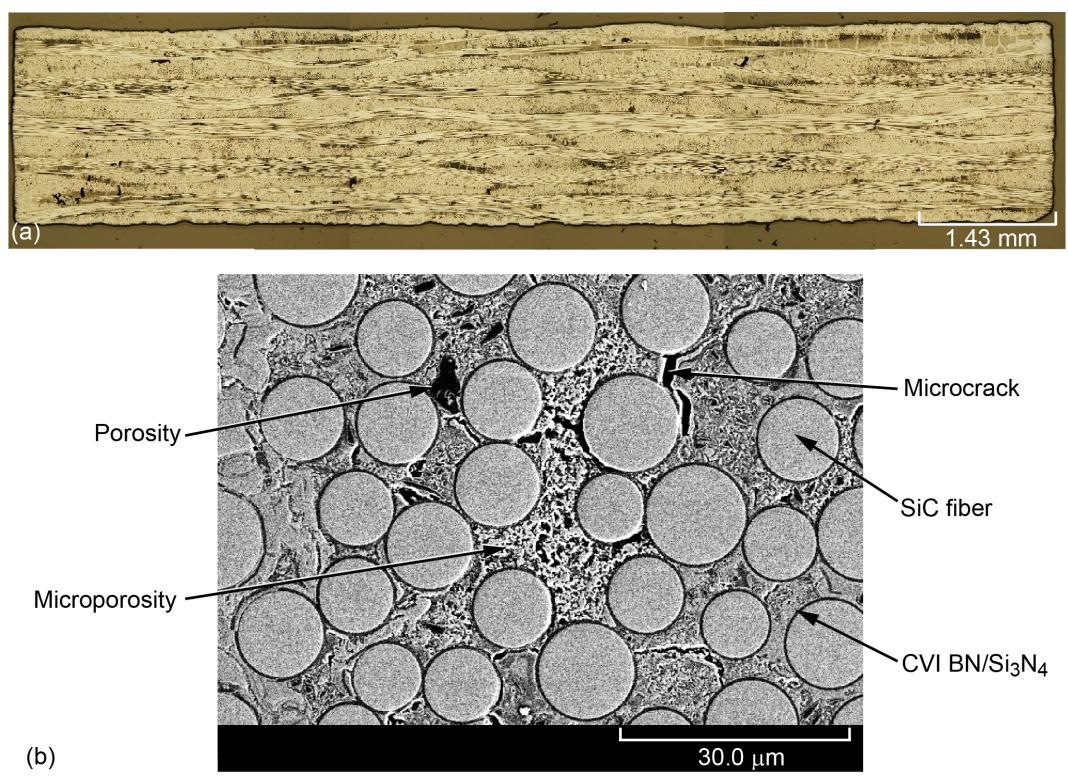
Figure 4.—(a) Optical photograph of a cross-section of a 2D woven PIP SiC/SiC composite showing fabric layup (b) SEM photograph of a fiber tow showing matrix microcracks, porosity, and CVI BN/Si₃N₄ interface coating thickness.

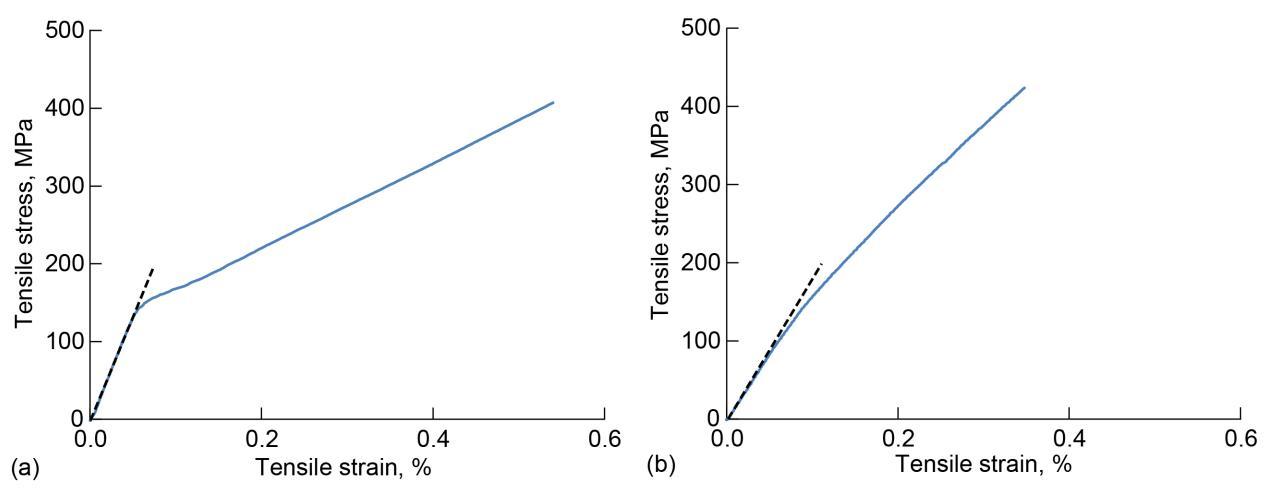
Figure 5.—Room temperature tensile stress-strain behavior of as-fabricated (a) CVI SiC/SiC (II) and (b) PIP SiC/SiC composites.

Room-temperature tensile stress-strain behaviors of as-fabricated CVI SiC/SiC (II) and PIP SiC/SiC composites are shown in Figure 5. The tensile stress-strain behavior of the CVI SiC/SiC (II) composite shows an initial linear region followed by a knee in the curve and another linear region with distinctly different slope until final failure. The slope of the initial linear region is significantly steep, which indicates a high composite elastic modulus. The stress at which the deviation from linearity occurs in the stress-strain curve will from now on be referred to as PLS, and the strain corresponding to PLS will be referred to as the proportional limit strain. In the case of CVI SiC/SiC composites, previous studies have shown that at or near the PLS, a partial through-the-thickness matrix crack is formed (Refs. 3 and 24). As the stress on the specimen is increased, additional through-the-thickness matrix cracks are formed normal to the loading direction and the spacing between the matrix cracks decreases. This process continues until the matrix crack spacing reaches a limiting value. Formation of the initial matrix crack at or slightly above the PLS, formation of multiple matrix cracks as the stress increased above the PLS, and saturation of matrix crack density at ~60 to 70 percent of the ultimate tensile strength (UTS) of the composite have been confirmed from acoustic emission and resistivity data generated during tensile tests of similar composites, as well as by microscopy of specimens loaded to different stress levels until failure (Refs. 3 and 24). Beyond this point, the entire load is carried by the SiC fibers until the ultimate fracture of the composite. This type of composite is classified as a matrix-dominated composite (Ref. 2). On the other hand, the tensile stress-strain behavior of a PIP SiC/SiC composite is parabolic or nonlinear from the beginning until final failure (Figure 5). A pseudo PLS can be estimated but may not represent initial failure of the PIP SiC matrix. In this composite, because the PIP SiC matrix is weak and heavily microcracked due to crystallization and

shrinkage processes of the multiple PIP cycles performed during fabrication, the stress-strain behavior is essentially controlled by the fibers. Also, the slope of the initial pseudo-linear elastic region is significantly lower than that of CVI SiC/SiC composites. This type of composite is referred to as a fiber-dominated composite (Ref. 3). Whether a composite is matrix or fiber dominated can be easily determined by calculating the effective modulus of the matrix, E_m, using the following equation.

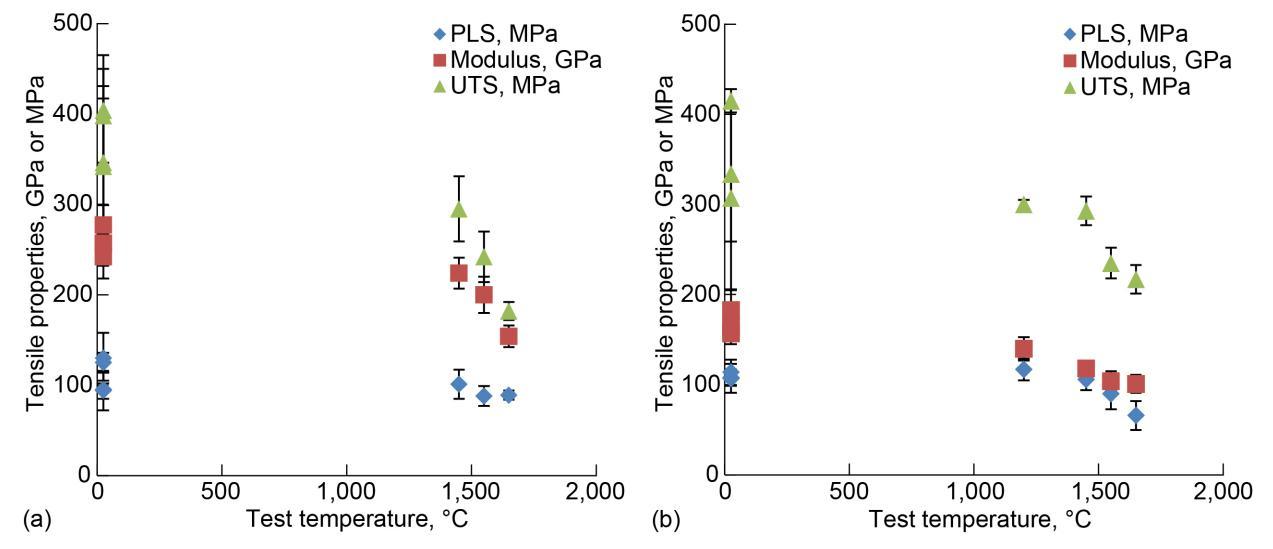
The variation of in-plane tensile properties of CVI SiC/SiC (II) and PIP SiC/SiC composites as a function of temperature is plotted in Figure 6(a) and (b), respectively. The data was generated from the specimens machined from four different composite panels. Each data point in the plots represents an average of 5 specimens and the scatter bands represent \pm one standard deviation. In the as-fabricated condition, both types of composites show significant batch-to-batch variation in in-plane properties, but at elevated temperatures scatter in the data decreases. From ambient temperature to ~1,315 °C, in-plane properties do not degrade significantly, but above this temperature range, all three properties (PLS, E, and UTS) decrease with increase in temperature.

To estimate the maximum fiber stress at failure, the UTS data of both composites shown in Figure 6 were divided by the volume fraction of the fibers in the loading direction for the corresponding composites. For this calculation, it is assumed that UTS is controlled predominantly by the fibers. This assumption is valid because a fully cracked matrix does not bear any significant load. The variation in the estimated fiber strengths with increase in temperature for both composites is shown in Figure 7. It is clear from the figure that the fiber strength retention in the as-processed CVI SiC/SiC (II) composites is better than that in the PIP SiC/SiC composites. This suggests that during processing the fibers in the PIP SiC/SiC composites are degraded to a greater extent than those in the CVI SiC/SiC composites.

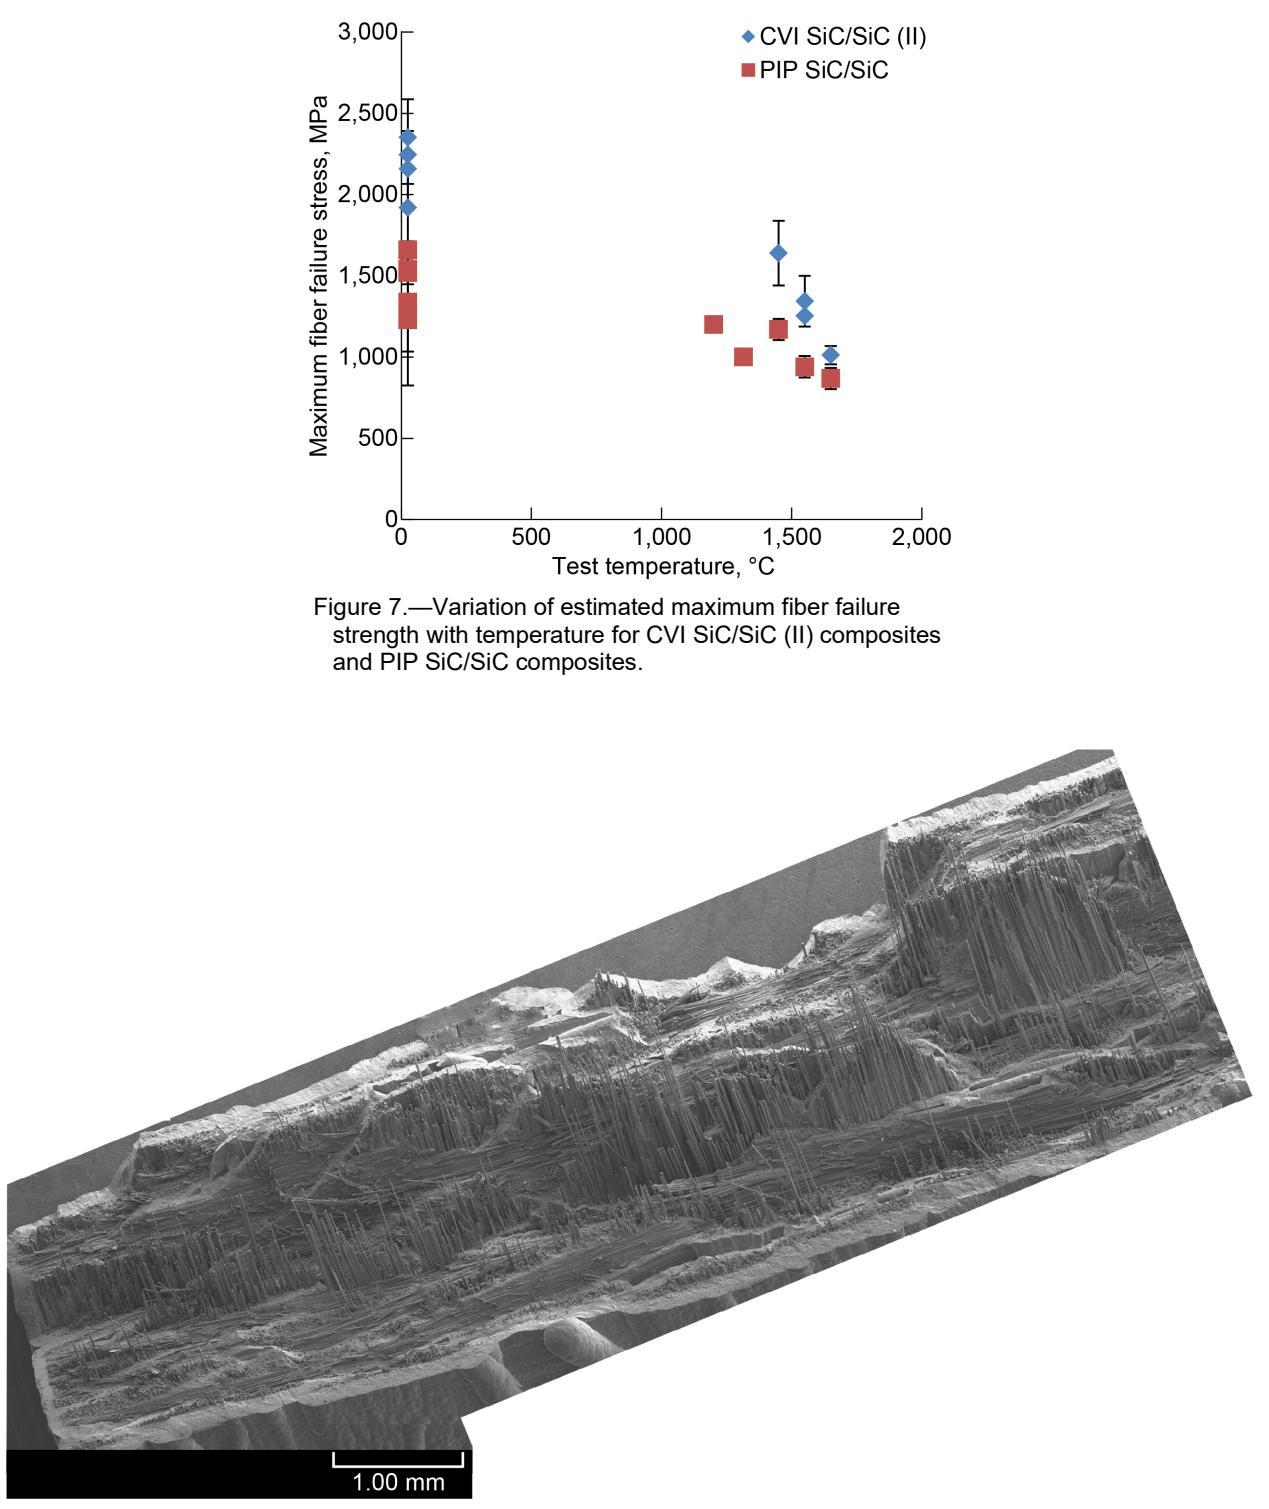
Figure 8.—The fracture surface of a CVI SiC/SiC (II) composite tensile tested at room temperature.

Fracture surface morphologies of a CVI SiC/SiC(II) composite tensile tested at room temperature is shown in Figure 8. The fracture surface is irregular and shows limited fiber pull out. Similar features were also observed on the fracture surfaces of the specimens tensile tested at temperatures to 1,650 °C.

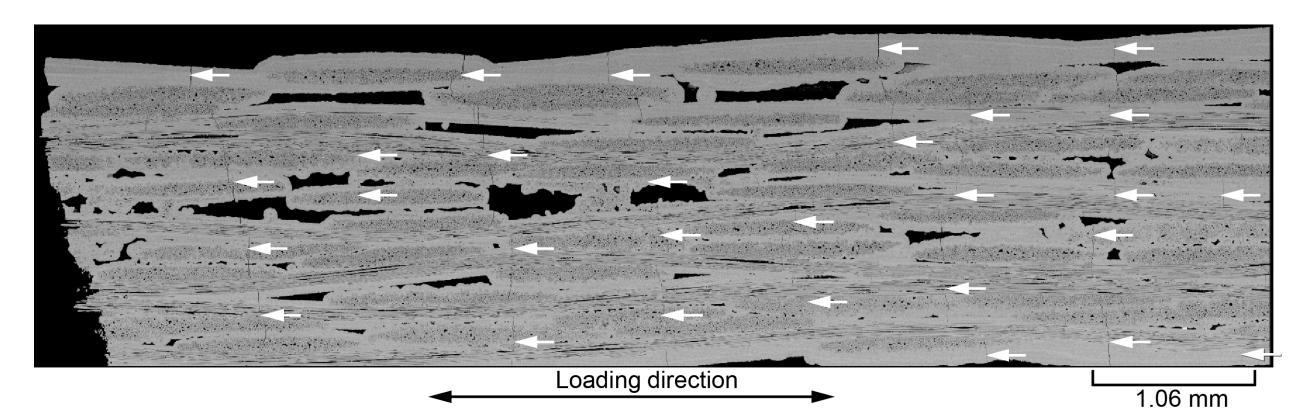
Figure 9.—The longitudinal cross-section of a CVI SiC/SiC (II) composite tensile tested at 1,650 °C in air showing the dominant fracture path and multiple matrix cracks normal to the loading direction.

Examination of the longitudinal cross sections of CVI SiC/SiC (II) composite specimens tensile tested from ambient temperature to 1,650 °C show similar features: a dominant crack that led to final failure and periodic through-the-thickness matrix cracks. An SEM image of the longitudinal cross section of a CVI SiC/SiC (II) composite specimen tensile tested at 1,650 °C is shown in Figure 9. The dominant crack that led to final failure is on the left in the photograph. The multiple matrix cracks that formed normal to the loading direction (white arrows) during tensile loading can be seen in the photograph. The matrix cracks appear to link internal pores. The average matrix crack spacing was measured from the longitudinal cross sections of tensile tested specimens at different temperatures. Table II shows the measured average matrix crack spacing from 25 to 1,650 °C, which do not show any trend with increase in temperature.

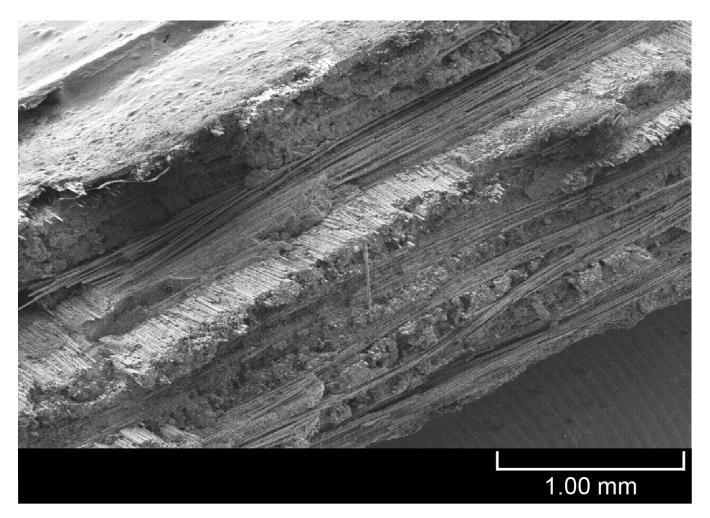
Figure 10.—The fracture surface of a PIP SiC/SiC composite tensile tested at room temperature.

The fracture surfaces of tensile tested PIP SiC/SiC composites from ambient temperature to 1,650 °C are irregular and test temperature did not affect the fracture morphology. An SEM photograph of the representative fracture surface of a PIP SiC/SiC composite tensile tested at ambient temperature is shown in Figure 10. The fracture surface shows no fiber pull out, suggesting high interfacial shear strength between the fiber and the matrix. The longitudinal cross sections of PIP SiC/SiC composites tested from ambient temperature to 1,650 °C also showed only one major crack that caused the final failure. However, in some specimens tensile tested at 1,550 °C and above, a few tunnel cracks were also observed on some 90° tows. Comparison of longitudinal cross-sectional and fracture surface analyses suggest that the damage mechanism(s) and the events that led to the final failure in CVI and PIP SiC/SiC composites are different. In PIP SiC/SiC composites, because of the high interfacial shear strength between the fiber and the matrix, the crack is initiated by a single flaw, possibly a fractured load-bearing fiber tow and the cracked PIP matrix around it, and then the crack grew and linked with similar flaws in different fiber plies causing the final failure. Although not shown, fractured fiber tows have been observed in as-fabricated PIP SiC/SiC composites. In contrast, when CVI SiC/SiC composites are tested under tensile mode, a partial through-the-thickness matrix crack is formed initially around PLS. As the load on the specimen is increased, the matrix crack grows. When it reaches fiber/matrix interface, it gets deflected due to low interfacial shear strength between the fiber and matrix. With increase in load from PLS and UTS, additional matrix cracks are formed at fairly regular intervals perpendicular to the loading direction of the specimen. One of these cracks becomes a dominant crack and linked with other cracks in the same plane causing the final failure.

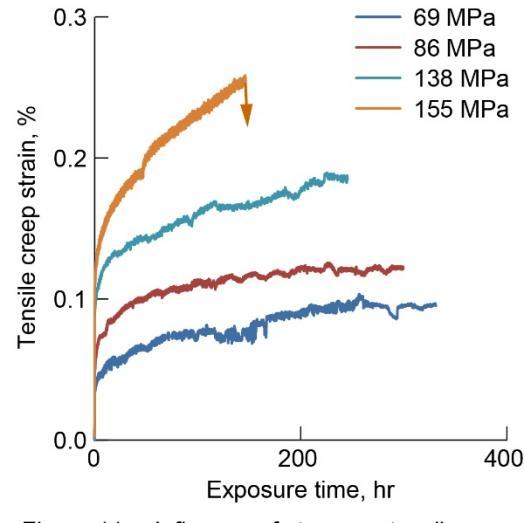
Figure 11.—Influence of stress on tensile creep behavior of CVI SiC/SiC (I) composites tested at 1,315 °C.

The influence of stress on the creep behavior at 1,315 °C is shown in Figure 11. The creep data shown in the figure were all generated from the same panel. At 155 MPa, the specimen failed after 147 hr (the downward arrow in the figure indicates failure), but at lower stresses specimens survived 300 hr exposure. According to the figure, the accumulated creep strain increases with increase in creep stress at a fixed exposure time. However, batch-to-batch as well as within batch variations in creep behaviors do exist even at a fixed temperature and stress because of the local variations in microstructure and porosity in CVI SiC/SiC composites. These variations will also create a nonuniform strain field, and result in a greater amount of strain within the gauge section of the specimen when compared with the gauge section in which both the stress and strain fields are uniform. In addition, if these local stresses are greater than the PLS, the CVI SiC matrix will crack locally either during the initial creep loading or during the creep deformation, exposing bridging SiC fibers for oxidation and crack growth.

In Figure 11, at high stresses ($\sim \geq 138$ MPa), the CVI SiC matrix may be partially or completely cracked. If completely cracked, the SiC fibers control the creep rupture life. If the CVI SiC matrix is partially cracked, both the SiC fibers and the CVI SiC matrix control the creep rupture life. In both cases, oxidation of the exposed fibers between the segments of fully cracked or partially cracked CVI matrix will reduce creep rupture life. At stresses below the PLS, the CVI matrix may crack during creep deformation due to stress relaxation in the fiber, and the stress on the matrix will increase with time and eventually reach its fracture strength. Here, creep rupture life is controlled by the slow crack growth rates of CVI SiC matrix and SiC fibers. At stresses well below the PLS, such as at 69 MPa in Figure 11, creep tests will last a long time (≥ 500 hr). Although stress relaxation is occurring in SiC fibers under these conditions, the CVI matrix can withstand the increase in stress without considerable damage or failure.

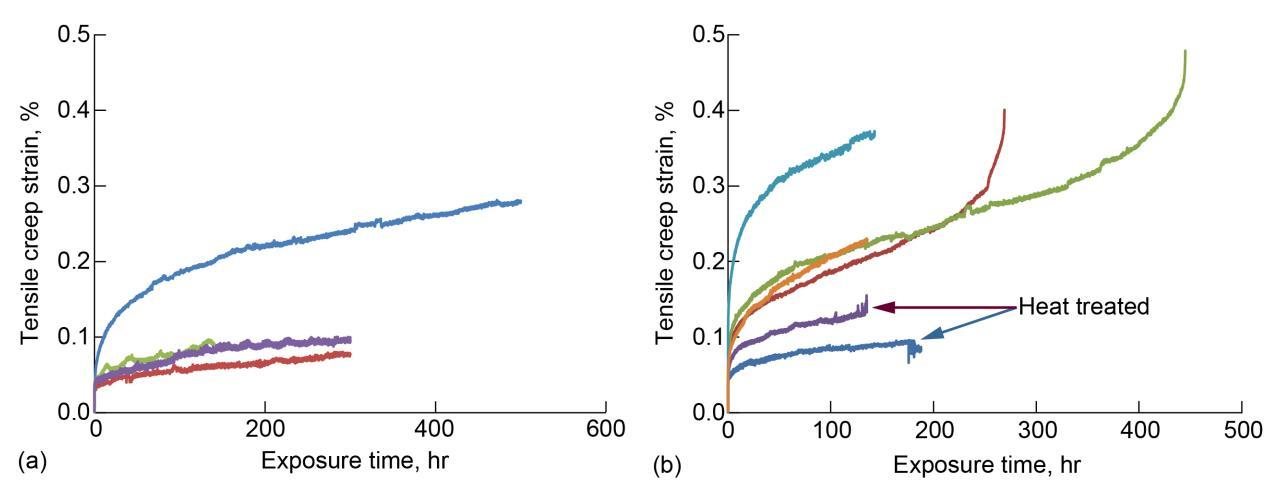
Figure 12.—Variation in tensile creep behavior of CVI SiC/SiC composites at 1,450 °C and at 69 MPa: (a) CVI SiC/SiC (I), (b) CVI SiC/SiC (II).

To determine variability in creep behavior at a fixed temperature and stress, creep tests were conducted on specimens from different batches of CVI SiC/SiC composites. Figure 12(a) and (b) show typical variation in creep behavior seen at 1,450 °C at 69 MPa from different batches of CVI SiC/SiC composite fabricated by two different vendors. Although observed but not shown is that at a fixed temperature, variability in creep behavior decreases with decrease in creep stress, and conversely at a fixed stress, variability in creep behavior decreases with decrease in temperature. Also shown in Figure 12(b) is the influence of thermal heat treatment on the creep behavior of CVI SiC/SiC (II) composites generated from the same panel. In general, the creep curves in Figure 11 and Figure 12 display an instantaneous elastic strain upon application of the load followed by two or three, time dependent creep regimes: a primary, a pseudo-secondary and, rarely, a tertiary creep. The elastic strain is recoverable. The accumulated creep strain is partially recoverable with time if unloaded and held at the creeping temperature. The primary and secondary creep regimes follow a power law.

The thermal heat treatment does show improved creep resistance of CVI SiC/SiC composites (Figure 12(b)) as long as creep tests were conducted at stresses below the PLS and the CVI SiC matrix was not cracked. Although not shown, above the PLS, creep resistance of heat-treated composites is similar to that of the non-heat-treated composites.

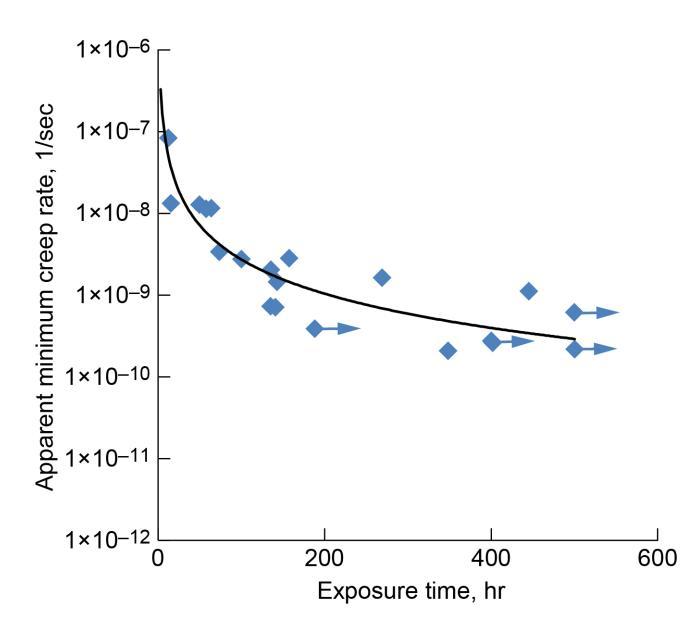
Figure 13.—Variation of apparent minimum creep rate with exposure time for CVI SiC/SiC (II) composites crept at 1,450 °C at 69 MPa. The symbols with an arrow indicate run-out.

Further examination of the creep curves indicates that a steady-state creep rate may not be reached in CVI SiC/SiC composites at a constant temperature and stress, even when the creep tests were continued for >400 hr. To illustrate this, the variation of apparent minimum creep rate with exposure time for the specimens crept at 1,450 °C at 69 MPa for up to 500 hr is shown in Figure 13. In this figure, the apparent creep rates of some specimens that failed during the creep tests and some specimens that were tested for 100, 200, and 500 hr without failure are shown.

It is clear from the figure that the apparent creep rate decreases with increase in time without reaching a steady state even after 500 hr of testing. Decreasing apparent minimum creep rate with increasing exposure time is due to two reasons: first, CVI SiC matrix itself does not show a steady-state creep. This fact is substantiated by the creep data of DiCarlo et al. (Refs. 41 and 42) on CVD SiC fibers and Tressler et al. (Ref. 43) on CVI SiC/SiC mini composites. Second, stress relaxation occurs due to difference in the creep resistances of polymer-derived SiC fibers and CVI SiC matrix. The estimated or reported values of apparent steady-state creep rate for polymer-derived SiC fibers such as SylramicTM-iBN and Hi-Nicalon- S^{TM} and CVI SiC matrix are ~10⁻⁷ to 10⁻⁸/sec (Refs. 28 and 29) and 10⁻⁹ to 10⁻¹⁰/sec (Ref. 30), respectively, at 1,400 °C and at stresses up to 275 MPa. Since the creep resistance of polymer-derived SiC fibers is an order-of-magnitude lower than that of the CVI SiC matrix, stress relaxation occurs in the SiC fibers during a creep test. As a consequence, the load on the fibers decreases and that on the CVI SiC matrix increases with increase in exposure time until the final failure of the composite. Therefore, longterm creep durability of CVI SiC/SiC composites below the matrix cracking stress is controlled by the CVI SiC matrix and not by the polymer-derived SiC fibers. Additionally, not knowing a steady-state minimum creep rate in this system will also cause substantial error in determining the creep parameters such as the primary and secondary stress exponents and other creep constants. Therefore, to reduce uncertainty in determining the creep parameters, long-term (>300 hr) creep tests should be conducted.

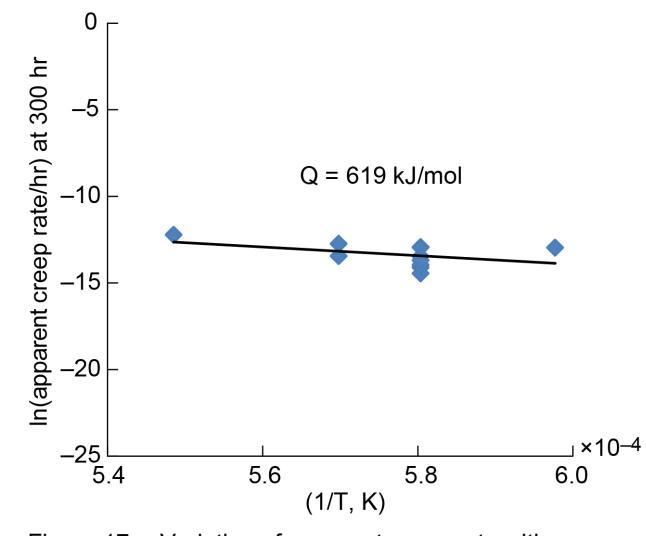
Figure 17.—Variation of apparent creep rate with reciprocal of absolute temperature for CVI SiC/SiC (I) and (II) composites creep tested from 1,400 to 1,550 °C at 69 MPa.

With the knowledge of the apparent creep rates at 300 hr for CVI SiC/SiC (I) and (II) composites tested at 69 MPa from 1,400 to 1,550 °C, we determined the activation energy for primary creep (Q) by plotting ln(apparent creep rate) versus 1/T (Figure 17). This plot yields a linear behavior. The slope of which is -Q/R. Knowing the slope of the line and the gas constant R = 8.3144 J/mol K, Q was calculated. The calculated value of Q is 619 kJ/mol. Creep activation energy varying from 400 to 900 kJ/mol has been reported for CVD or CVI SiC matrix (Refs. 41, 43, and 44), and the value reported here is well within that range. The observed wide variation in creep activation energy is probably due to subtle variation in the stoichiometry of CVD/CVI SiC fabricated by different vendors as well as different creep testing methods used (tensile, compression, bend stress relaxation, etc.).

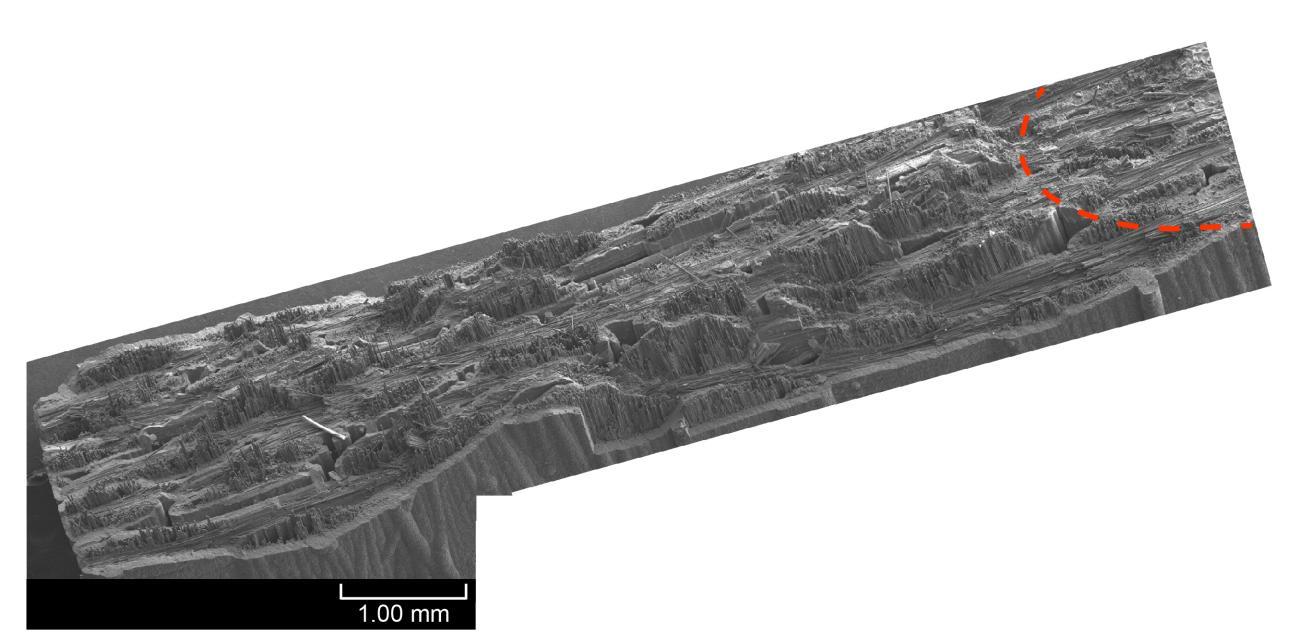
Figure 18.—The fracture surface of a CVI SiC/SiC (II) composite specimen tensile creep ruptured at 1,450 °C at 69 MPa for 58 hr.

The morphology of the fracture surface and fracture path of a creep ruptured CVI SiC/SiC composite specimen is shown in Figure 18. The fracture surface indicates no significant fiber pull-out, and a relatively flat region up to the red dotted line on the right side of the specimen. The energy dispersive spectroscopy (EDS) examination of this region indicates formation of silica scale. The dominant crack that caused creep rupture probably initiated and propagated from this region. The longitudinal cross section of the same specimen near the fractured end shows a single dominant crack causing the stress rupture and no additional secondary through-the-thickness matrix cracks normal to the loading direction are noticed.

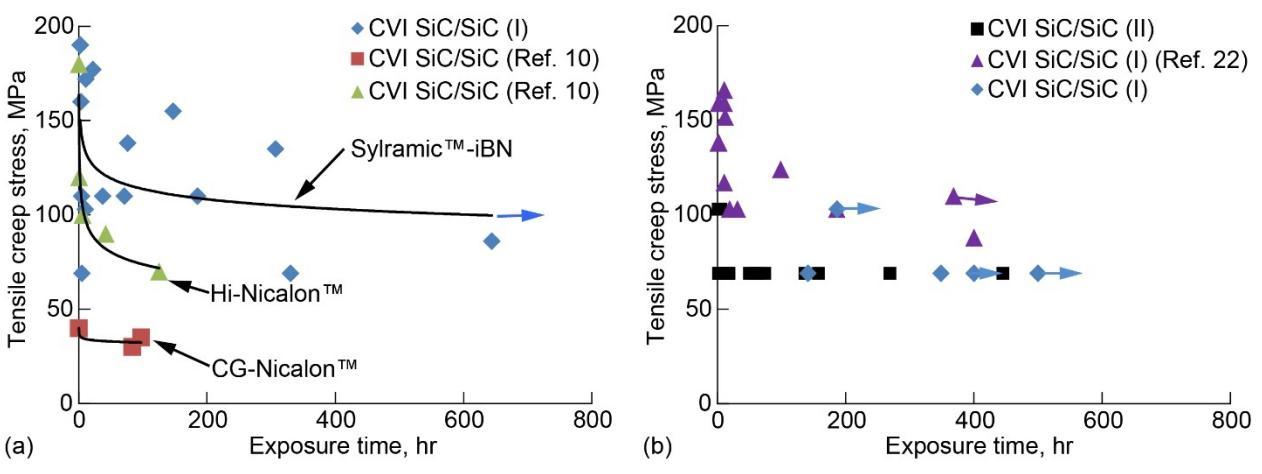
Figure 19.—Creep durability of CVI SiC/SiC composites at (a) 1,315 °C, and (b) 1,450 °C.

Creep durability of CVI SiC/SiC (I) and (II) composites with SylramicTM-iBN fibers at 1,315 and 1,450 °C is plotted in Figure 19 and compared with the literature data on other CVI SiC/SiC composites with CG NicalonTM, Hi-NicalonTM, and SylramicTM-iBN fibers. The CVI SiC/SiC composites containing CG NicalonTM and Hi-NicalonTM fibers had a carbon interface, and the CVI SiC/SiC (I) and (II) composites and the composite from Reference 22 had a BN interface and SylramicTM-iBN fibers. Comparison of the plots in Figure 19(a) indicates that creep durability of CG NicalonTM and Hi-NicalonTM fibers was significantly lower than that containing SylramicTM-iBN fibers predominantly due to relative creep resistance of the fibers; creep resistance of SylramicTM-iBN > Hi-NicalonTM fibers. Wide variation in creep rupture life was seen at both temperatures, even at a fixed stress. In Figure 19(b), the creep life of CVI SiC/SiC composite (I) appears to be better than that of CVI SiC/SiC composite (II); possibly due to higher PLS in the former (denser material). The arrows in Figure 19(b) represent specimens crept for predetermined exposure times, where a run out condition was achieved.

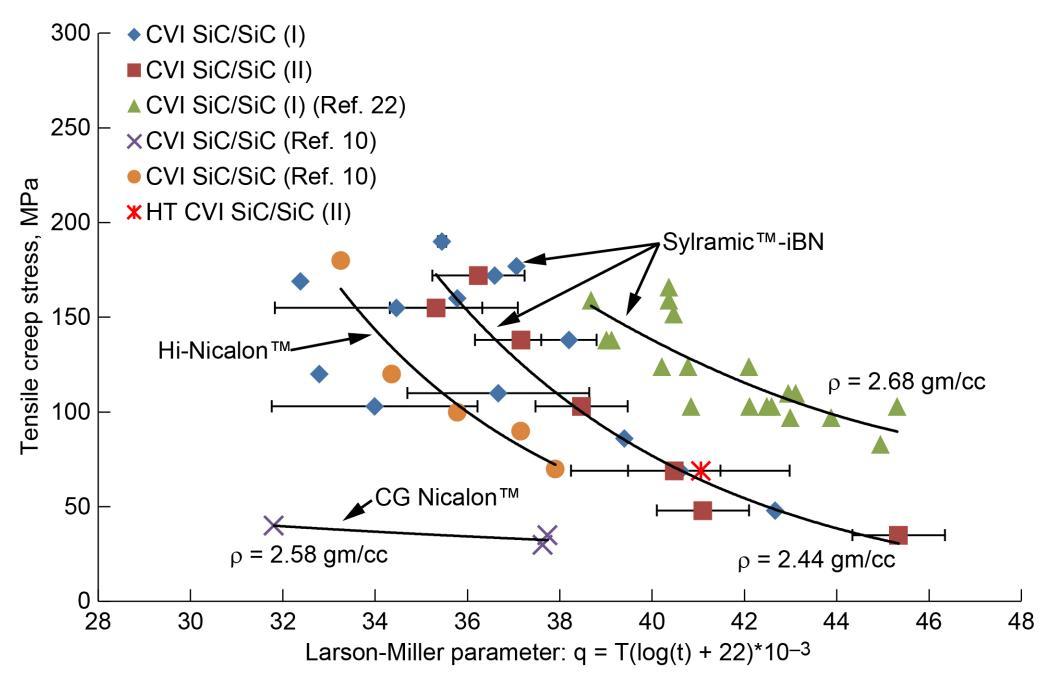
Figure 20.—Larson-Miller plot for CVI SiC/SiC composites.

where T is the temperature (K), t_R is the creep rupture time and D is a constant. For SiC fibers and SiC/SiC composite systems, the best fit value of D is 22 (Ref. 41). One basic assumption in LMP is that a single creep mechanism operates under all tested conditions and is responsible for creep rupture. Figure 20 shows the LMP plot for CVI SiC/SiC (I) and (II) composites. Included in the plot LMP value for the heat-treated CVI SiC/SiC (II) composite. Also shown in the figure for comparison are the LMP plots published in the literature for the 2D woven CVI SiC/SiC composites with CG-NicalonTM and Hi-NicalonTM SiC fibers with a CVI carbon interface (Ref. 10) and SylramicTM-iBN fibers with a CVI BN interface coating (Ref. 22). In all these composites, the total vol% of SiC fibers is nearly the same (\sim 36 vol%) but the density values and interface coatings are different. It is apparent in Figure 20 that CVI SiC/SiC composites with different SiC fiber types, and the composites with the same type of fibers but with different densities, follow different LMP plots. Generally, as the matrix density increases, the LMP plot shifts to the right of the diagram, and as the creep resistance of the fiber or the interfacial shear strength between the fiber and matrix decreases (as in the case of the fibers coated with carbon interface), the LMP plot shifts to the left of the diagram. In the figure, the LMP plot of CVI SiC/SiC composites with CG-NicalonTM and Hi-NicalonTM SiC fibers show significantly lower creep rupture life compared to those containing SylramicTM-iBN fibers because creep rates of CG-NicalonTM and Hi-NicalonTM SiC fibers are an order of magnitude greater than that of SylramicTM-iBN fibers under the test conditions (Refs. 28 and 29). Another noteworthy observation in the plot is that creep durability of nonheat-treated and heat-treated CVI SiC/SiC (II) composites is nearly the same, which indicates that both non heat-treated and heat-treated composites were cracked either during initial loading or during creep.

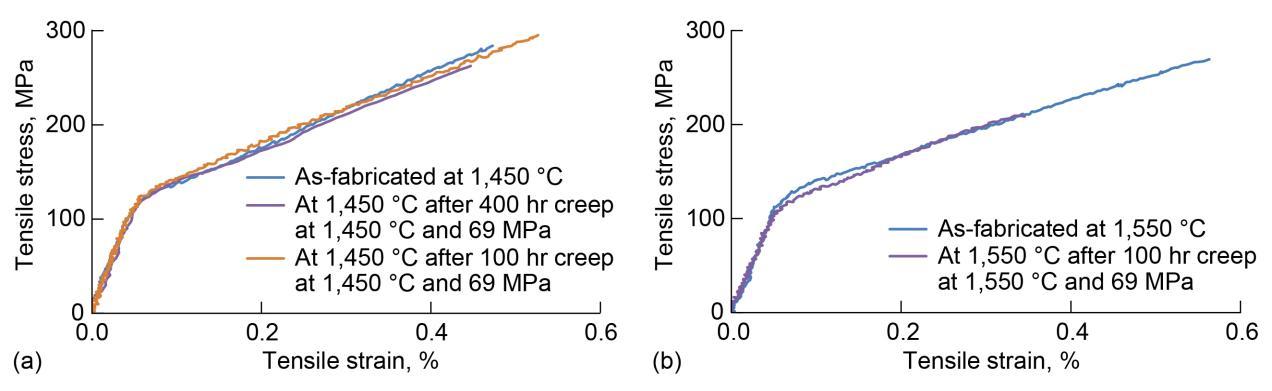
Figure 21.—Comparison of fast fracture tensile stress-strain curves of CVI SiC/SiC (II) composite before and after creep testing: (a) 1,450 °C (b) 1,55 0°C.

The specimens that survived predetermined creep exposures were unloaded from the creep temperature, and then fast fracture tensile tested either at the creep test temperature or at room temperature to determine the influence of accumulated non-recoverable creep strain on the tensile stress-strain behavior and on inplane tensile properties. Figure 21(a) and (b) show the tensile stress-strain behaviors of as-fabricated CVI SiC/SiC(II) composites at 1,450 and 1,550 °C and those of crept composite at 1,450 and 1,550 °C at 69 MPa for 100 and 400 hr, but tested at the creep testing temperatures. Comparison of tensile stress-strain behaviors in Figure 21(b) indicates no significant effect of accumulated creep strain on the tensile strain behavior and that PLS (stress corresponding to deviation from linearity) and E (primary elastic modulus) of as-fabricated and crept composites are nearly the same. Whereas, UTSs of the crept composites at 1,550 °C are 10 to 20 percent lower than those of as-fabricated composites.

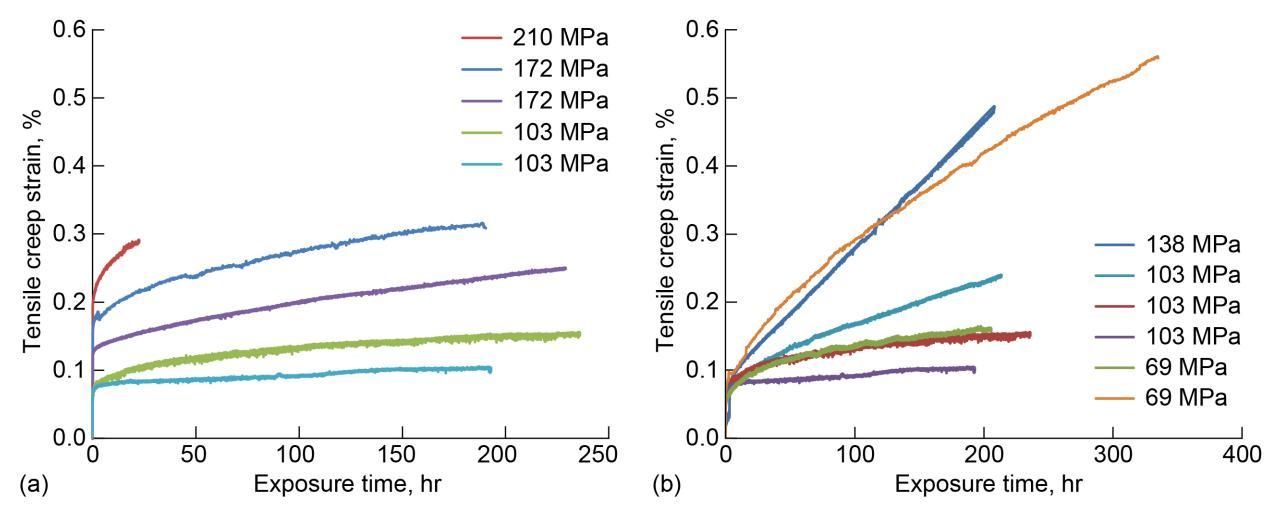
Figure 22.—Influence of stress on creep behavior of PIP SiC/SiC composites at (a) 1,315 °C and (b) 1,450 °C.

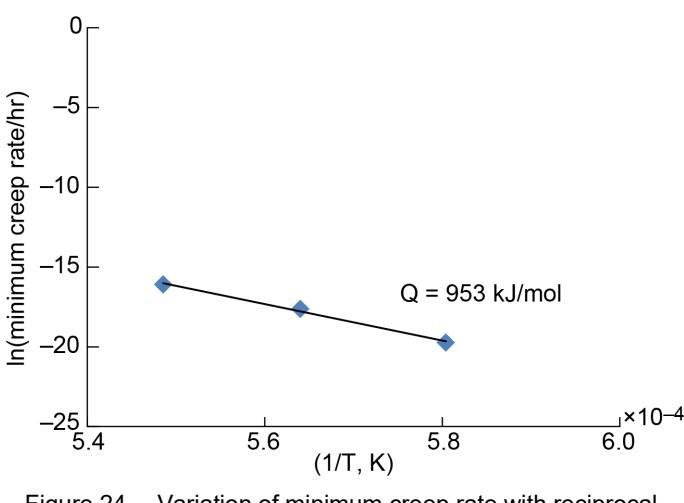
Figure 24.—Variation of minimum creep rate with reciprocal of absolute temperature for PIP SiC/SiC composites creep tested from 1,315 to 1,550 °C at 103 MPa.

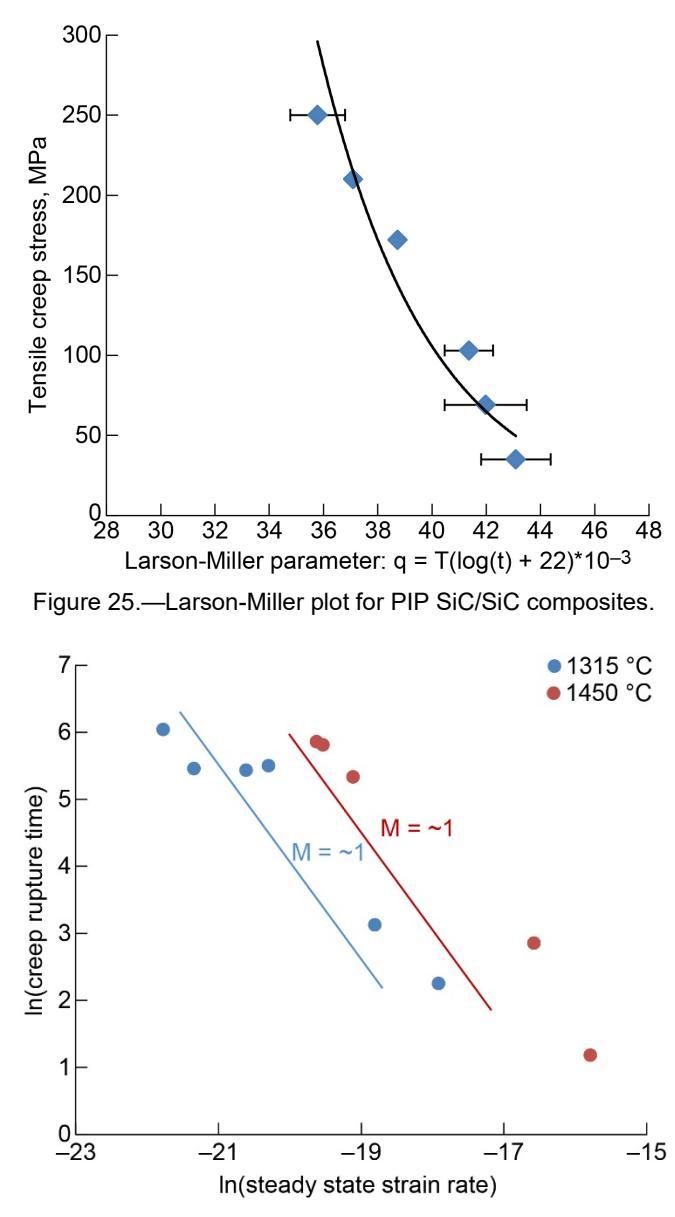
Figure 26.—Monkman-Grant plots for PIP SiC/SiC composites.

where ϵ^{*M} is the steady-state creep rate, t_R is the creep rupture time, M and K are constants. The Monkman-Grant plots for PIP SiC/SiC composites tested at 1,315 and 1,450 °C are shown in Figure 26. The slope of each line shown in the plot is the M constant, which is ~1 at both temperatures.

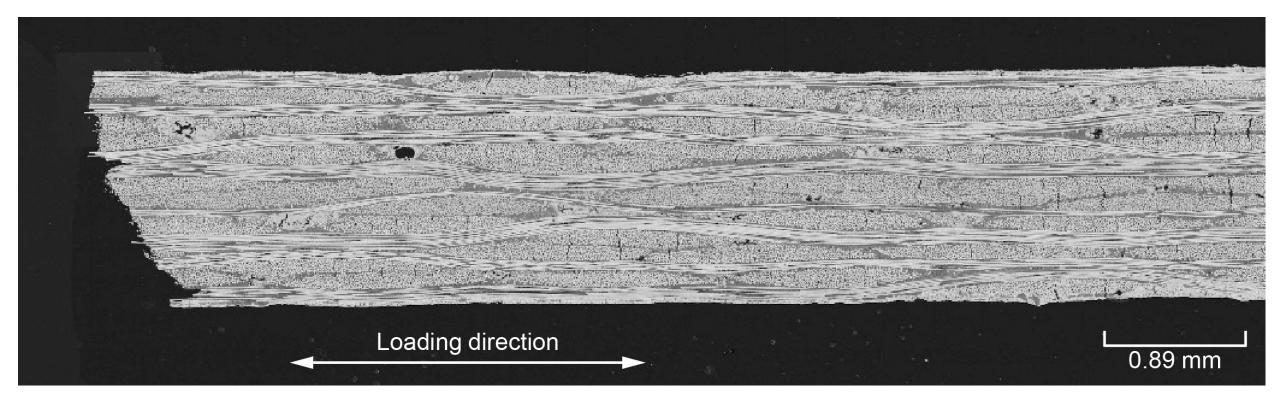
Figure 27.—The longitudinal cross section of a PIP SiC/SiC composite creep ruptured after 351 hr exposure at 1,450 °C at 69 MPa showing the path of the dominant crack that caused failure and formation of tunnel cracks on 90° tows.

Examination of the fracture surfaces of creep ruptured specimens from 1,315 to 1,650 °C at different stresses showed features similar to that found on as-fabricated specimens tensile tested at room temperature: fracture occurring in different fiber plies and linking, and no fiber pull out. The longitudinal cross sections of the same specimens near the fractured end indicate macro-cracks in [90°] fiber tows normal to the loading direction. However, the density of these cracks increases with increase in the temperature at a fixed stress and increase in stress at a fixed temperature. Figure 27 shows a longitudinal cross section of a PIP SiC/SiC composite creep ruptured at 1,450 °C at 69 MPa after 351 hr exposure. In the figure, the dominant crack that led to final failure as well as random tunnel cracks that developed during creep deformation on 90° tows can be seen.

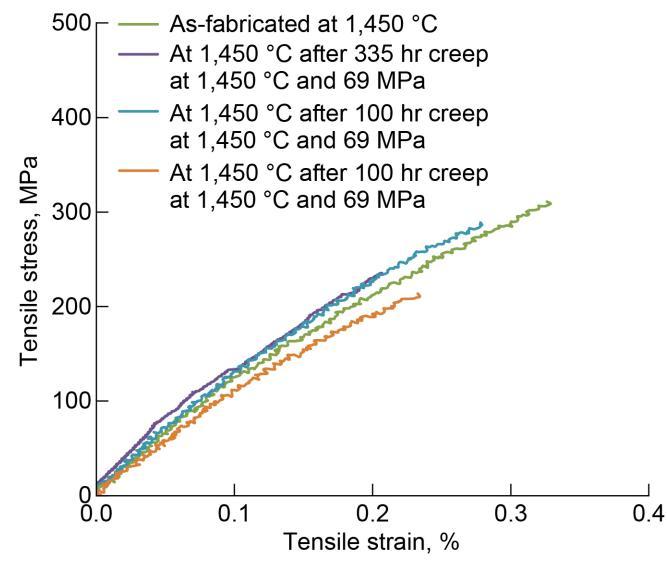
Figure 28.—Comparison of tensile stress-strain behaviors of PIP SiC/SiC composites before and after creep.

Figure 28 shows the tensile stress-strain behaviors at 1,450 °C for the specimens that were previously creep tested at 69 MPa at 1,450 °C for 100 and 335 hr, as well as the tensile stress-strain behavior of the as-fabricated composite at 1,450 °C. Comparison of the tensile stress-strain behaviors indicates that the UTSs of some crept composites were lower than those of as-fabricated composites tested, but there is no trend with exposure time. The residual in-plane tensile properties of all crept specimens are shown in Table IV. In general, in-plane tensile properties of the composites tested at 1,315 °C, but those composites crept at 1,450 °C and above do show some loss in UTS and ultimate tensile strain with increase in exposure time because of creep and oxidation effects on SiC fibers.

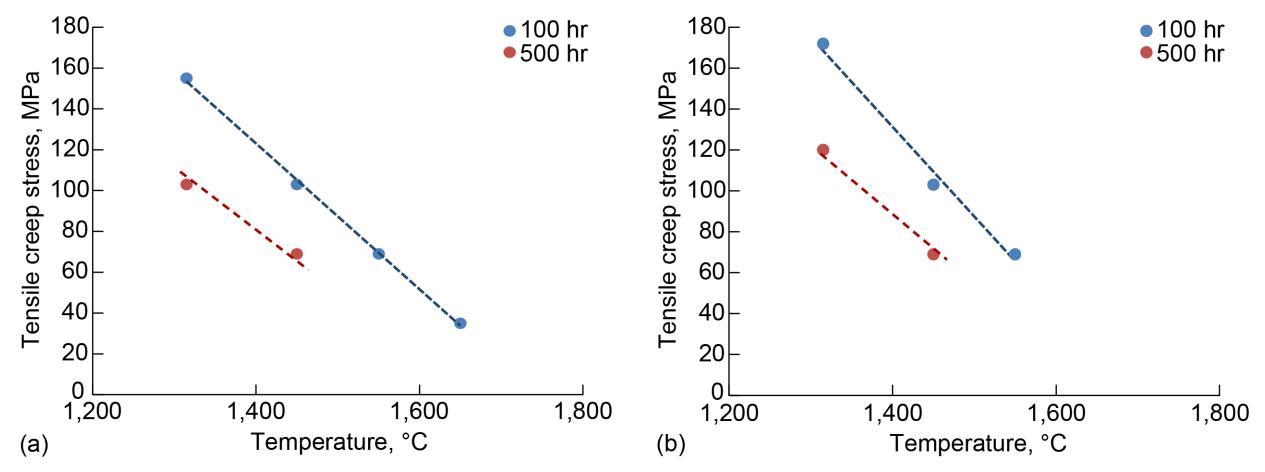
Figure 29.—Variation of 100- and 500-hr creep durability with temperature for (a) CVI SiC/SiC and (b) PIP SiC/SiC composites.
