In-Plane Tensile Properties, Creep Behavior and Failure Mechanisms of CVI and PIP SiC/SiC Composites at Temperatures to 1,650 °C in Air

R.T. Bhatt HX5, LLC, Brook Park, Ohio

J.D. Kiser Glenn Research Center, Cleveland, Ohio

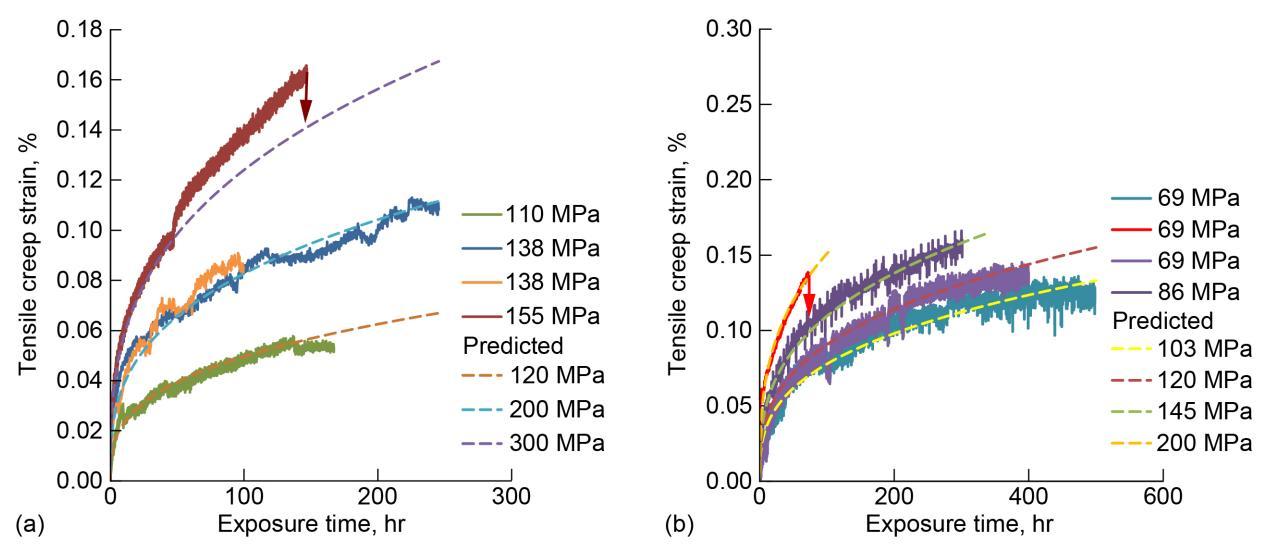
Figure 30.—Tensile creep behaviors based on global (applied) and local stresses (estimated from creep parameters): (a) CVI SiC/SiC (I) composites at 1,315 °C and (2) CVI SiC/SiC (II) composites tested at 1,450 °C. Downward arrows in the figures indicate failed specimens.

Although the creep time exponent, p, is the same for all CVI SiC composites tested in this study, significant variations in the creep behaviors were observed when multiple specimens were tested at a fixed temperature and stress from the same batch and/or from different batches of CVI SiC/SiC composites fabricated either from the same vendor or from different vendors. These variations are possibly caused by average local stress being different from the global applied stress. Note that all creep tests were conducted under load control, and the global stress was calculated based on outer dimensions of the specimen and the load, but in reality, net load bearing cross-sectional area varies from region to region in CVI SiC/SiC composites because of pore size variation. Reduced cross section increases average stress on the specimen. In addition, the presence of stress raiser (bent fiber tow during weaving), sharp corners of pores, and tooling bumps (CVI SiC nodules on the specimen surface) will further enhance the local stresses.

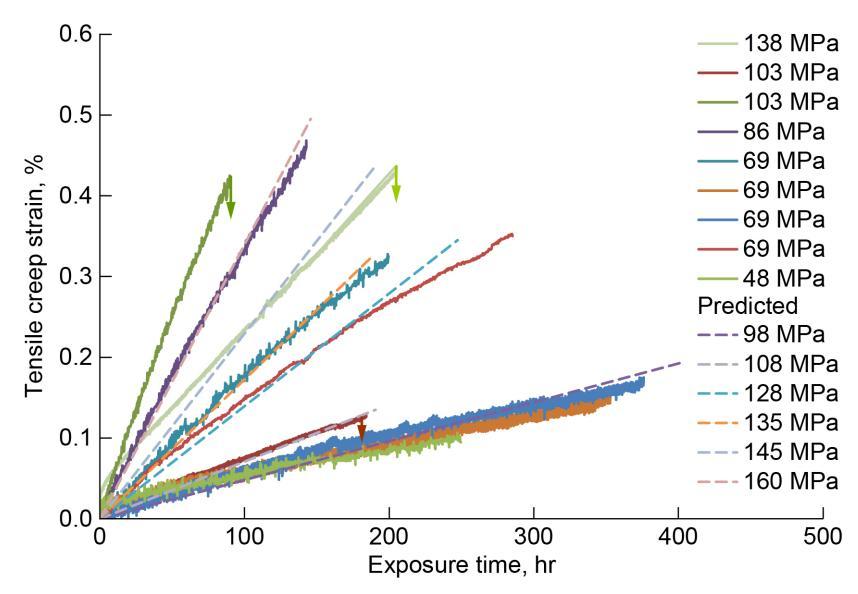
Figure 31.—Secondary creep behaviors of PIP SiC/SiC composites at 1,450 °C based on global (applied) and estimated local stresses (predicted from the creep parameters)

Even though creep of PIP SiC/SiC composites is controlled by the fibers, the difference between the average local and global applied stresses can still occur depending on microcrack density and pore size distribution in the PIP SiC matrix and the extant damage to the load bearing fibers during processing as well as during creep deformation. In addition, these microcracks can also grow during creep deformation depending on the stress and temperature. To determine the magnitude of stress enhancement occurring in these composites, an approach similar to that used for CVI SiC/SiC composites was adopted. Using creep parameters shown in Table VI, secondary creep behavior of PIP SiC/SiC composites at a fixed global (applied) stress was matched with the creep behavior predicted based on estimated local stress. Figure 31 shows secondary creep behaviors of PIP SiC/SiC composites at a fixed global stress end the corresponding predicted creep behaviors based on estimated local stresses (from the creep parameters). Two conclusions can be drawn from the figure: first, at a fixed stress, minimum creep rate vary significantly. Second, local stress in the composite can be 2 to 3 times greater than the global stress.
