**APOLLO EXPERIENCE REPORT -
MANNED THERMAL-VACUUM
TESTING OF SPACECRAFT**

by James C. McLane, Jr.

*Lyndon B. Johnson Space Center
Houston, Texas 77058*

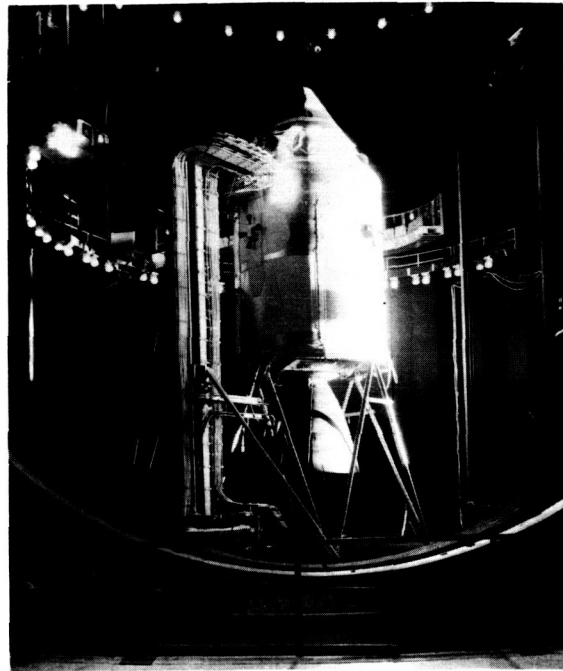
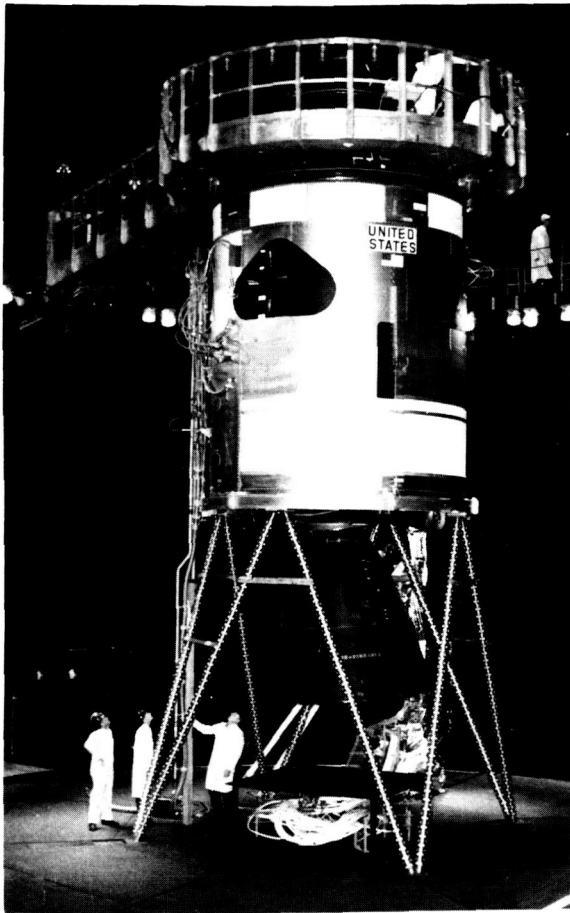
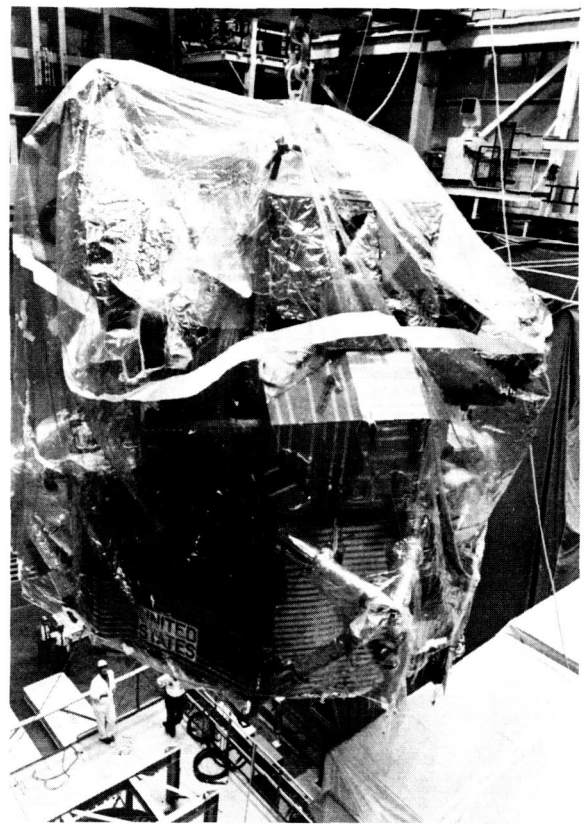
(a) Spacecraft 008.

Figure 2. - Thermal-vacuum test spacecraft.

(b) Spacecraft 2TV-1.

(c) Spacecraft LTA-8.

spacecraft for a subsequent flight mission was uneconomical. A second alternative was the fabrication of a simplified test spacecraft with thermal simulators for much of the expensive, long-lead-time equipment. This approach was not considered seriously because of the obvious potential for inaccurate test results when even subtle differences from flight configuration exist. Also, this approach would effectively negate the philosophy of qualifying flight spacecraft by similarity to the test spacecraft. For a third alternative, certain production spacecraft could be dedicated to the thermal-vacuum test program. This approach was adopted, and it had many advantages. First, late design and production changes to the spacecraft could be evaluated individually and foregone where the change would not clearly influence the forthcoming test. Early delivery of the spacecraft could be ensured further by selectively permitting the use of prototype or non-flight-qualified hardware when cost and expediency dictated and when evaluation showed that the component was not critical to the test. The increased safety of the ground test compared with the flight test made this substitution feasible in many instances. An additional attractive feature of this approach was that the use of test-dedicated spacecraft left the test program essentially open ended to account for contingencies; that is, contingency retests could be added to the program without a cut-off date forced by refurbishment-schedule requirements, as would be necessary if the spacecraft were to be used on a later flight. To make this approach more cost effective, the test spacecraft were also used for many secondary non-thermal-vacuum tests (cabin-noise studies, radiological shielding surveys, biological sterilization demonstrations, and many others). Three spacecraft were dedicated to the program (fig. 2). Spacecraft (SC) 008 was the first man-rated Block I command and service module (CSM) to be produced and was the first Apollo spacecraft tested. Spacecraft 2TV-1 was the first production Apollo Block II CSM. Spacecraft LTA-8 was the first production man-rated lunar module, although it was preceded by two lunar modules that were designated for unmanned development flights and were not equipped with all flight systems. Tests of these three spacecraft comprised the program, with major manufacturing effort, to update Earth-orbital configuration to lunar-mission configuration, being performed onsite at MSC on spacecraft 2TV-1 and LTA-8 between the initial and final tests.

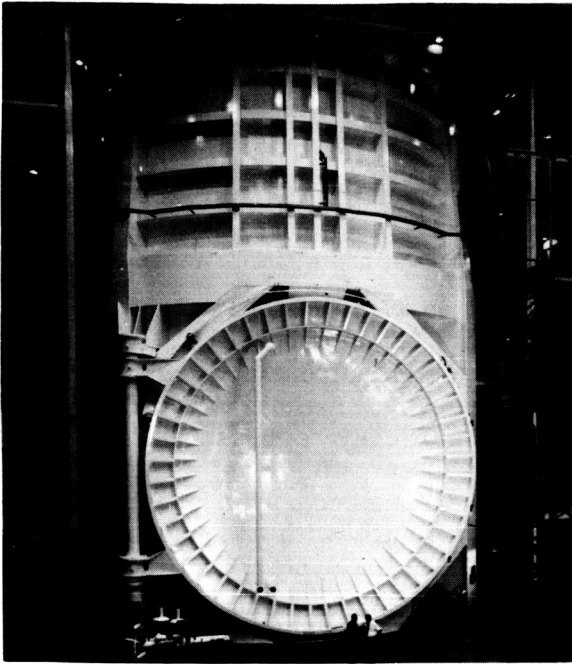
Figure 3. - Chamber A.

Chamber A (fig. 3), the largest of the two thermal-vacuum chambers, was intended to be used for tests of large manned spacecraft and clusters of spacecraft (such as the mated CSM/LM). The chamber has external dimensions of 65 feet in diameter by 120 feet in height, and a nominal upright test volume of approximately 25 feet in diameter and 75 feet in height was provided for spacecraft that weighed as much as 150 000 pounds (fig. 4). For tests requiring high-quality solar simulation, this test volume was limited to 20 feet in diameter by 65 feet in height, because penetration ports were not available for the modular system of carbon-arc-source solar-simulator

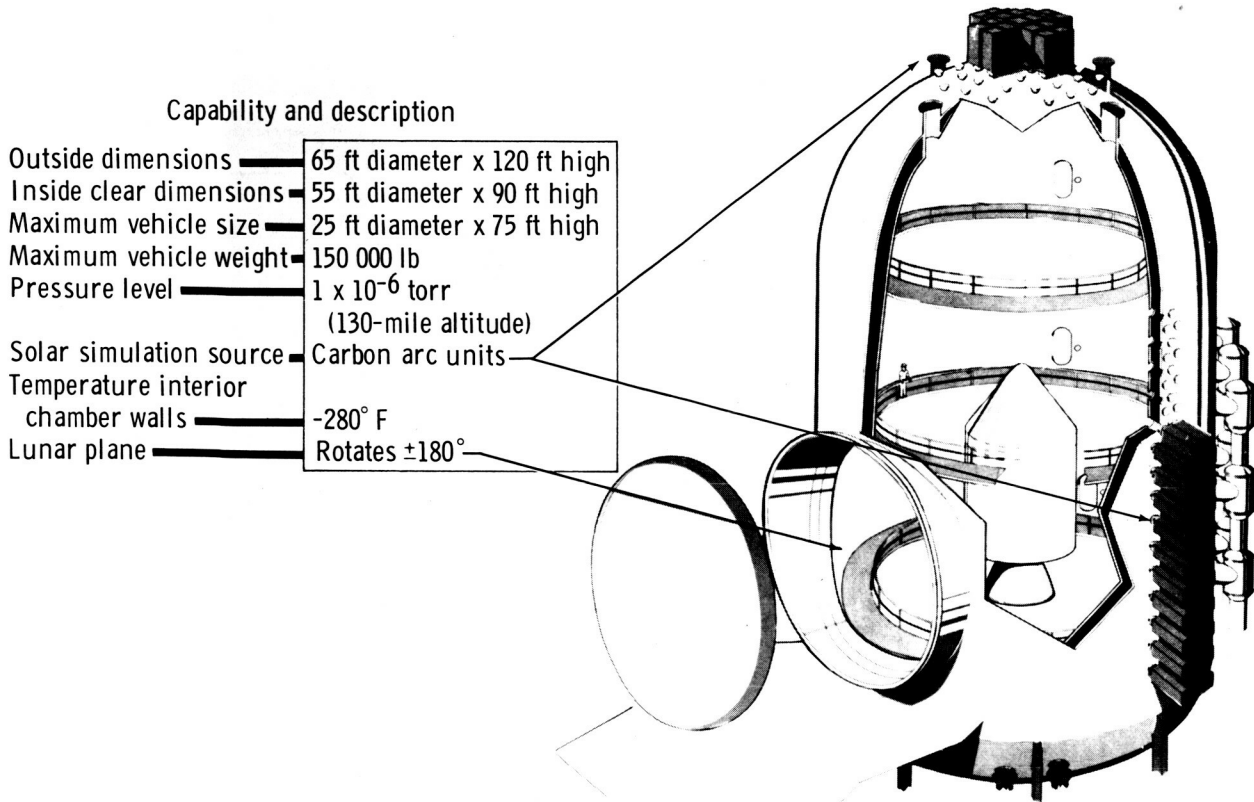
Figure 4. - General features of chamber A.

Other gases, including oxygen and nitrogen and excluding only helium, hydrogen, and neon, were pumped at the rate of 15 torr-liters/sec by cryocondensing surfaces arranged around the chamber walls and maintained at 17° K. The three noncondensable gases were pumped at the rate of approximately 0.4 torr-liter/sec by 18 large oil-diffusion pumps. Atmospheric leakage from the more than 300 vacuum feedthroughs usually required about half of the available pumping capacity, leaving the other half to account for the gas load generated by leakage and outgassing from the spacecraft under test. A chamber pressure of 1×10^{-6} torr was attainable with these gas loads present. A double manlock, one for maintaining inside safety and rescue observers at intermediate rescue pressures and the other to permit hard-vacuum ingress and egress by test crewmen, was located at the ground level of the chamber. A single manlock for inside observers was located 31 feet above floor level. An emergency repressurization system was provided that could bring the chamber to a rescue working level of 6 psia in 30 seconds with a mixture of dry oxygen and nitrogen. Repressurization from that level to full atmospheric pressure was accomplished originally with unconditioned atmospheric air; however, after the initial tests of the CSM, the system was modified to permit full repressurization in 90 seconds by the use of a dry oxygen-nitrogen mixture to avoid the heavy chamber fogging that would occur if small amounts of atmospheric water vapor were present when the cryogenic heat-sink shroud was still cold.

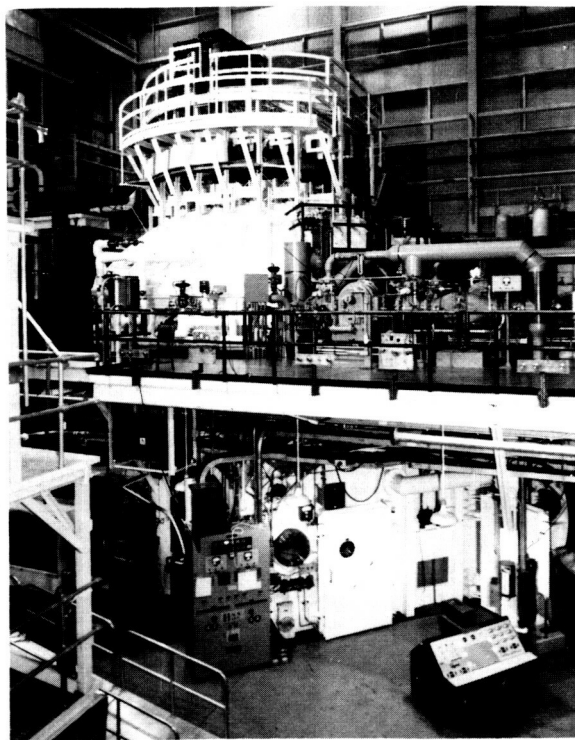
Figure 5. - Chamber B.

Chamber B (fig. 5) was provided to perform tests on smaller spacecraft such as the Apollo command module (CM), on space suits and other extravehicular activity (EVA) equipment, and on subsystems and intermediate-size equipment. Chamber B systems were similar to those of the larger chamber A but generally reduced in size. The 35-foot-diameter by 43-foot-high external chamber dimensions resulted in a useful test volume of approximately 13 feet in diameter by 27 feet in height for spacecraft that weighed as much as 75 000 pounds (fig. 6). Fixed penetrations for a 20-foot-diameter top Sun were provided, but the actual initial installation of solar modules provided an irradiated area only 5.6 feet in diameter. Because there was no side solar simulator, rotation of the floor was not provided. Chamber B was also equipped to present only 90° K heat-sink surfaces to the test volume. Originally, the design vacuum level was 1×10^{-4} torr, and this level was attained by the use of a system of oil-diffusion pumps. Before Apollo testing was undertaken, a 17° K cryopumping system was added, providing a final pumping capacity of 12 torr-liters/sec for condensable gases and 0.25 torr-liter/sec for the noncondensable gases at a chamber pressure of

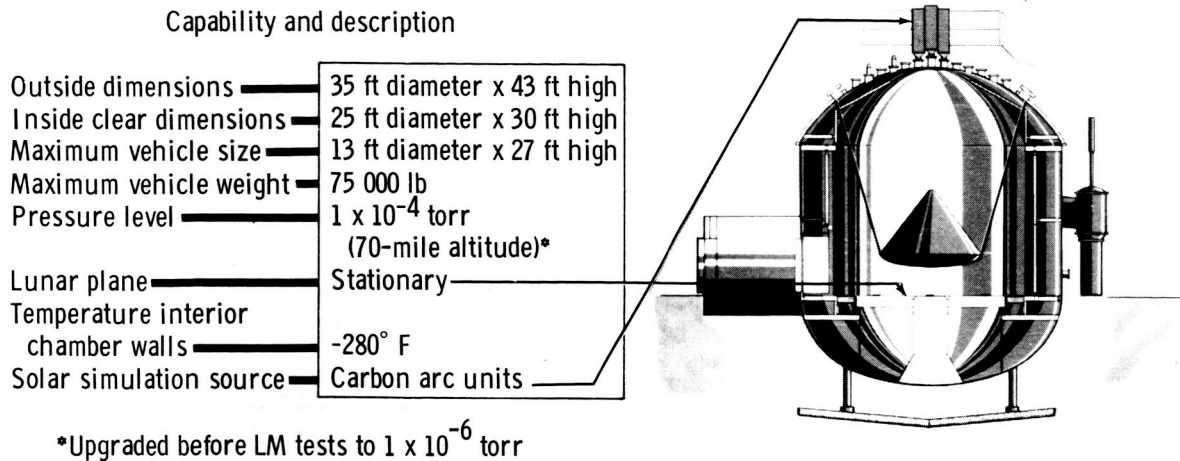
Figure 6. - General features of chamber B.

1×10^{-6} torr. Because of fewer vacuum penetrations in chamber B, atmospheric in-leakage was limited to approximately 3 torr-liters/sec, leaving approximately the same capability for spacecraft gas load as was available in chamber A. The emergency re-pressurization systems in chambers A and B had essentially identical performance.

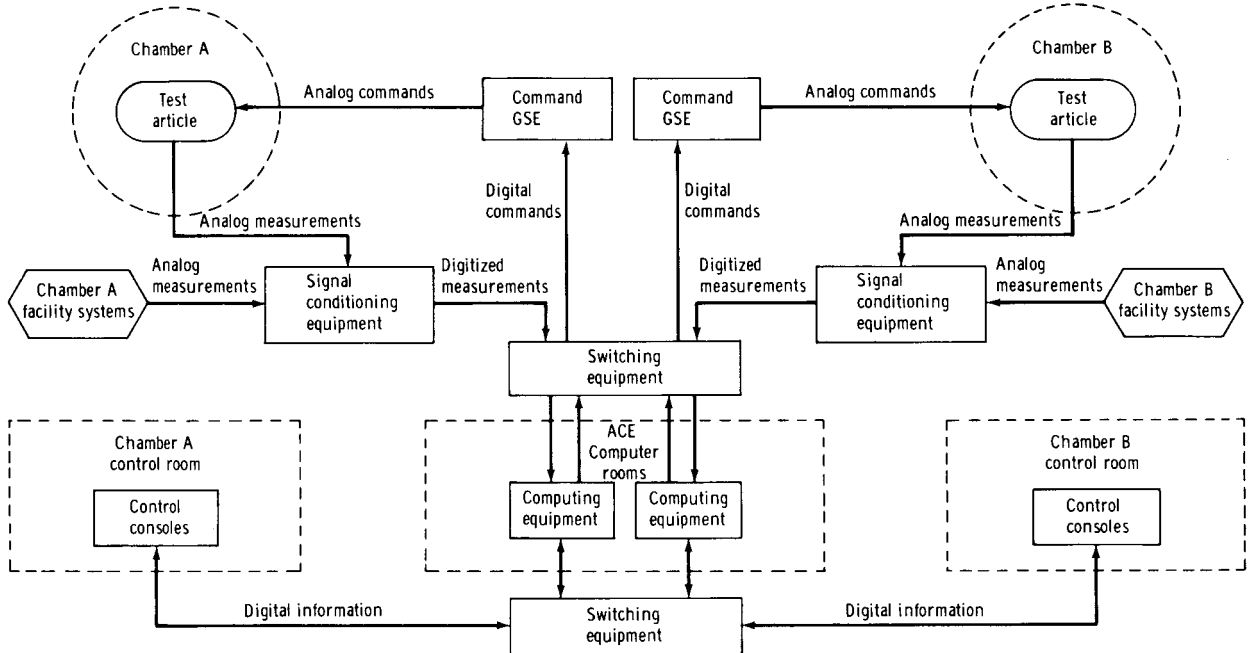
Figure 7. - Block schematic of SESL ACE systems.

thermal-vacuum facility and were also used for up-link command and down-link data-acquisition functions during the test (fig. 7). Data-acquisition capability included real-time processing of some 500 of the approximately 2000 total test-article measurements to assist the test team during performance of the test. A few essential facility measurements also were handled by the system. During thermal-vacuum tests, one ACE station was designated as prime, and the other station was maintained in backup status in order to assume all control and data-acquisition functions within 5 minutes of a failure of the prime station, thus avoiding test abort. By maintaining these computer systems in common configuration with those at other Apollo sites, the maximum experience benefit was obtained by similarity to the other operations.

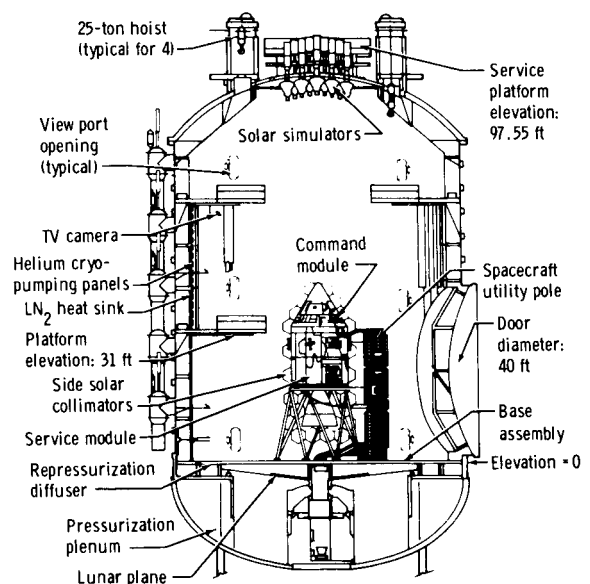
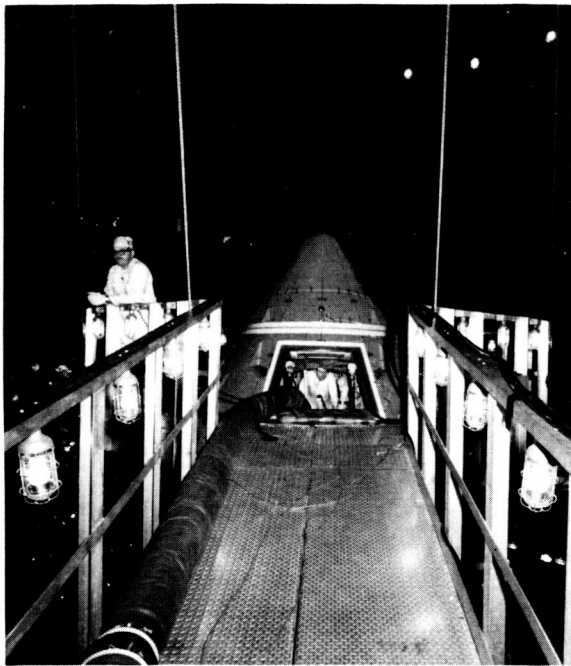
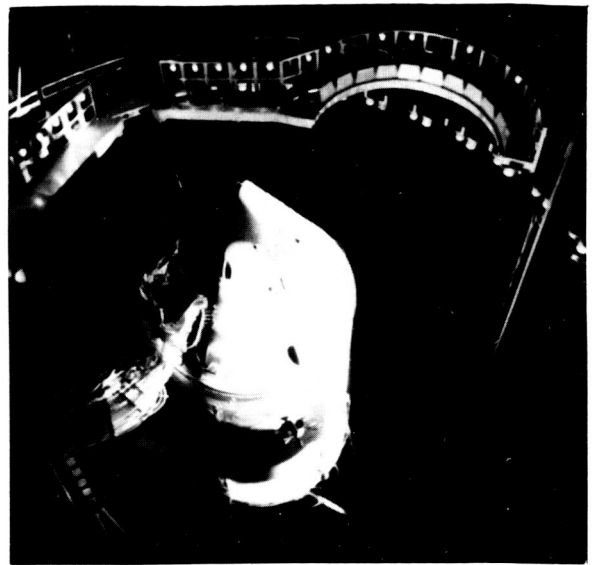
Figure 8. - Orientation of CSM in chamber A.

(a) View from manlock (ramp closed).

(b) View from above (ramp open).

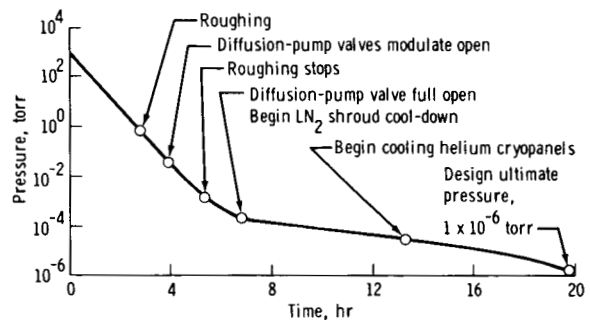
Figure 11. - Chamber A pumpdown curve.

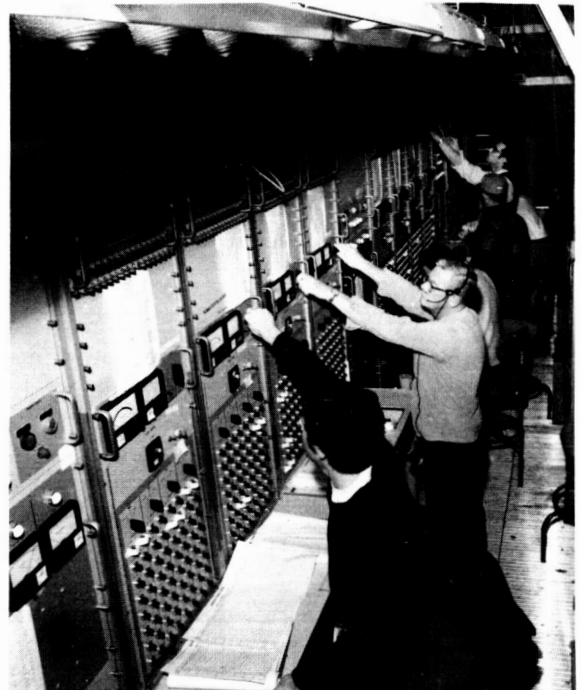
Figure 13. - Section of the LM skin heater control consoles.

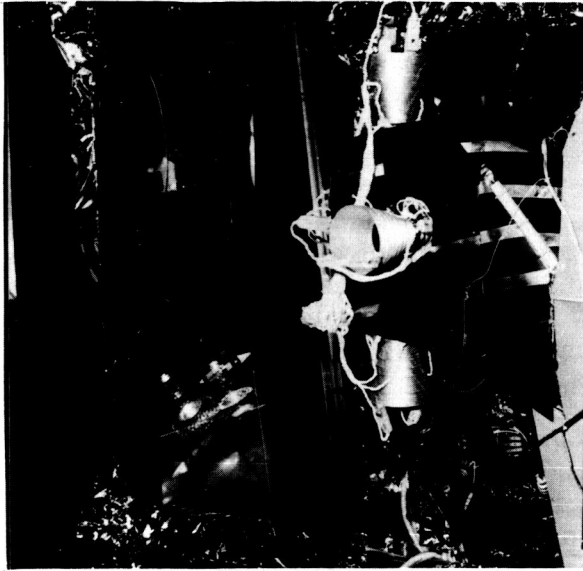
Figure 14. - Electrically heated RCS engines on the LM.

Thermal soakback from the rocket engines and nozzle extensions of the RCS, ascent propulsion system, and descent propulsion system were important factors in the LM thermal model. Because of this fact, rocket firings were simulated thermally by electric heater elements that were installed on the engines and rocket nozzles. These heaters were activated at the appropriate times in the mission to simulate conditions during and after engine burns. For the descent-engine-burn and ascent-engine-burn simulations, the soakback lasted 5 to 10 hours after a 10- to 15-minute engine burn, and the heaters were operated at temperatures as great as 700° F. The descent-engine-base heat shield was similarly heated to as much as 950° F to simulate conditions associated with descent-engine firings. Typical simulations of reaction control system injector soakbacks involved the heaters operating for 15 to 30 minutes at temperatures as great as 300° F (fig. 14). As in the tests of the CSM, the main propulsion tanks were loaded with dummy propellant (in this case Freon TF) and were offloaded to tanks outside the chamber during the tests to simulate changes in thermal mass during engine firings. Changes in the thermal mass of the RCS tankage were not very significant; the tanks were loaded with dummy propellant for the duration of the mission.

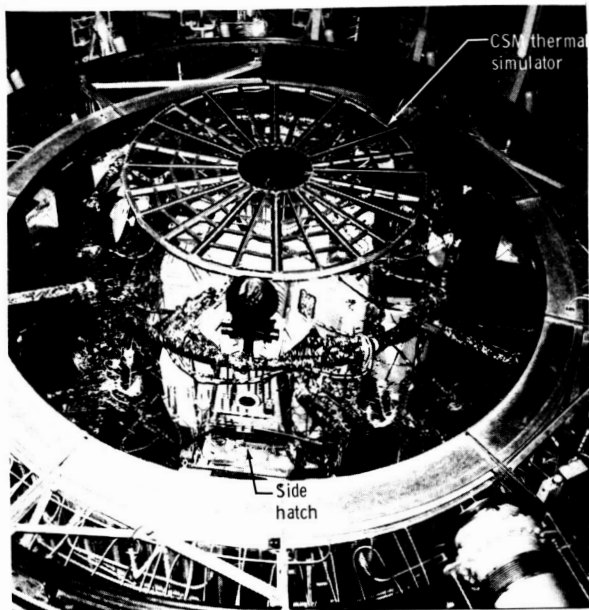
Figure 15.- Spacecraft LTA-8 installed in chamber B.

Schedule developments resulted in requirements to conduct tests of the Block II CSM (spacecraft 2TV-1) and the LM (spacecraft LTA-8) during the same approximate time period. As a result of the previous tests of spacecraft 008, chamber A was already configured for the CSM, including an extensive installation of GSE. Therefore, it was logical that the Block II CSM testing be continued in that chamber. Using the conformal-skin-heater technique, chamber

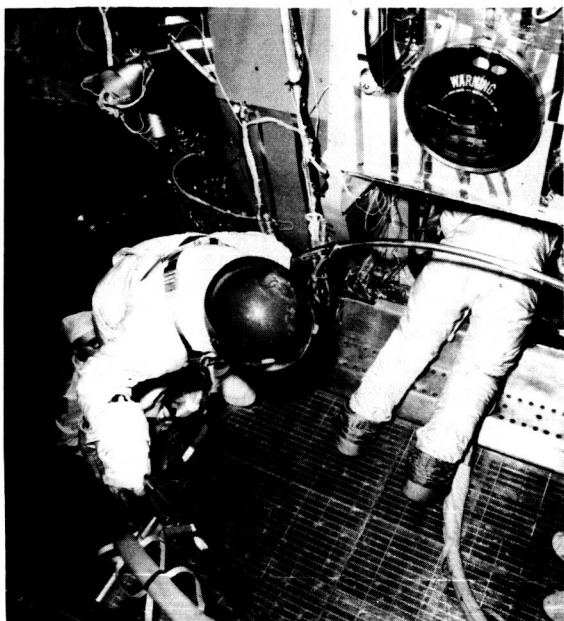
Figure 16. - Lunar module access platform.

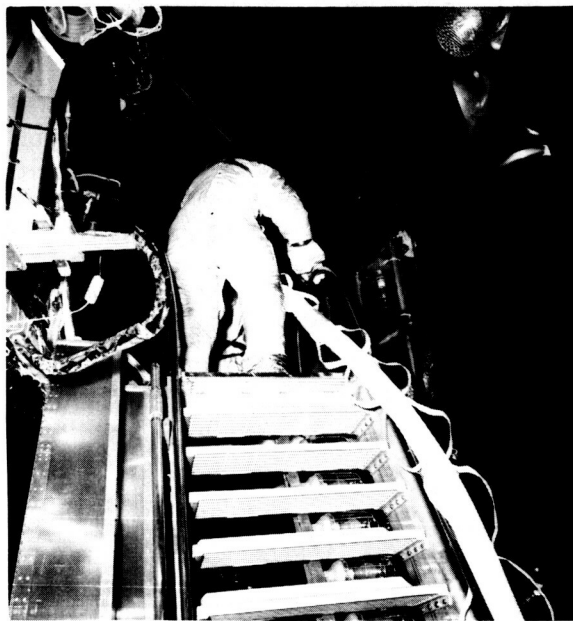
Figure 17. - Stairs to access platform.

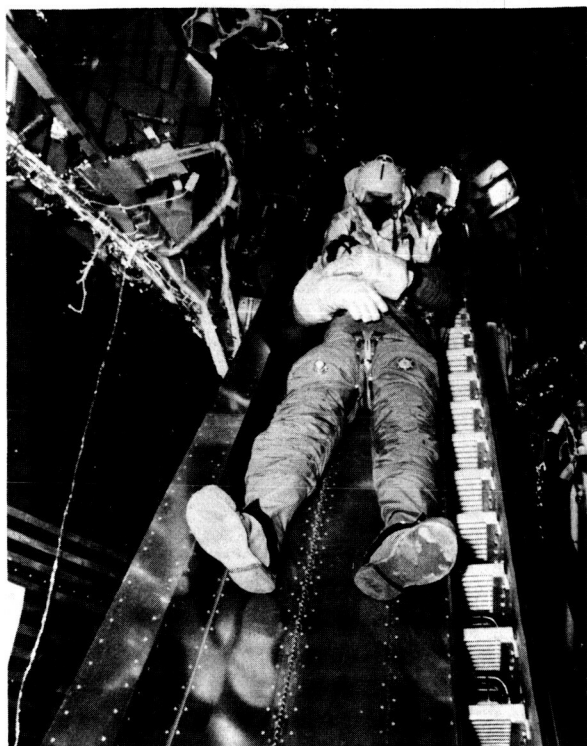
Figure 18. - Foldaway slide deployed for simulated rescue.

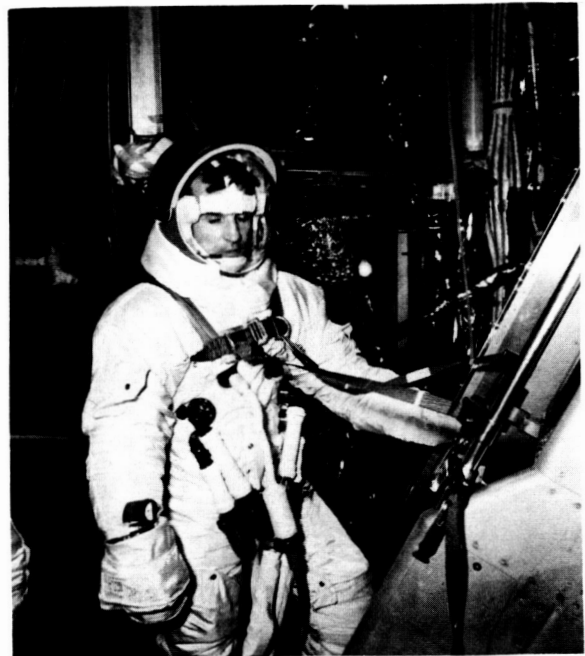
Figure 19. - Falling restraint system and umbilical connections.

Two other features of the ingress-egress scheme needed innovation. First, there was the requirement to provide a positive restraint against falling in case a crewman slipped or became unconscious during any part of the operation. Closely associated with this was the requirement to provide breathable oxygen at the correct pressure, temperature, and flow rate to the pressurized suit while the crewman was in the chamber. The first concept attempted involved the use of the flight EVA portable life support system (PLSS) and an overhead suspension block and tackle as a mobility assist and falling restraint. Dry runs using the block and tackle were proof that this approach was impractical because the weight and bulk of the PLSS made it extremely difficult to climb the stairs and enter the side hatch in a kneeling position. This factor resulted in the use of an umbilical to supply breathing oxygen from a controlled facility source and to provide electrical service to bioinstrumentation and communication equipment in the suit. The umbilical consisted of two 1.25-inch flexible hoses, a 37-conductor electrical cable, and a Beta-cloth cover for thermal and mechanical protection. The

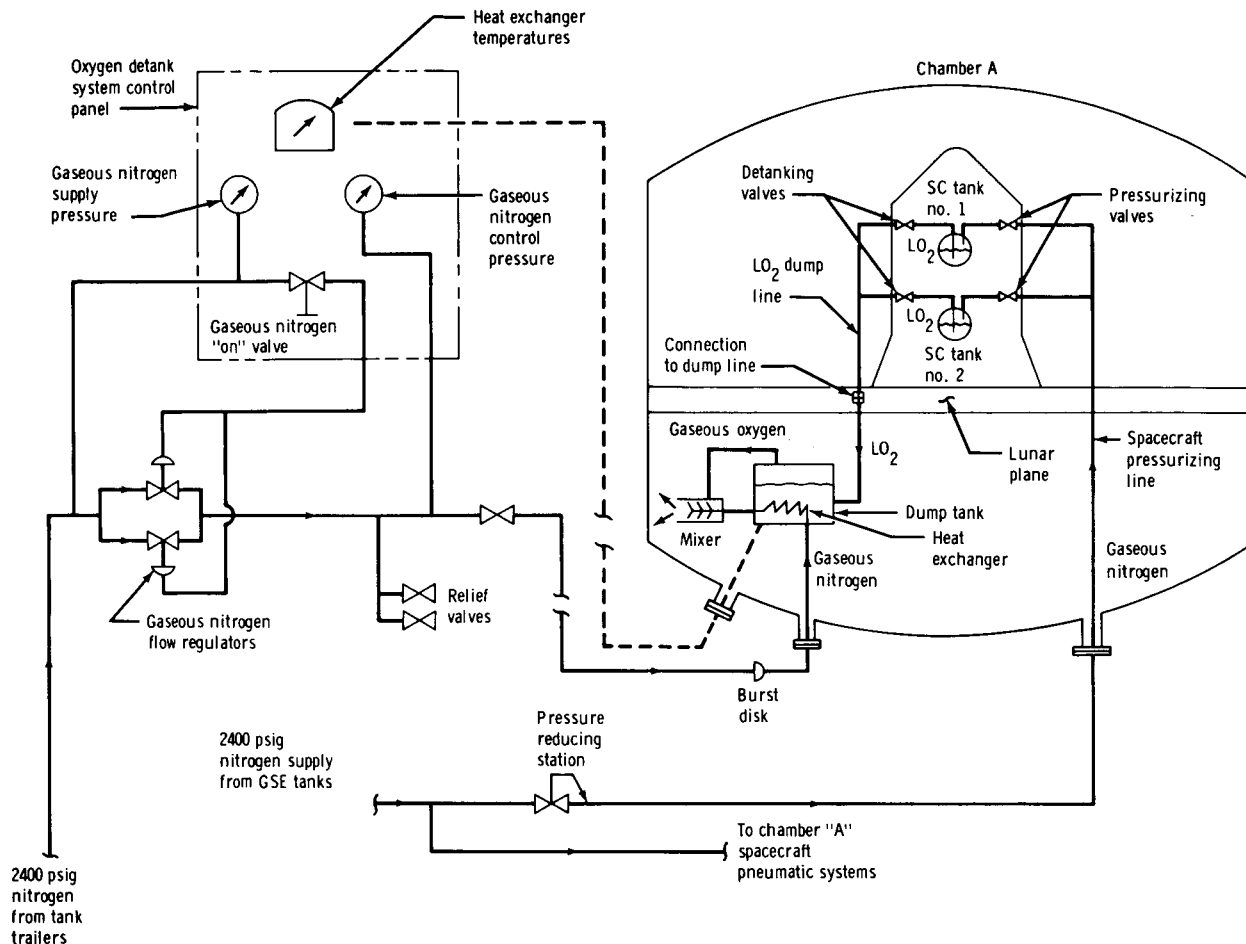
Figure 20. - Schematic diagram, LO₂ dump system.

The most significant change to the test configuration was the addition of the full 640-pound flight load of cryogenic oxygen on board the spacecraft for use during testing. This change resulted from an urgent need to confirm integrated thermal conditions and proper functioning in areas where cold oxygen from the tanks was routed. A new review of special safety hazards was undertaken because of this quantity of high-pressure liquid oxygen (LO_2) in the confined chamber. A gross rupture of either of the two tanks was considered to be very unlikely. The most probable mode of failure that might produce a real hazard was a small or medium leak in the oxygen system that could build up locally an oxygen-rich atmosphere in a poorly vented compartment to an extent sufficient to sustain combustion. The top deck of the service module (SM), where oxygen piping was close to a large amount of electronic equipment that had potential ignition sources, was a typical suspect area. In postulating such a leak and subsequent ignition, it was believed that the principal threat to crew safety and catastrophic destruction of the spacecraft could be relieved by quickly removing the large stored quantity of LO_2 from the spacecraft to a remote location where the supply of oxygen could be isolated. For this purpose, a stainless-steel dump tank was located within the chamber, suspended underneath the rotating floor. Special piping and valves were installed to permit dumping the LO_2 from the flight tanks through the fill-line inverted standpipes to the tank (fig. 20). Forcing pressure was maintained in the flight tanks during the dump

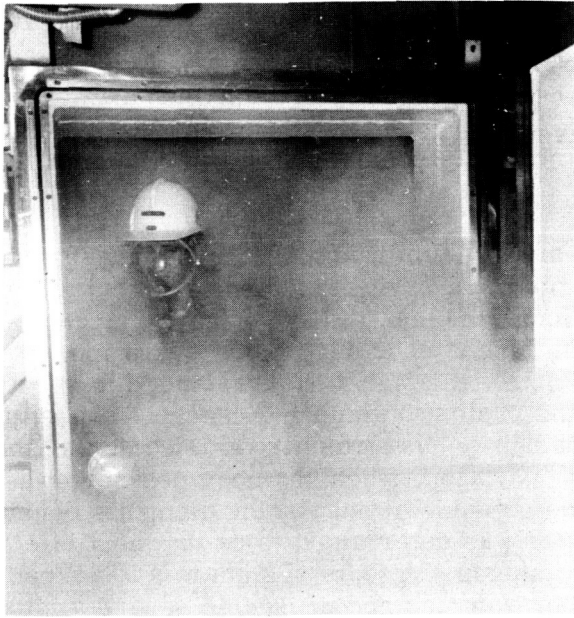
Figure 28. - Chamber fogging following a practice emergency repressurization and water deluge.

Because of the consequences of spacecraft damage from water deluge in the event of inadvertent operation of the system, it was decided to include no automatic initiation devices. During nontest operational phases, control of the system was from stations

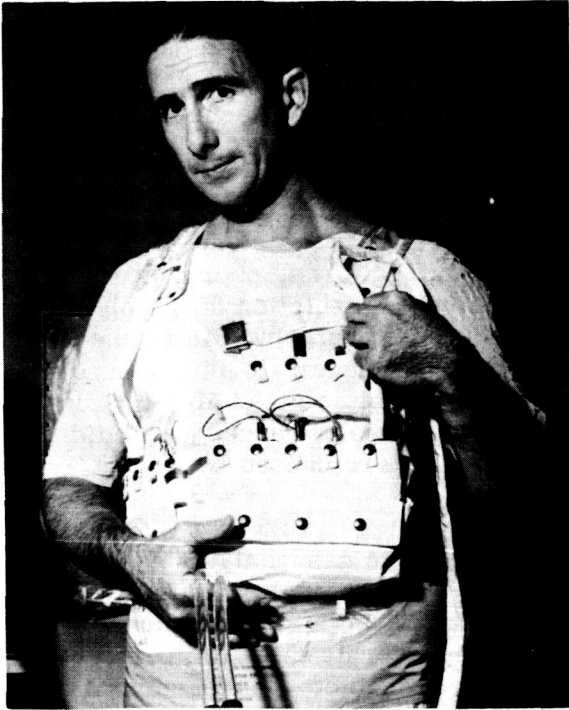
Figure 29. - Safety instrumentation package.

Signal conditioners for the instruments and the associated wiring harnesses were mounted on a vest-like supporting garment that was made of Teflon fabric; this vest was worn over the undergarment (fig. 29). The three barostats, which triggered chamber emergency repressurization when a lower safe limit of total pressure was sensed, also were mounted near the signal conditioners. All signals were brought out by means of a connector that could be mated directly to the electrical umbilical in the cabin or, if the crewman was garbed in a pressure suit, the connector could be mated to another hermetically sealed connector on the pressure garment and then to the umbilical. This entire assembly was referred to as the safety instrumentation package (SIP).

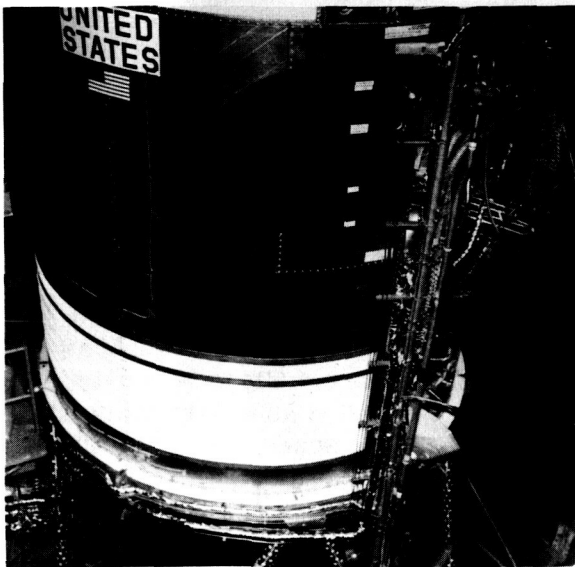
Figure 30. - Some of the GSE fluid lines in the CSM test installation.

Second manned test. - A major overhaul of the GSE fluid lines inside the chamber was accomplished before beginning the test. All mechanical connectors were replaced with welded connections. The flight-type disconnect fittings by which the oxygen and hydrogen fill and vent lines were connected to the spacecraft were reworked to minimize the possibility of leakage. As a result, this was the only test of the entire CSM series that was not jeopardized sporadically by massive leaks in these lines. Chamber pumpdown began on September 4, 1968, and operation during the thermal-vacuum test proceeded in a nominal manner, except for delays in starting the SM hot-soak phase that was scheduled immediately after pumpdown completion. Real-time requirements to evaluate the flow characteristics of the urine nozzle in a cold environment caused a hold between pumpdown and initiation of side-solar operations. To minimize impact to the overall test time line, the cabin depressurization and open-hatch EVA operation (fig. 41) were accomplished concurrently with the zero-g urine-nozzle evaluations. The original test time line was begun again on September 6, and all test phases were completed successfully in a nominal manner. The chamber vacuum was maintained at a level of approximately 2.5×10^{-6} torr throughout the test, except when the vacuum was interrupted intentionally because of specific test objectives.

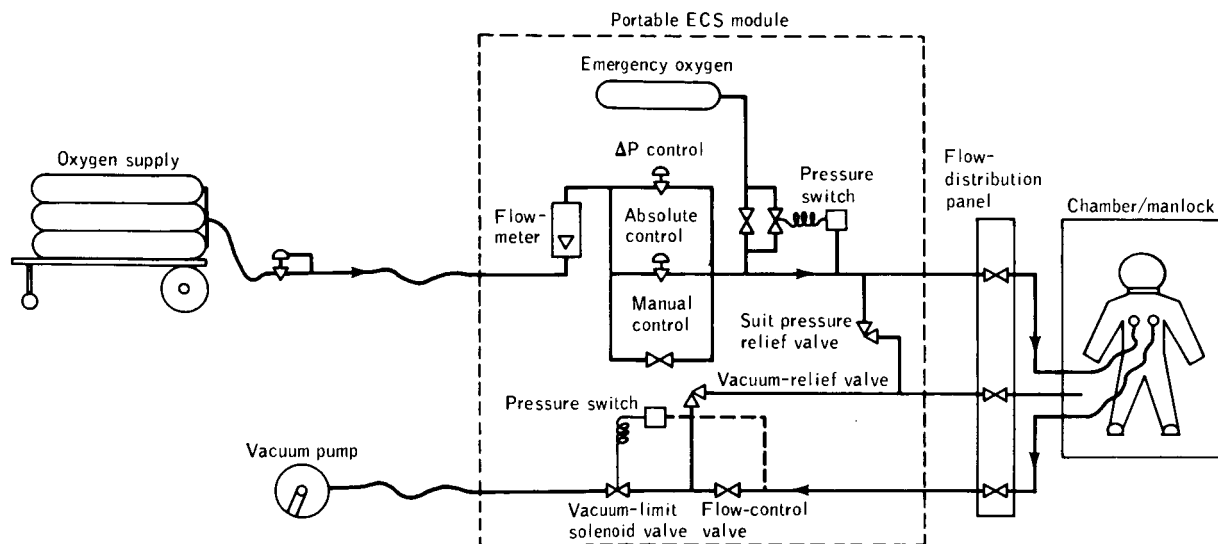
Figure 31. - Simplified schematic of facility open-loop ECS module.

In the new system, which was used in tests of the LM, the flow of O₂ to each of the two crewmen was regulated by the use of an individual control module (figs. 31 and 32). A third module was maintained in operational status on standby and could be valved into the circuit instantly in case of failure of either of the other modules (fig. 33). The pneumatic control system of these modules was designed to permit precise variable control of suit gas pressure and flow rate over the full range of manlock and chamber operating pressures. A major point of concern was the ability of the system to maintain suit pressure at or above the chamber or manlock pressure during an emergency-repressurization event. If, for any reason, the suited crewman was subjected to an external pressure load (referred to as negative pressure), the general effect would be to collapse the suit and apply force that would tend to move the crewman into the hard-helmet area of the assembly. At best, this condition would be very uncomfortable for the crewman, and could cause cardiac arrest in extreme circumstances. To preclude this possibility, a large check valve that was vented to the chamber atmosphere and that was calibrated to open at 0.02 psi negative suit pressure was installed inside the chamber in each ECS supply line. This check valve would admit air to the suit loop and, thus, to the pressure garment automatically in adverse circumstances.

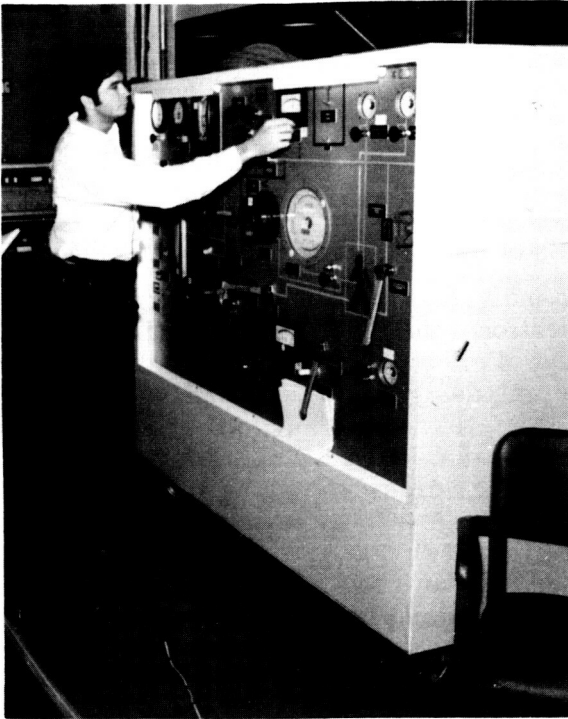
Figure 32. - Facility ECS module.

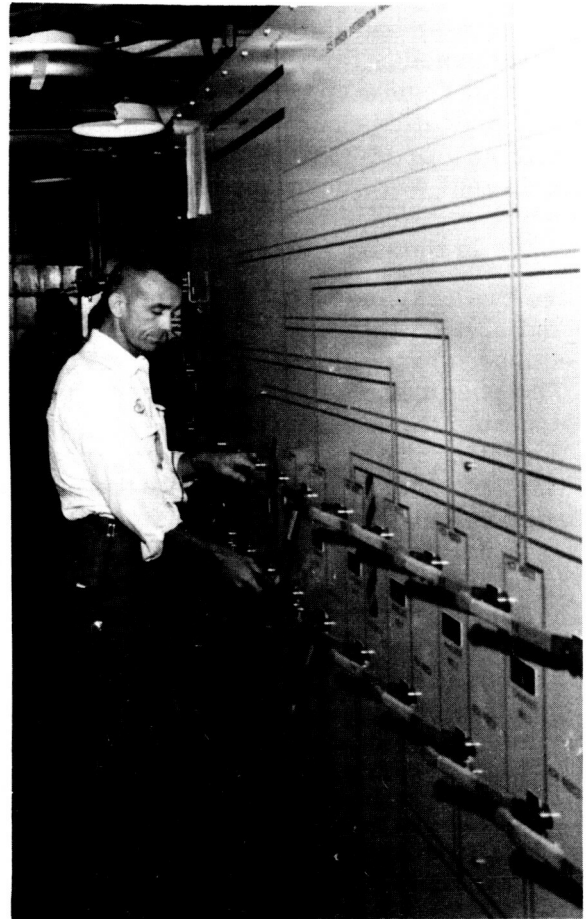
Figure 33. - Facility ECS flow distribution panel.

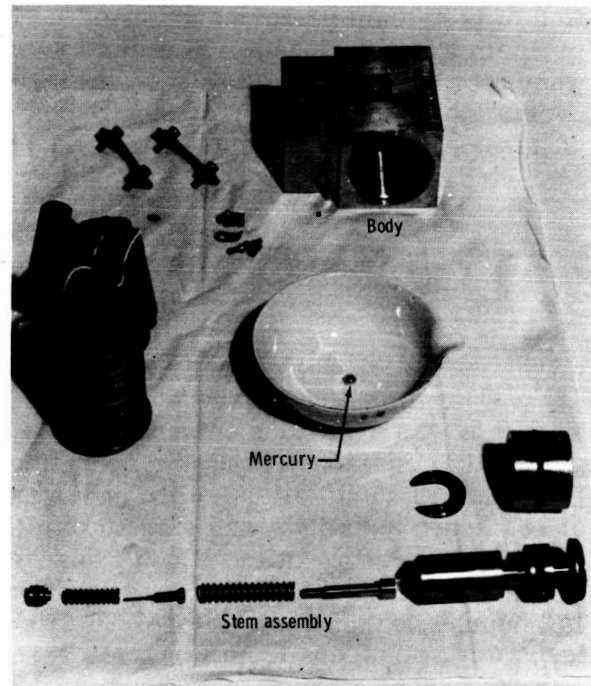
Figure 34. - Mercury recovered from the body and stem of contaminated facility ECS valve.

It was decided to open the ECS distribution system at convenient piping flanges, thereby dividing it into separate sections. This permitted checking for mercury in steps that would avoid spreading the contamination to other uncontaminated sections of the system. Three basic techniques for mercury detection were used. First, hot gaseous nitrogen was flowed through the isolated piping section, and the effluent was monitored by the use of an ultraviolet-absorption spectrometer. This method was considered to be the primary detection method; however, spot samples of the nitrogen effluent also were checked for mercury vapor by the use of selenium sulfide decoloration apparatus. If no trace of mercury was discovered, final assurance of noncontamination was obtained by evacuating the line and sequentially heating all elements during the evacuation with a hand-held heat gun. An LN₂-cooled trap (or cold finger) was installed between the line to be evacuated and the vacuum pump. Afterward, the line was repressurized and the cold-finger surface was analyzed carefully for traces of mercury. Using these techniques, it was determined that the mercury contamination was isolated in the piping section where it was discovered, and the source was determined to be a valve that apparently had been contaminated at the vendor's before delivery (fig. 34). As a result of this incident, prohibitions against the use of mercury in the laboratory were strengthened, and standard procedures for initial and periodic checks of environmental control systems for mercury contamination were instituted.

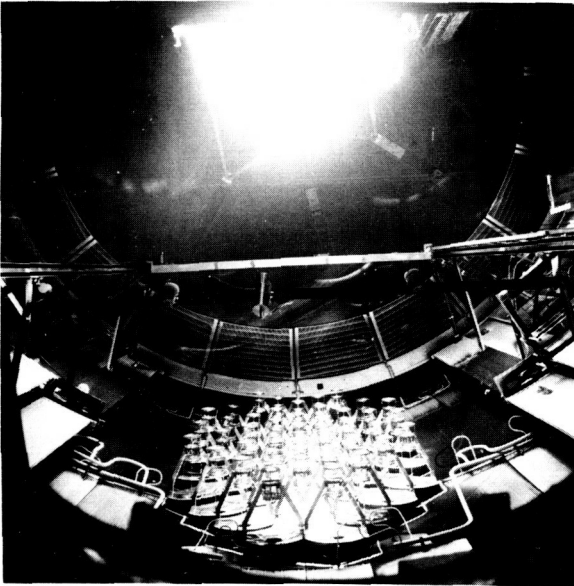
Figure 36. - Side-solar hot-soak and radiator-mode testing on spacecraft 008.

Side-solar hot-soak and radiator-mode testing was begun late on October 30 (fig. 36). This test phase was used for investigating transient and off-nominal modes of radiator operations, and several off-nominal modes of ECS operation were tested to determine operational limits that could be applied to mission rules. On October 31, another attempt was made to transfer potable water to the CM. This attempt was successful, and the water-shortage constraint was removed from the test time line. In addition to the successful demonstration of a multitude of off-nominal radiator modes, successful operation of the ECS suit loop was demonstrated, without problems, in a single lithium hydroxide canister mode. Late in the test phase, the ECS water/glycol pump circuit breakers were tripped, indicating abnormal operation. Manually resetting

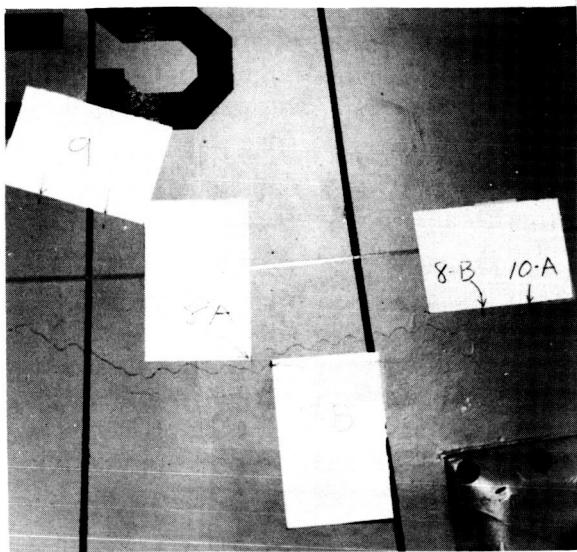
Figure 37. - Documentary photograph of cracks in the CM heat shield.

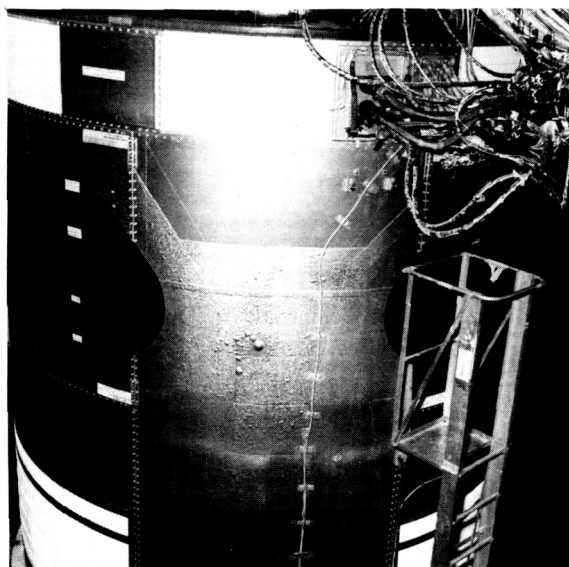
Figure 42.- Service module paint blistering.

an inoperative RIMS heater system and erratic RIMS bar movement instrumentation; and miscellaneous disturbances of the thermal environment that were caused by cryo-deposits, television lamps and floodlamps, and blistering of the CM thermal control coating and of the SM paint (fig. 42). The thermal-vacuum tests disclosed inadequate bay venting that required redesign of thermal blankets. Also as a result of the tests, passive-thermal-control attitudes were developed to prevent extreme temperature excursions during flight.
