NBS SPECIAL PUBLICATION **640**

Innovation for Maintenance Technology Improvements

Proceedings of the 33rd Meeting of the
Mechanical Failures Prevention Group,
held at the National Bureau of Standards,
Gaithersburg, MD, April 21-23, 1981

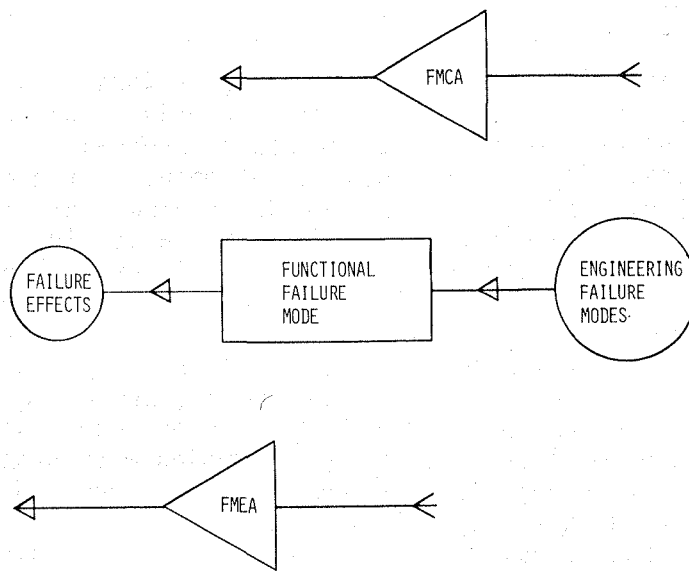
FIGURE 2: FAILURE MECHANISM AND CAUSE ANALYSIS AND FAILURE MODES AND EFFECTS ANALYSIS CONTRASTED.

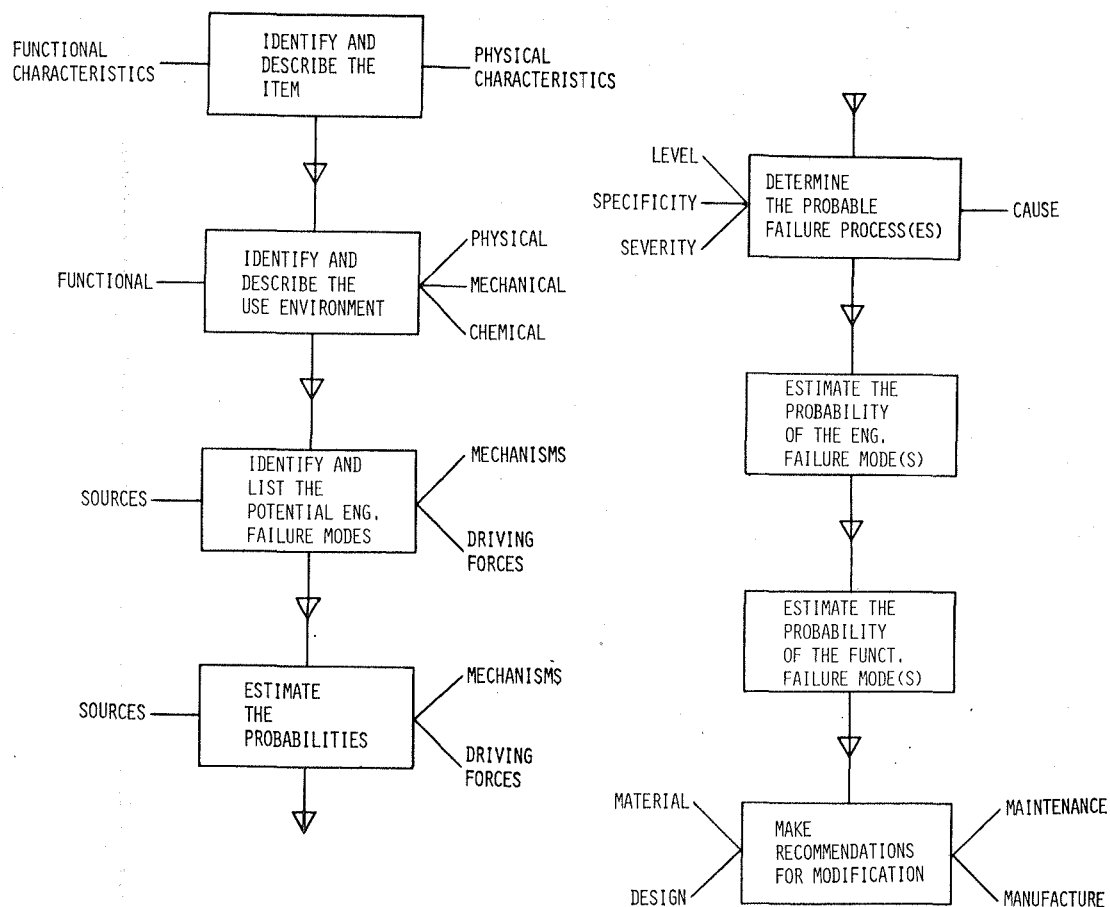
FIGURE 3: FMCA POTENTIAL FAILURE ANALYSIS OUTLINE.

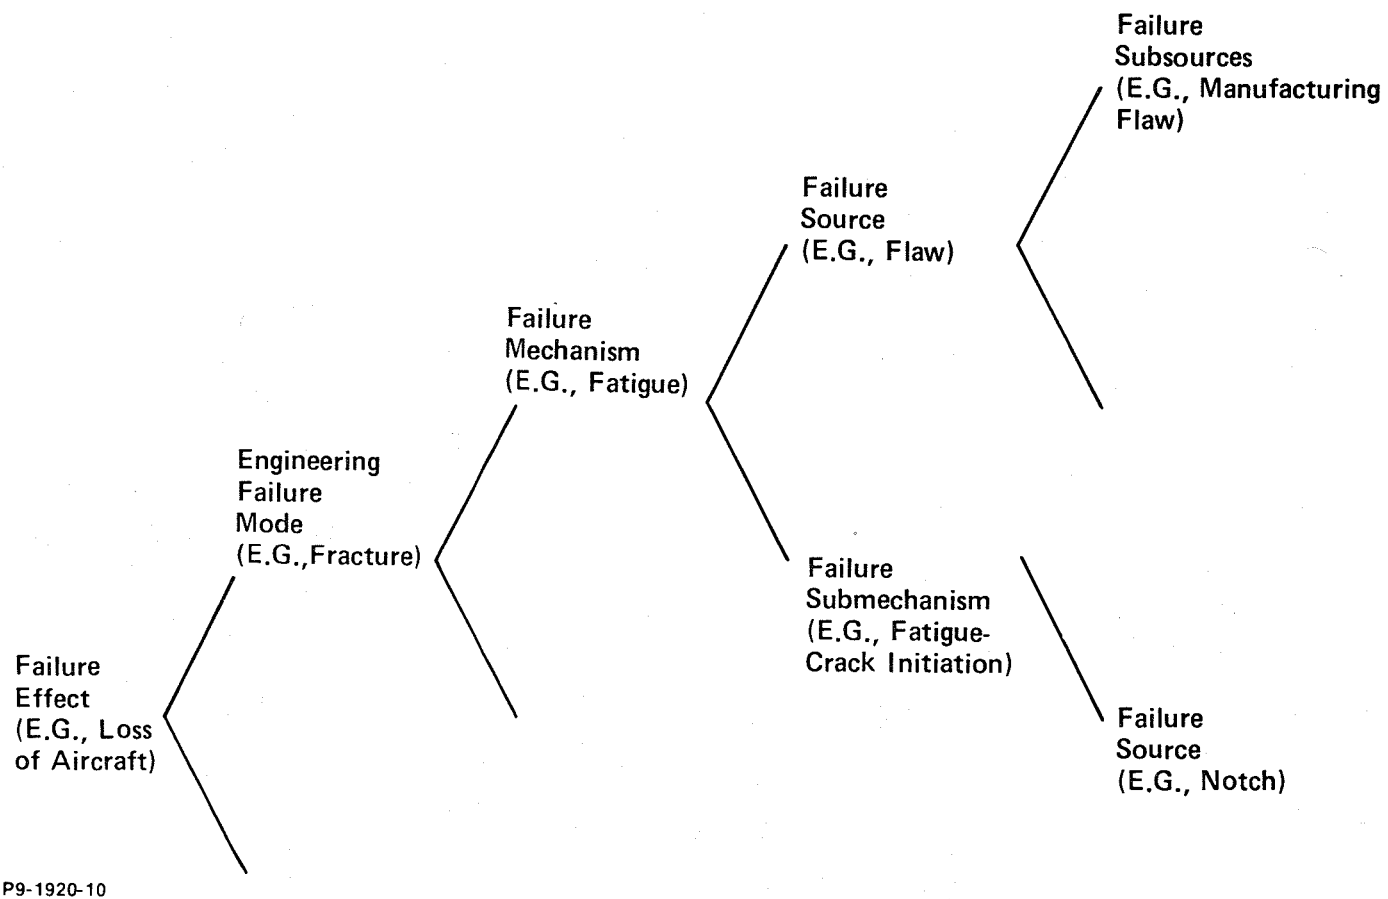
FIGURE 4: FMCA FAILURE TREE SCHEMATIC.

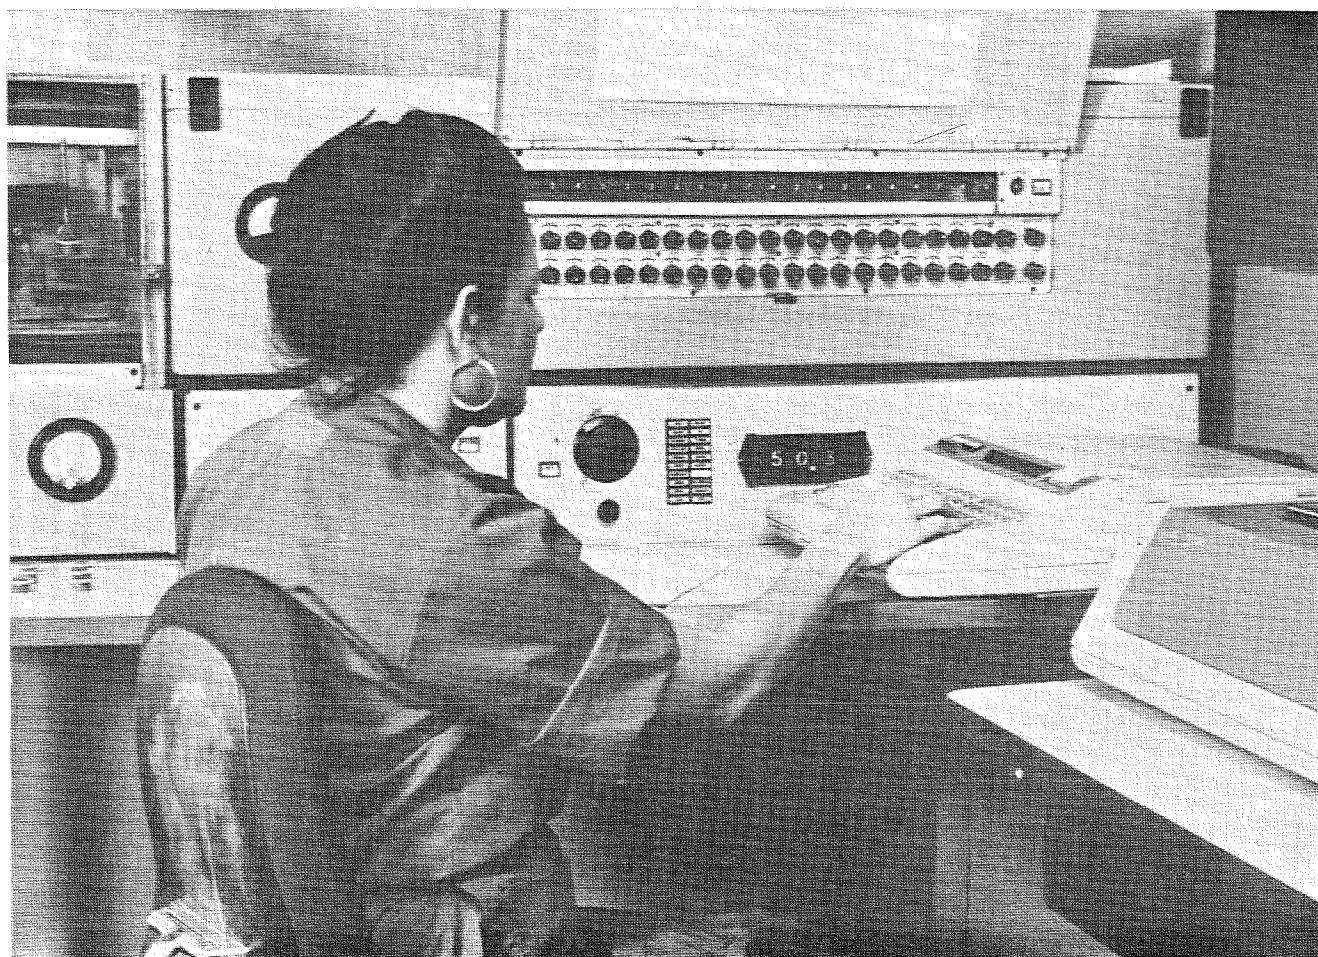
A Baird Corporation model FAS II atomic emission spectrometer interfaced to a Hewlett-Packard 9825 minicomputer. The H-P 9825 is used here as a data logger, recording analytical results on tape cartridges. These are in turn played through a central processing unit which updates the appropriate equipment files on a client's floppy disc.

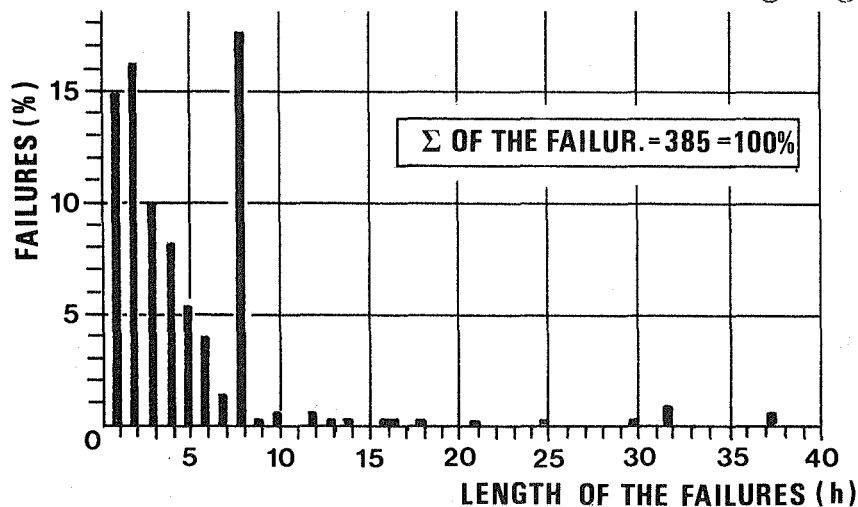
Fig. 1. Frequency distribution of the length of failures for a NC-Lathe

A typical machine in the mechanical industry is an NC-Lathe and if we are looking at the frequency distribution of the length of the failure we will have the following figure.

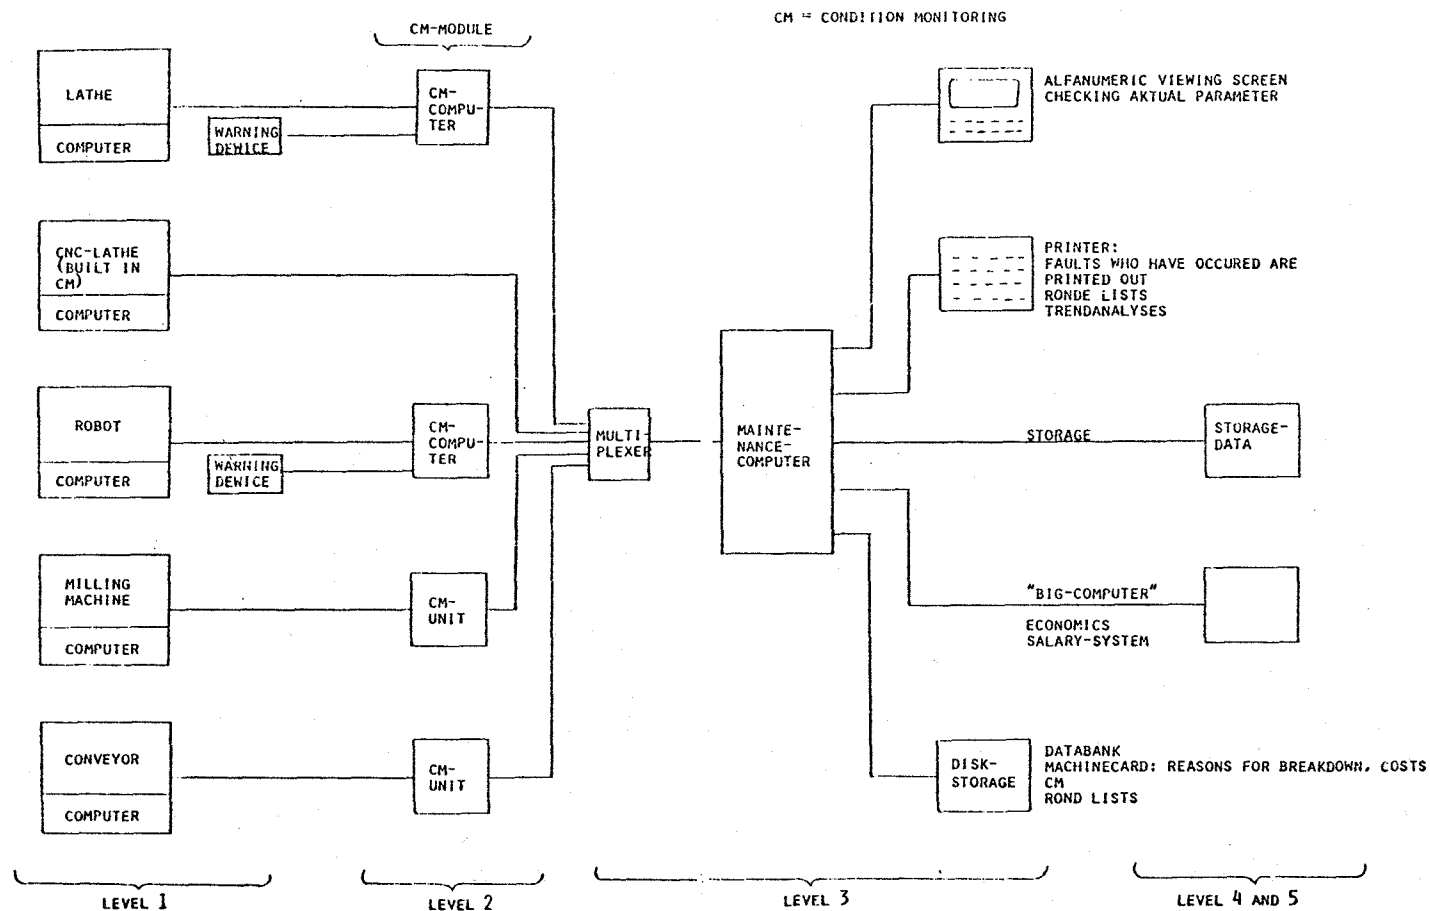
Fig. 2. Condition monitoring system for mechanical industry

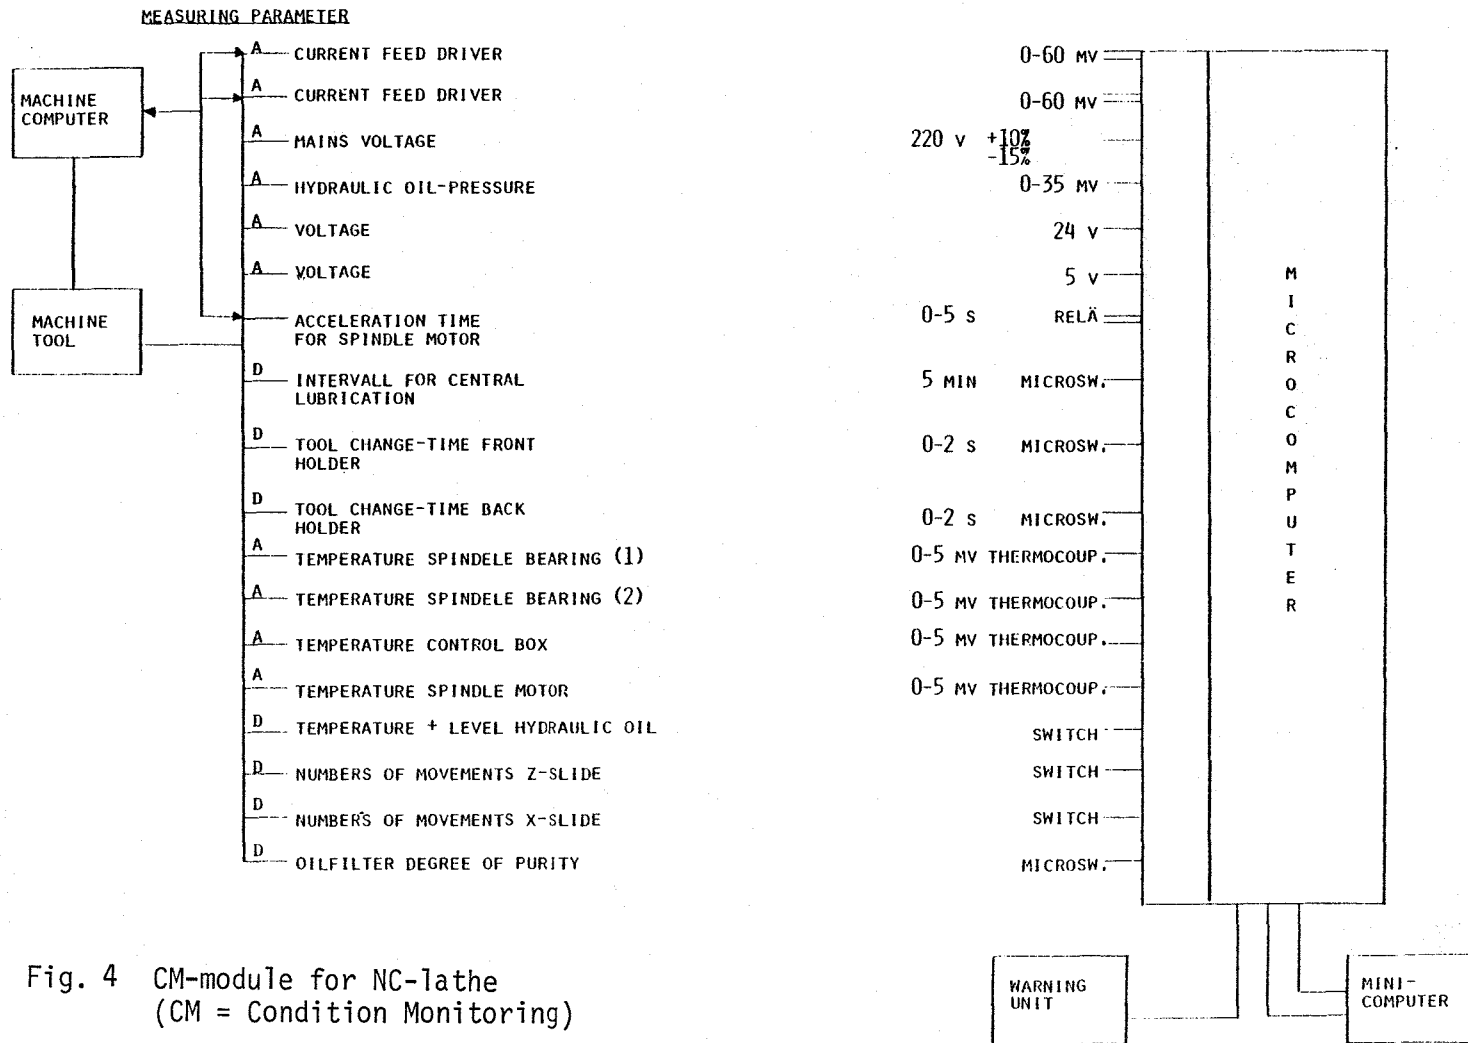
Fig. 4 CM-module for NC-lathe
(CM = Condition Monitoring)

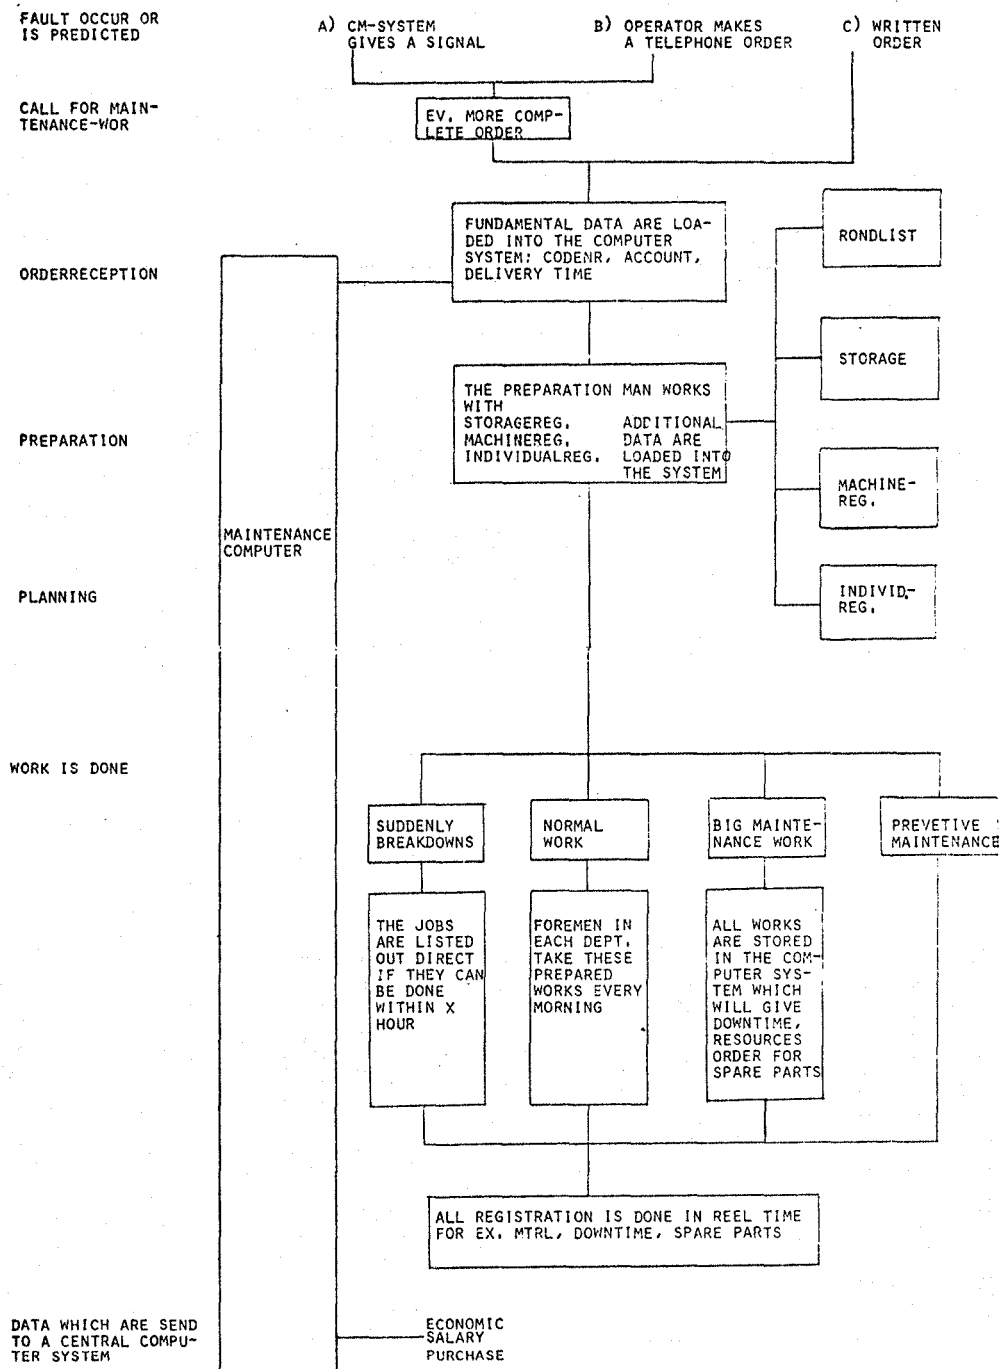
Fig. 5. Administrative maintenance system

The integration between an ACMS and an administrative system for maintenance can be seen in figure 5.

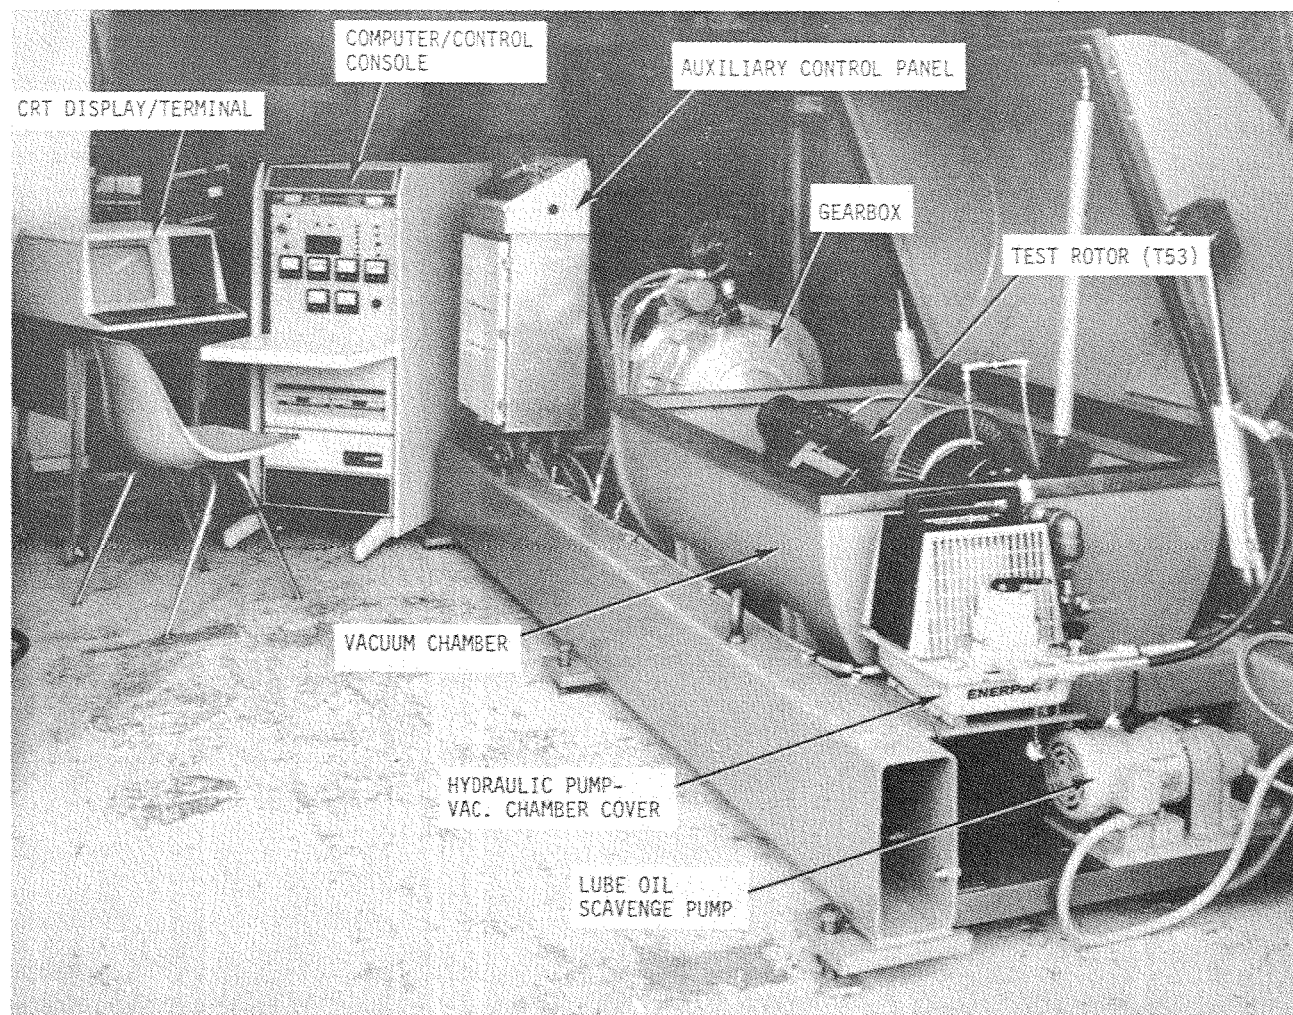
FIGURE I - U. S. Army High-Speed Balancing System -
Component Listing

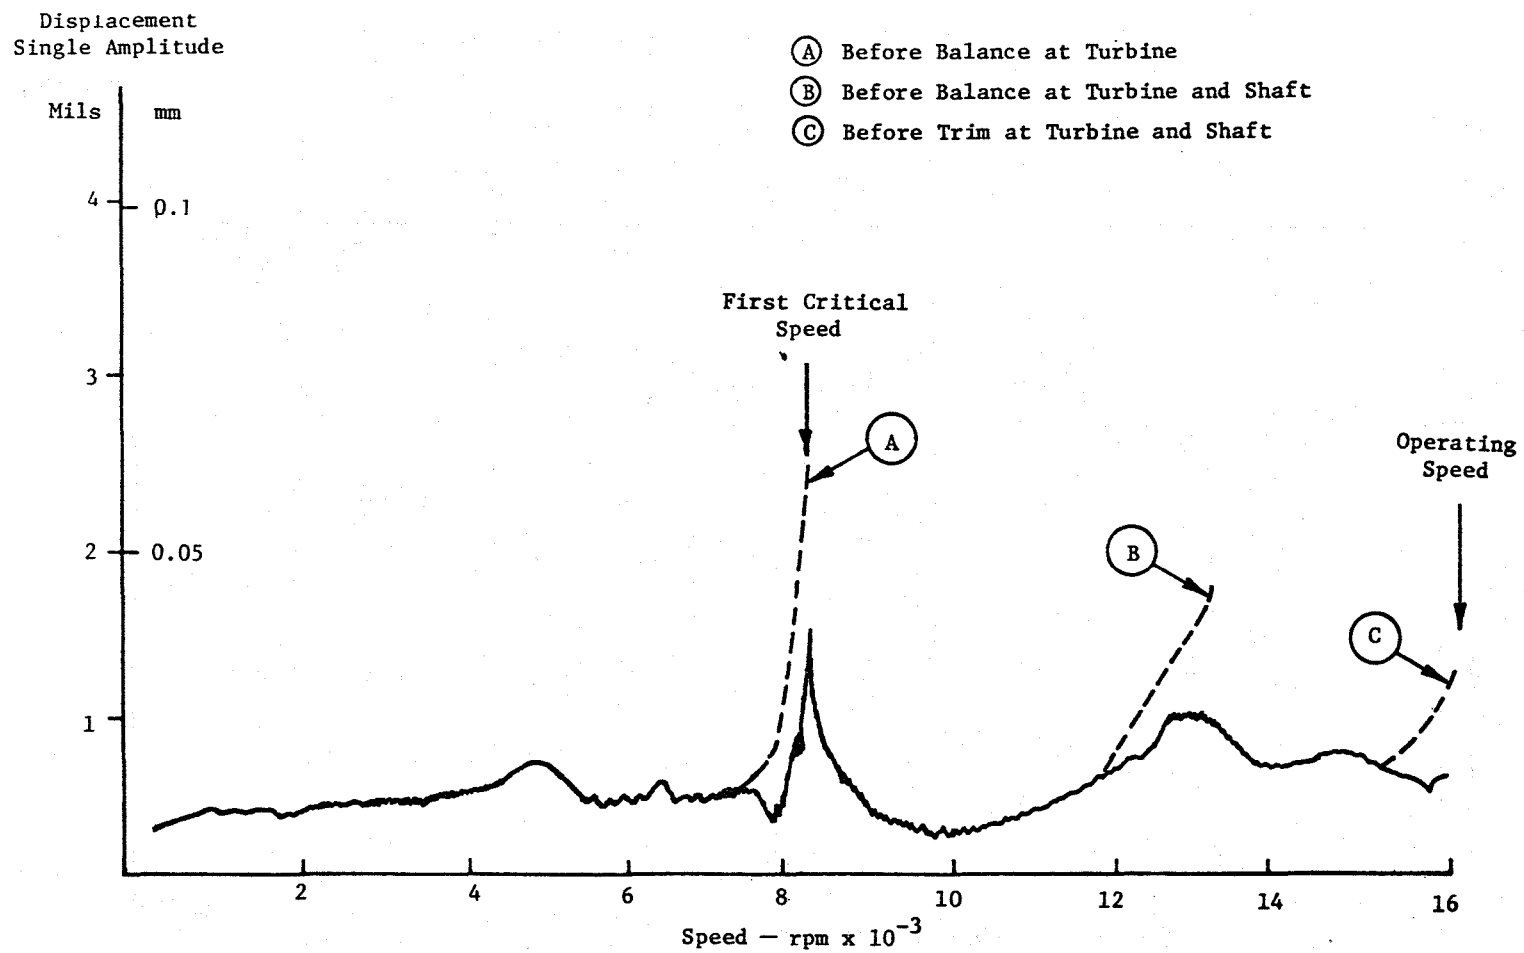
Fig. 3 - Results of High-Speed Balancing T55 Power Turbine

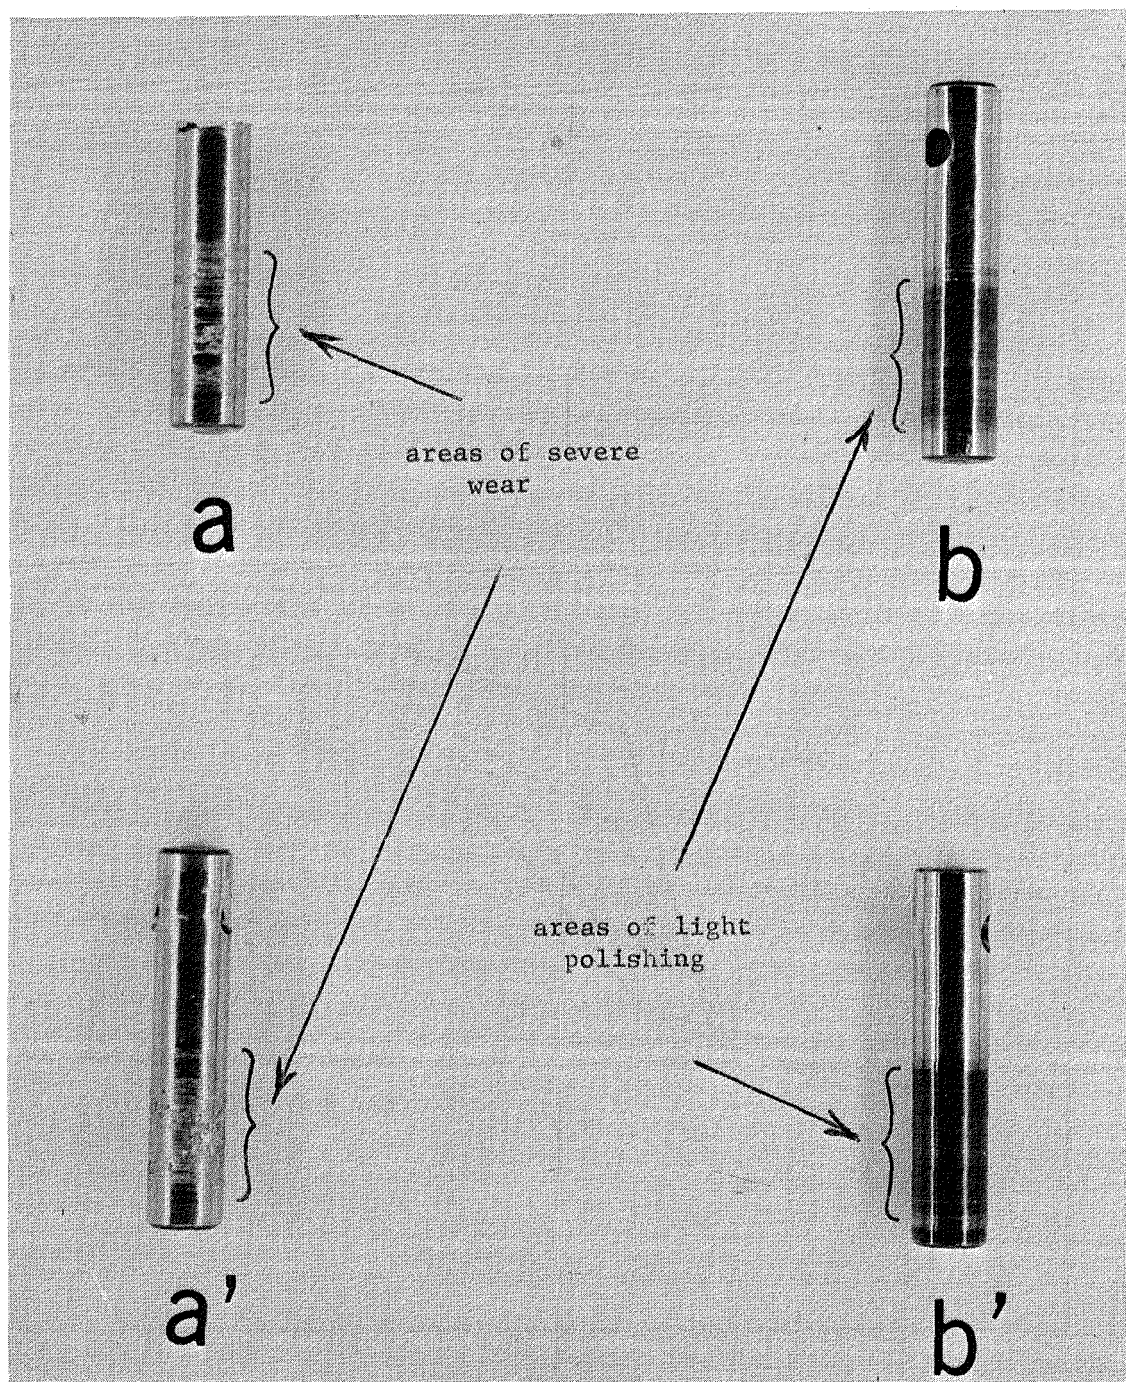
Figure 1. Effect of SbSbS₄ on Abrasive Wear

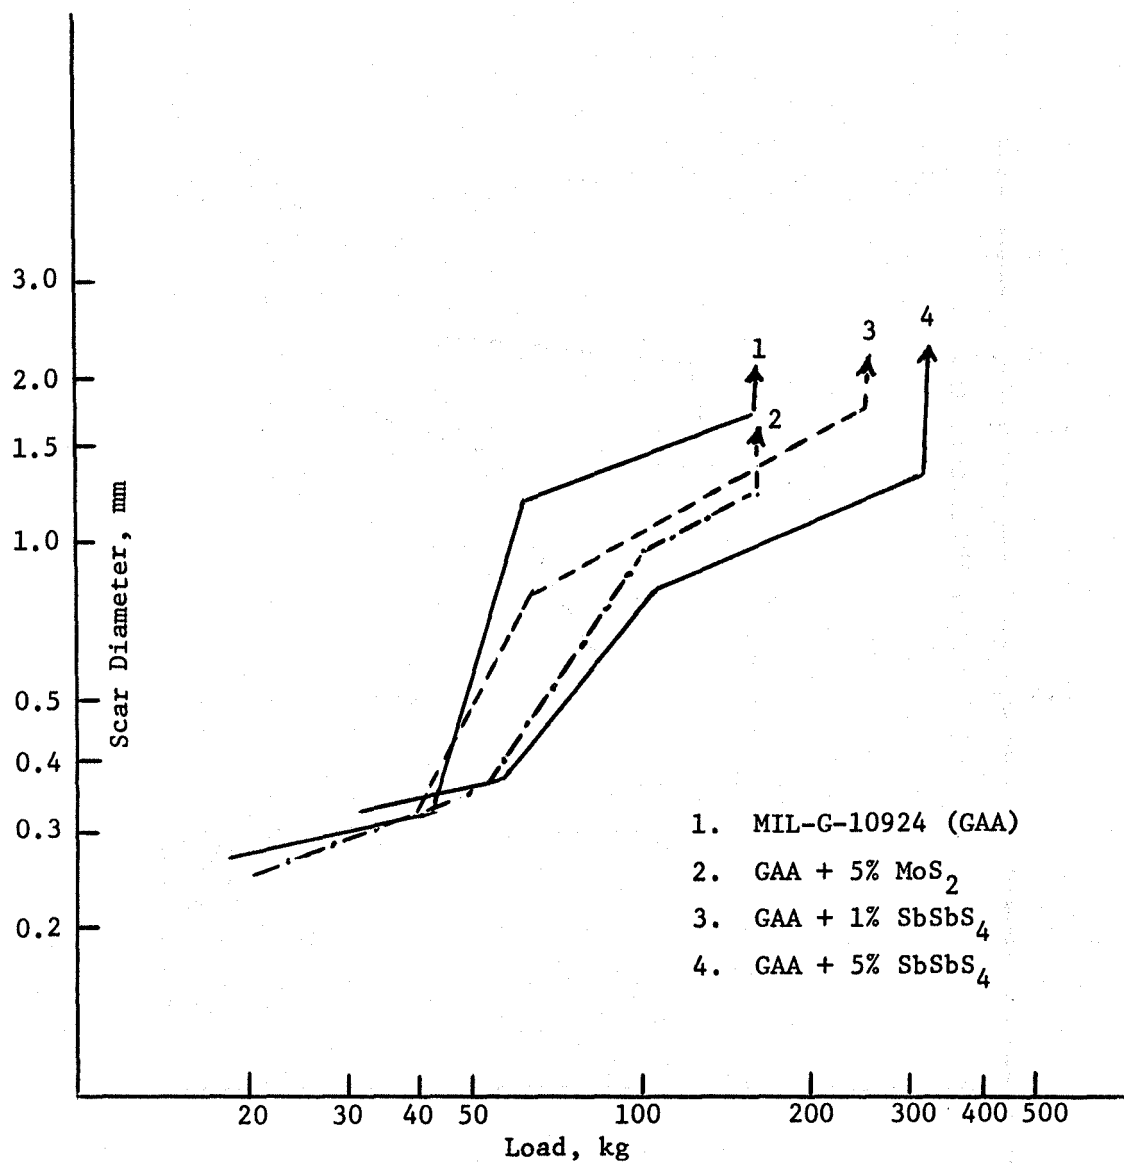
Figure 2. Wear Scar Diameter vs. Load; AISI-C-52100 Steel
Balls; 25°C, 1800 rpm, 10s

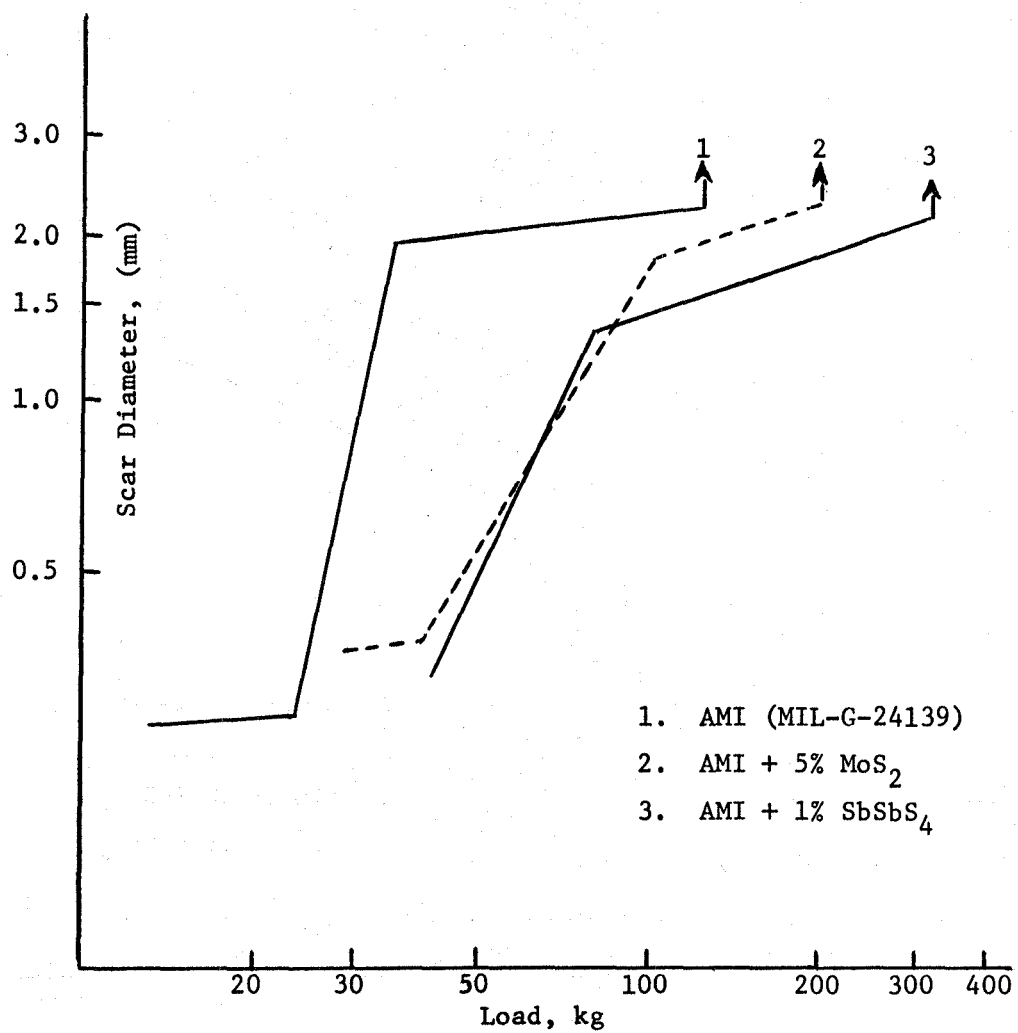
Figure 3. Wear Scar Diameter vs. Load; AISI-C-52100 Steel
Balls; 25°C, 1800 rpm, 10s

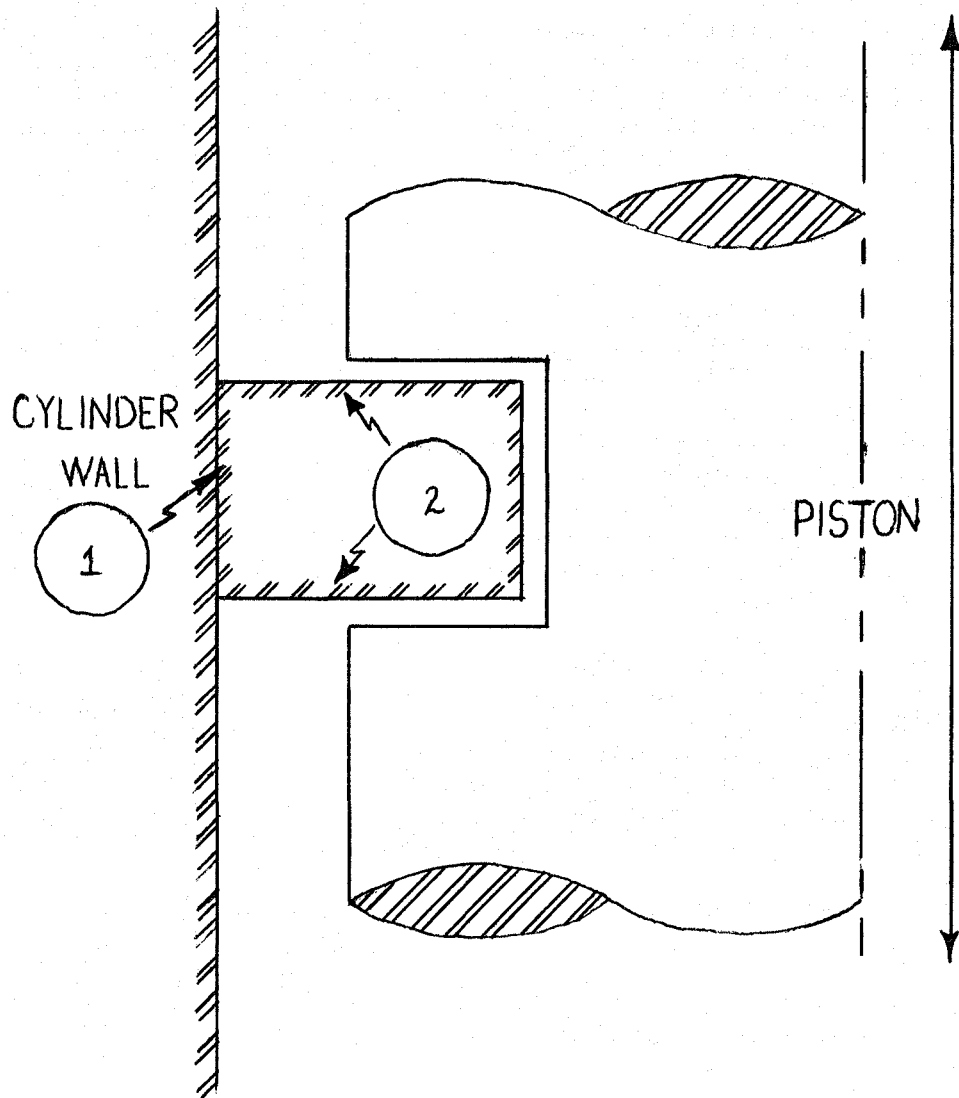
PLATE ONE
PISTON ASSEMBLY

When the implanted MoS_2 is exhausted on surface one (1) it will be replaced by implanted MoS_2 on surfaces two (2) nearest the cylinder wall.

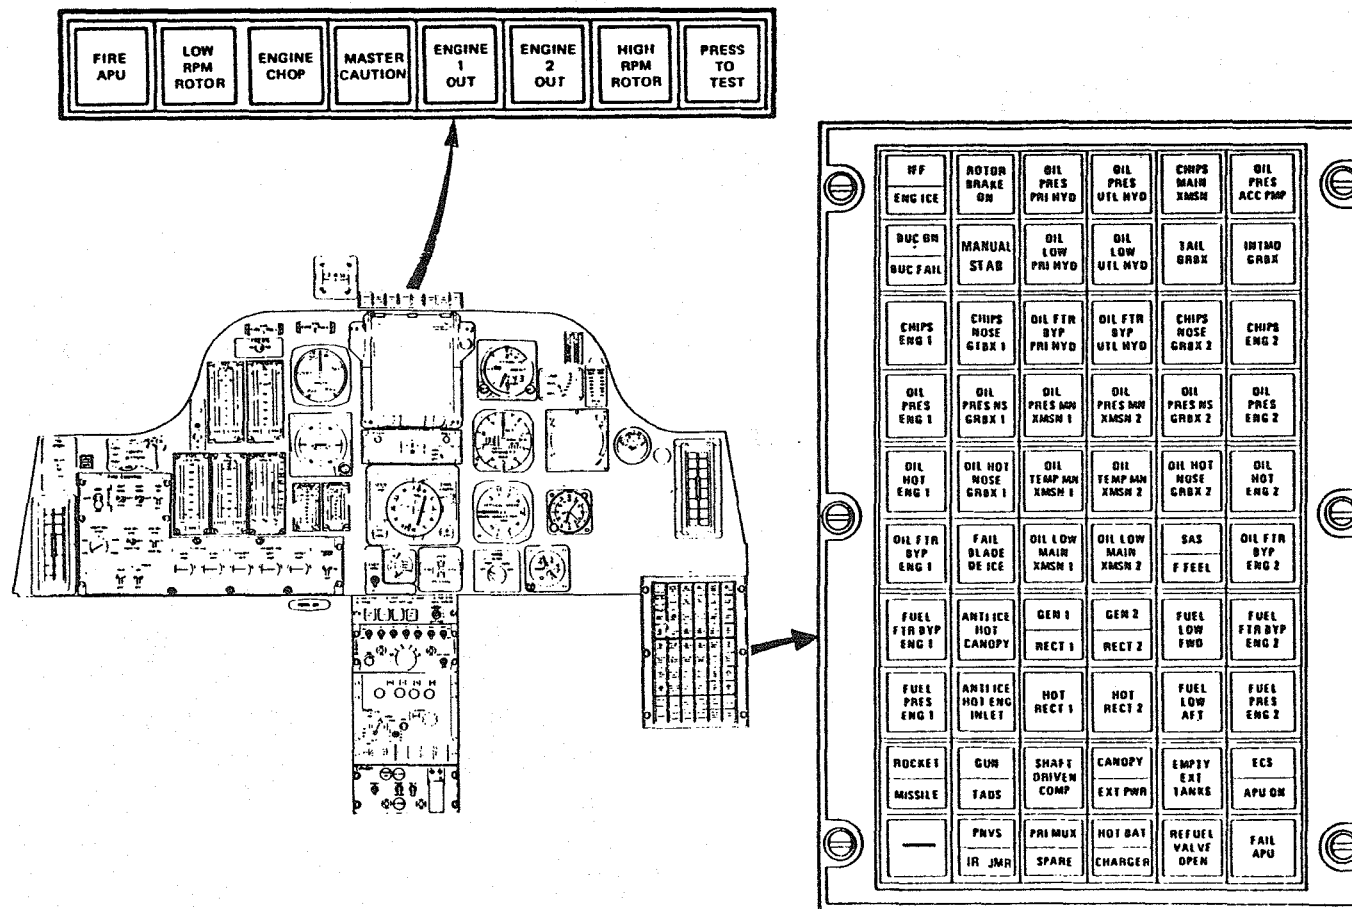
Figure 4: Pilot's Master Caution and Warning/Caution, Warning and Advisory Panels

Master Caution and Warning Panels and Caution, Warning and Advisory Panels (Figures 4 and 5) are installed in both the pilot and copilot/gunner stations. The two Master Caution and Warning Panels, one located on the top center of the pilot's instrument panel and the other on the top right side of the copilot/gunner's instrument panel, provide the initial indications of impending failure, actual failures, or dangerous conditions. The MASTER CAUTION display on these Master Caution and Warning Panels is pushbutton operated. Initially, the MASTER CAUTION will flash (5 ± 1 hertz rate) when a Caution, Warning and Advisory Panel segment simultaneously starts flashing (2 ± 1 hertz rate). Pressing the MASTER CAUTION display will cause it to extinguish and will convert the flashing fault segment to steady on. It will remain on until the fault or condition is corrected. When the PRESS TO TEST button on the Master Caution and Warning Panel is pressed, all Caution, Warning and Advisory lights in the crewstation are illuminated. When any of the remaining warning lights on the Master Caution and Warning Panel are lit, immediate attention is required by the crew members in accordance with operating instructions. An aural tone (700 to 1000 hertz continuous sweep) is incorporated with the LOW RPM ROTOR, ENG 1 OUT and ENG 2 OUT segments

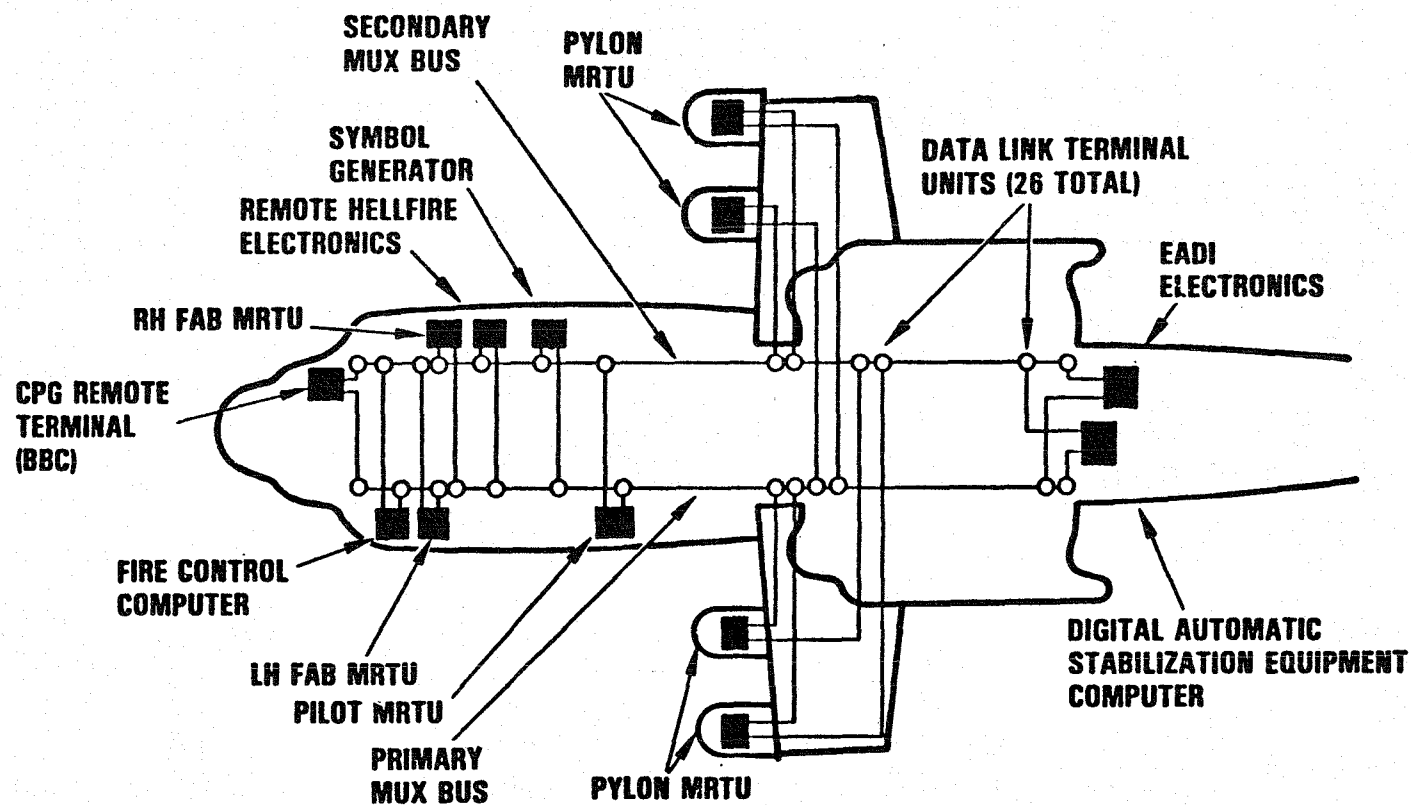
Figure 6: AH-64 Multiplex System Distribution

Data Bus Operation. The AH-64 MUX data buses consist of low-loss twisted, shielded, 24 gauge, Teflon insulated wire pairs, terminated at each end for impedance matching. The data bus operates asynchronously in a command/response mode, with data transfer occurring in either direction, but only one direction at a time (half duplex). All connections to the data bus system use a Data Link Terminal Unit (DLTU) which provides short-circuit isolation, impedance matching, and line termination. Sole control of data transfer on the bus resides with the bus

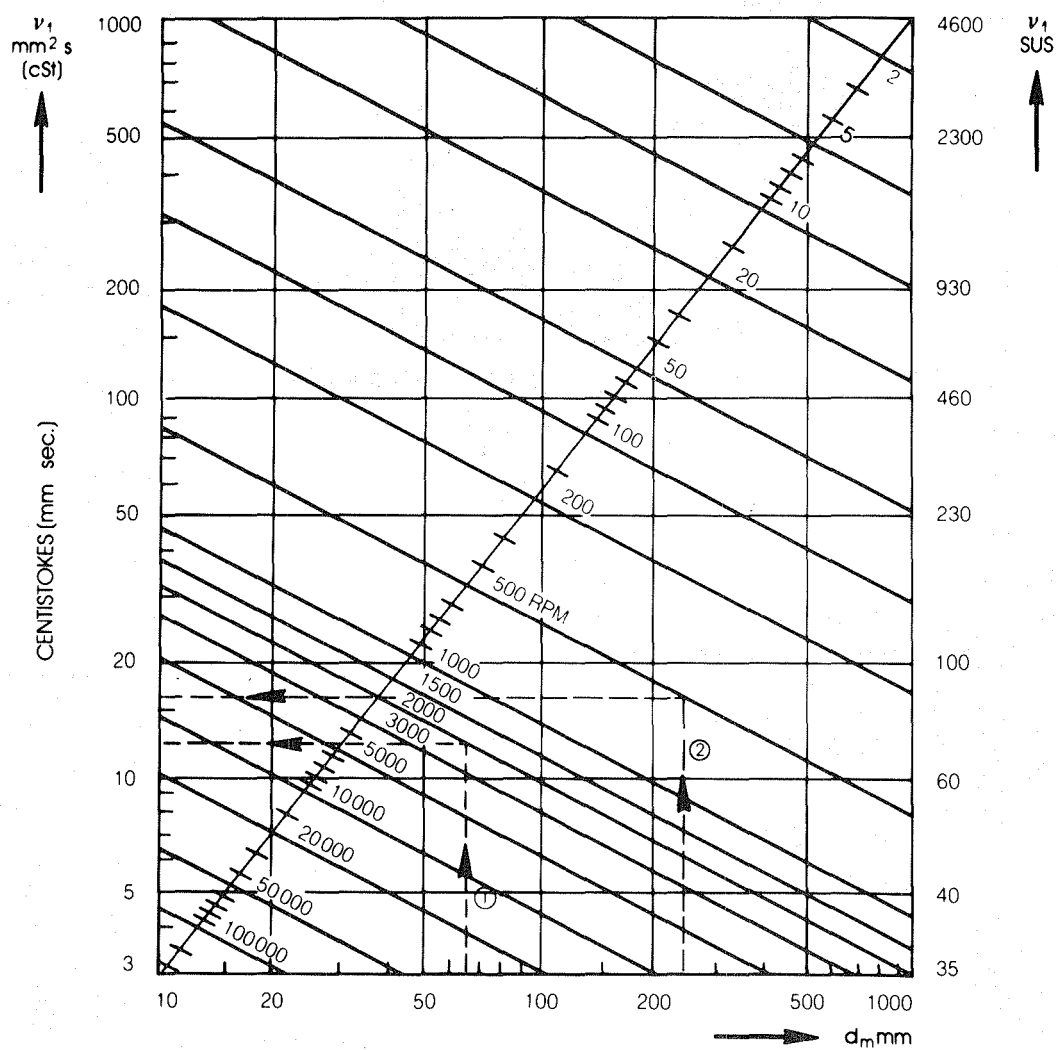
Minimum Required Lubricant Viscosity
 $d_m = (\text{bearing bore} + \text{bearing O.D.}) - 2$
 $\nu_1 = \text{required lubricant viscosity for adequate lubrication at the operating temperature}$

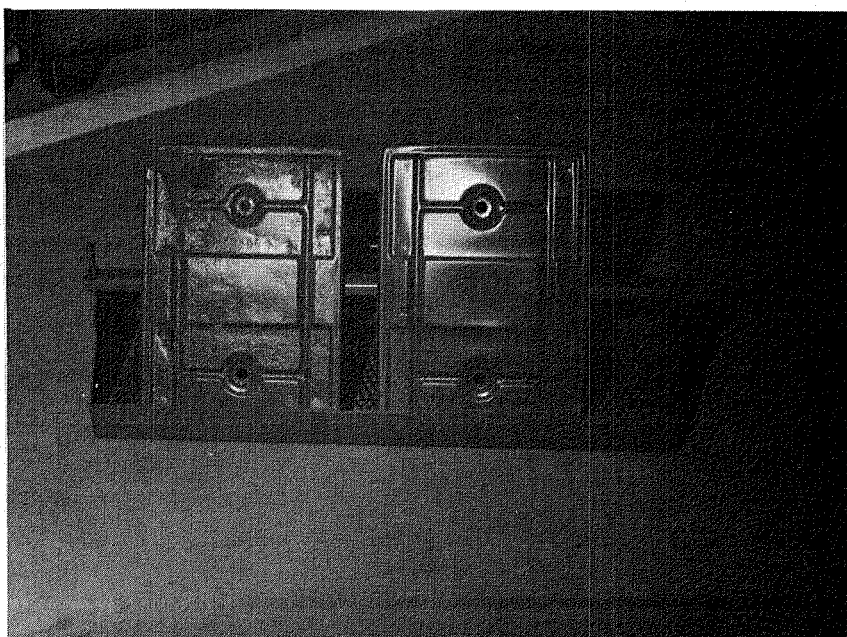
Figure 5. A corroded and a new battery tray.

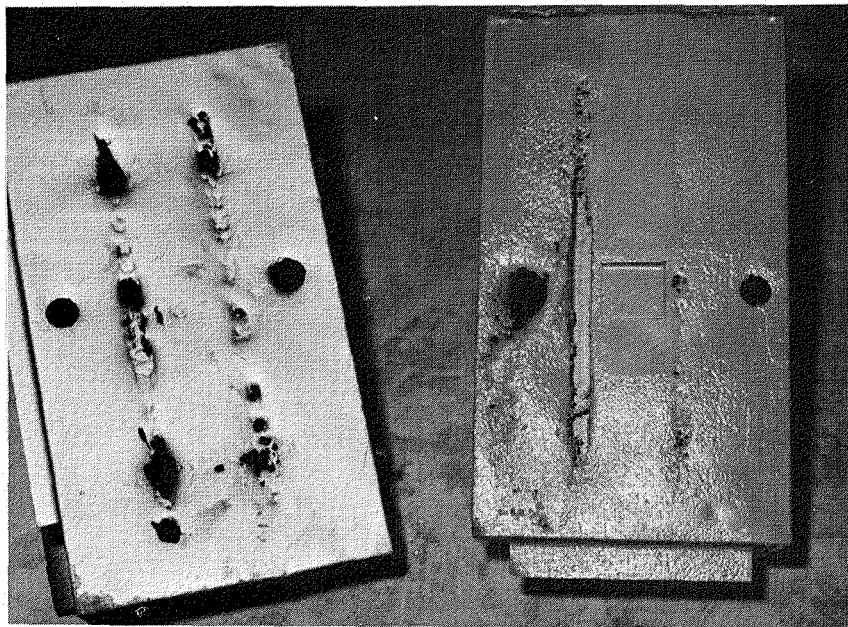
Figure 6. A coated and an uncoated truck battery box.

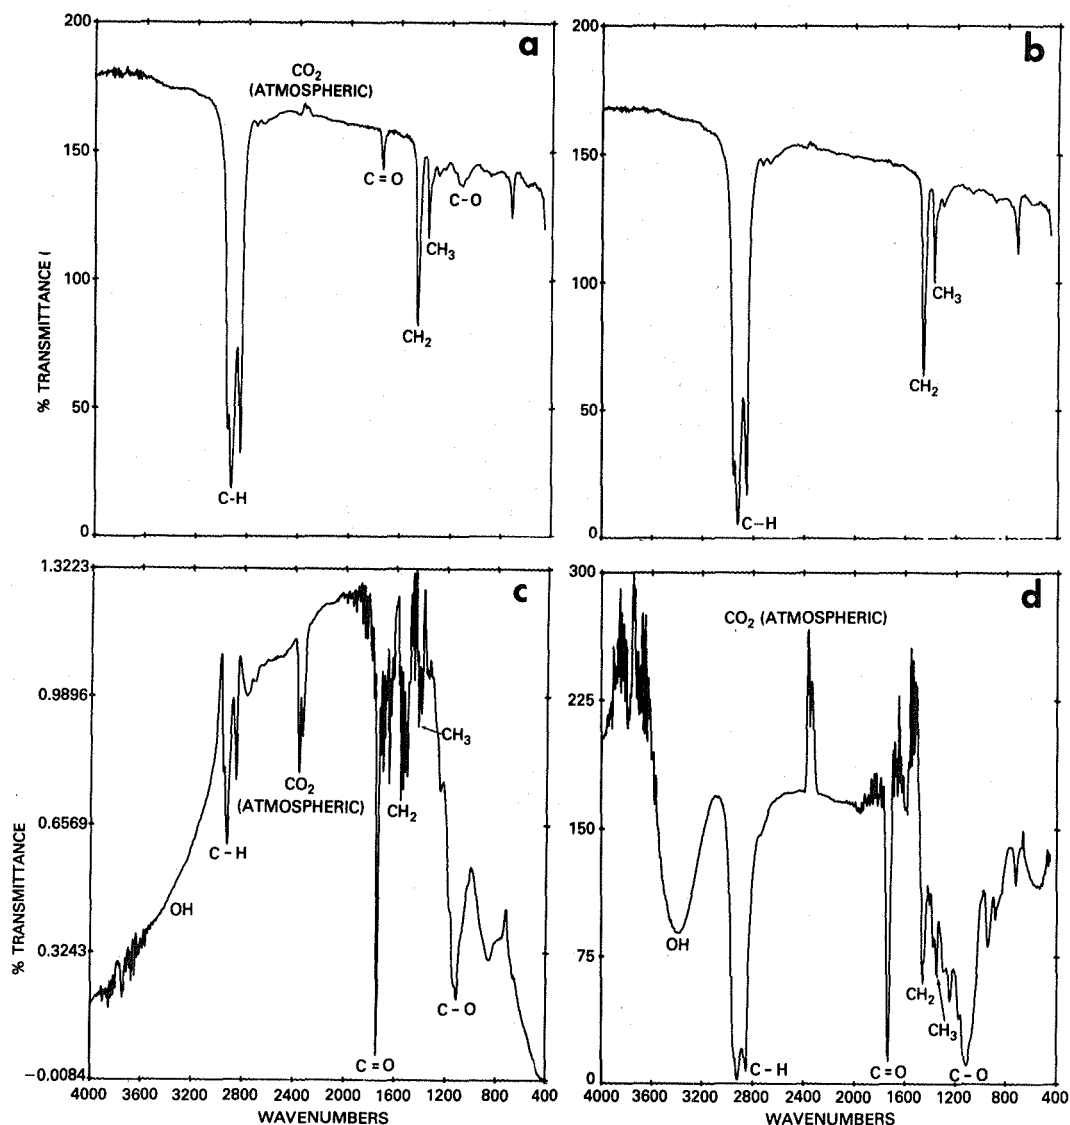
Figure 1: Antistatic Agent Transfer from Antistat-Containing Polymer Film to Lubricant After 5 Months Contact as Monitored by FTIR Spectra. a) Liquid Remaining on Substrate After Contact of SHC-B with PE + PEG; b) Pure SHC-B; c) Component Remaining After Subtraction of Fig. 1b from Fig. 1a; d) Pure PEG
