NBS SPECIAL PUBLICATION **640**

Innovation for Maintenance Technology Improvements

Proceedings of the 33rd Meeting of the
Mechanical Failures Prevention Group,
held at the National Bureau of Standards,
Gaithersburg, MD, April 21-23, 1981

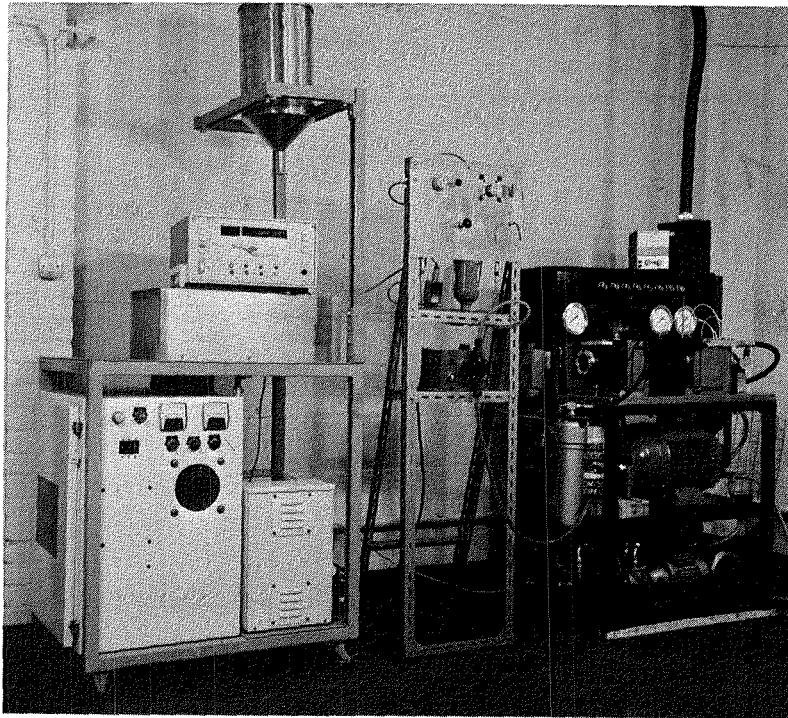
FIG. 1 Layout of Equipment.

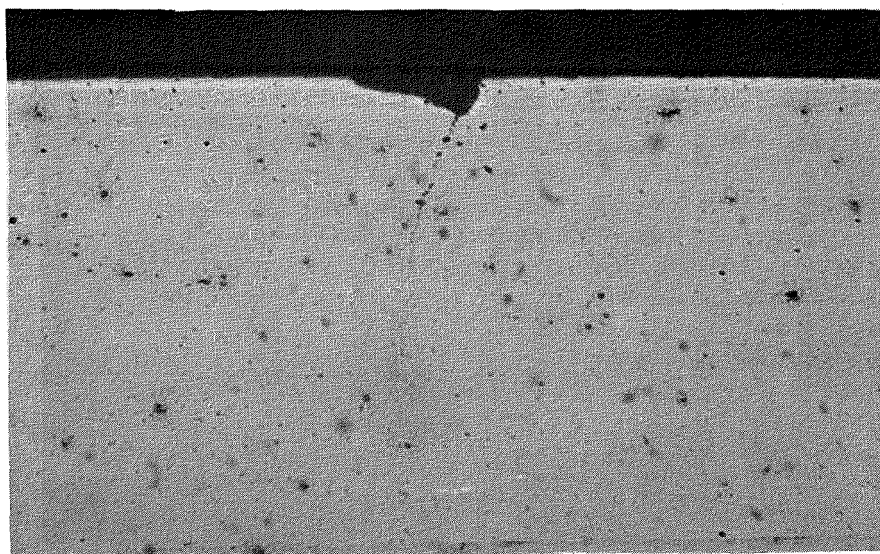
FIG. 7 Crack Propagation from an Indentation with 40 Micron Filtration ($\times 500$).

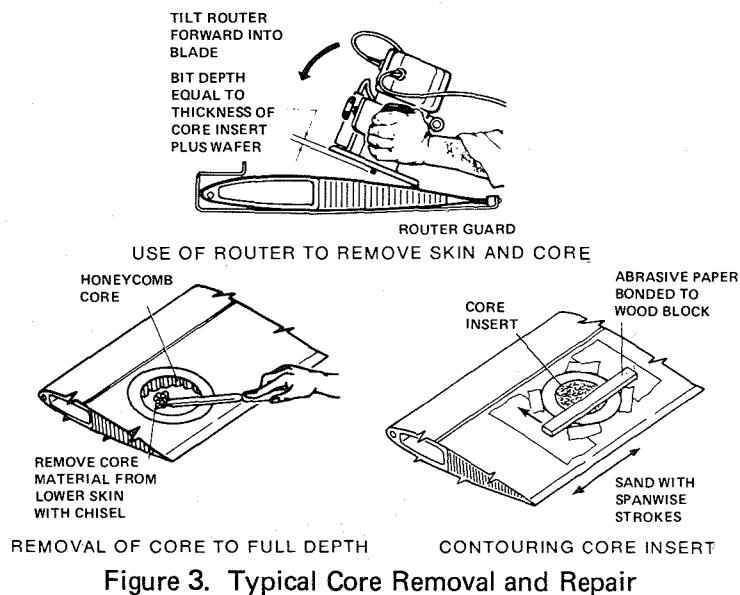
Figure 3. Typical Core Removal and Repair

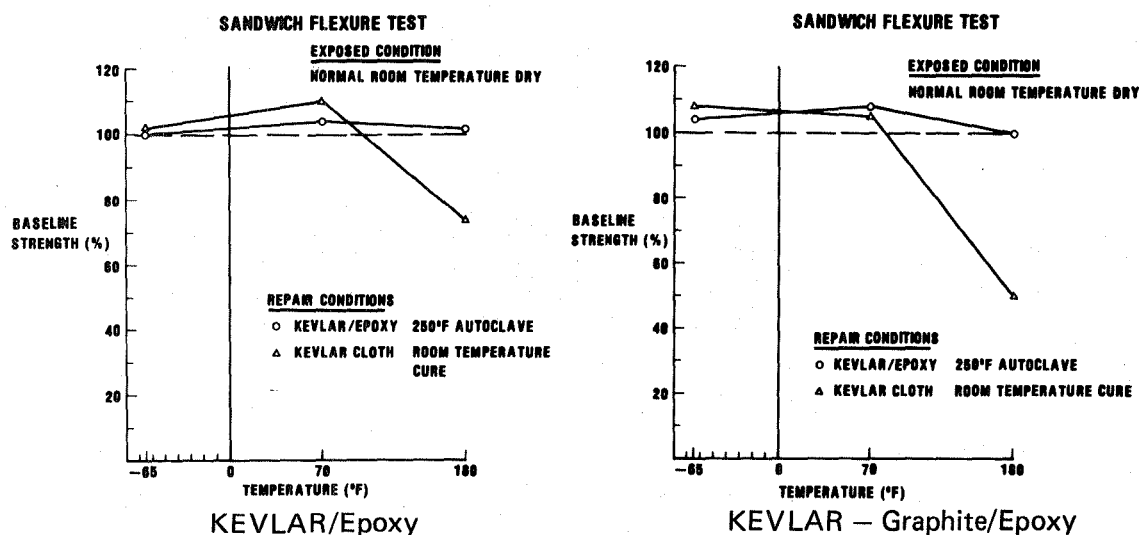
Figure 9. 250°F Cure Specimens

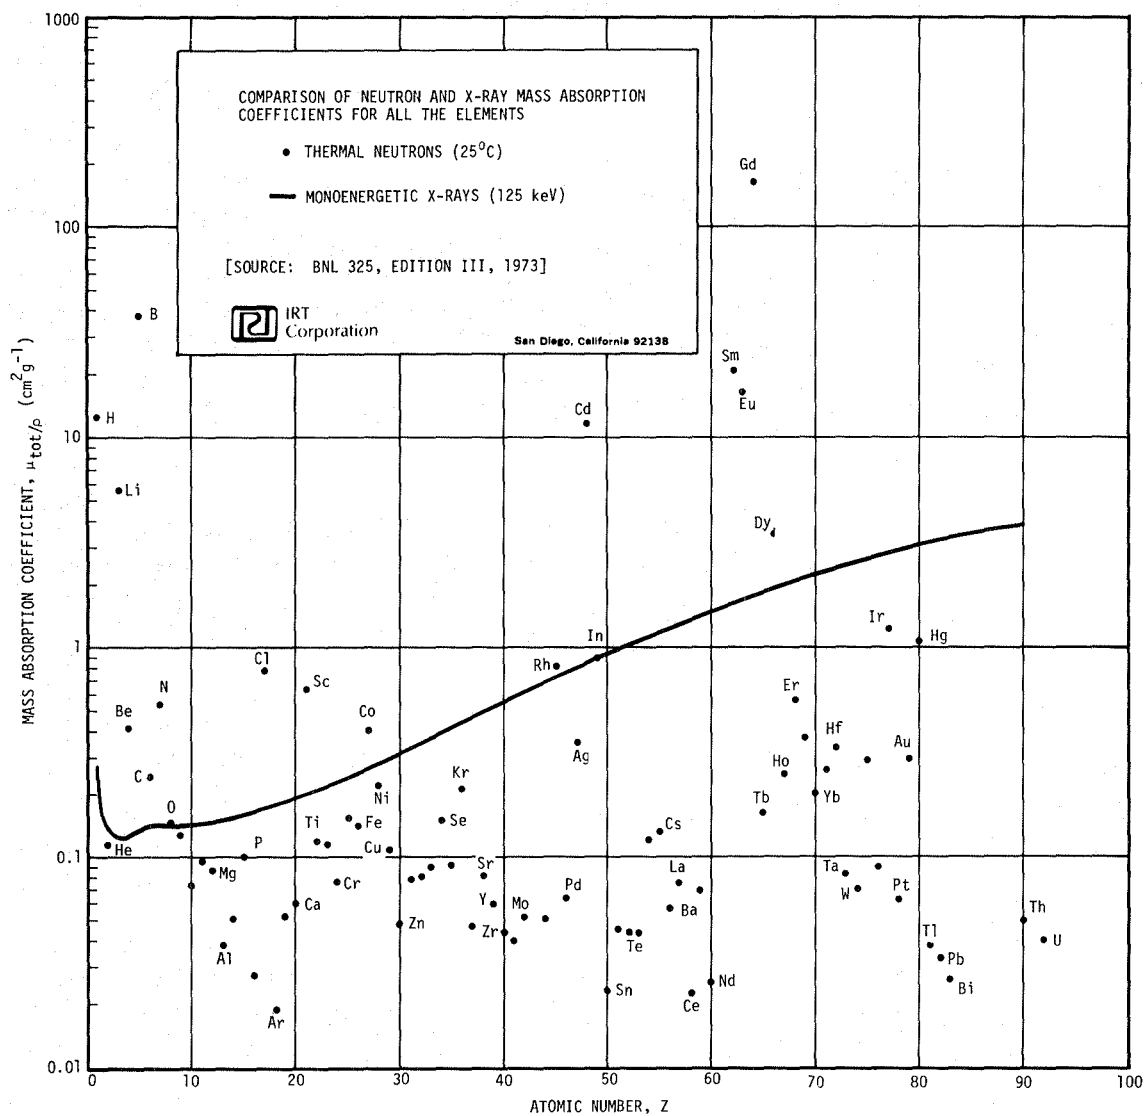
Figure 1. Comparison of x-ray and n-ray mass absorption coefficients

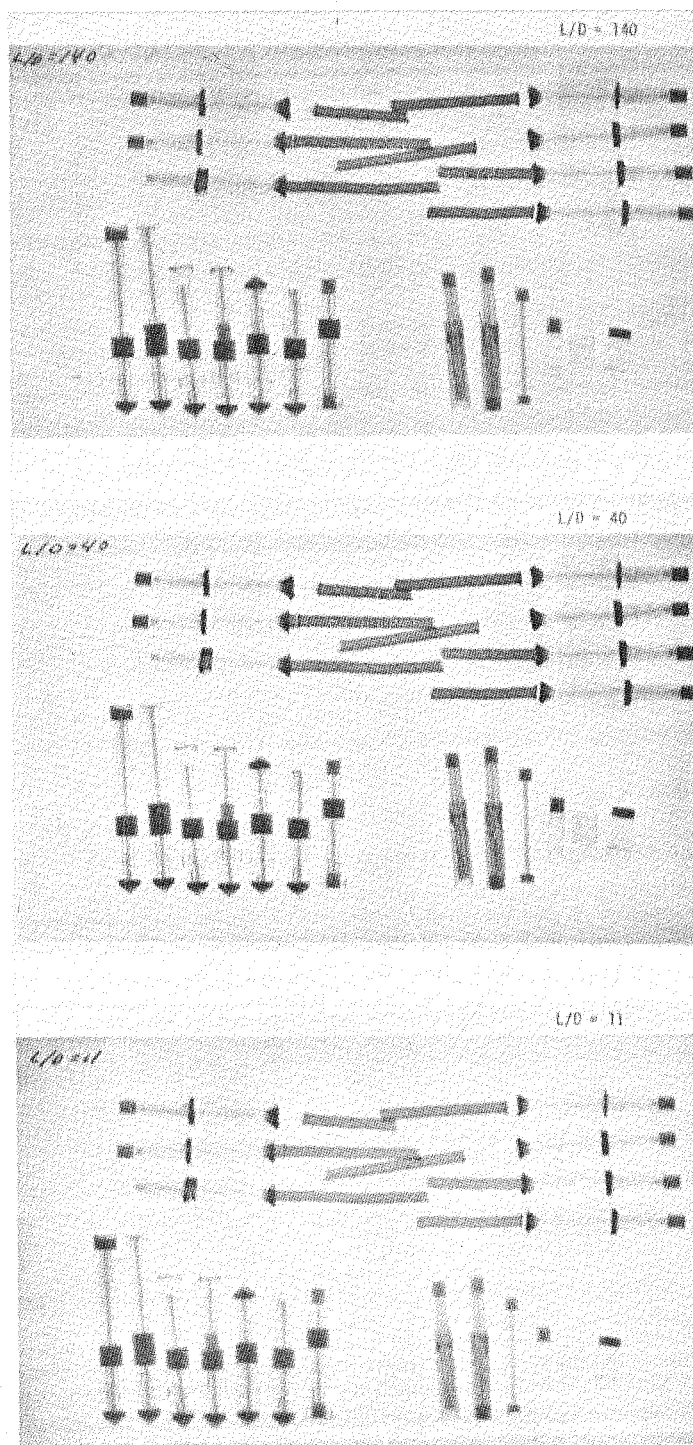
Figure 3. Prints of neutron radiographs of explosive train devices having known defects (such as missing end tips) taken with L/D ratio (resolution) of 140, typical of reactor-based radiography, and L/D ratios of 40 and 11, more typical of Cf-252-based neutron radiography.

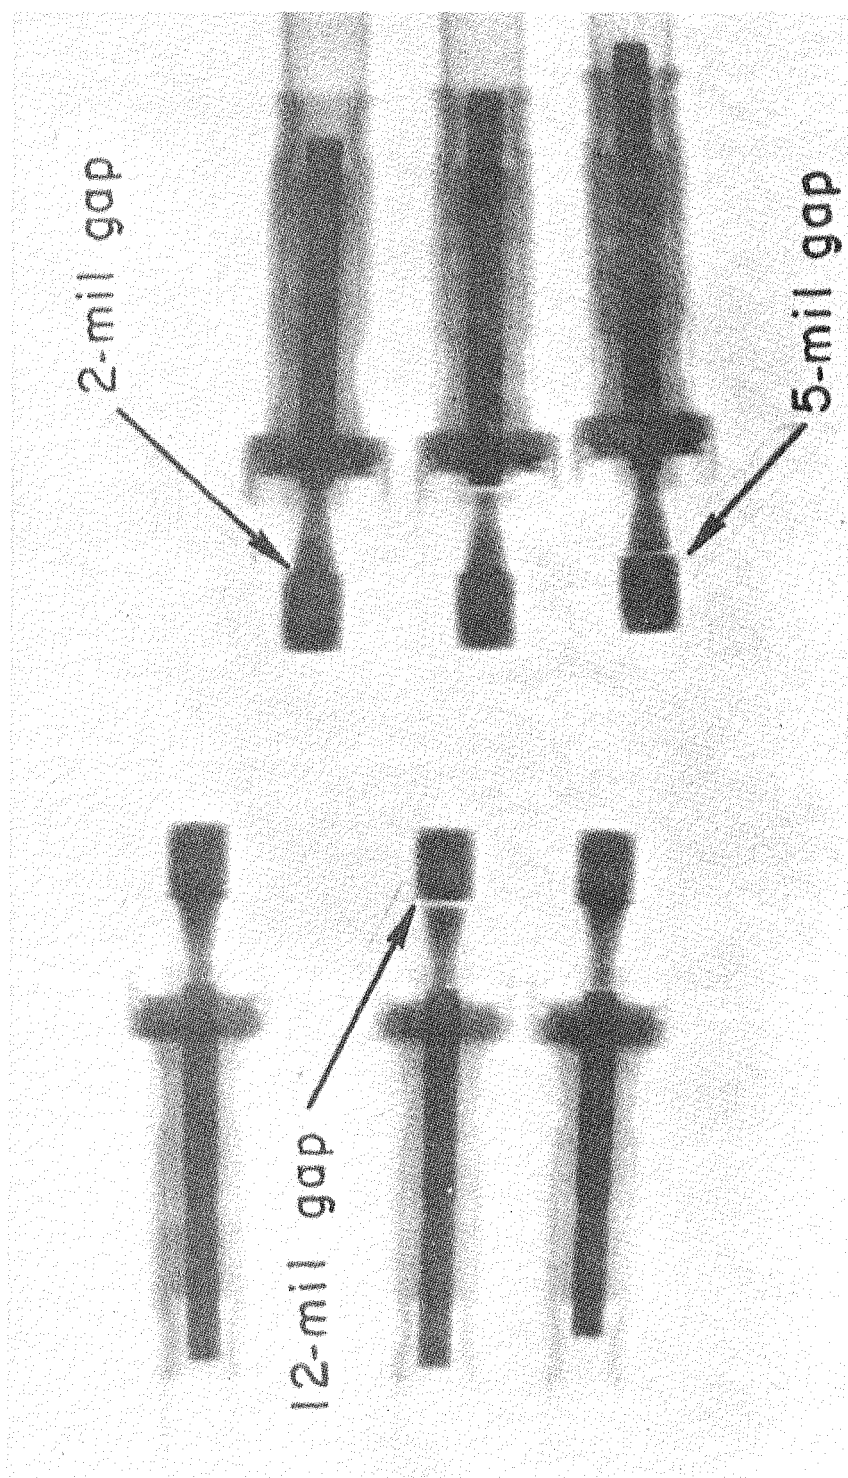
Figure 4. Enlarged print of neutron radiograph of shielded mild detonating cords with known defects (gaps of 12, 6, and 2 mils) identified by the arrows.

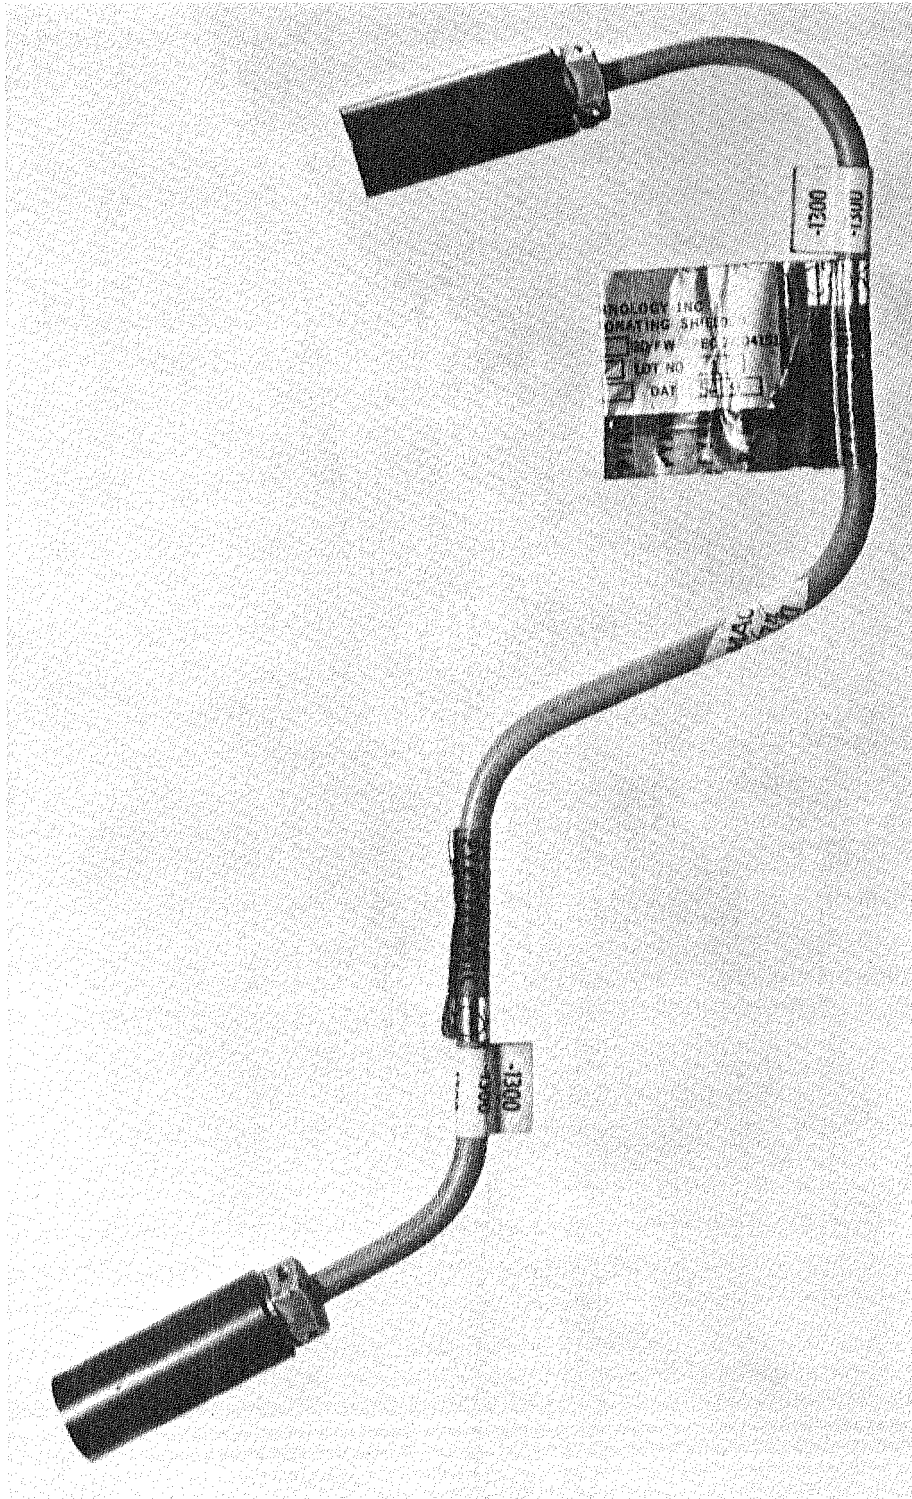
Figure 5. Photograph of pyrotechnic device used in the F-111 aircraft

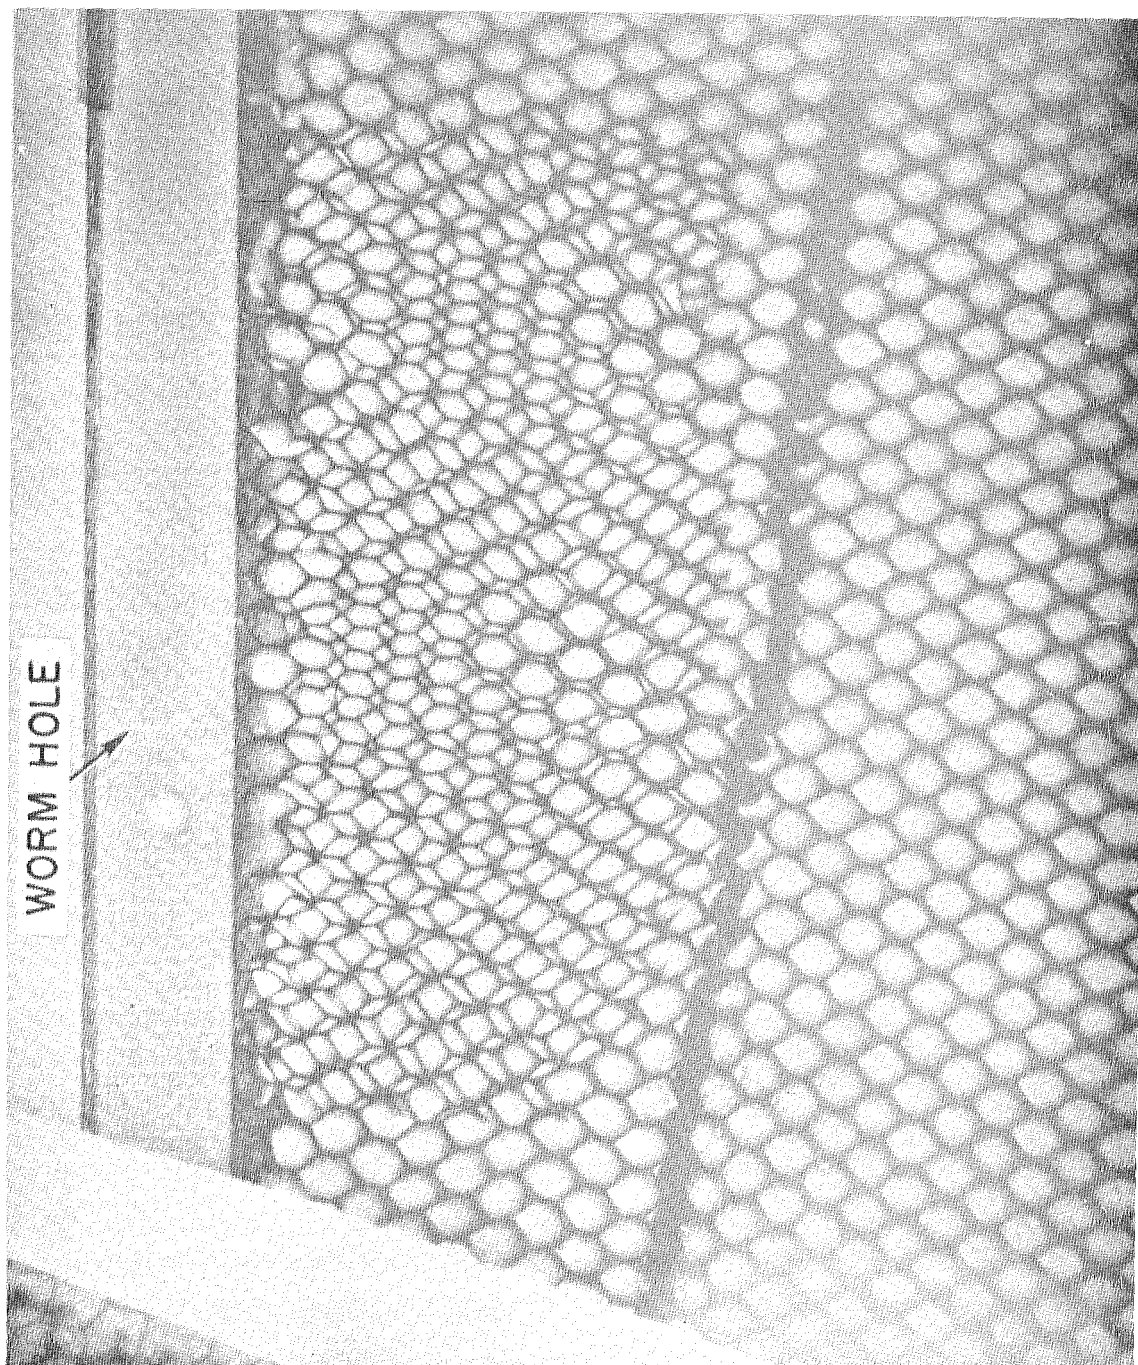
Figure 9. Neutron radiograph of a portion of the leading edge of the vertical stabilizer of an F-111 aircraft. The adhesive bond line between the aluminum arrowhead and the aluminum skin shows adhesive deficiencies providing possible leakage paths between the honeycomb cells and the outside environment. One such "worm hole" is labeled.

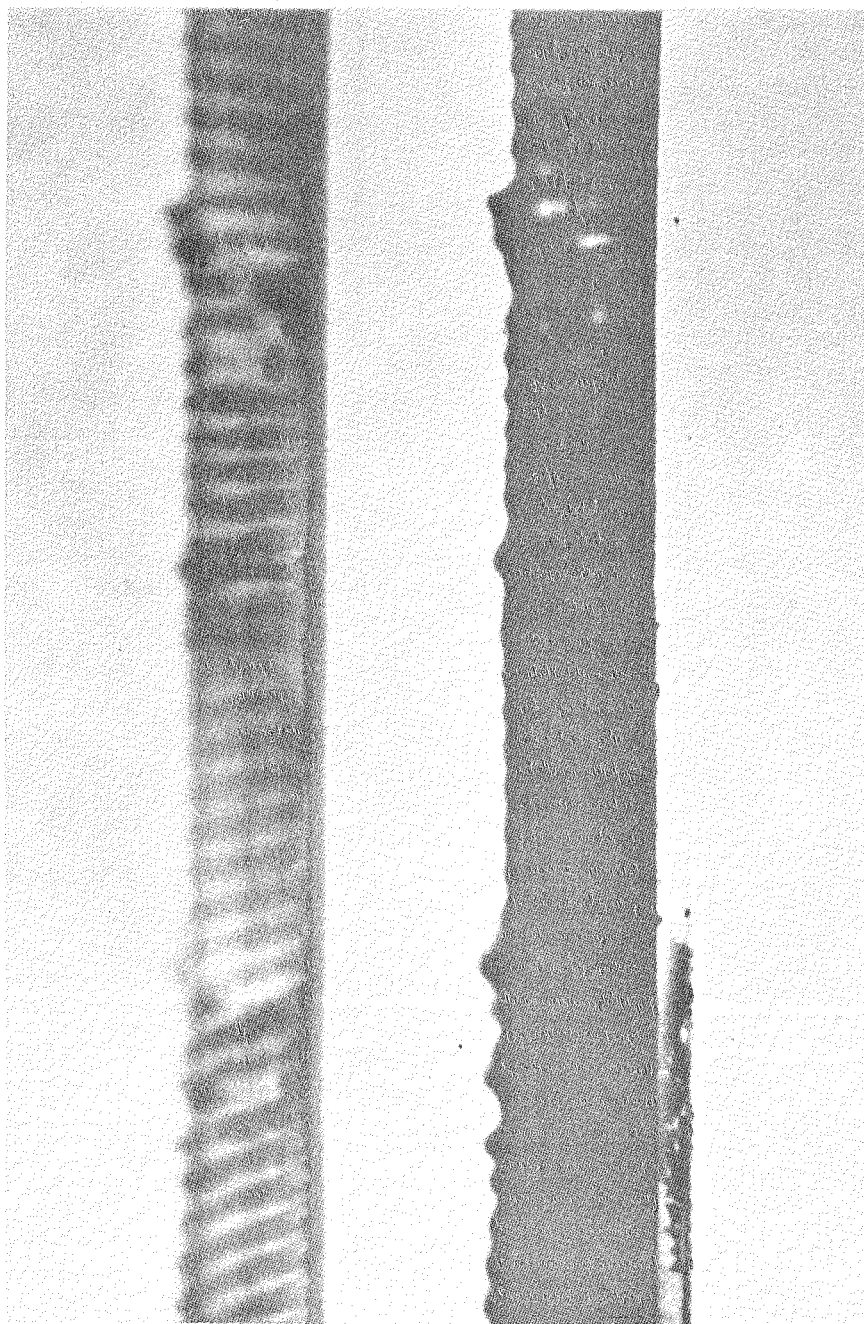
Figure 10. A composite of two neutron radiographs of a portion of a 540 helicopter blade system. The one at the left is a standard neutron radiograph showing the bond line between the C-spar and the spar closure clip, as well as the honeycomb. The one at the right shows the result after treatment with an enhancing agent. The penetration of the enhancing agent into the disbonded area helps clearly identify the extent of the disbond.

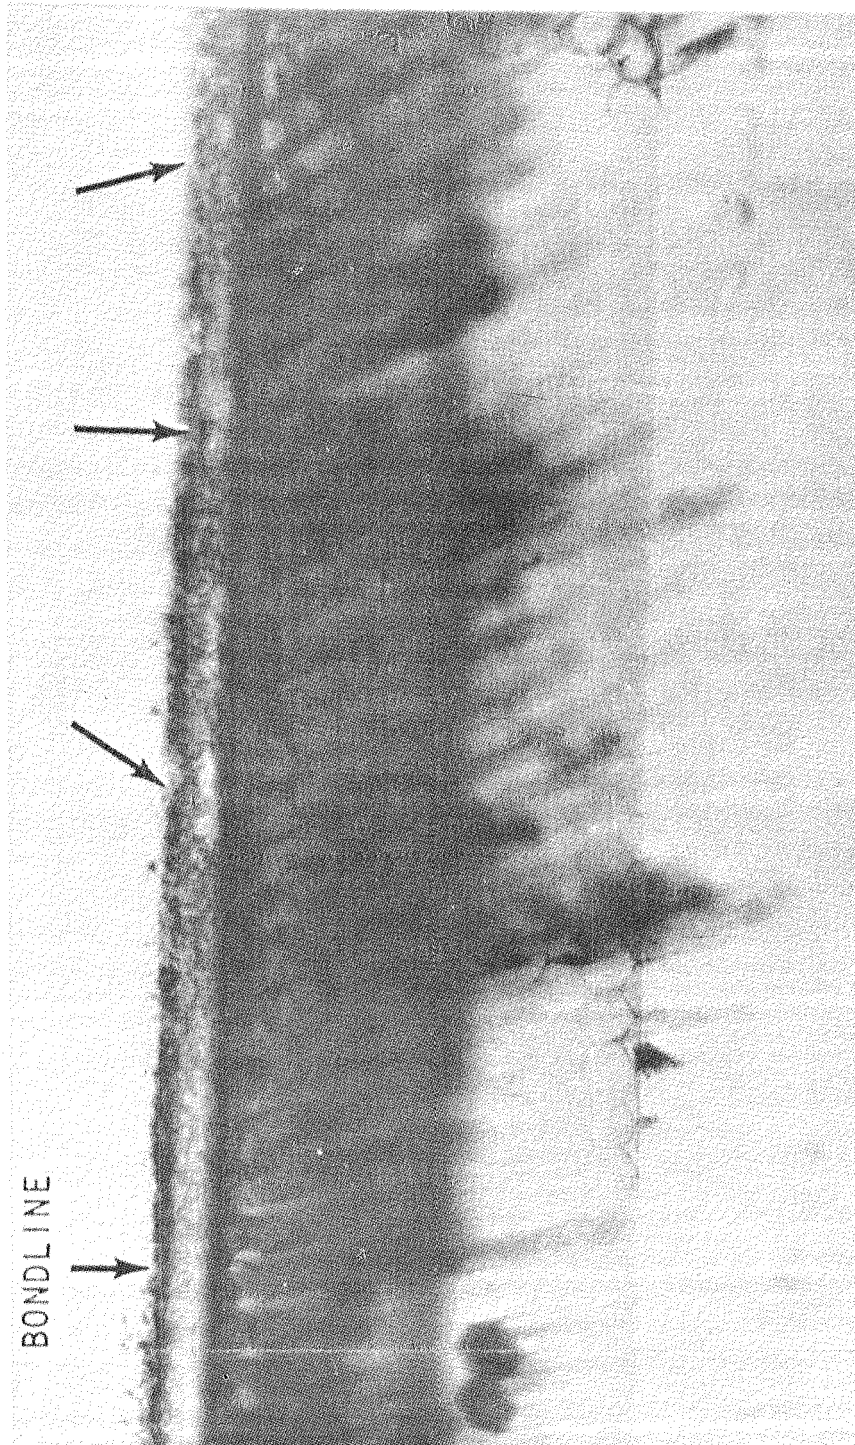
Figure 11. Neutron radiograph of a helicopter blade with fretting corrosion. The uneven nature of the bond line results from metal-to-metal contact due to inadequate quantities of adhesive.

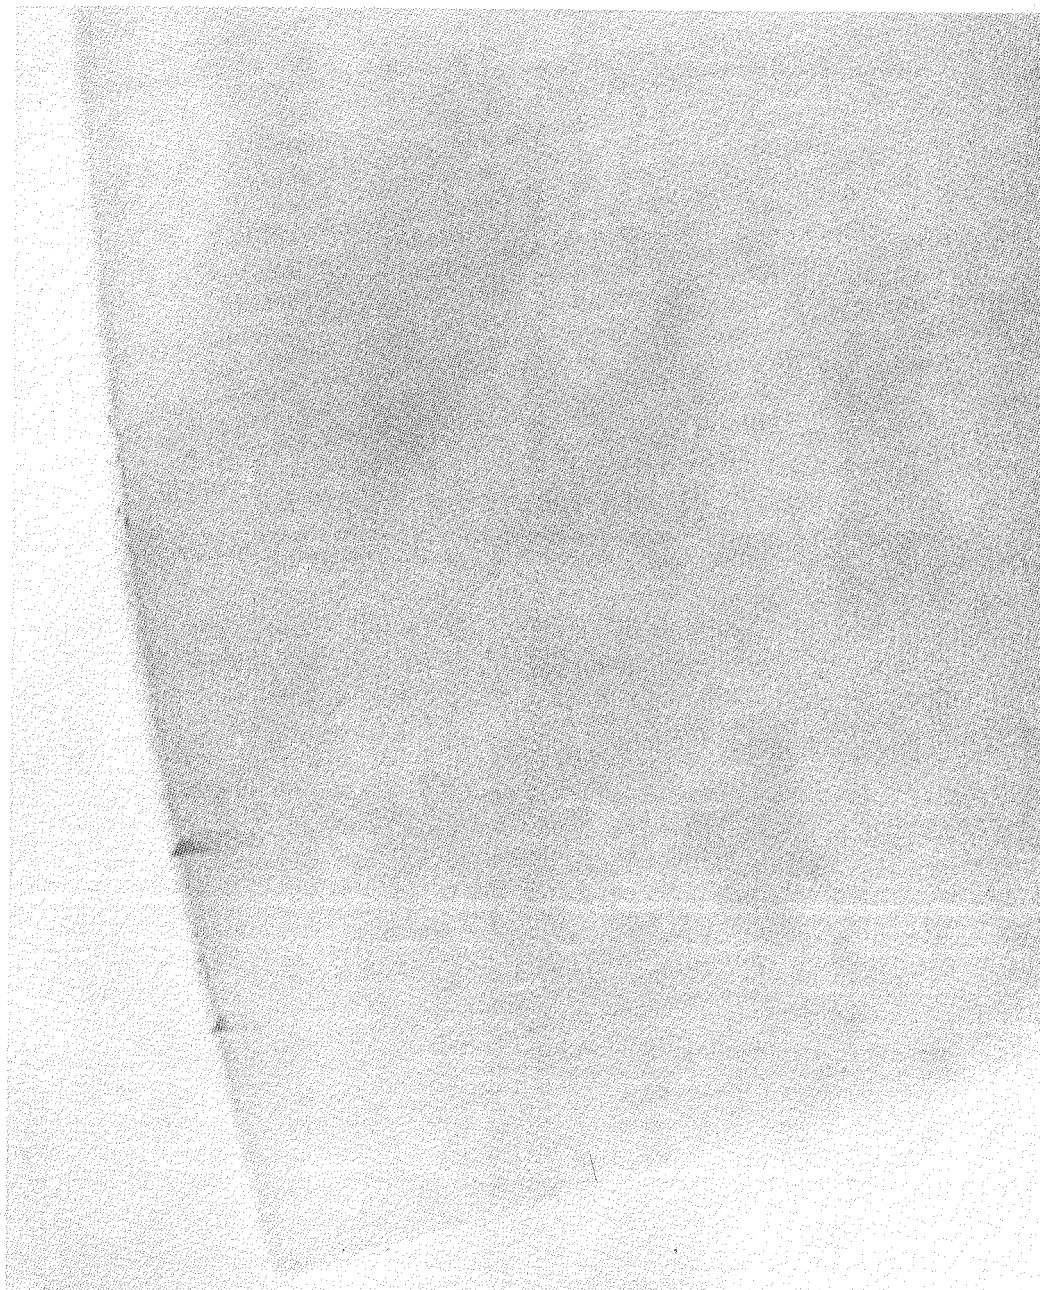
Figure 14. Neutron radiograph showing cracks at the tip of compressor blade of a TF-30 engine. The enhancing agent used in this case assists in defining the depth and orientation of the cracks.

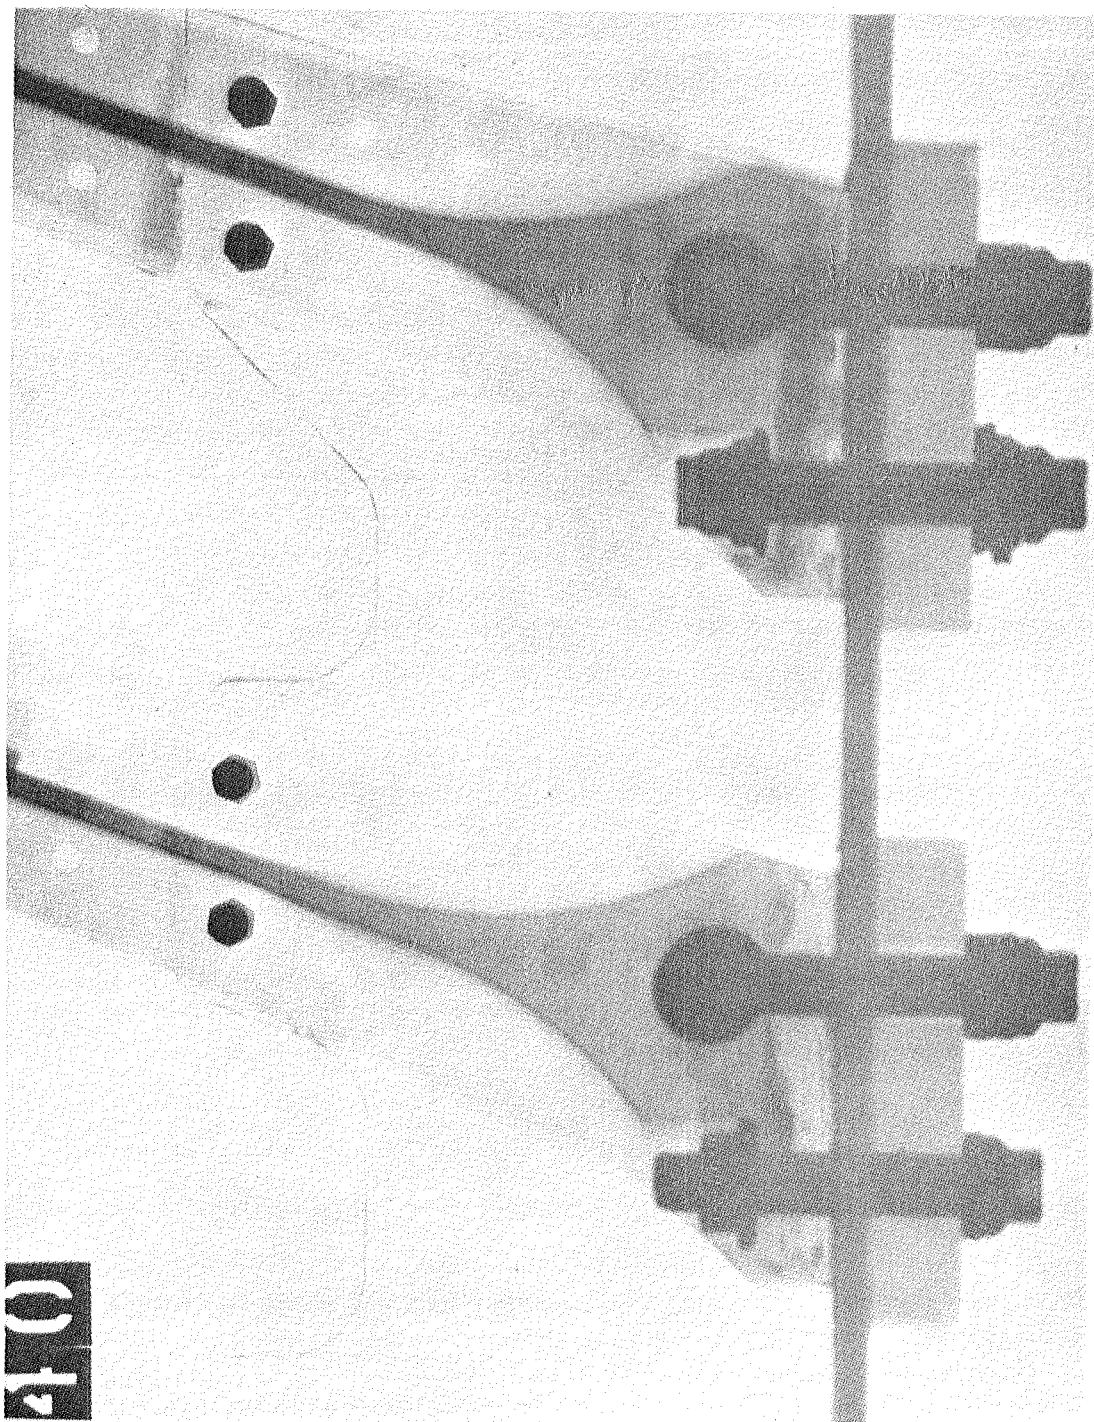
Figure 15. Neutron radiograph of a portion of the DC-9 wing tank showing the outline of the stringer, tee cap, and a set of bolts. The corroded area is visible through the stringer approximately two inches thick.

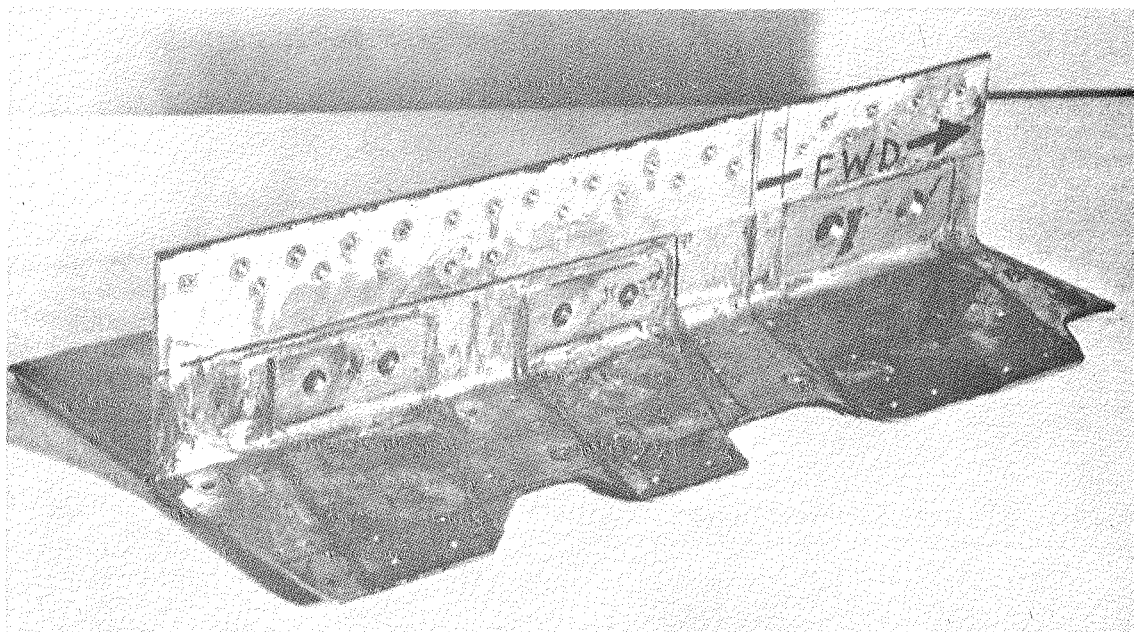
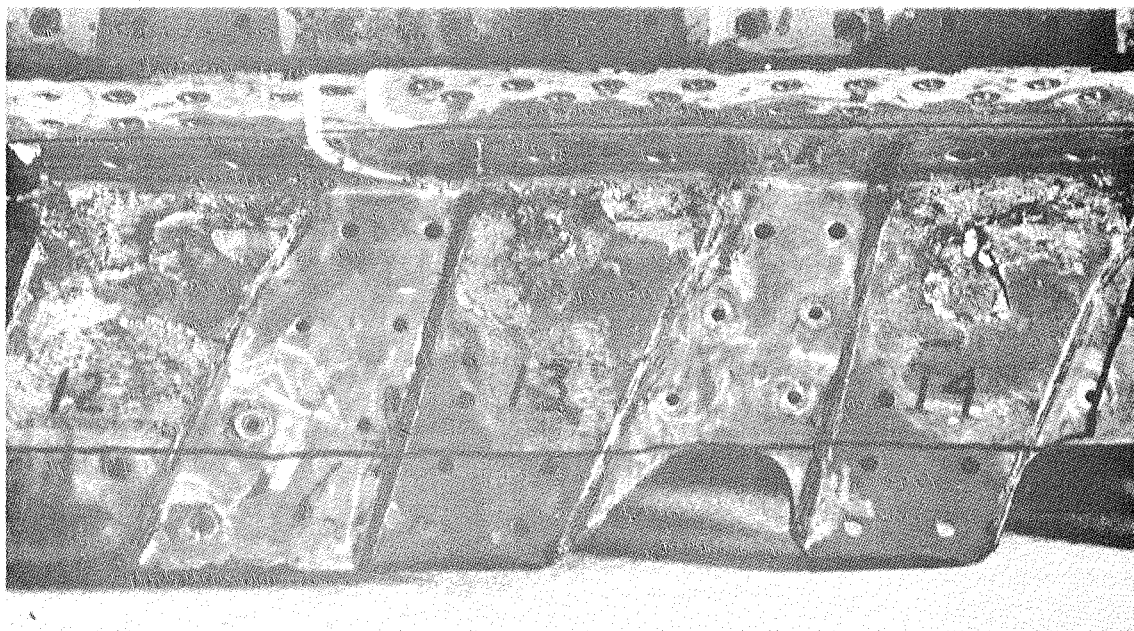
Figure 16. Photograph showing two views of the tee-cap surface from the DC-9 wing tank. Tee caps identified as 13 and 14 correspond to radiographs displayed in Figure 15.

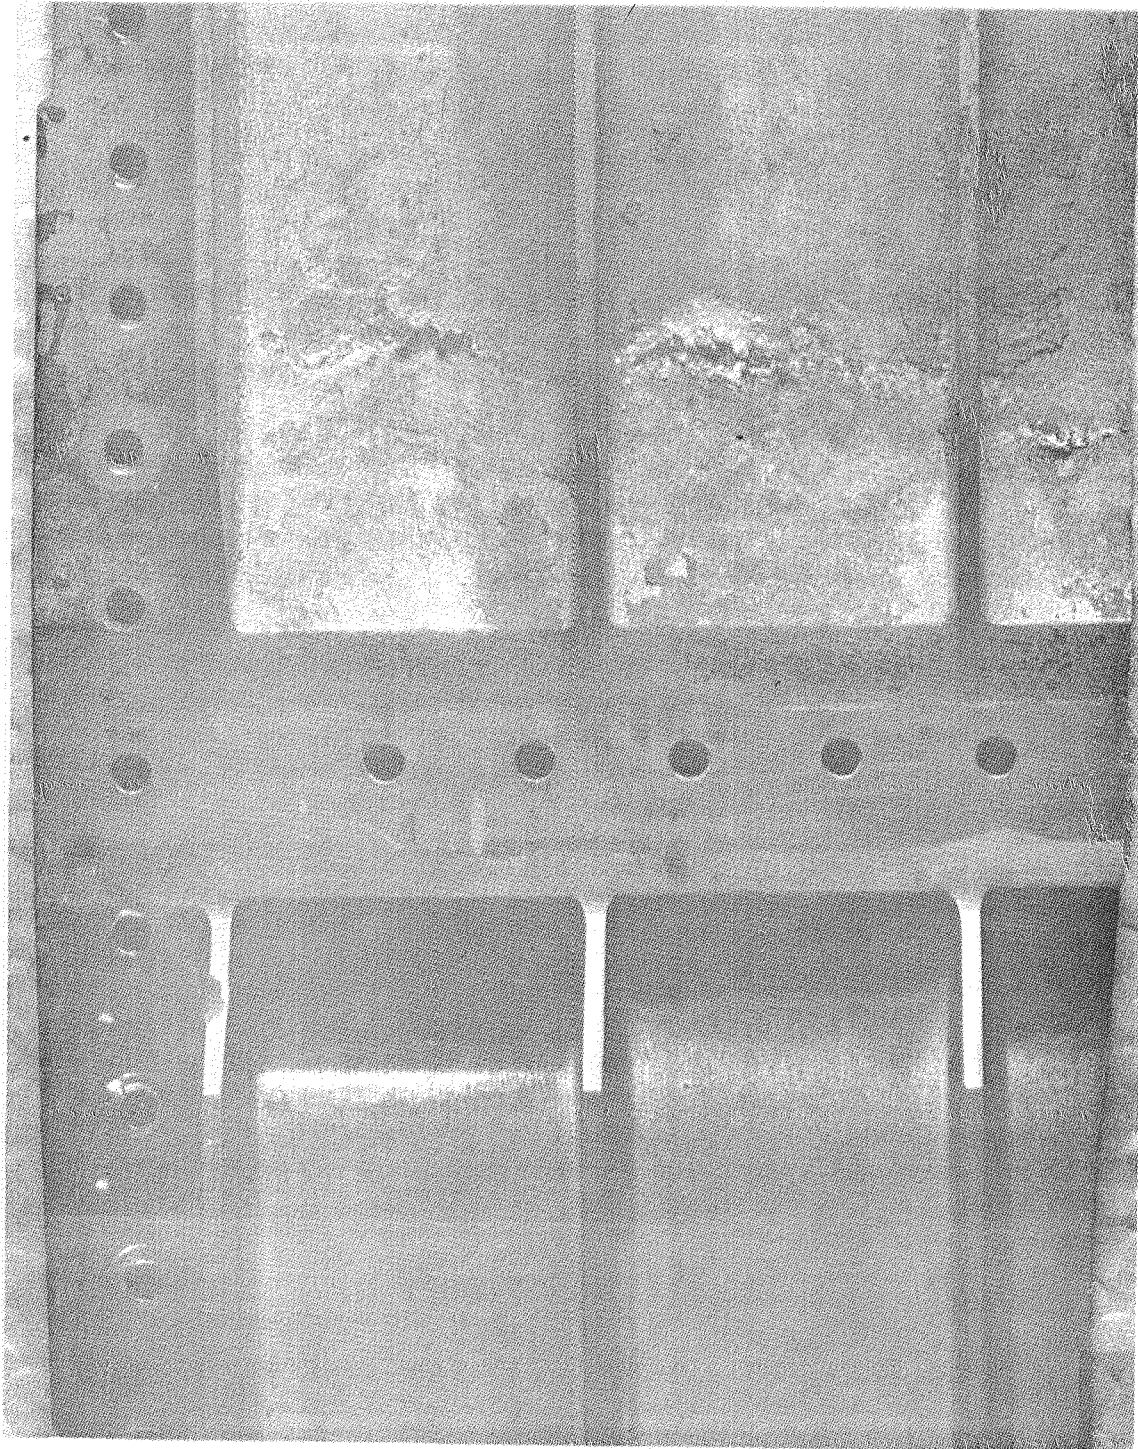
Figure 17. Photograph of a portion of the lower wing skin structure of a C-130 aircraft, showing the origin of the corrosion attack. The extent of corrosion is not clear from such visual inspection.

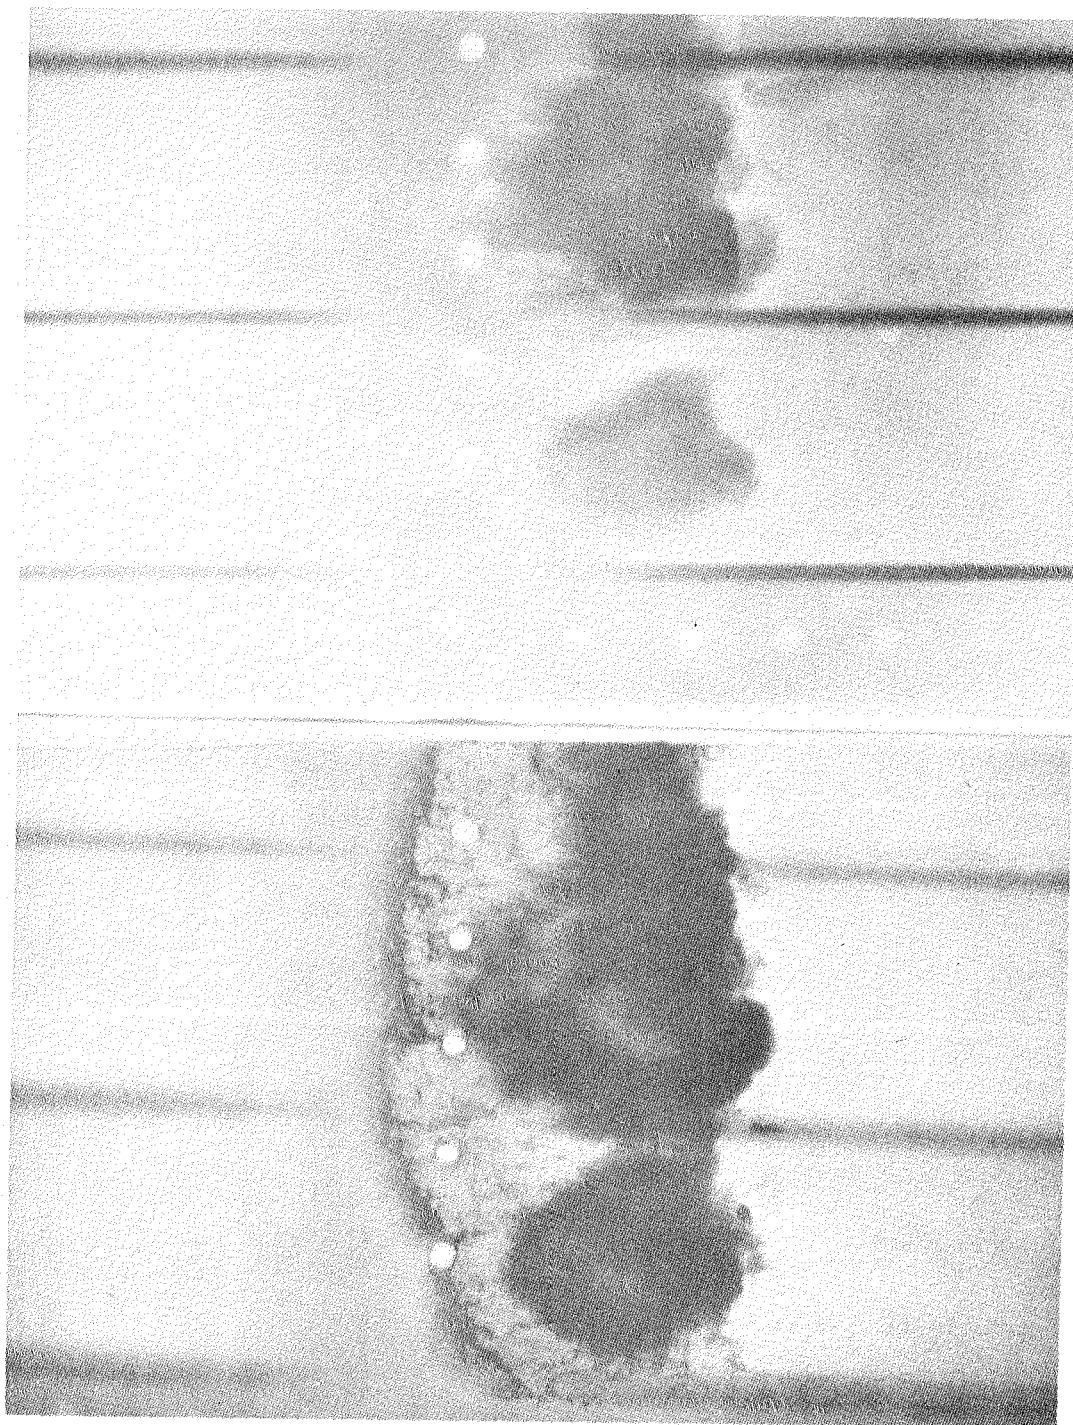
Figure 18. Neutron radiograph of C-130 wing structure. The neutron radiograph at the top is obtained in the usual way, and the one at the bottom with the use of a penetrant. The intergranular corrosion is seen to extend beyond the rivet holes, clearly explaining the cause of fuel leak from these holes.

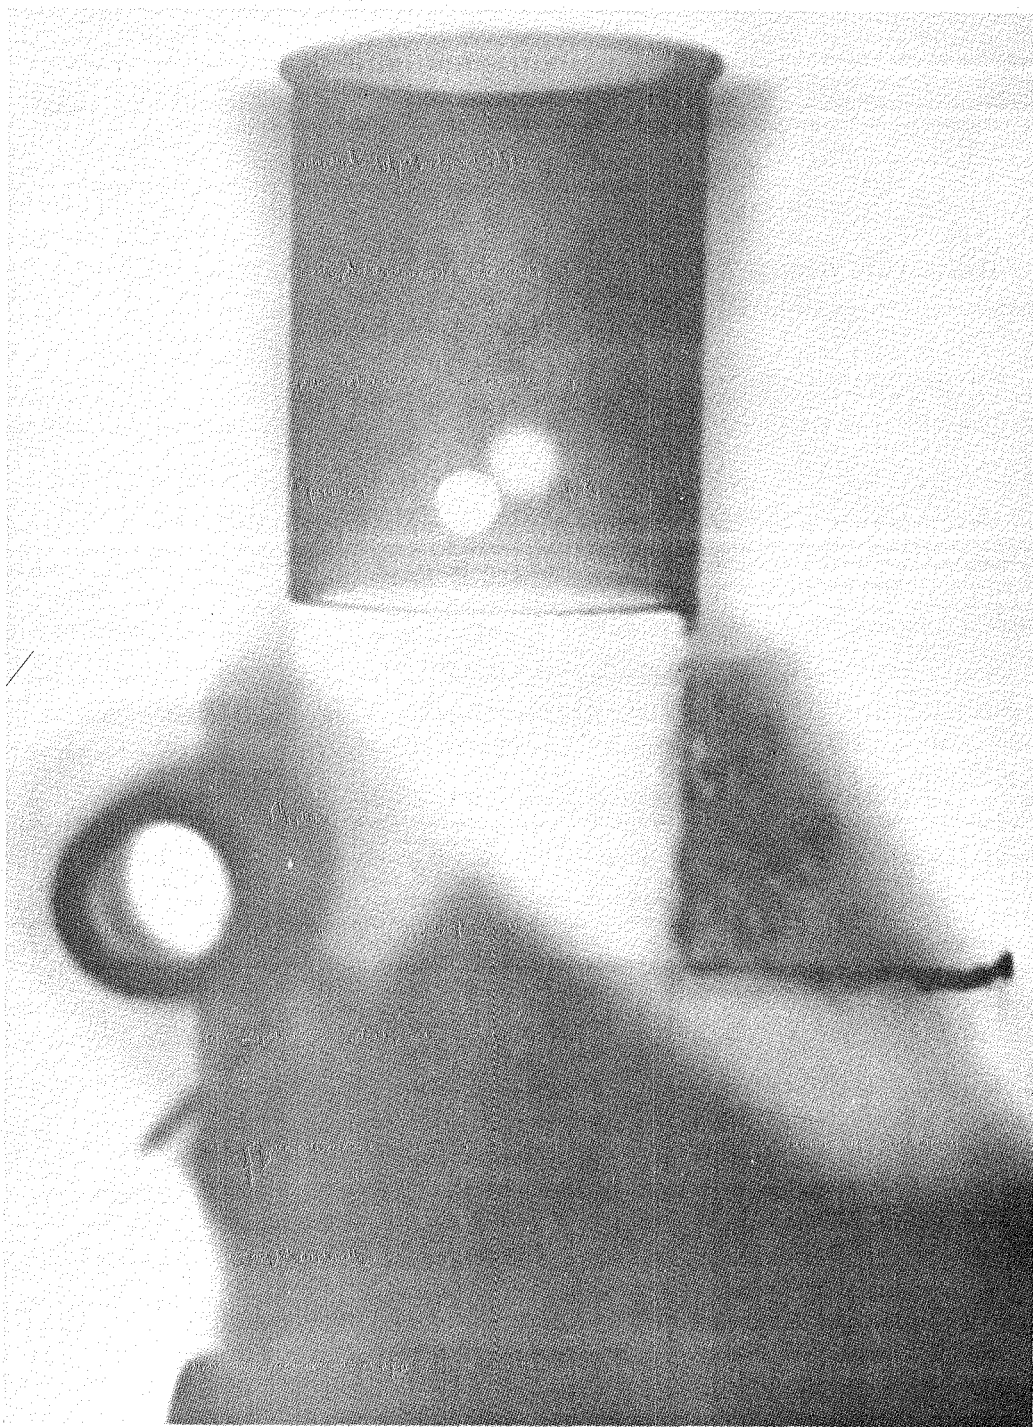
Figure 19. Neutron radiograph of an A-7 nose landing gear strut showing the extent, shape, and nature of stress-corrosion crack. This crack was barely visible, even after its location was confirmed by the eddy current technique.

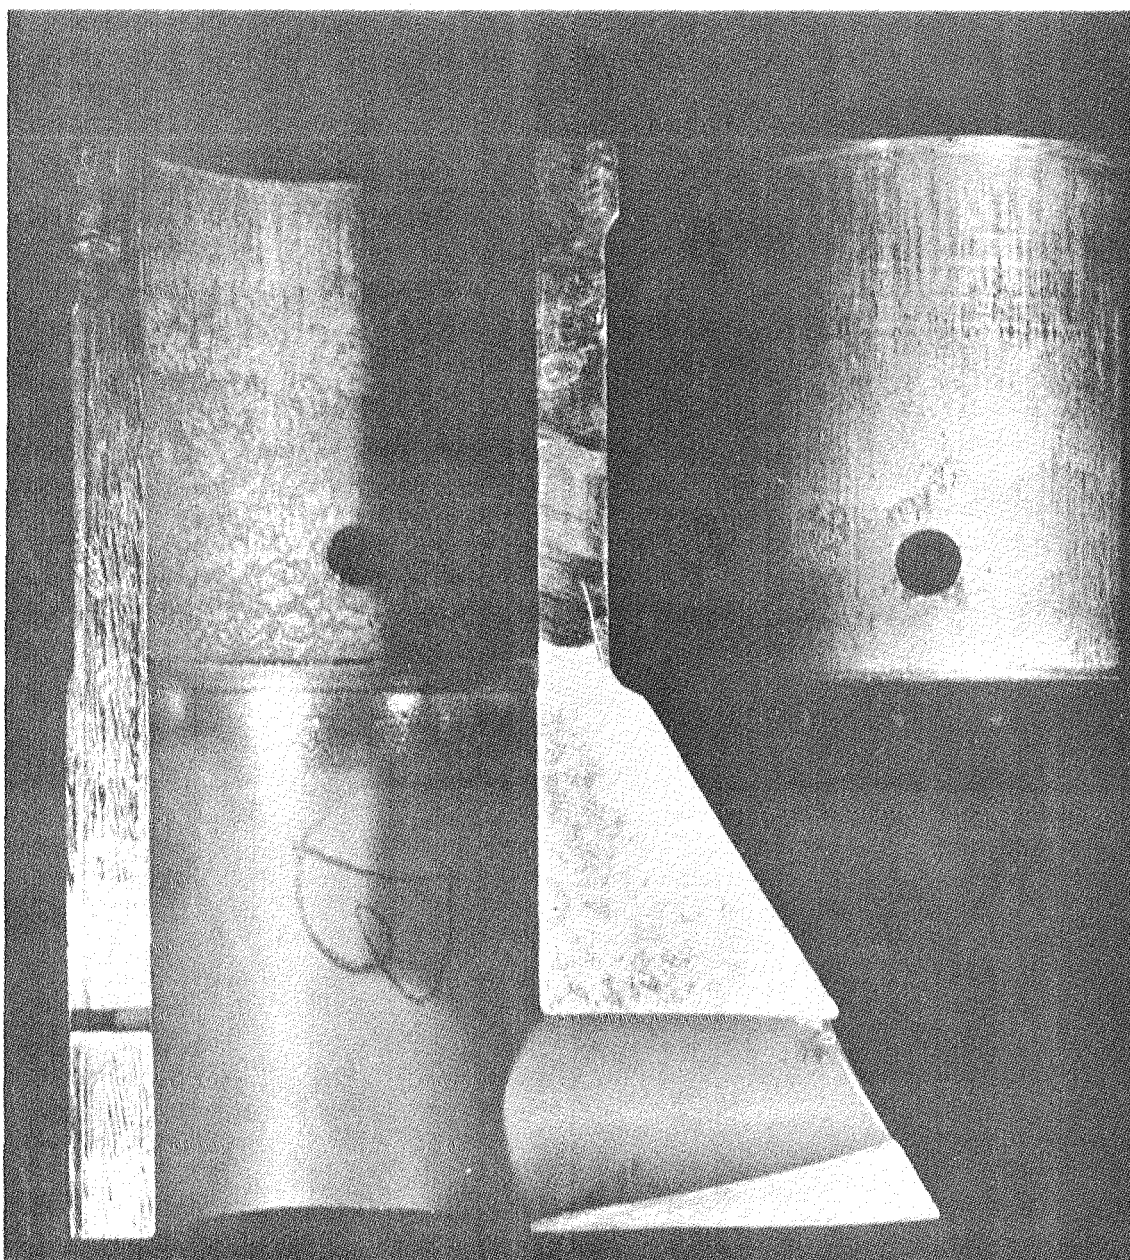
Figure 20. Photograph of the sectioned trunnion area showing the extent and shape of stress-corrosion crack

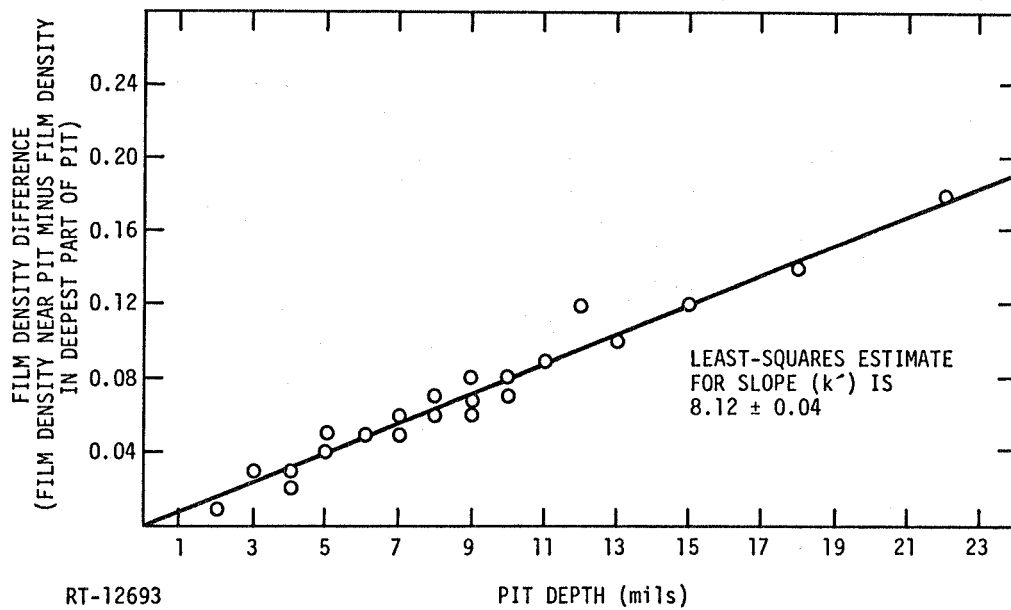
Figure 21. Graph of film density difference versus pit depth for corroded pits located on F-4 torque box panels (with AA film)
