NBS SPECIAL PUBLICATION **640**

Innovation for Maintenance Technology Improvements

Proceedings of the 33rd Meeting of the
Mechanical Failures Prevention Group,
held at the National Bureau of Standards,
Gaithersburg, MD, April 21-23, 1981

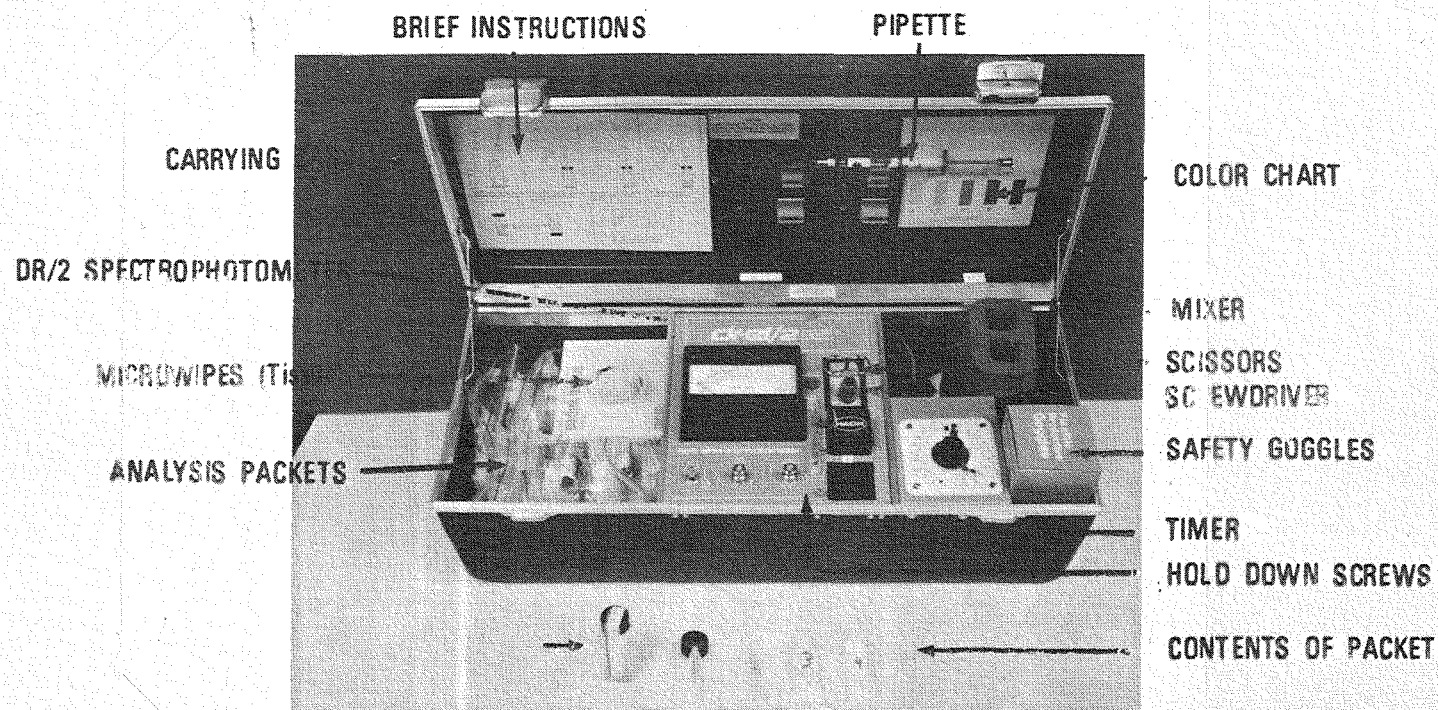
Figure 2. Colorimetric oil analysis field test kit.

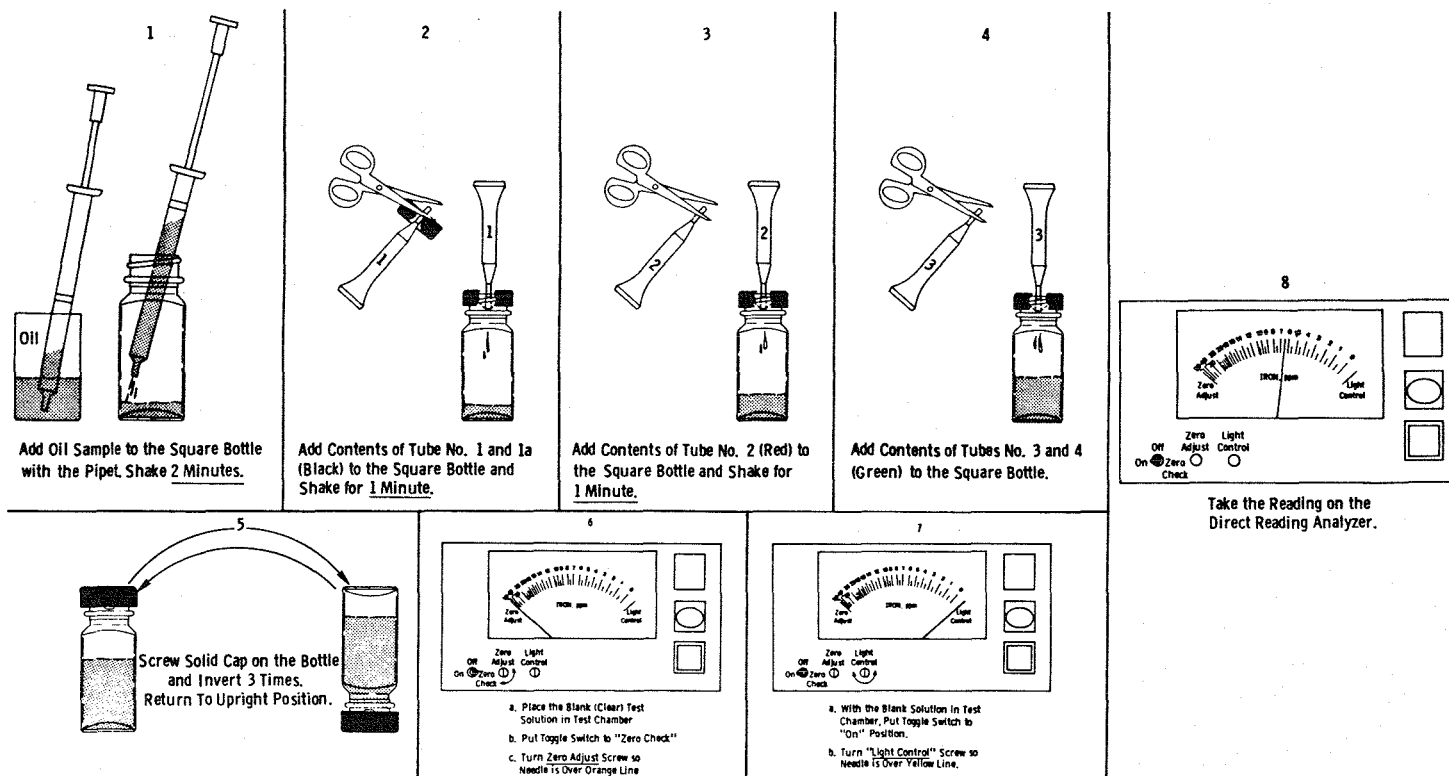
Figure 3. Pictorial step-by-step instruction sheet for the colorimetric method.

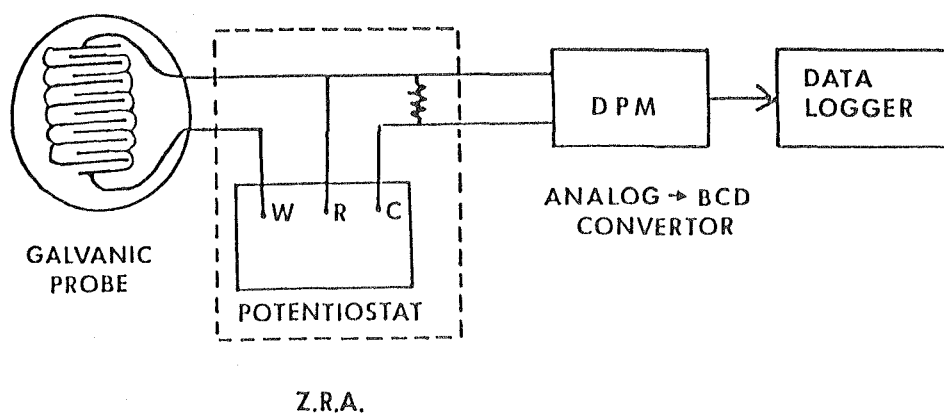
FIGURE 1. ENVIRONMENTAL CORROSIVITY MONITORING PROBE AND THE RELATED INSTRUMENTATION SCHEMATIC.

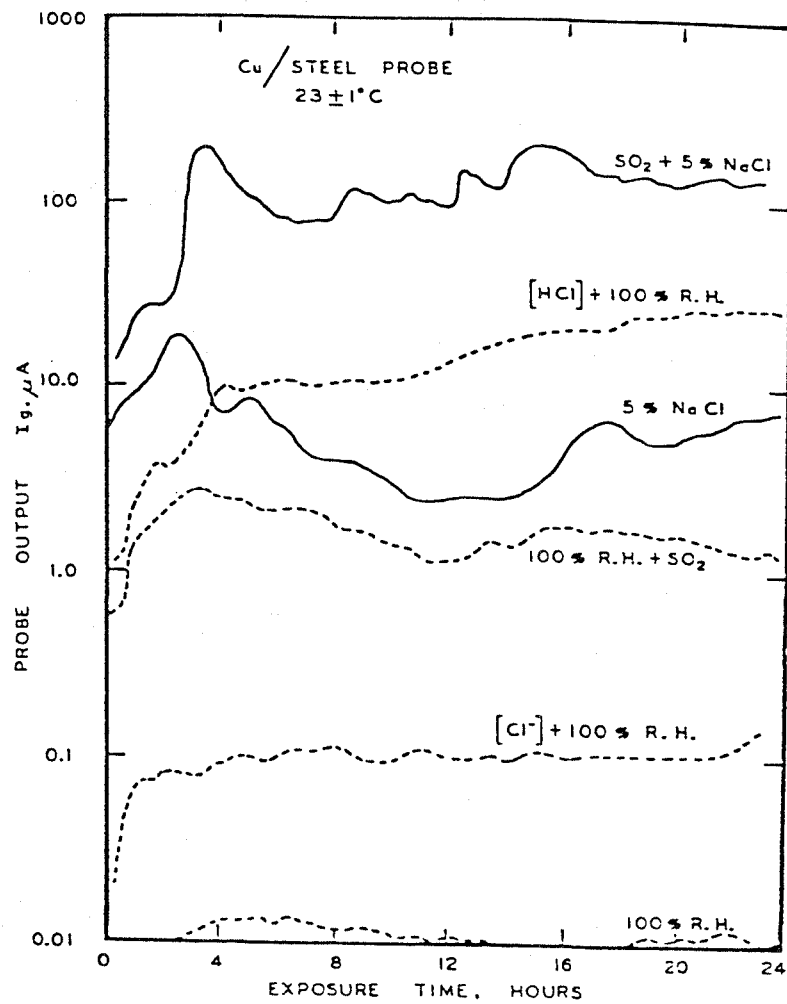
FIGURE 2. GALVANIC CURRENT TRANSIENTS OF COPPER/STEEL PROBE EXPOSED TO VARIOUS LABORATORY SIMULATED ENVIRONMENTS.

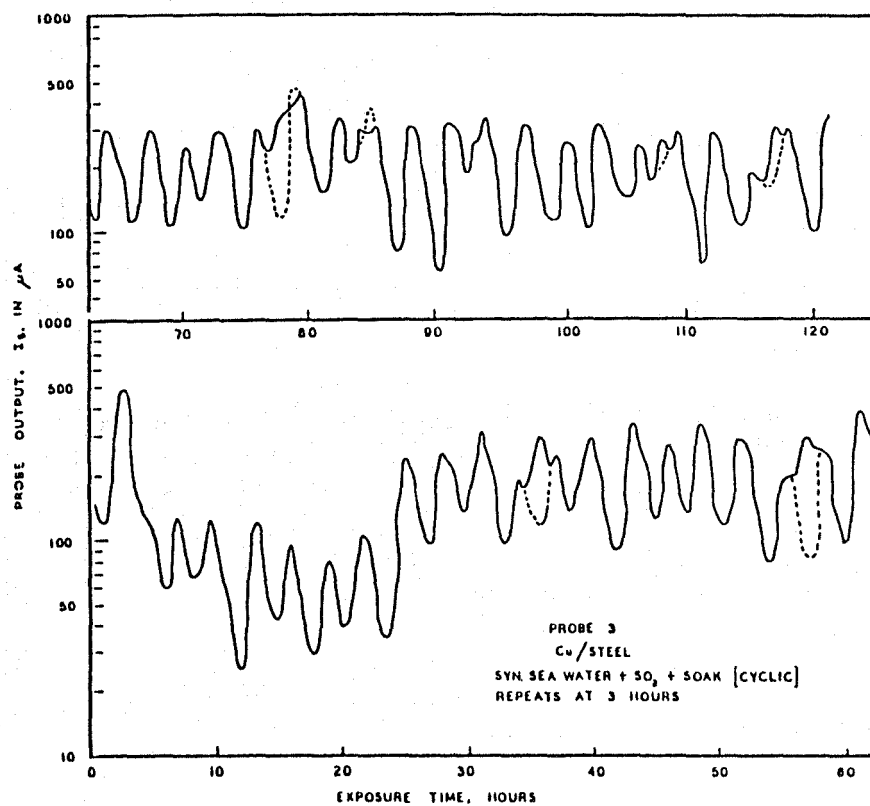
FIGURE 7. PERFORMANCE OF COPPER/STEEL PROBE IN AN ALTERNATING CORROSIVE ENVIRONMENT (SOAK CYCLE) OVER A LONG PERIOD OF EXPOSURE SHOWING THE CYCLIC NATURE OF THE ENVIRONMENTAL CORROSIVITY TEST.
