Copy No. 215
RM No. L8E14a

FLIGHT MEASUREMENT OF THE STABILITY CHARACTERISTICS
OF THE DOUGLAS D-558-1 AIRPLANE
(BUAERO NO. 37971) IN SIDESLIPS

Walter C. Williams

April 18, 1949

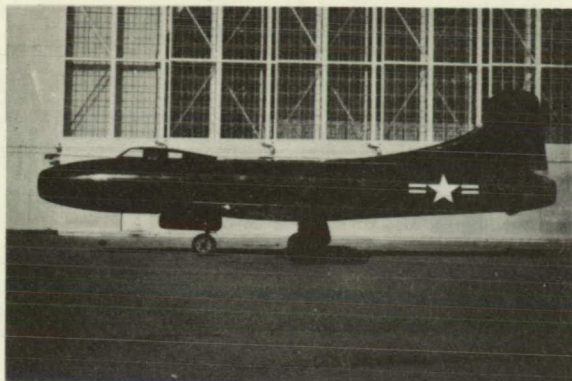
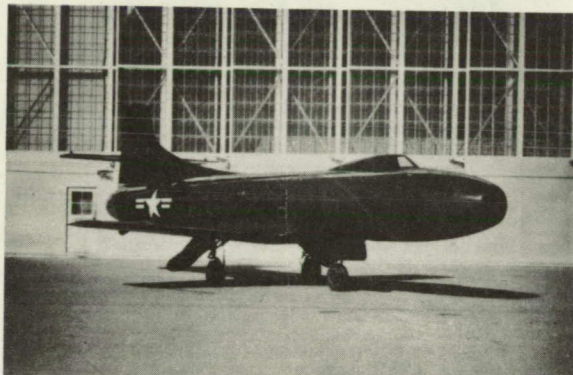
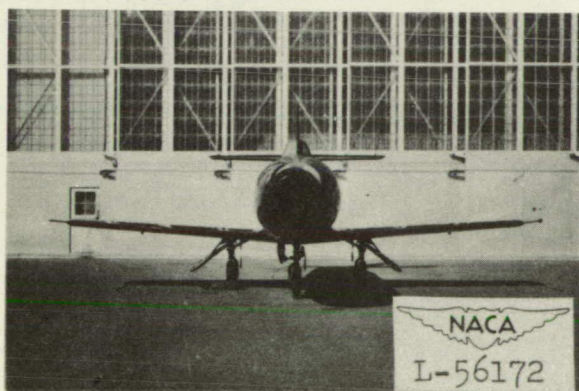
(a) Side view.

(b) Three-quarter front view.

(c) Front view.

Figure 1.- Photographs of D-558-1 airplane.

The Douglas D-558-1 airplane is a single-place low-wing monoplane powered by a single General Electric TG-180 turbojet engine. General views of the airplane are given in figures 1(a), (b), and (c). A three-view layout of the airplane is given in figure 2. Detailed specifications of the airplane are given in reference 1.

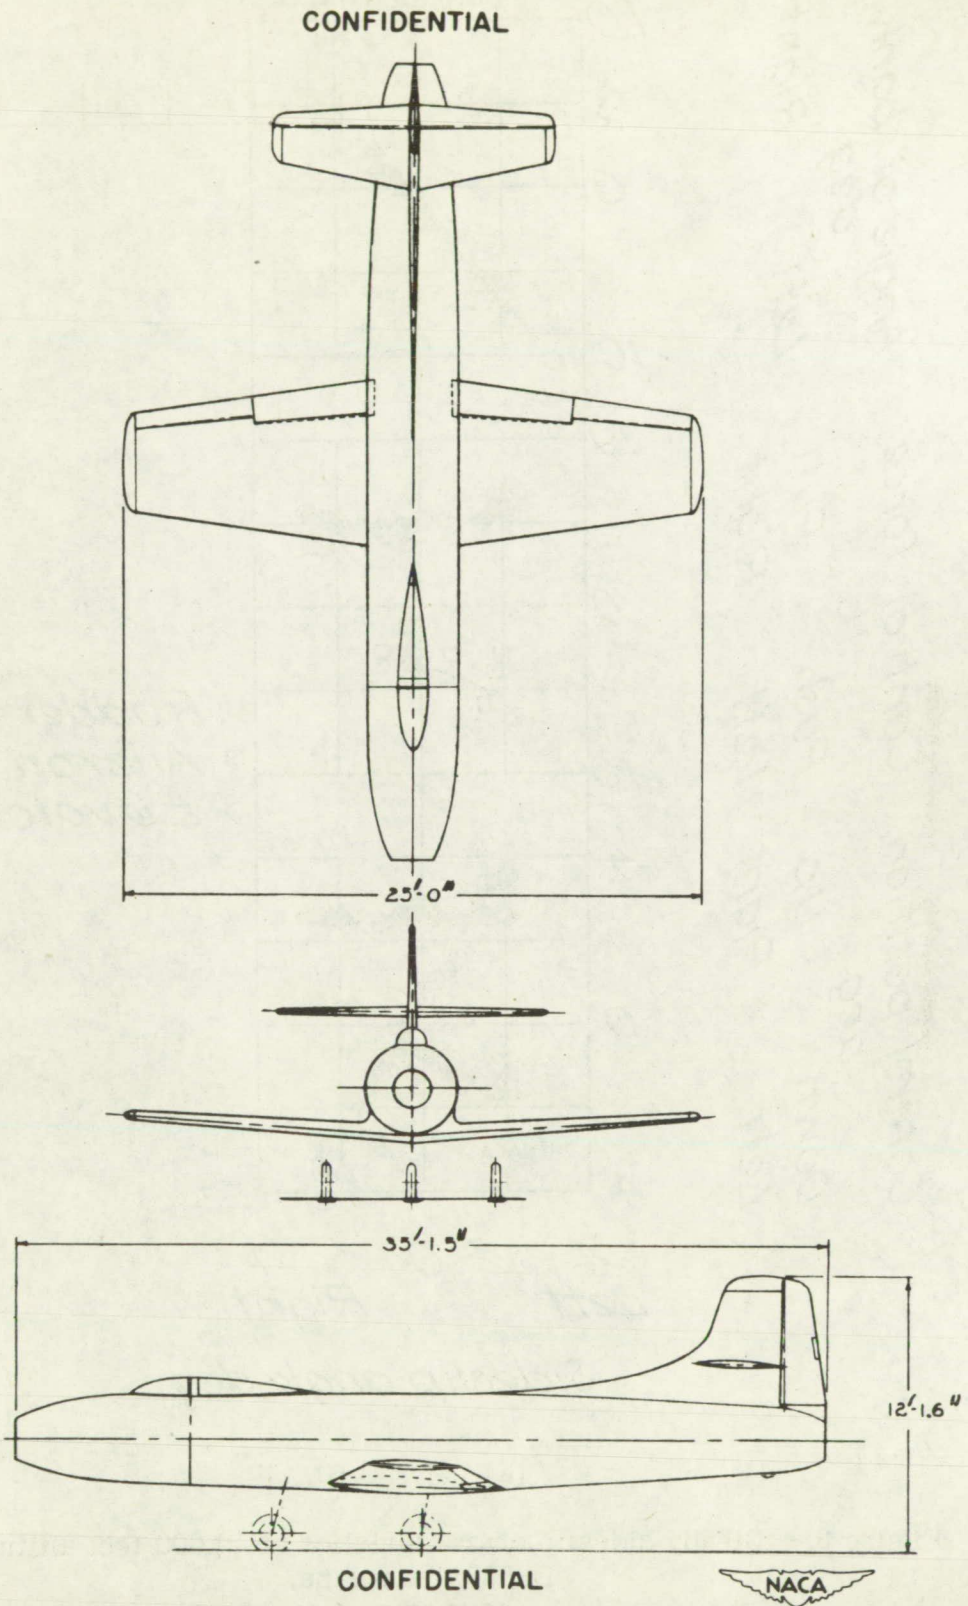
Figure 2.- Three-view drawing of D-558-1 airplane.

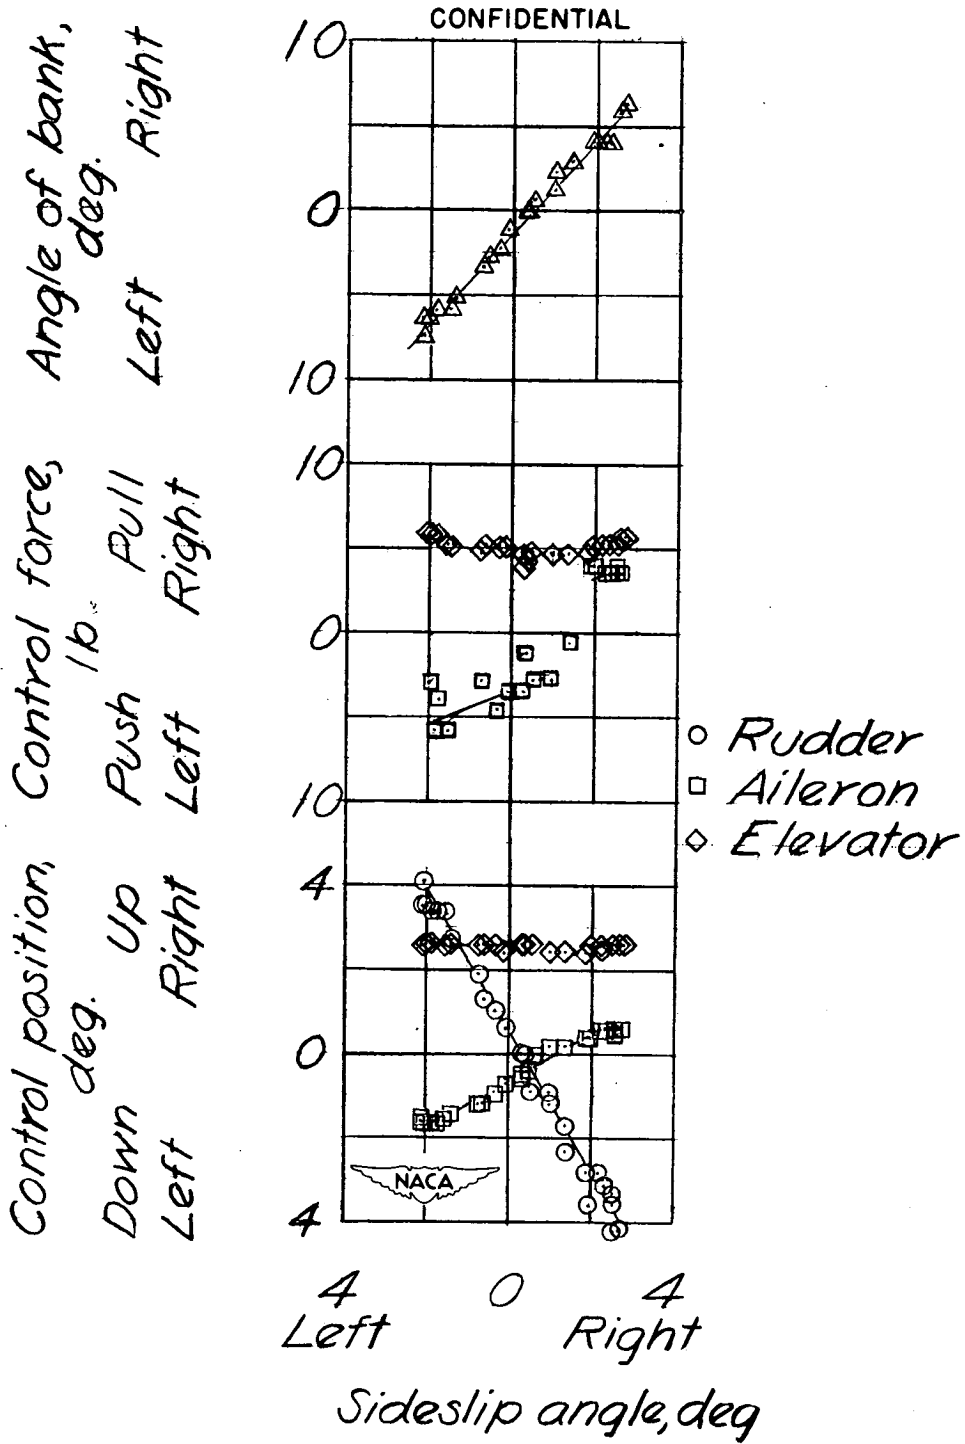
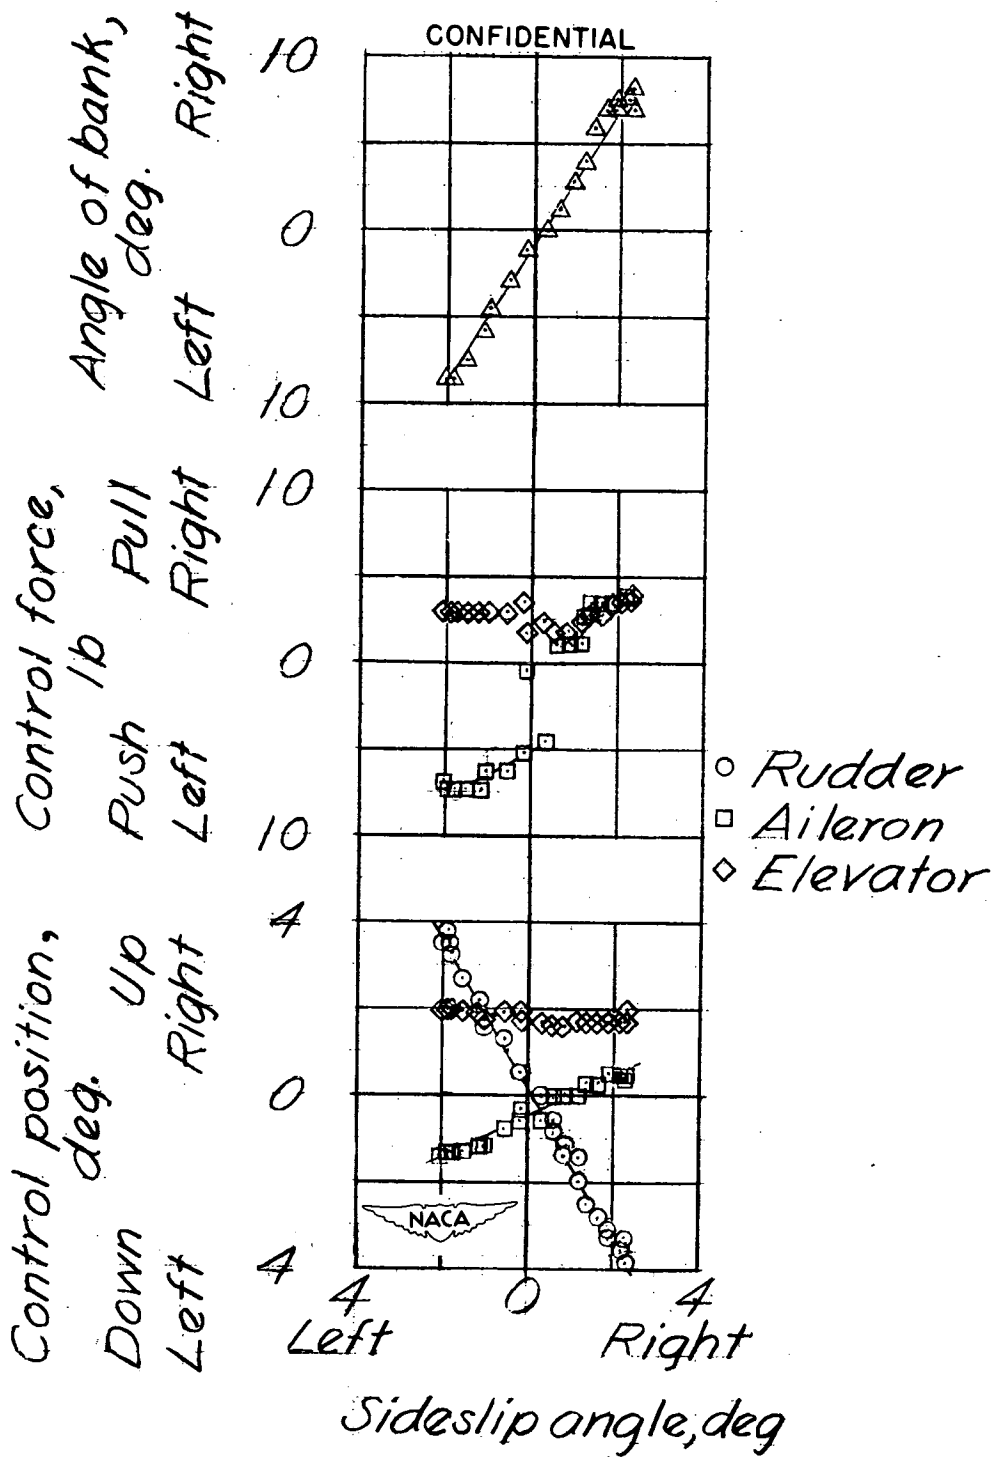
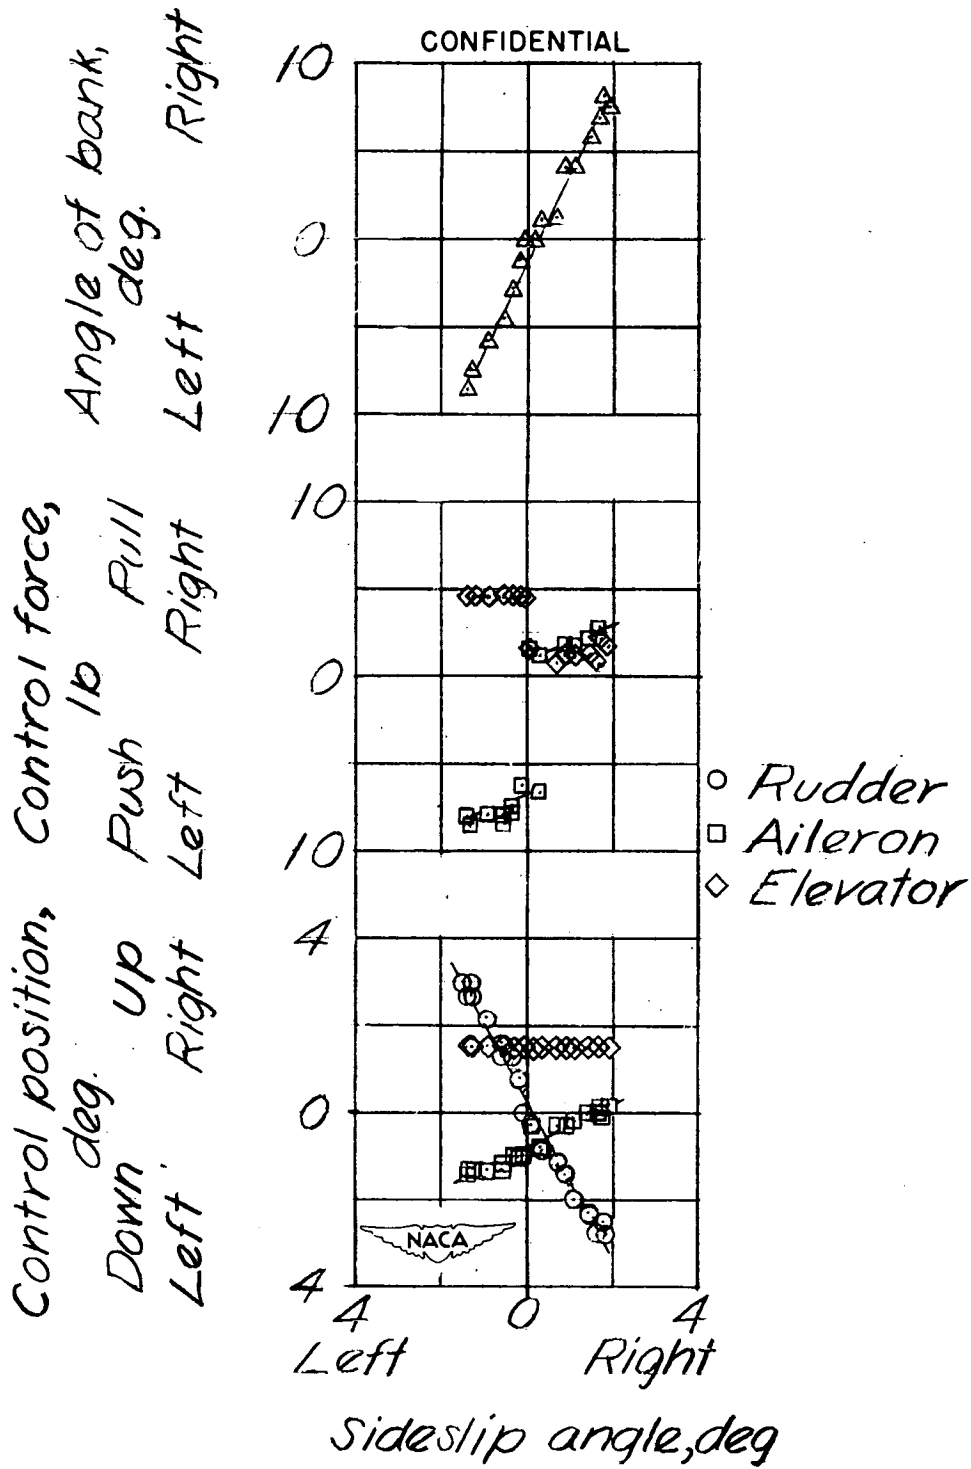
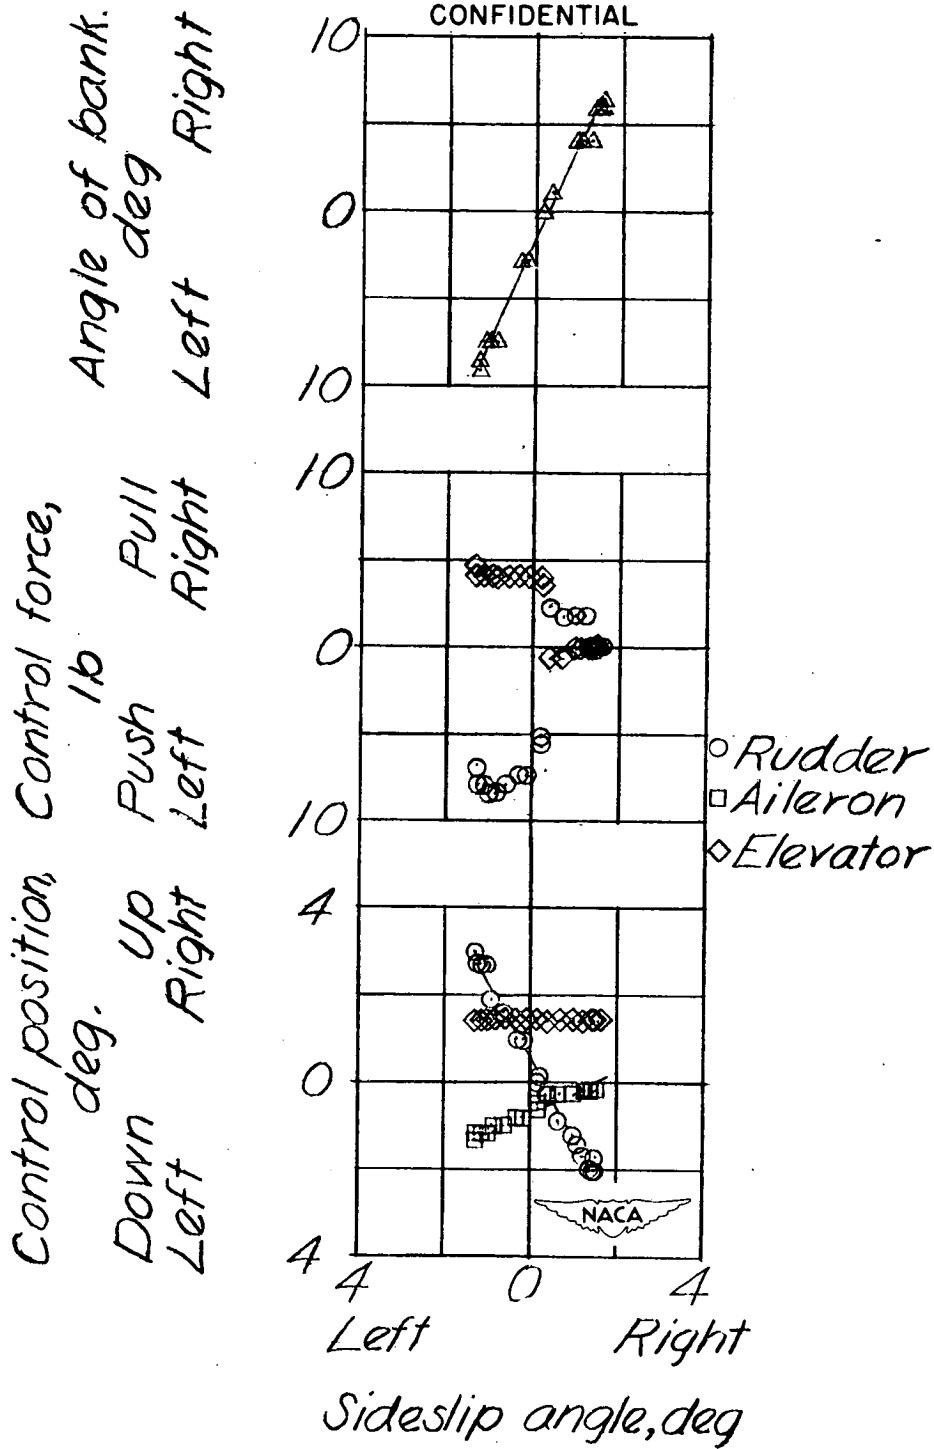
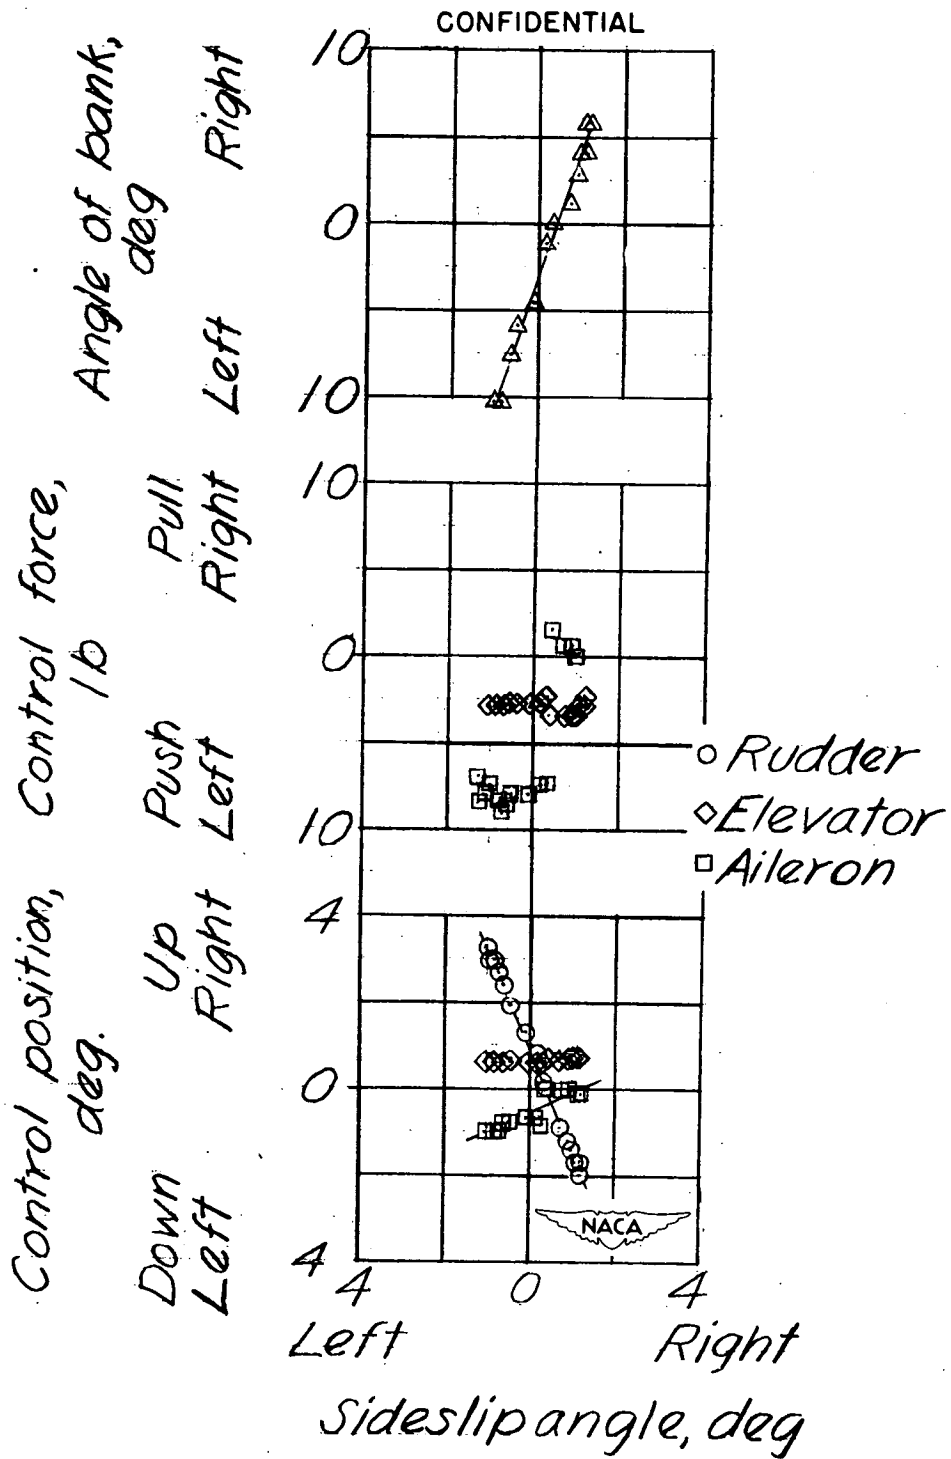
Figure 3.- Steady sideslip characteristics at 10,000 feet altitude.
D-558-1 airplane.

The results of the tests made at 10,000 feet are given in figures 3(a) to 3(f) whereas results obtained at 30,000 feet are in figures 4(a) to 4(g). In these figures, rudder, aileron, and elevator position and force and angle of bank are plotted as functions of sideslip angle. The values of bank angle were obtained from measurements of the transverse acceleration. No measurements of rudder force were obtained, however, at 10,000 feet altitude. The variation of rudder position and force with sideslip angle gives a measure of the static directional stability, control fixed and free. A measure of the dihedral effect, control fixed and control free, is afforded by the variation of aileron position and force with sideslip angle. The pitching moment due to sideslip is illustrated by the variation of elevator position and force with sideslip angle and the variation of angle of bank with sideslip angle gives a measure of the cross-wind-force characteristics.

The data given in figures 3 and 4 show that the directional stability of the D-558-1 is high throughout the speed range tested. The dihedral effect of the airplane is positive, although low, throughout the speed range. There are some discontinuities in the variation of aileron force and position with sideslip angle near zero sideslip. It is believed that these discontinuities are caused by the friction in the control system in the case of the force measurements and caused by some play in the aileron linkage between the aileron and the point of measurement in the case of position measurements. The slopes of these curves, however, should afford a good measure of the dihedral effect. There appears to

A comparison of the directional stability data presented in figures 3 and 4 shows that there is a variation in the directional stability parameter $d\delta_r/d\beta$ with Mach number and indicated airspeed. To illustrate this fact, figure 5 was prepared to show the variation of $d\delta_r/d\beta$ with Mach number and indicated airspeed for the two test altitudes (10,000 and 30,000 ft). In this figure, it can be seen that the increase in the apparent directional stability with increasing speed is a function of Mach number. The increase in apparent directional stability at any given Mach number as the altitude is decreased is probably caused by a decrease in rudder effectiveness. This decrease in rudder effectiveness is probably caused by distortion of the vertical tail and fuselage at the higher values of dynamic pressure encountered at the lower altitude.

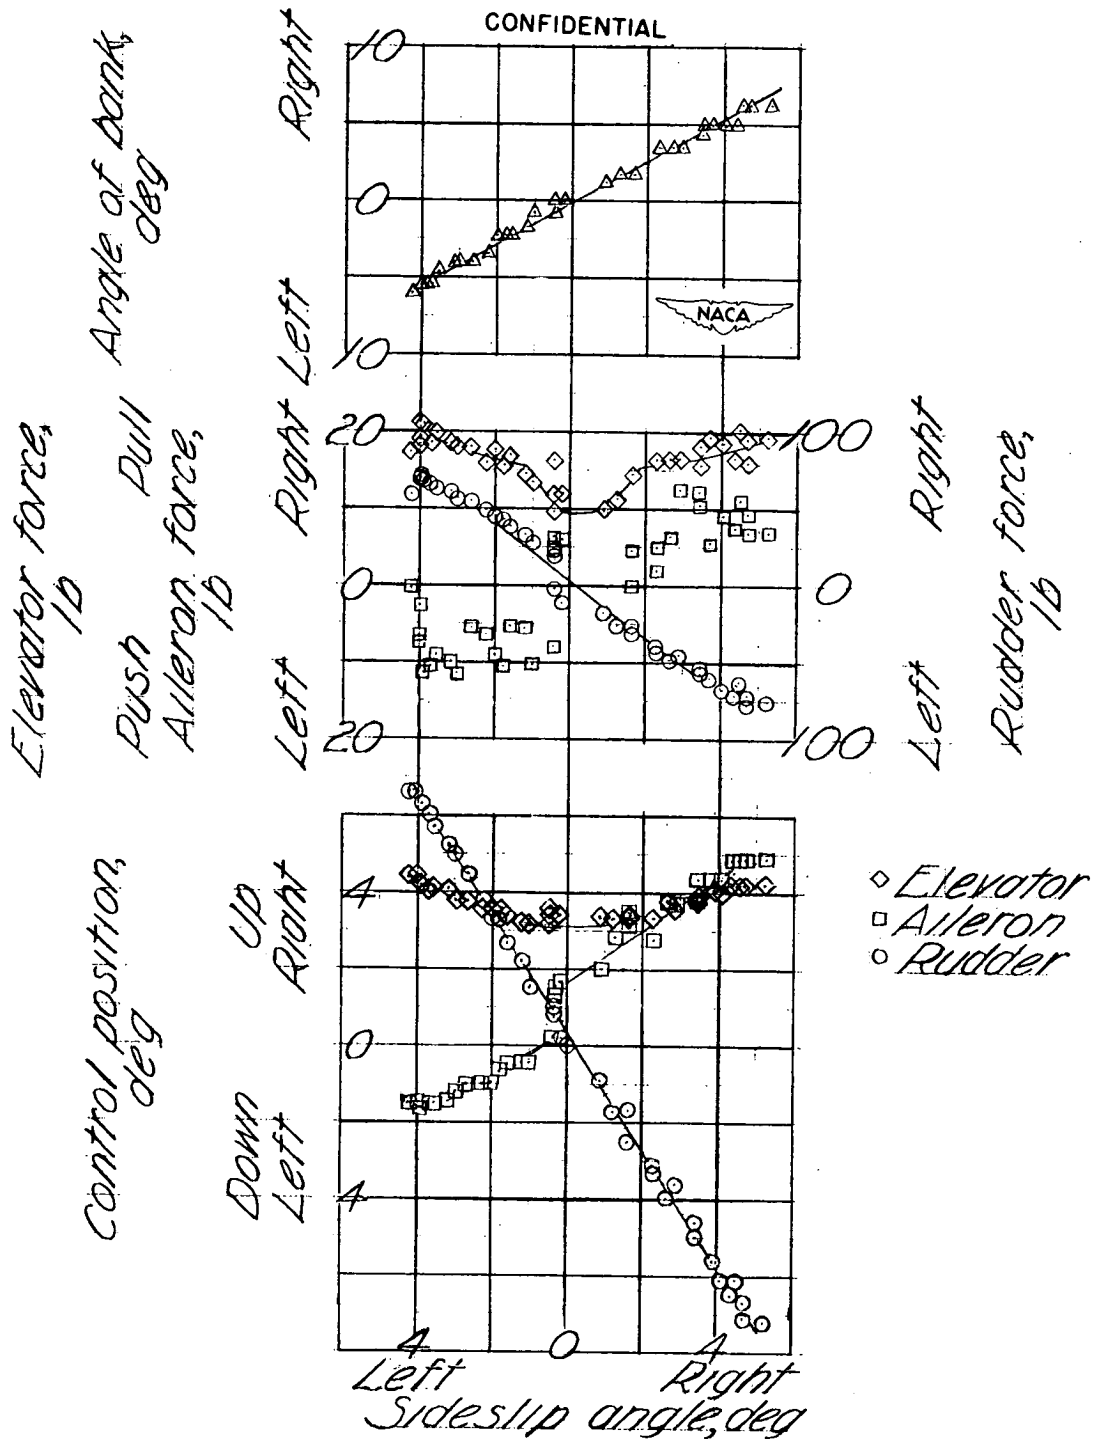
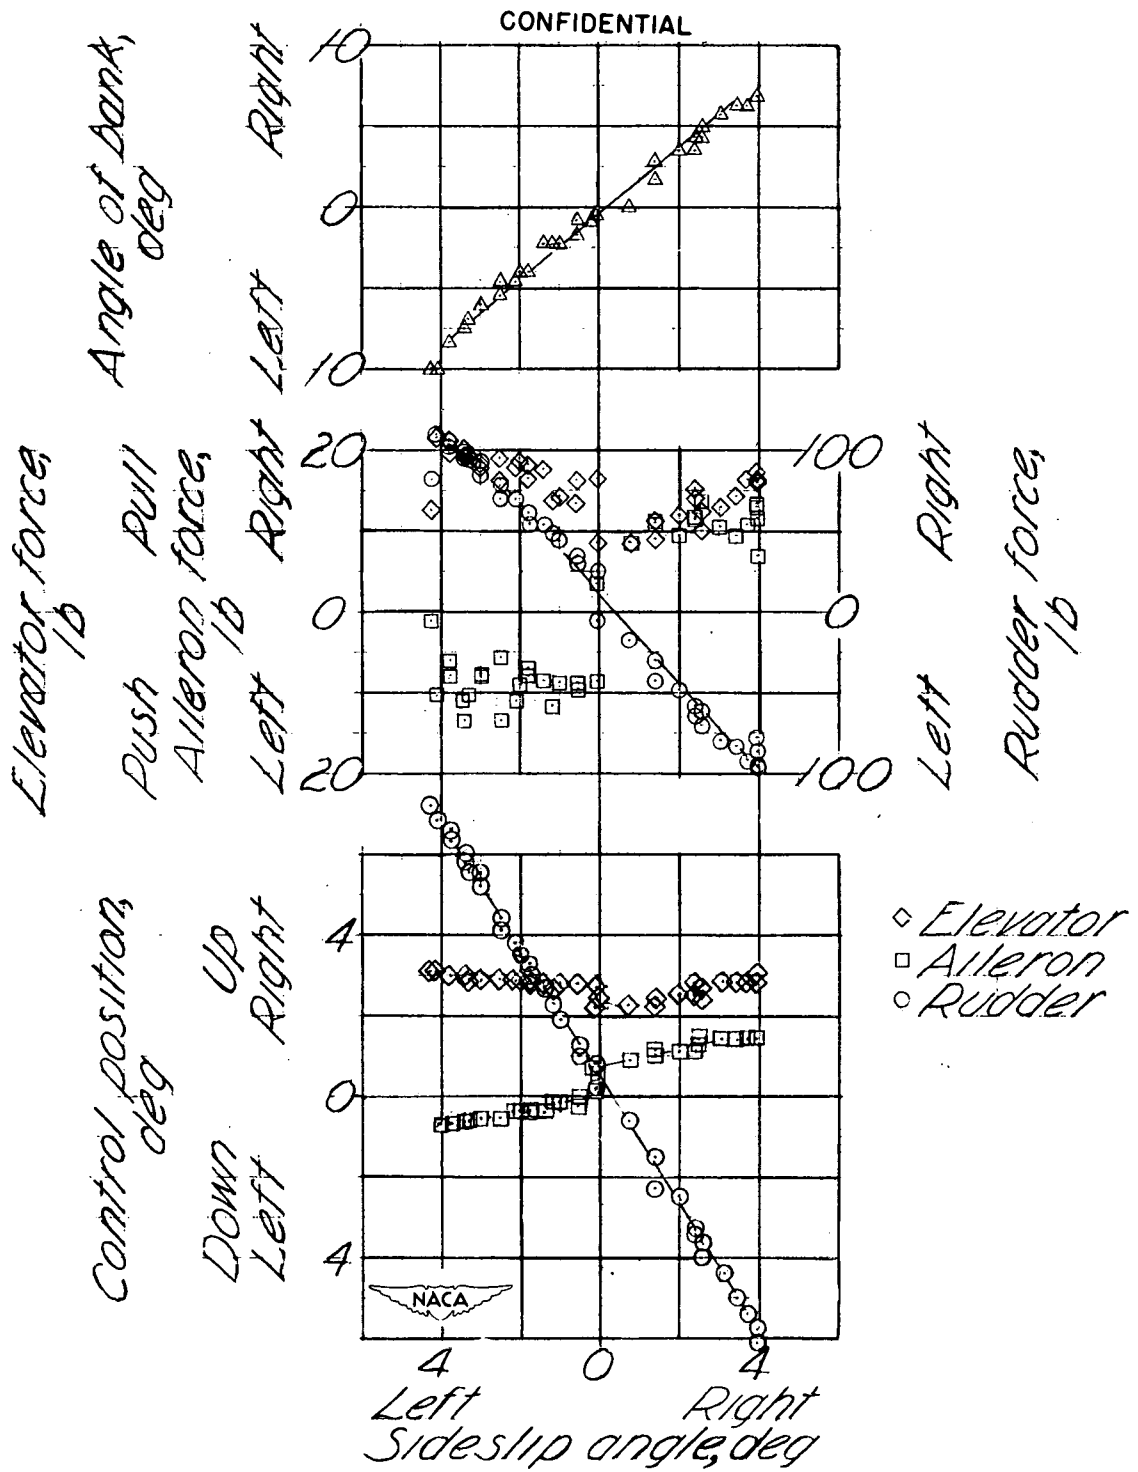
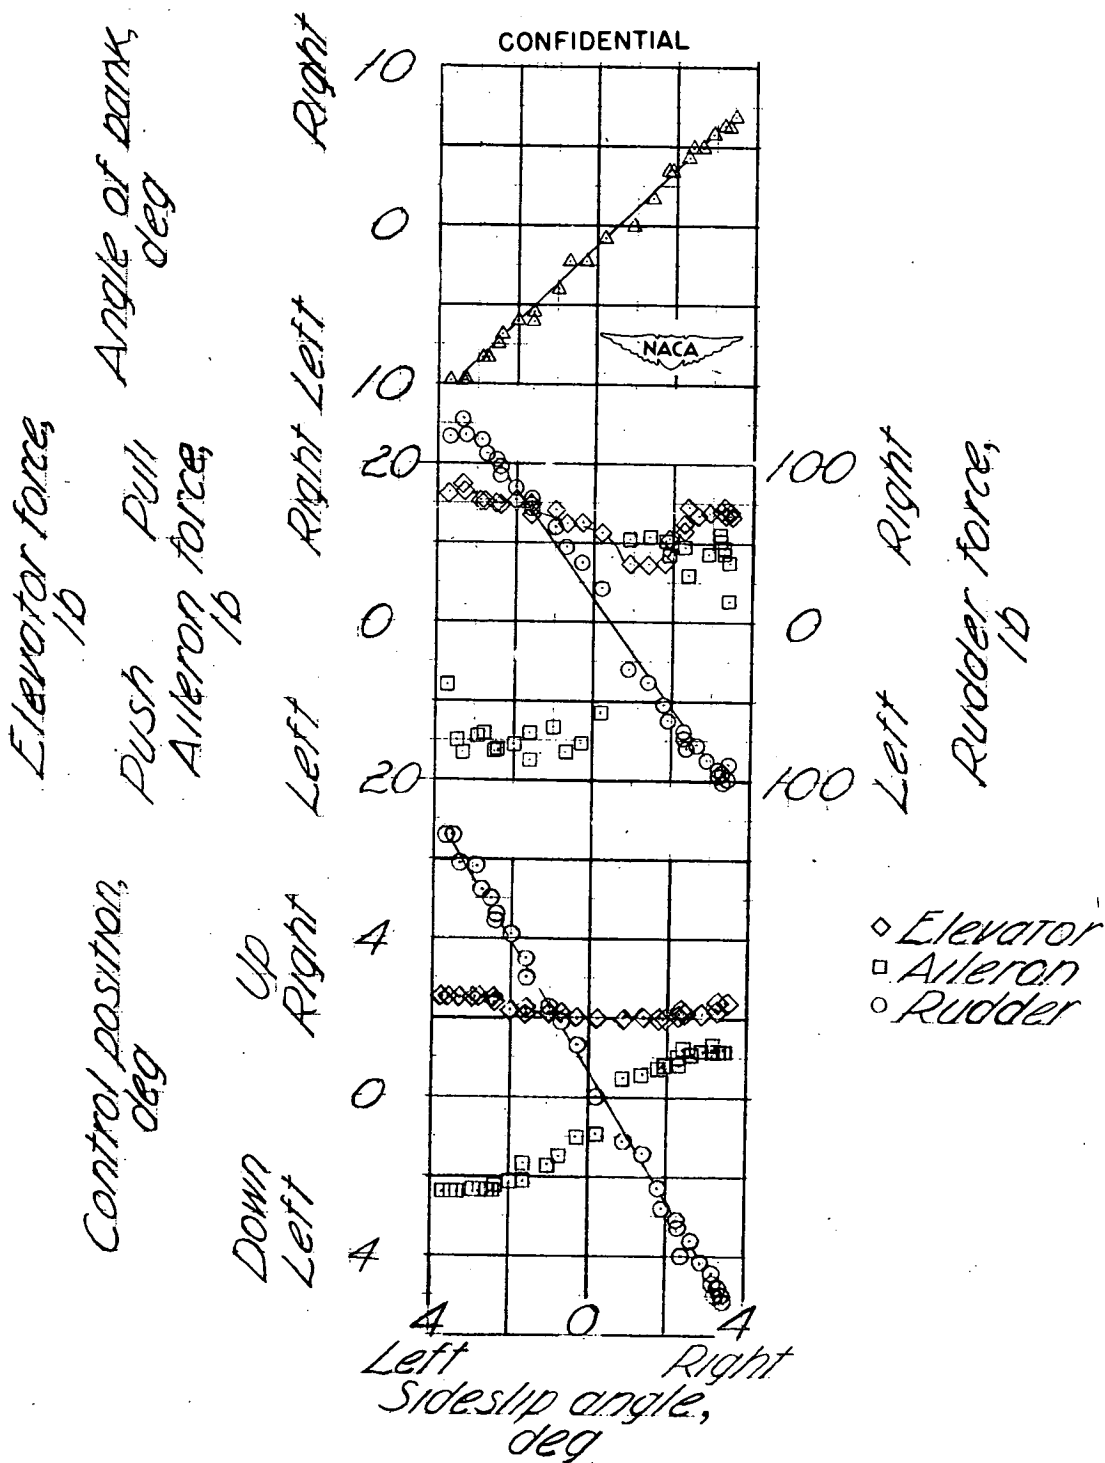
Figure 4.- Steady sideslip characteristics at 30,000 feet altitude.
 D-558-1 airplane.

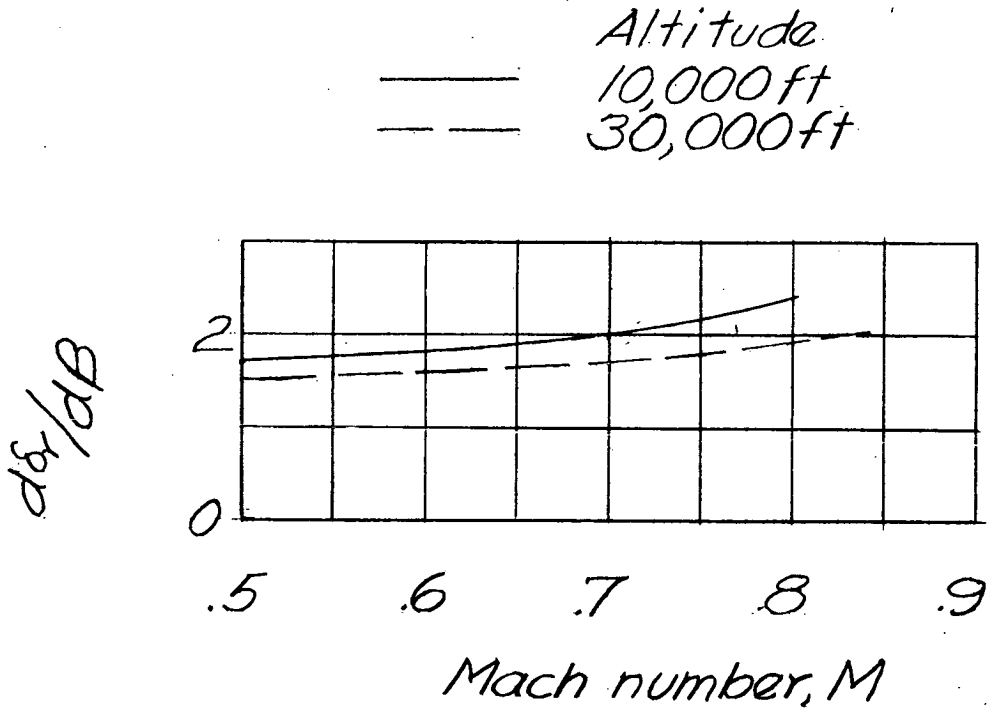
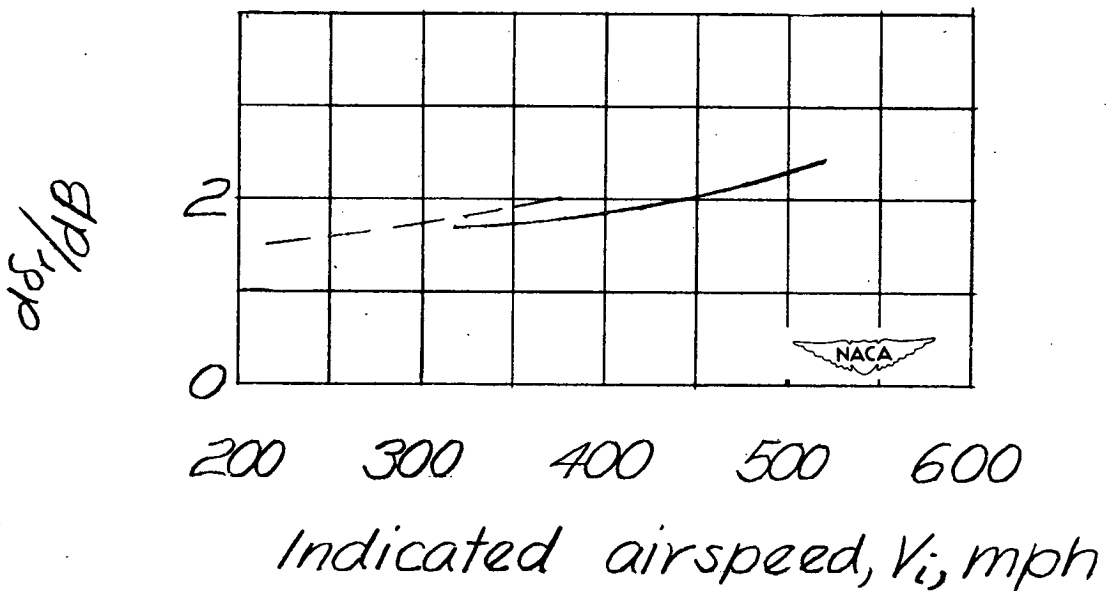
Figure 5.- Variation of $d\delta_r/d\beta$ with Mach number and indicated airspeed.
