FLIGHT MEASUREMENTS OF THE RUDDER CONTROL AND SIDESLIP

CHARACTERISTICS OF FOUR VERTICAL TAIL ARRANGEMENTS

ON THE P-40 SERIES AIRPLANES -

MEMORANDUM REPORT

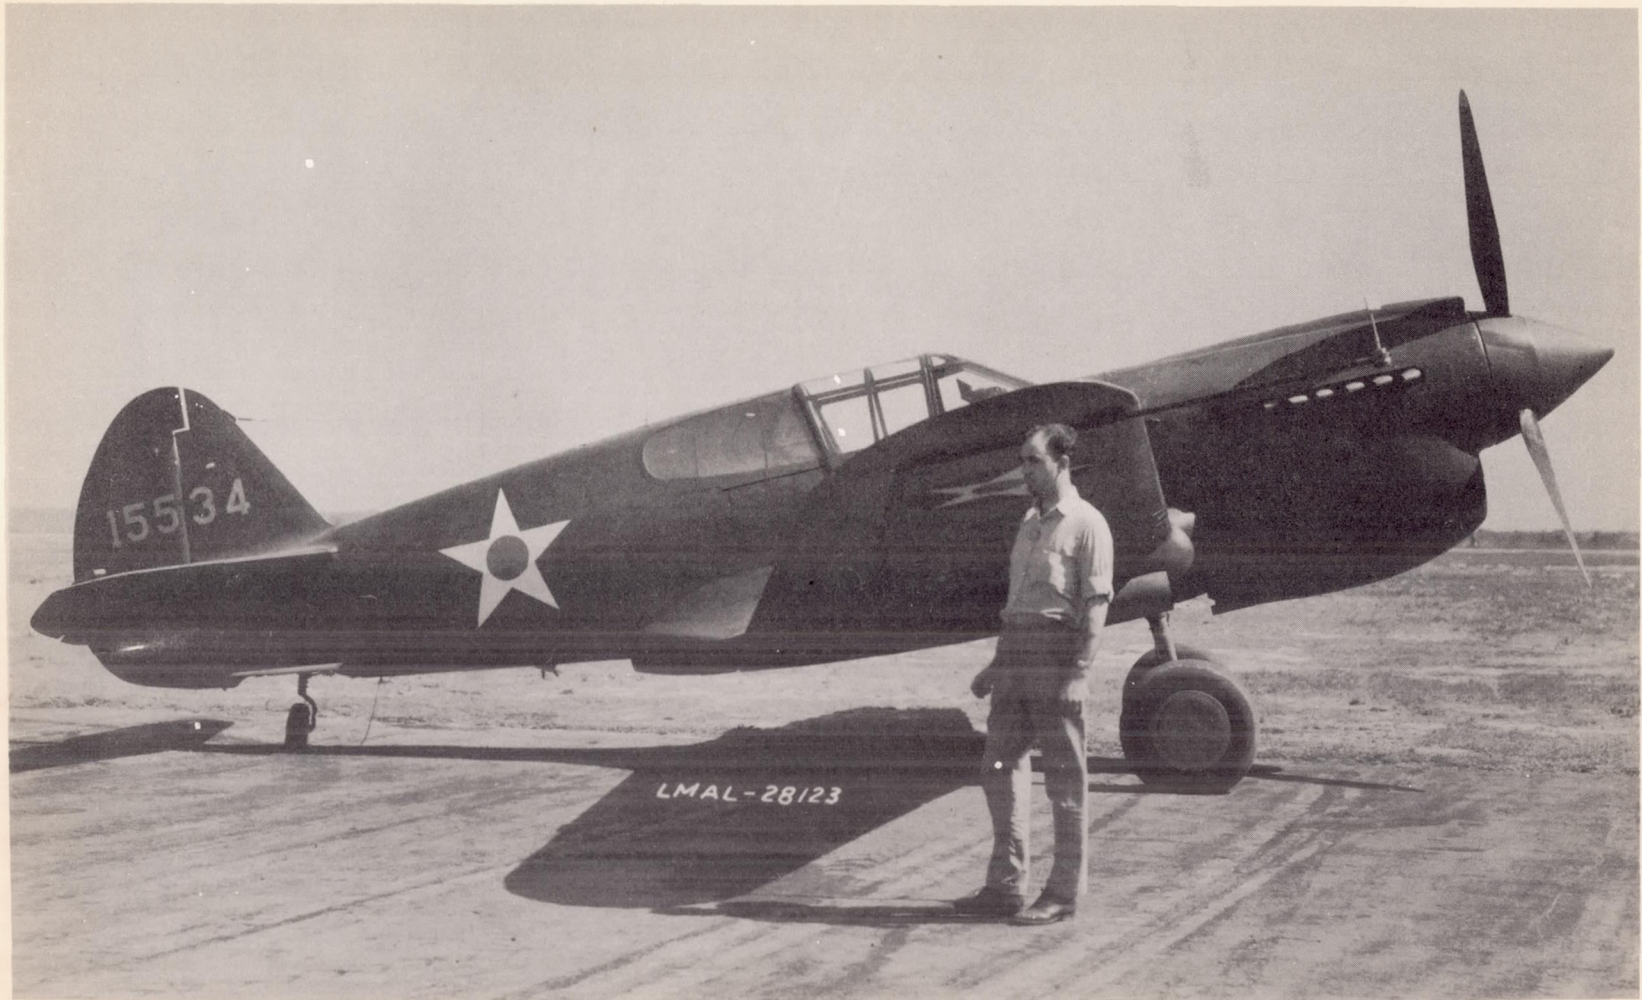
Figure 1.- Side view of Curtiss P-40E airplane with original vertical tail surfaces.

Photographs of the four tail arrangements tested are shown in figures 1 through 6. Tests of the original vertical tail, Curtiss fin extension no. 1, and Curtiss fin extension no. 6 on a tall fin (Curtiss dwg. SK-5524) and rudder (Curtiss dwg. SK-5676) were made on a P-40E airplane. Flight measurements with the original vertical tail moved aft 20 inches were conducted on a modified P-40F airplane.

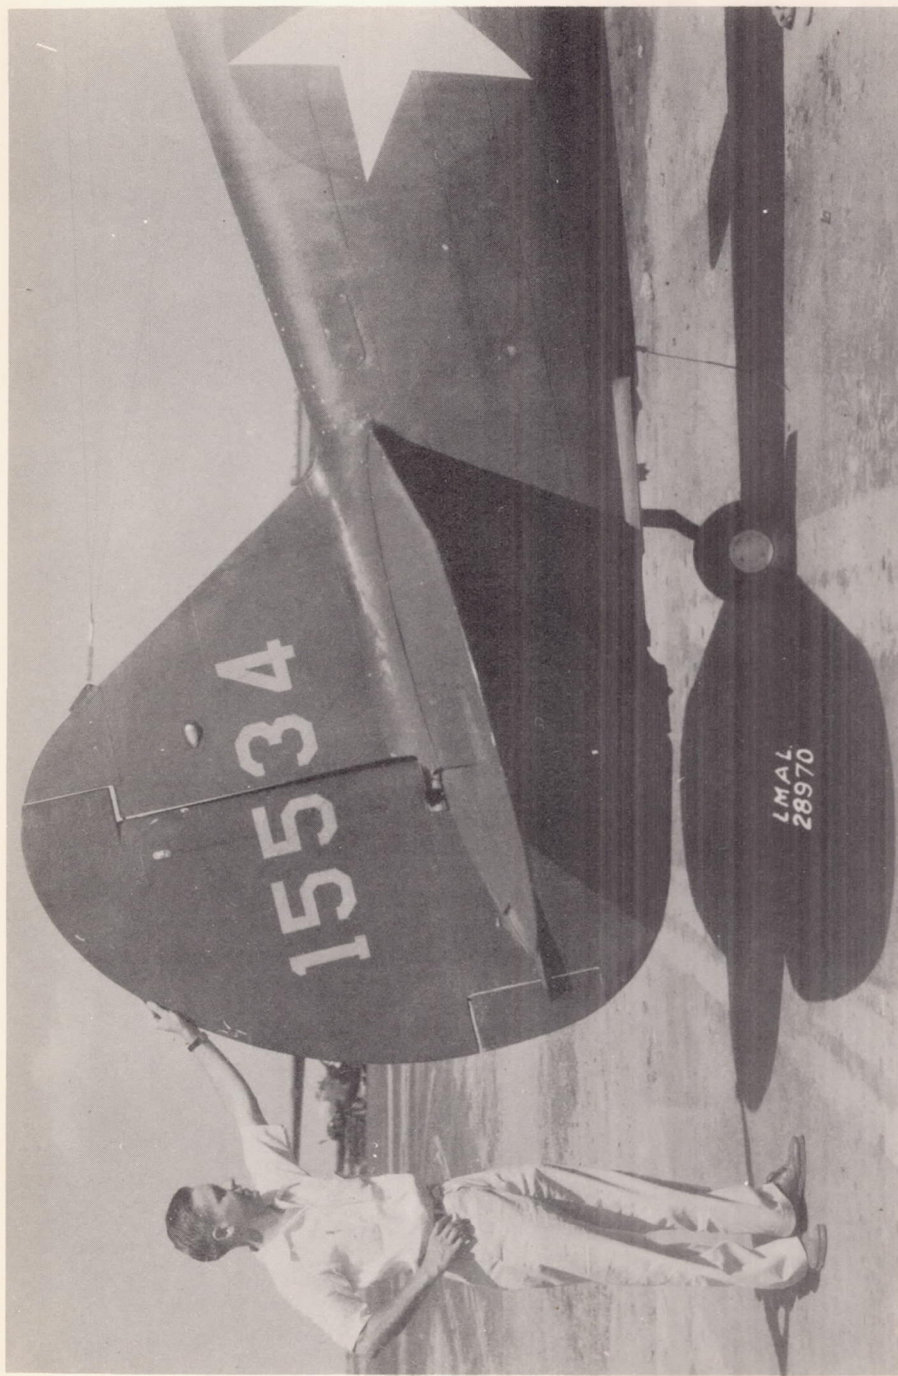
Figure 2.- Side view of original P-40E vertical tail.

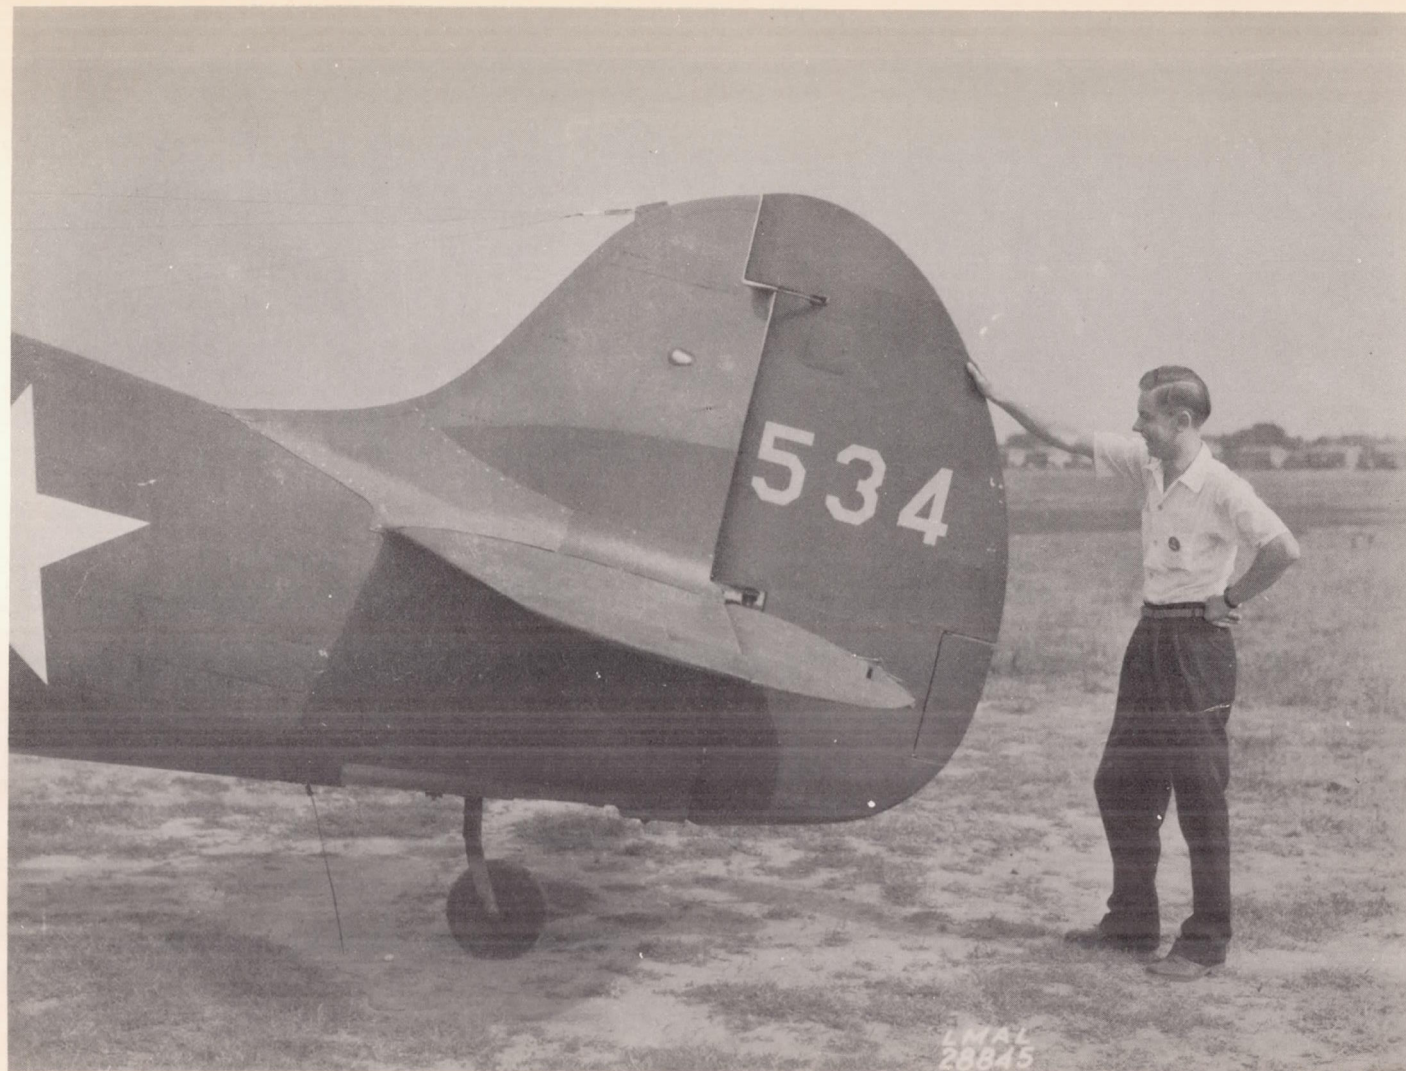
Figure 3.- Side view of Curtiss fin extension No. 1 on original P-40 vertical tail.

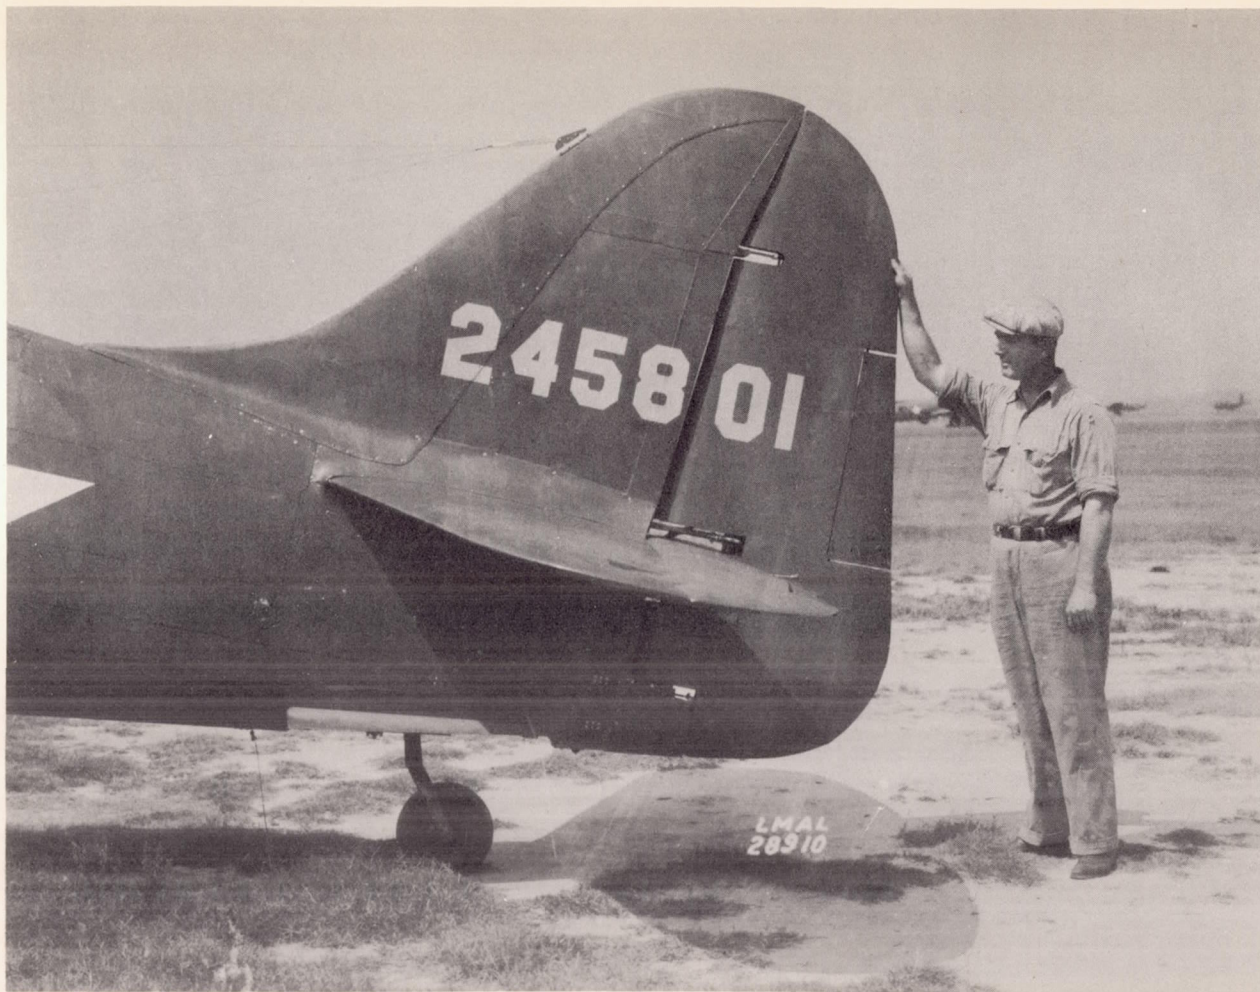
Figure 4.- Side view of Curtiss fin extension No. 6 on a tall fin
(Curtiss DWG. Sk-5524) and rudder (Curtiss DWG. Sk-5676).

Fin extension no. 6 on the tall fin (Curtiss dwg. SK-5524) and rudder (Curtiss dwg. SK-5676) are recommended as the most satisfactory of the four vertical tail arrangements tested insofar as rudder force change with speed or power, rudder force reversals in sideslips, and directional stability are concerned.

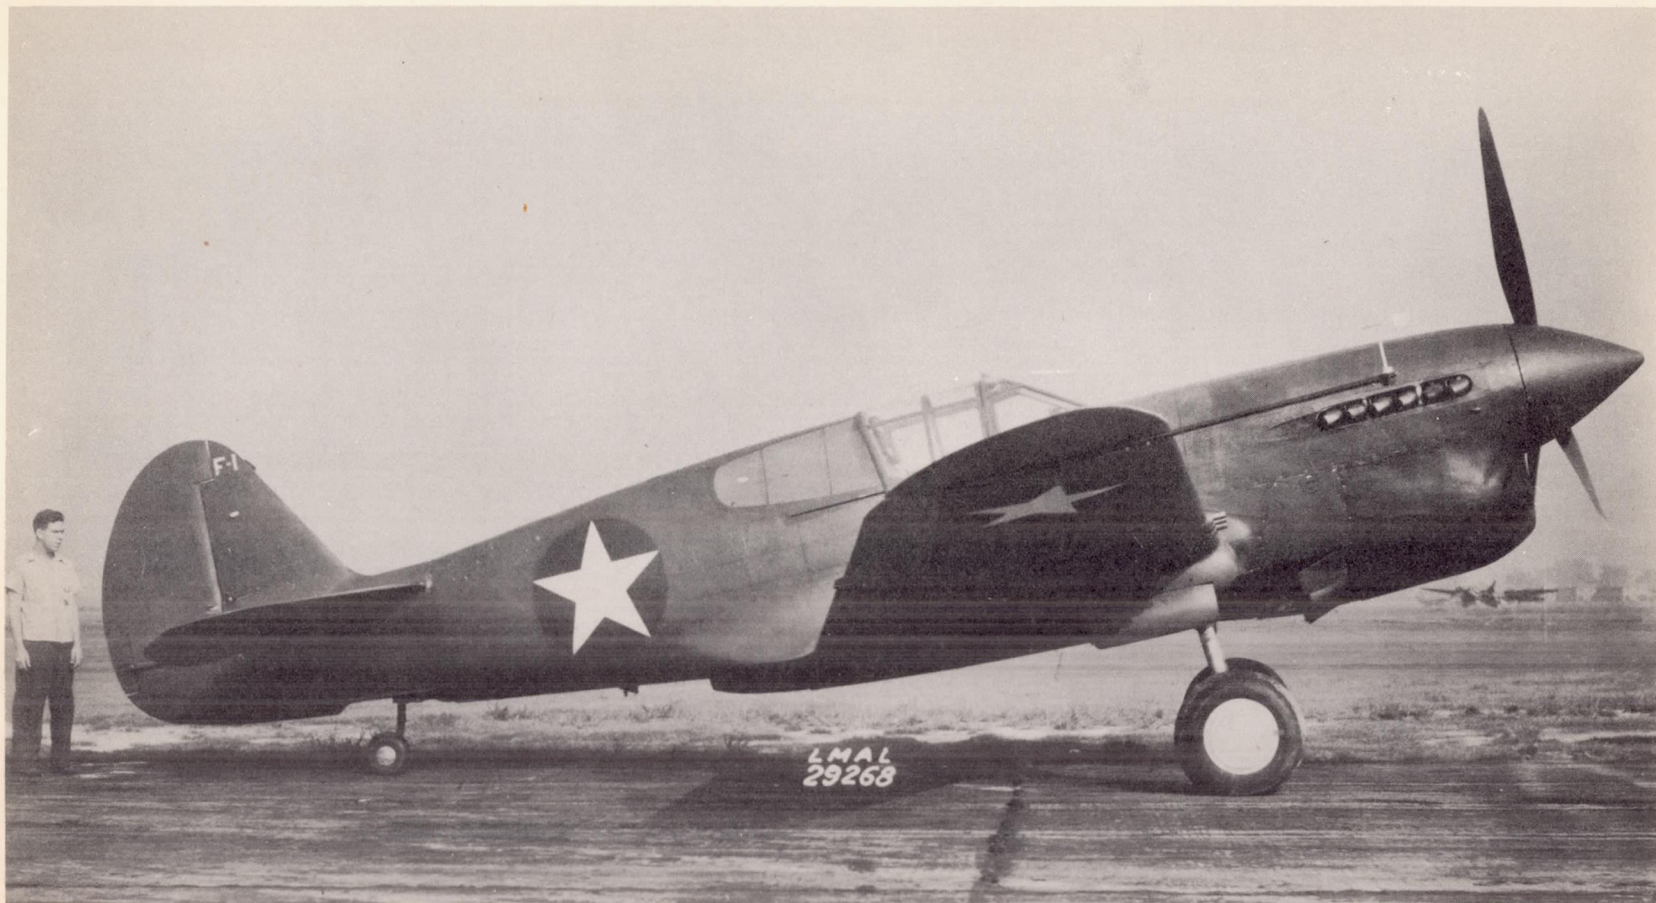
Figure 5.- Side view of Curtiss P-40F airplane with an original vertical tail on a 20-inch fuselage extension.

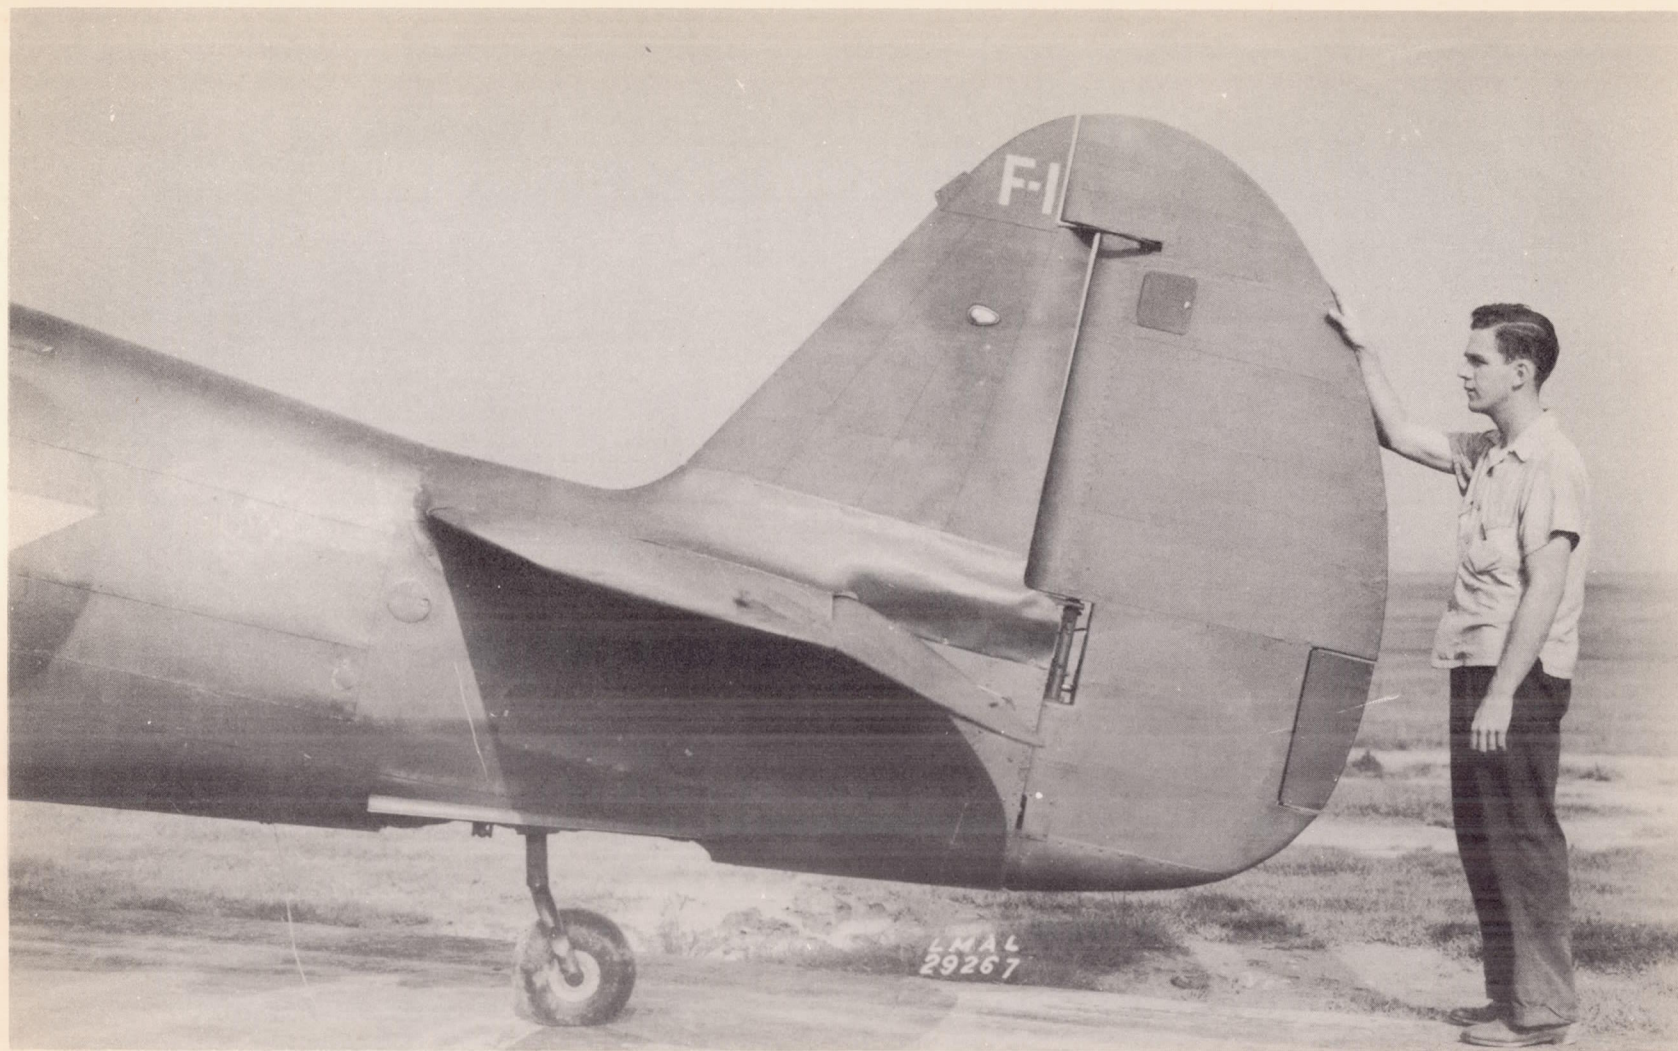
Figure 6.- Side view of original vertical tail on the P-40F airplane with a 20-inch fuselage extension.

The test results further indicate that the 20-inch fuselage extension in itself, as tested on the P-40F airplane, did not contribute as much to directional stability as measured by $\frac{d\delta_R}{d\psi}$ as did the slight addition of area accomplished by adding fin extension no. 1 to the original P-40E fuselage vertical tail combination. This can be readily seen from table I by comparing test no. 1 with

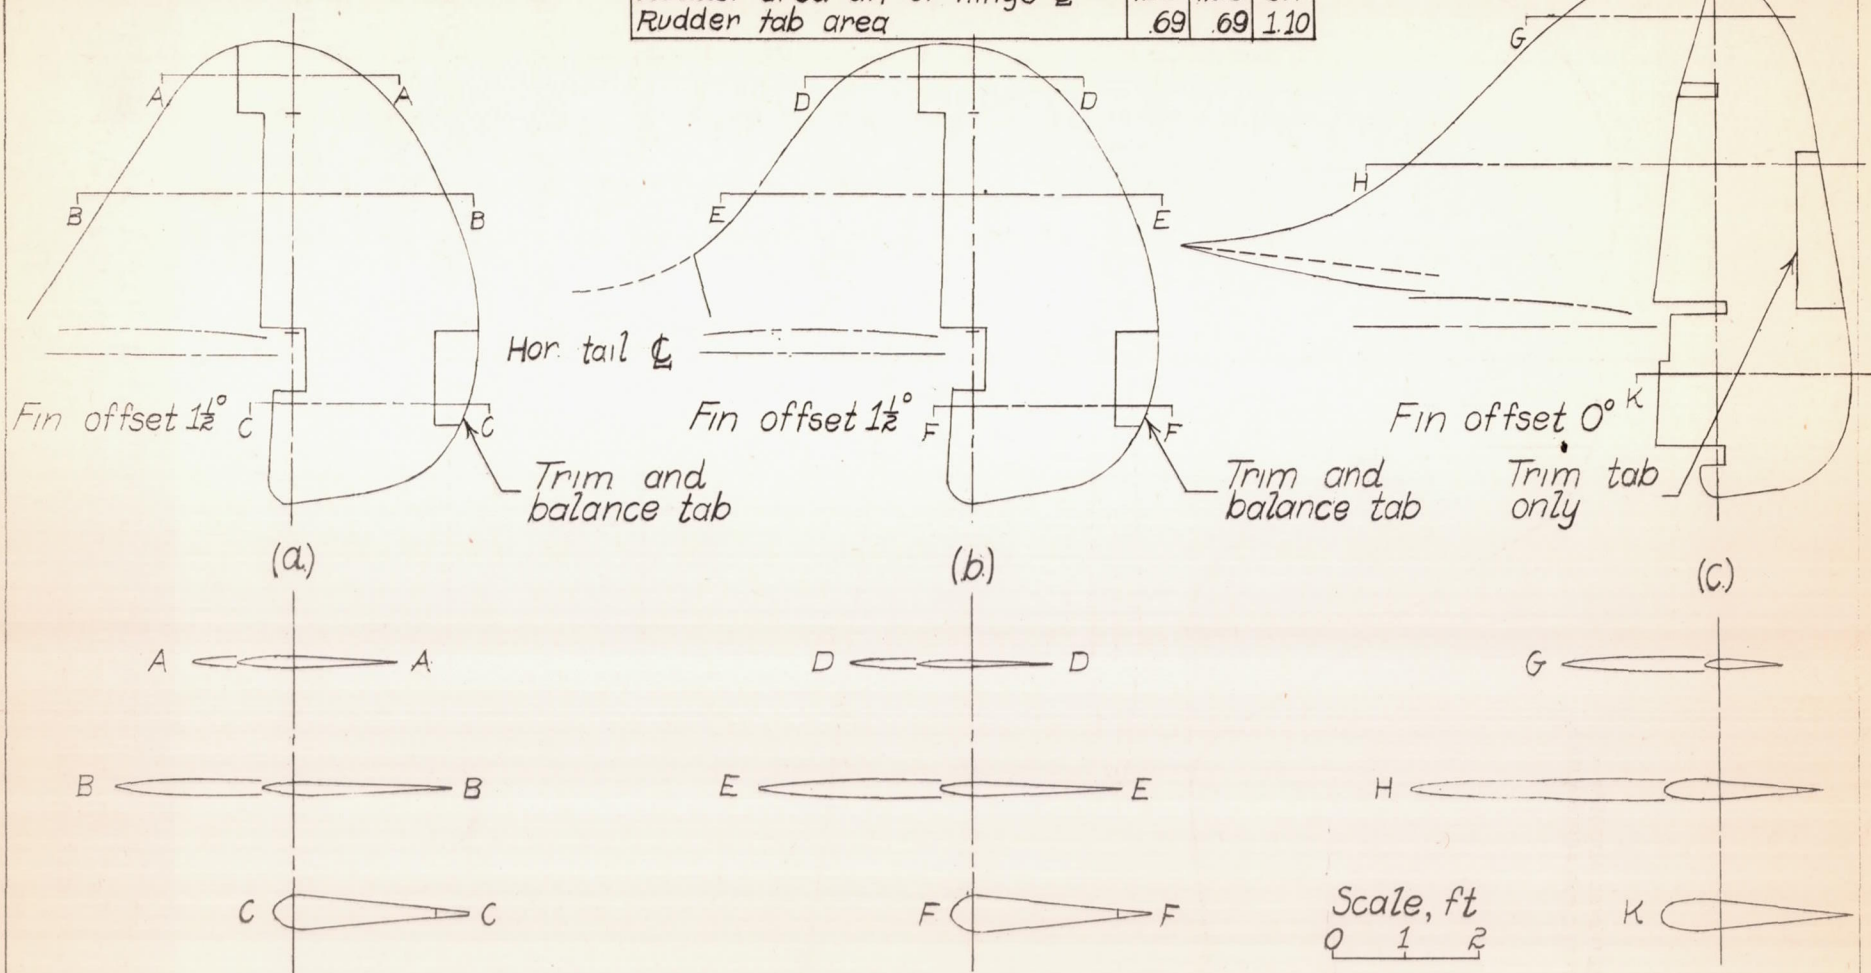
Approximate areas, sq. ft.	(a)	(b)	(c)
Total vertical tail area	22.0	23.4	28.7
Fixed fin area	7.5	8.9	15.2
Total rudder area	14.5	14.5	13.5
Rudder area forward of hinge ζ	2.5	2.5	3.8
Rudder area aft of hinge ζ	12.0	12.0	9.7
Rudder tab area	.69	.69	1.10

Figure 7a. - Vertical tails tested on P-40E airplane: (a) original P-40E vertical tail; (b) fin extension no. 1 on original vertical tail; (c) fin extension no. 6 on tall fin (Curtiss dwg. SK-5524) and rudder (Curtiss dwg. SK-5676).

Line drawings of the vertical tail surfaces, that is, the original vertical tail, Curtiss fin extension no. 1, and Curtiss fin extension no. 6, along with their respective areas, are shown on figure 7. The rudder of the original vertical tail surfaces and of that used with fin extension no. 1 were equipped with balancing trim tabs, while the rudders used with Curtiss fin extension no. 6 and the 20-inch fuselage extension on the P-40F airplane were equipped with trim tabs only. The relations between rudder trim tab position, rudder position, and cockpit tab setting are shown on figures 8 through 11. The fin offset on the original vertical tail and on the tail with fin extension no. 1 was $1-1/2^{\circ}$, while the fin offset for fin extension no. 6 and the 20-inch fuselage extension was 0° .

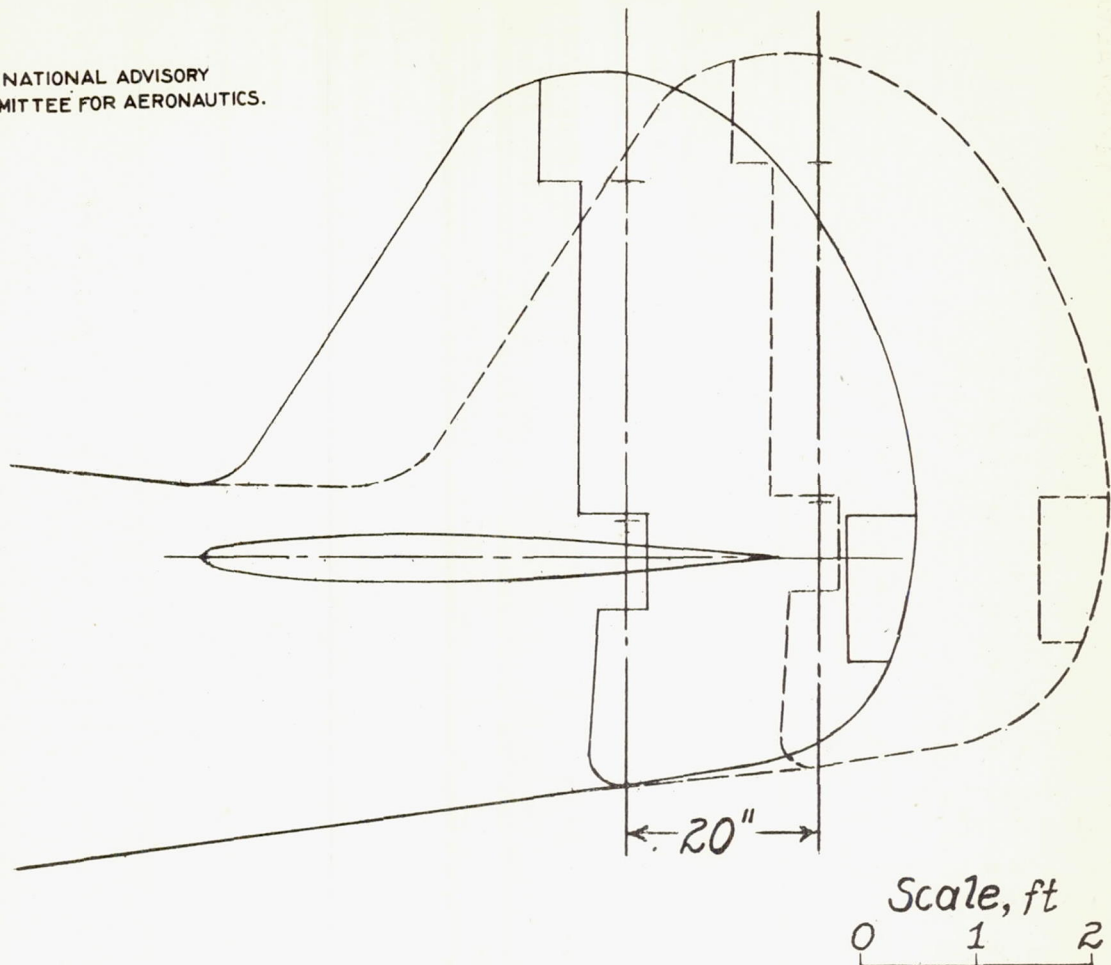
- P-40E Airplane
Fin offset $1\frac{1}{2}^\circ$
Trim and balance tab
- P-40F Airplane
Fin offset 0°
Trim tab only
20" fuselage extension

Figure 7b. - Comparison of original vertical tail arrangements tested on the P-40E airplane and on the P-40F airplane with the extended fuselage.

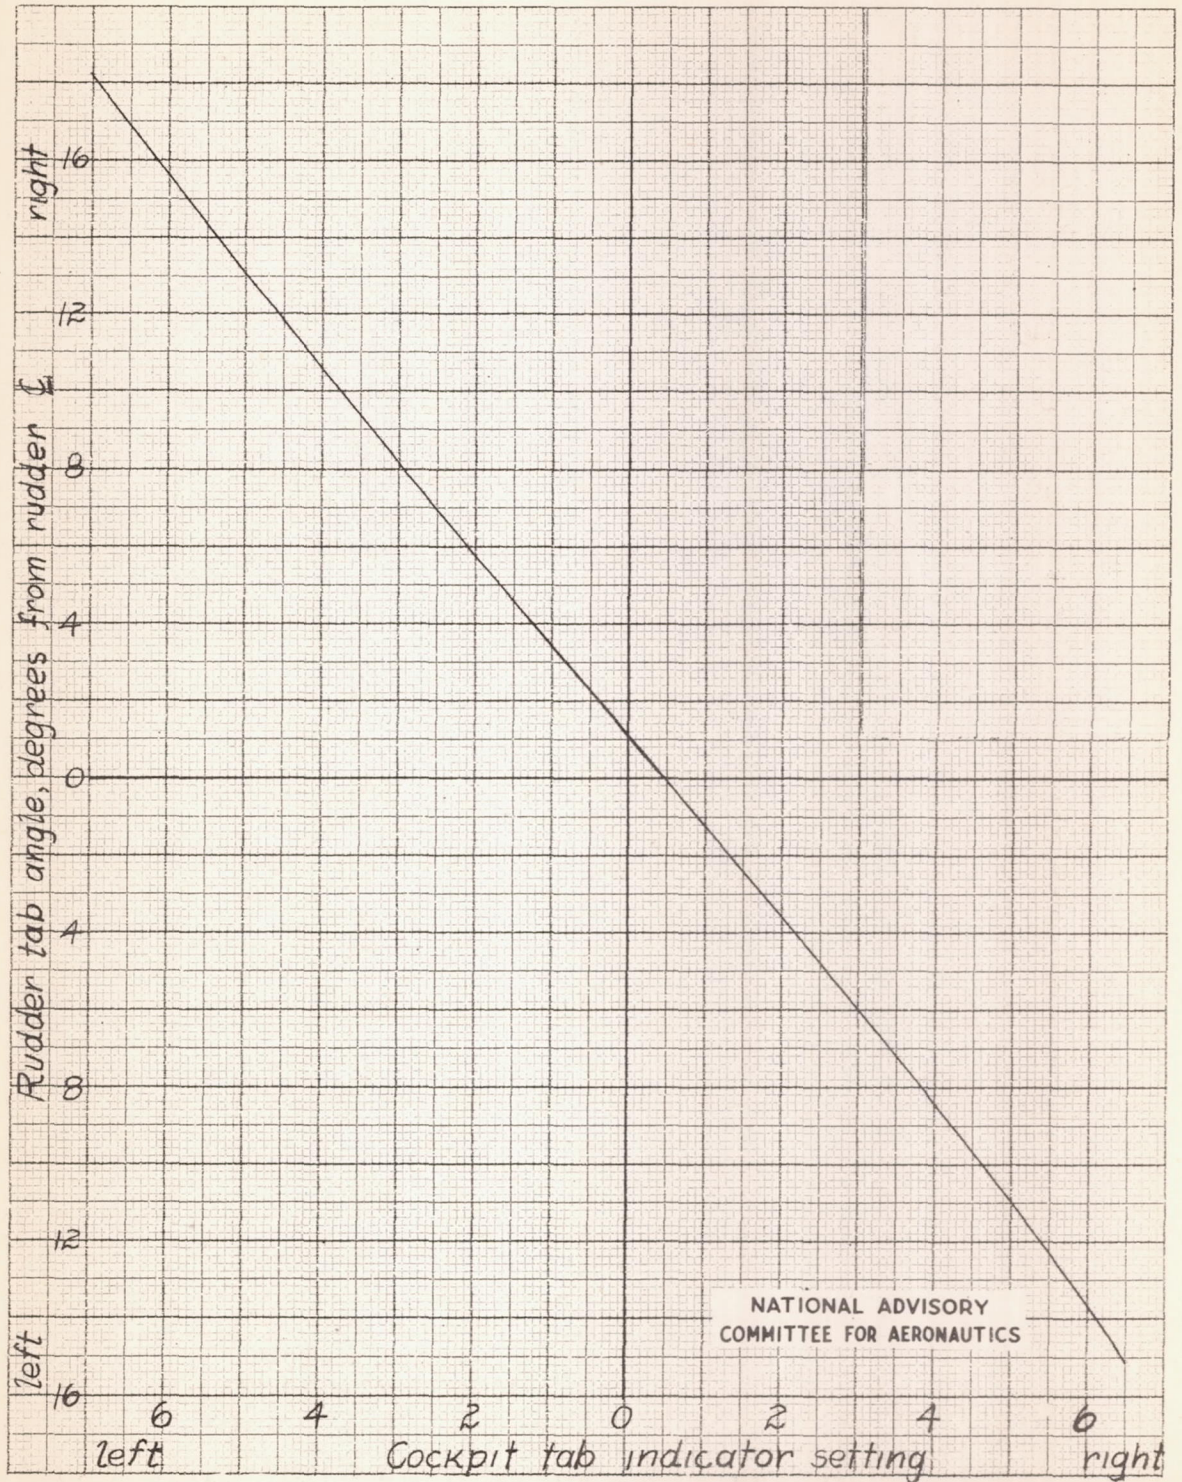
Figure 8.- Relation between rudder tab position and cockpit indicator setting with rudder parallel to thrust axis, P-40E airplane, original vertical tail with and without fin extension no. 1, fin offset 1-1/2°.

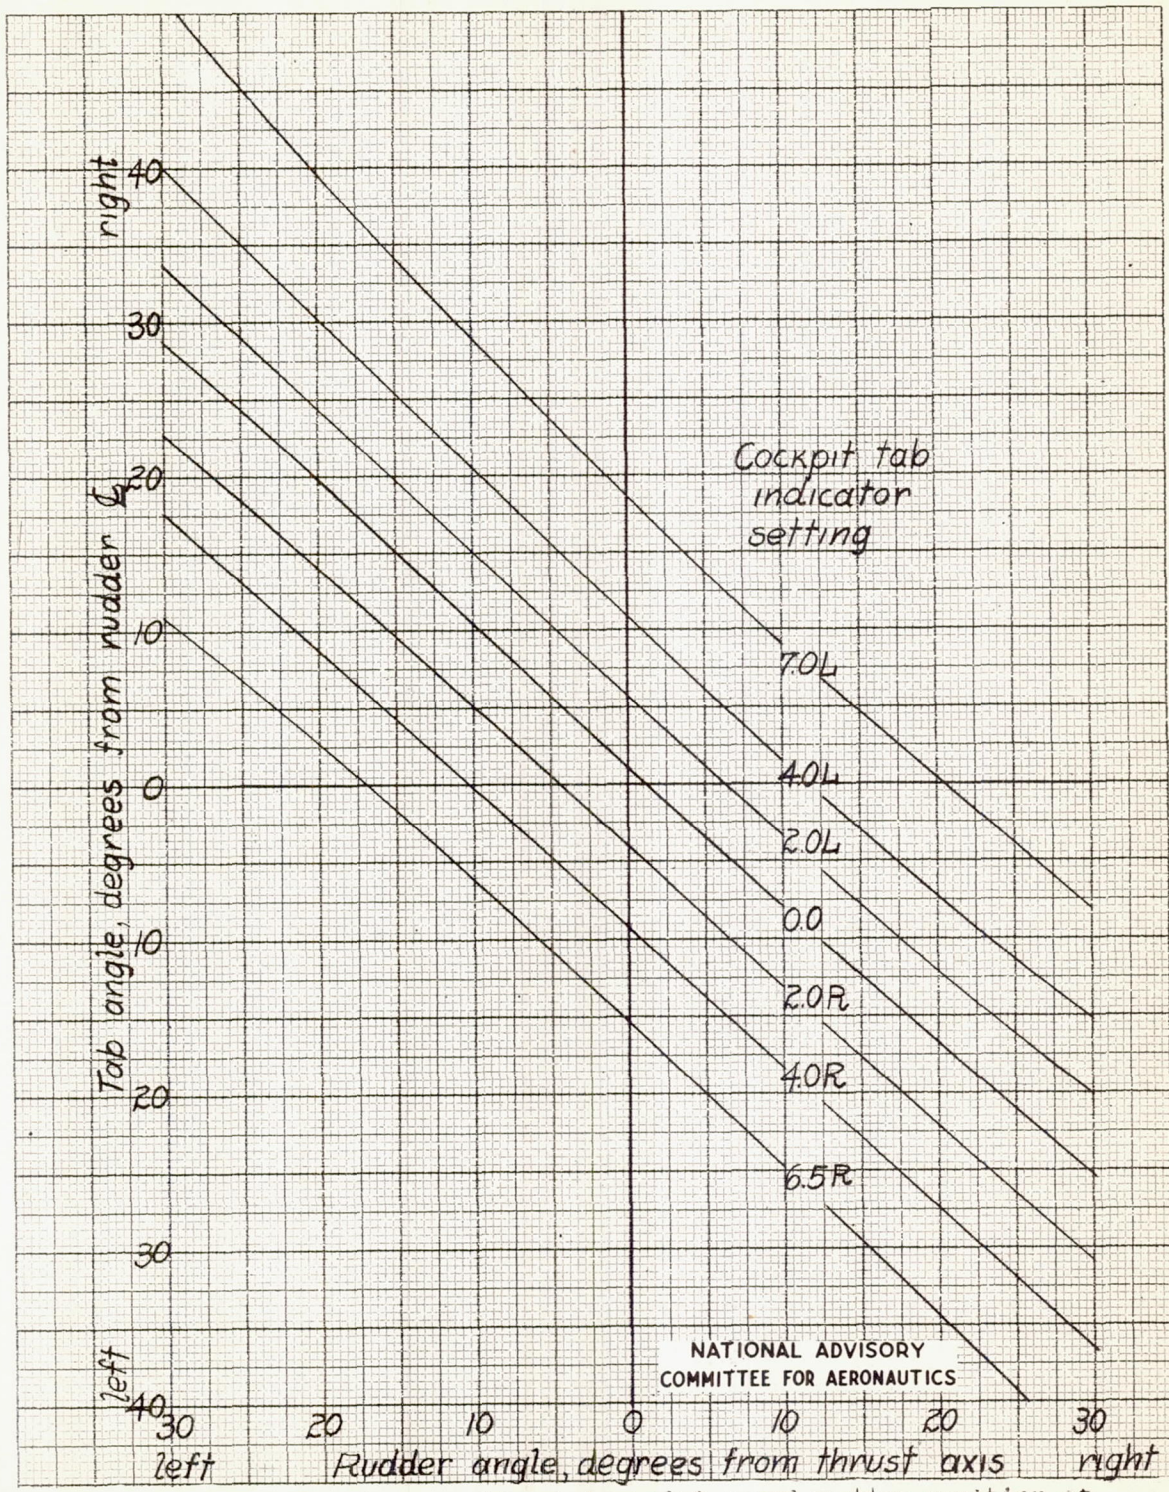
Figure 9.- Relation between rudder tab position and rudder position at various cockpit tab indicator settings, P-40E airplane, original vertical tail with and without fin extension no. 1, fin offset 1-1/2°.

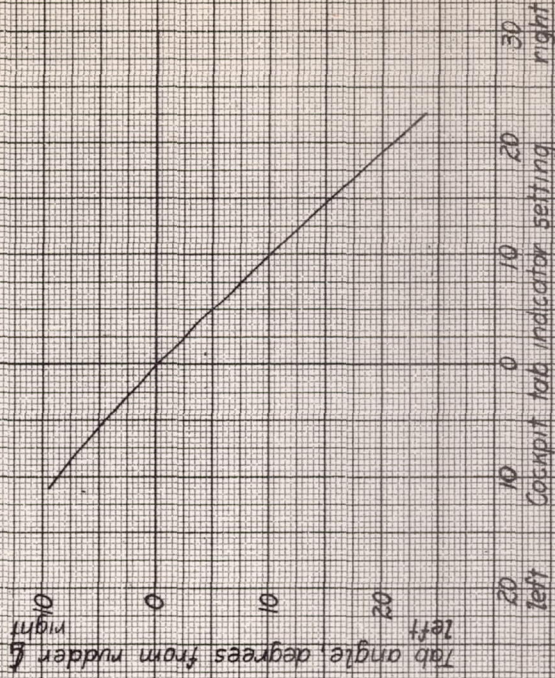
Figure 11. - Relation between rudder trim tab position and cockpit indicator setting, P-40G airplanes, original vertical tail on 20-inch fuselage extension, fin offset 0°.

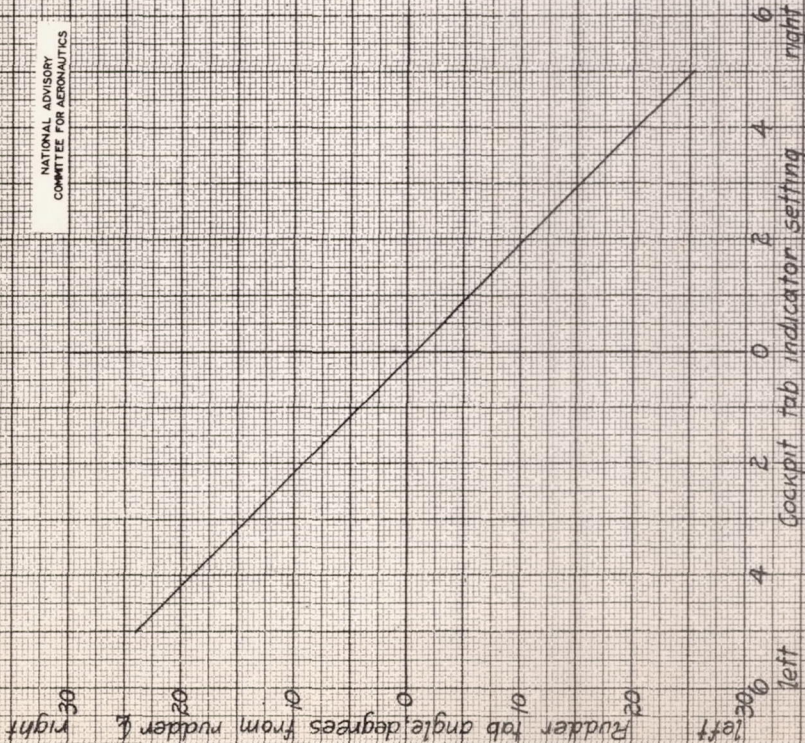
Figure 10. - Relation between rudder trim tab position and cockpit indicator setting, P-40G airplanes, fin extension no. 6 on tall fin and rudder, fin offset 0°.

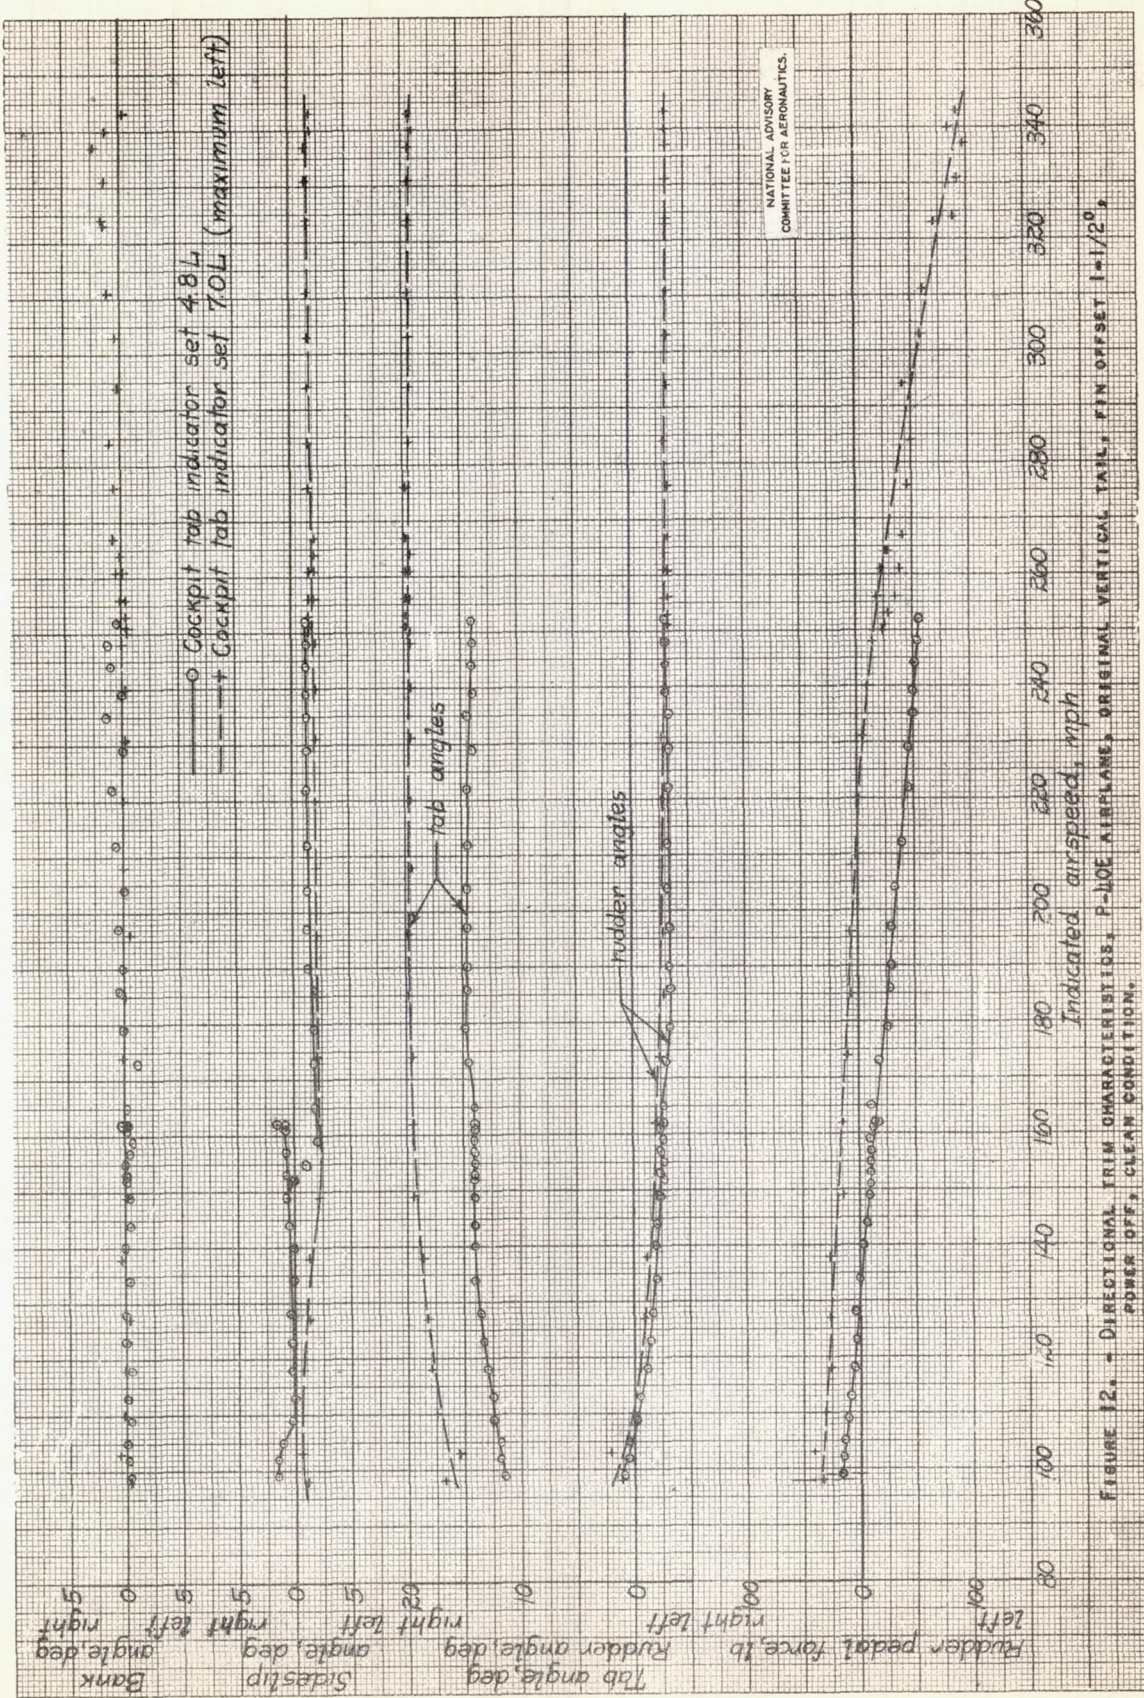
FIGURE 12. - DIRECTIONAL TRIM CHARACTERISTICS, P-10E AIRPLANE, ORIGINAL VERTICAL TAIL, FIN OFFSET 1+1/2", POWER OFF, CLEAN CONDITION.

The rudder-control characteristics in straight flight are presented for the four vertical tail arrangements tested in figures 12 through 23. The effectiveness of the rudder trim tabs as a function of indicated airspeed is shown on figure 24.

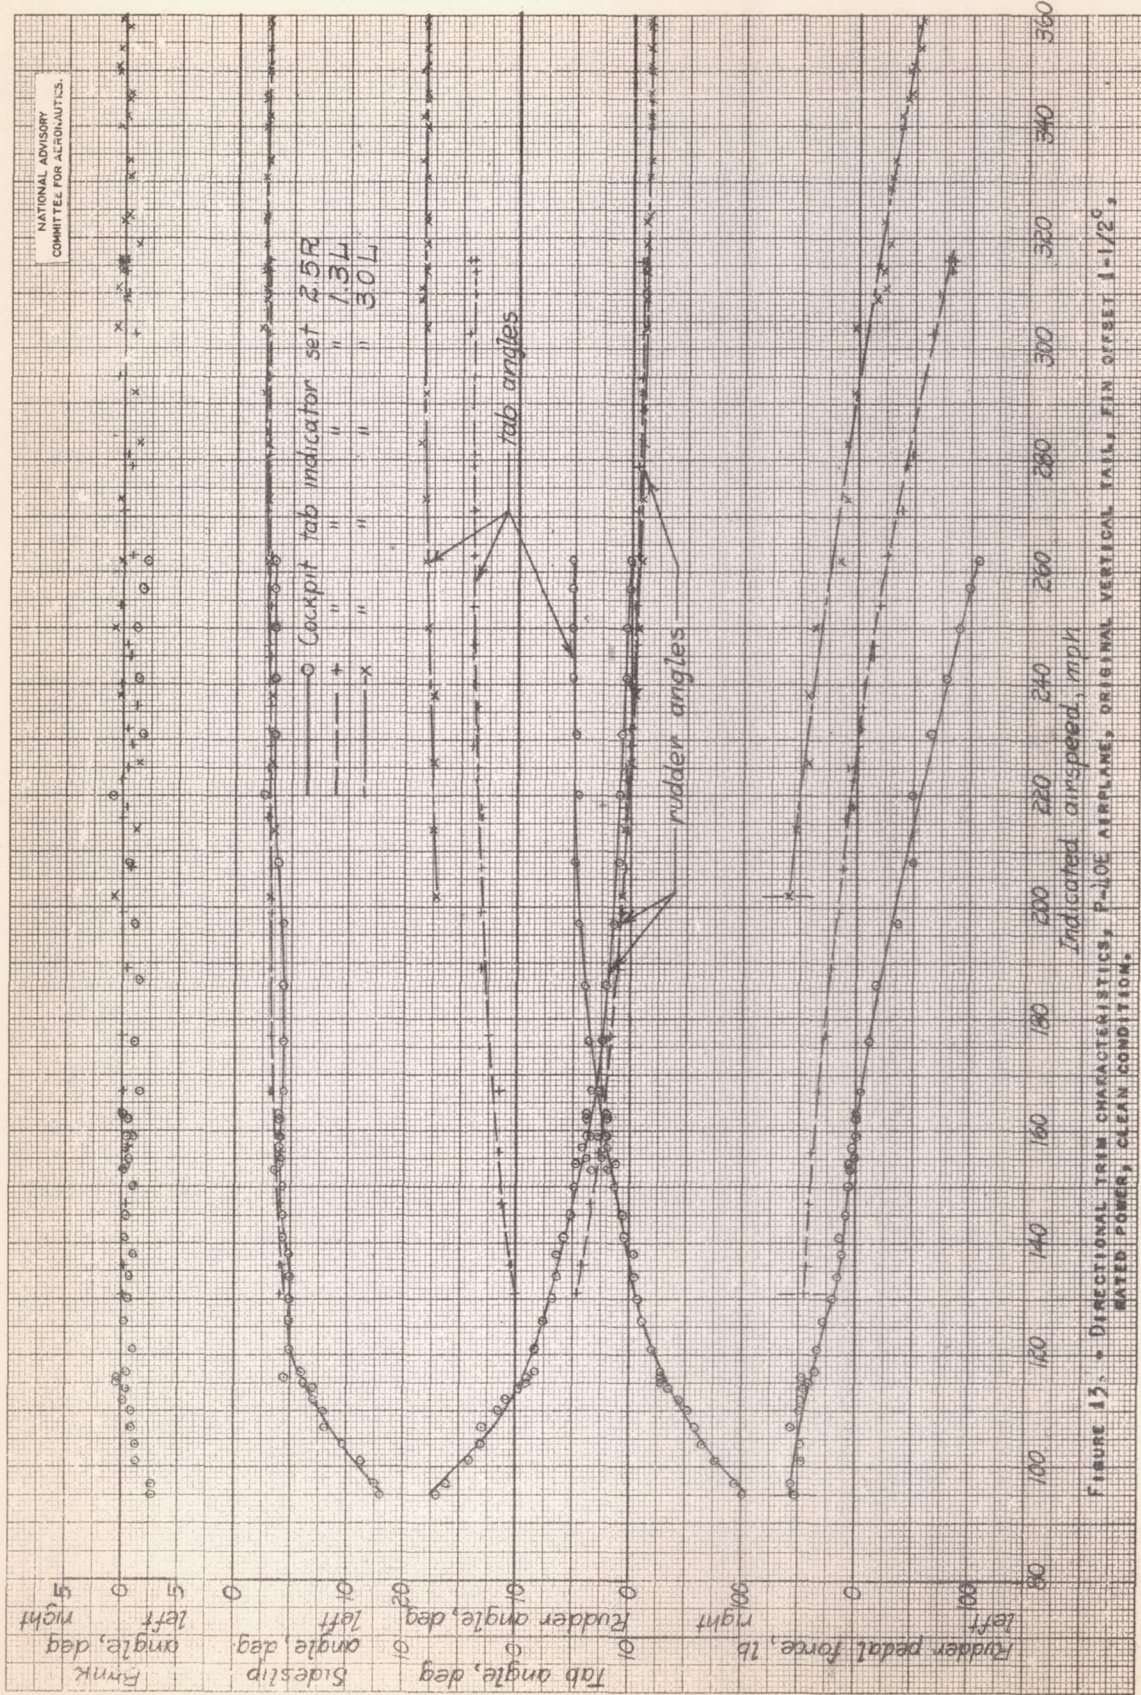
FIGURE 15. DIRECTIONAL TRIM CHARACTERISTICS, P-40E AIRPLANE, ORIGINAL VERTICAL TAIL, FIN OFFSET 1-1/2°, BATED POWER, CLEAN CONDITION.
