FLIGHT MEASUREMENTS OF THE RUDDER CONTROL AND SIDESLIP

CHARACTERISTICS OF FOUR VERTICAL TAIL ARRANGEMENTS

ON THE P-40 SERIES AIRPLANES -

MEMORANDUM REPORT

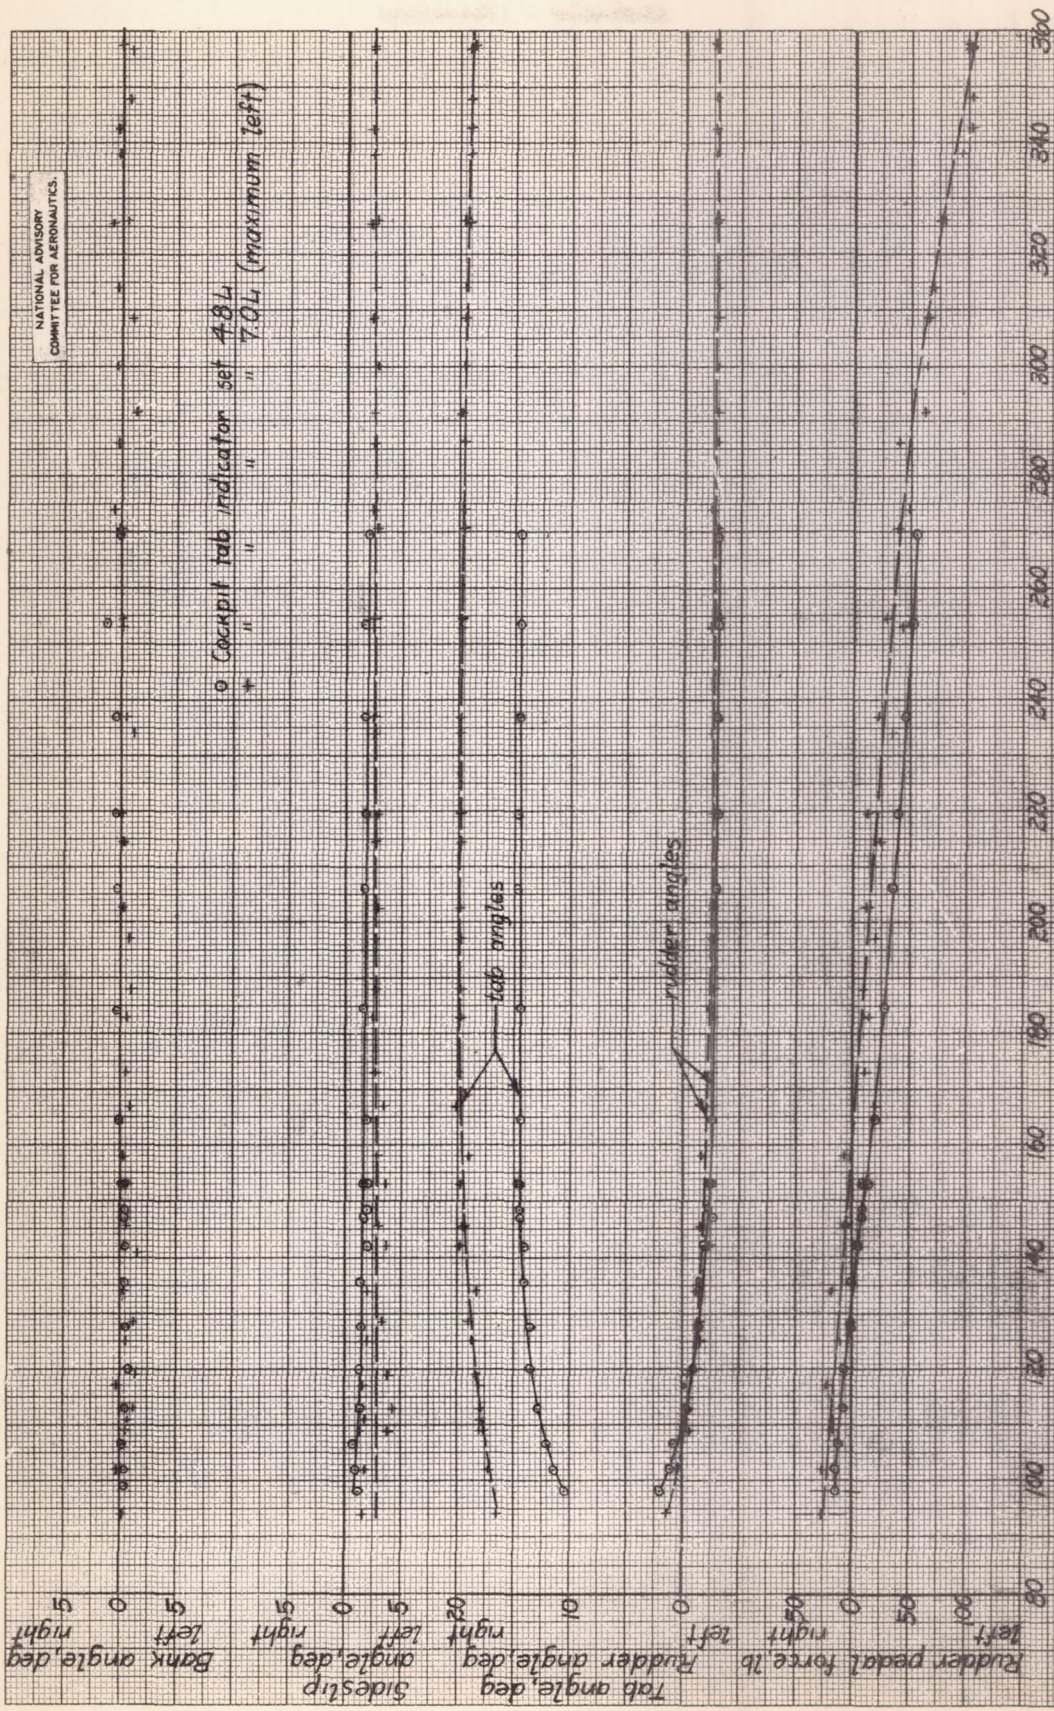
FIGURE 15. - DIRECTIONAL TRIM CHARACTERISTICS, P-30C AIRPLANE, FIN EXTENSION NO. 1 ON ORIGINAL VERTICAL TAIL, FIN OFFSET 1-1/2", POWER OFF, CLEAN CONDITION.

The rudder-control characteristics in straight flight are presented for the four vertical tail arrangements tested in figures 12 through 23. The effectiveness of the rudder trim tabs as a function of indicated airspeed is shown on figure 24.

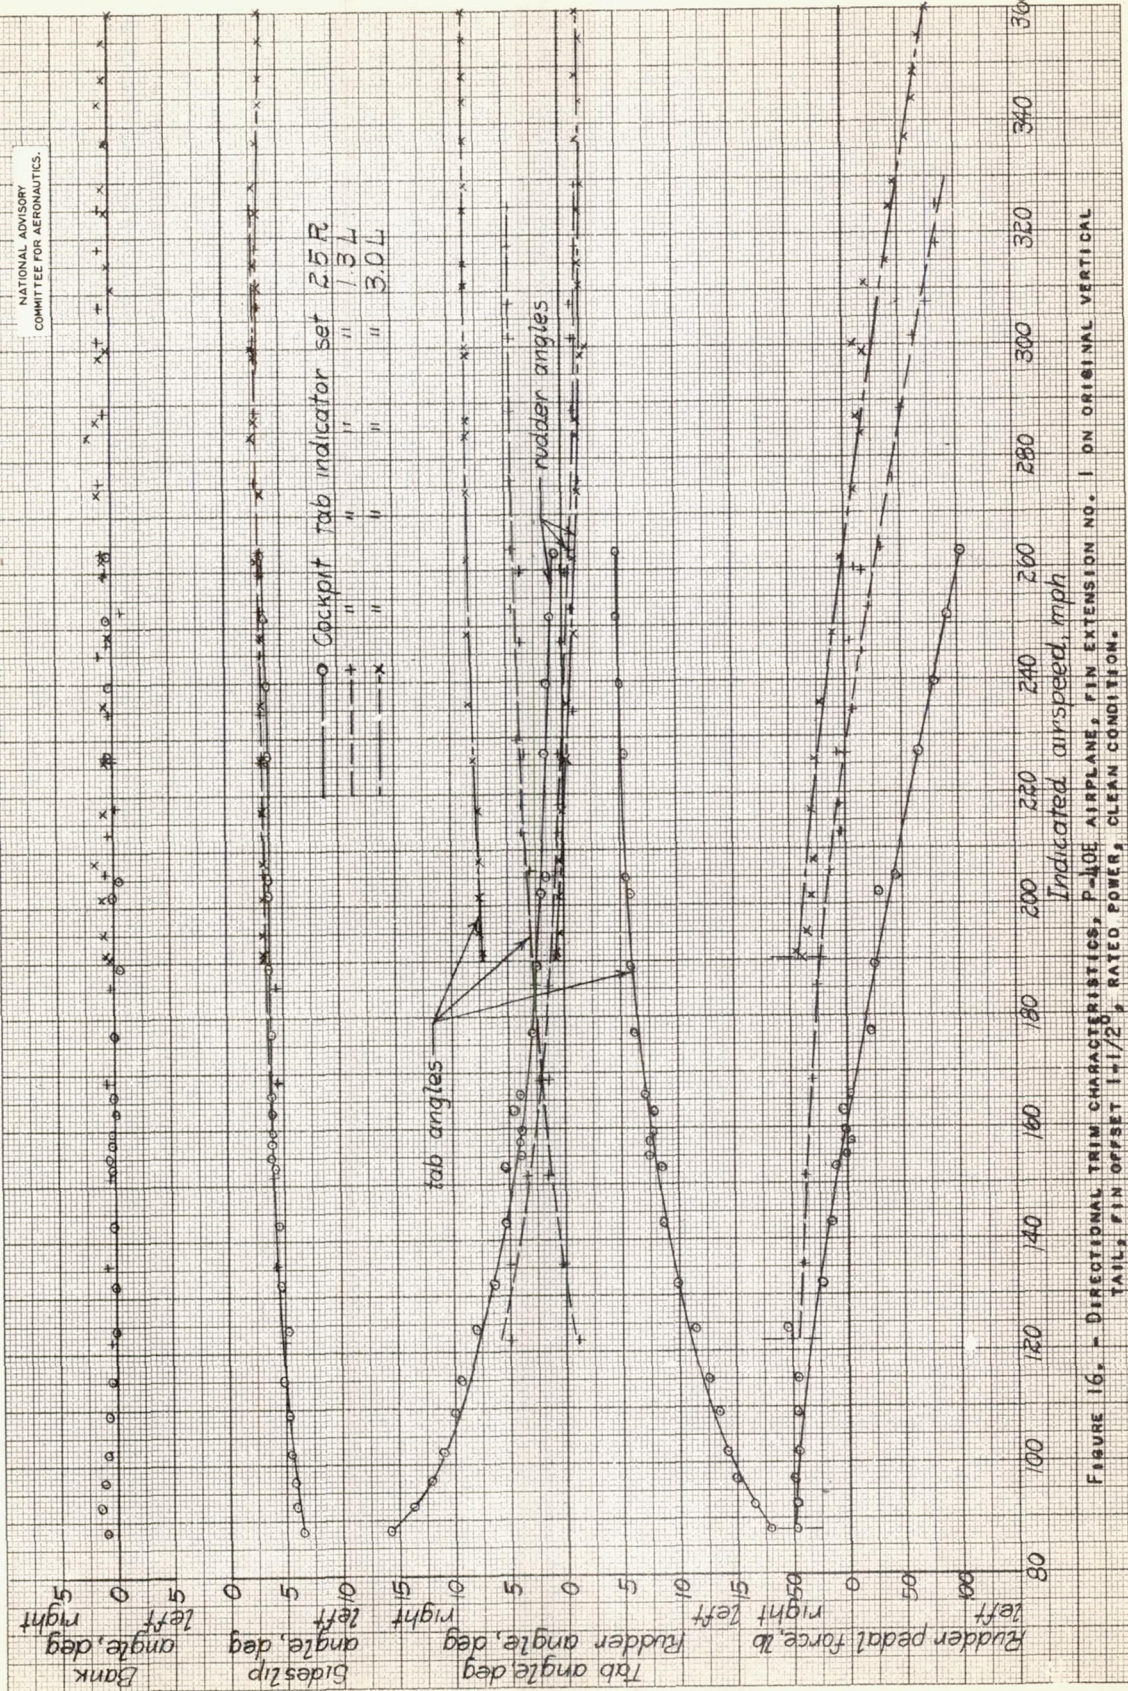
FIGURE 16. - DIRECTIONAL TRIM CHARACTERISTICS, P-10E AIRPLANE, FIN EXTENSION NO. 1 ON ORIGINAL VERTICAL TAIL, FIN OFFSET 1-1/2° RATED POWER, CLEAN CONDITION.

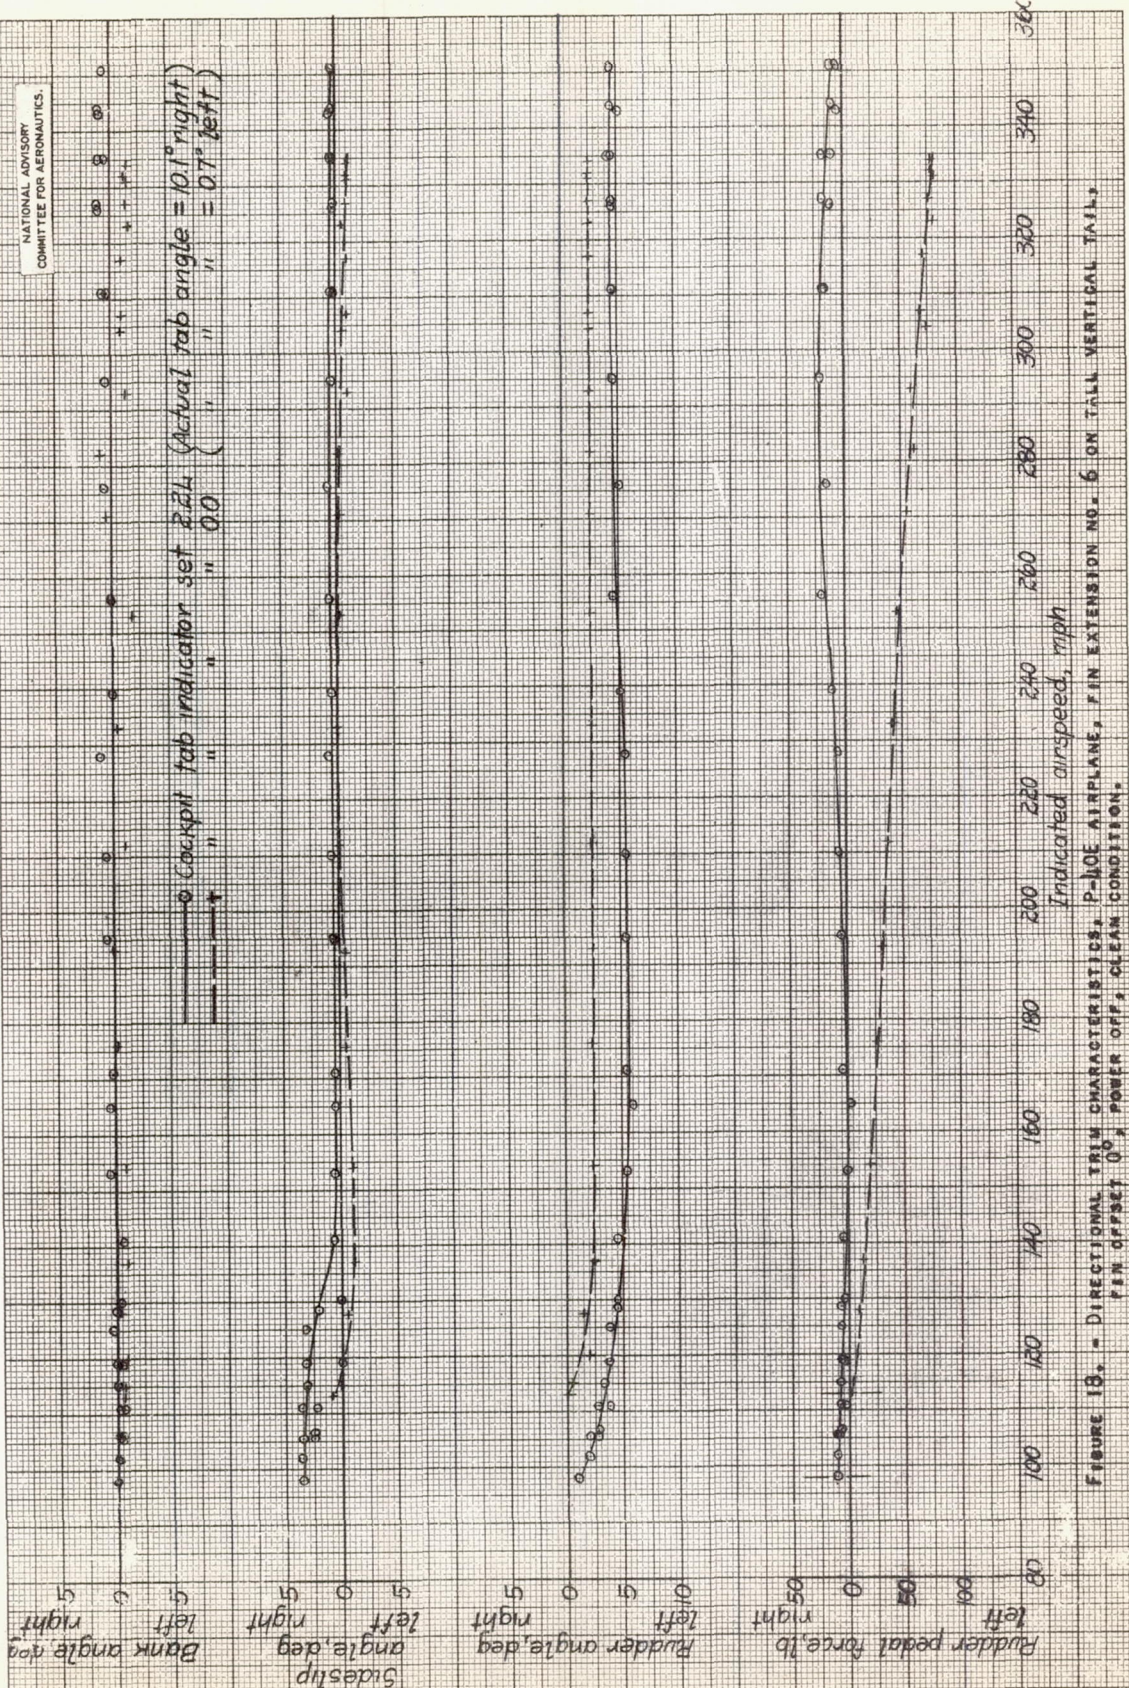
FIGURE 13. - DIRECTIONAL TRIM CHARACTERISTICS, P-10E AIRPLANE, FIN EXTENSION NO. 6 ON TALL VERTICAL TAIL, PEN OFFSET 0, POWER OFF, CLEAN CONDITION.

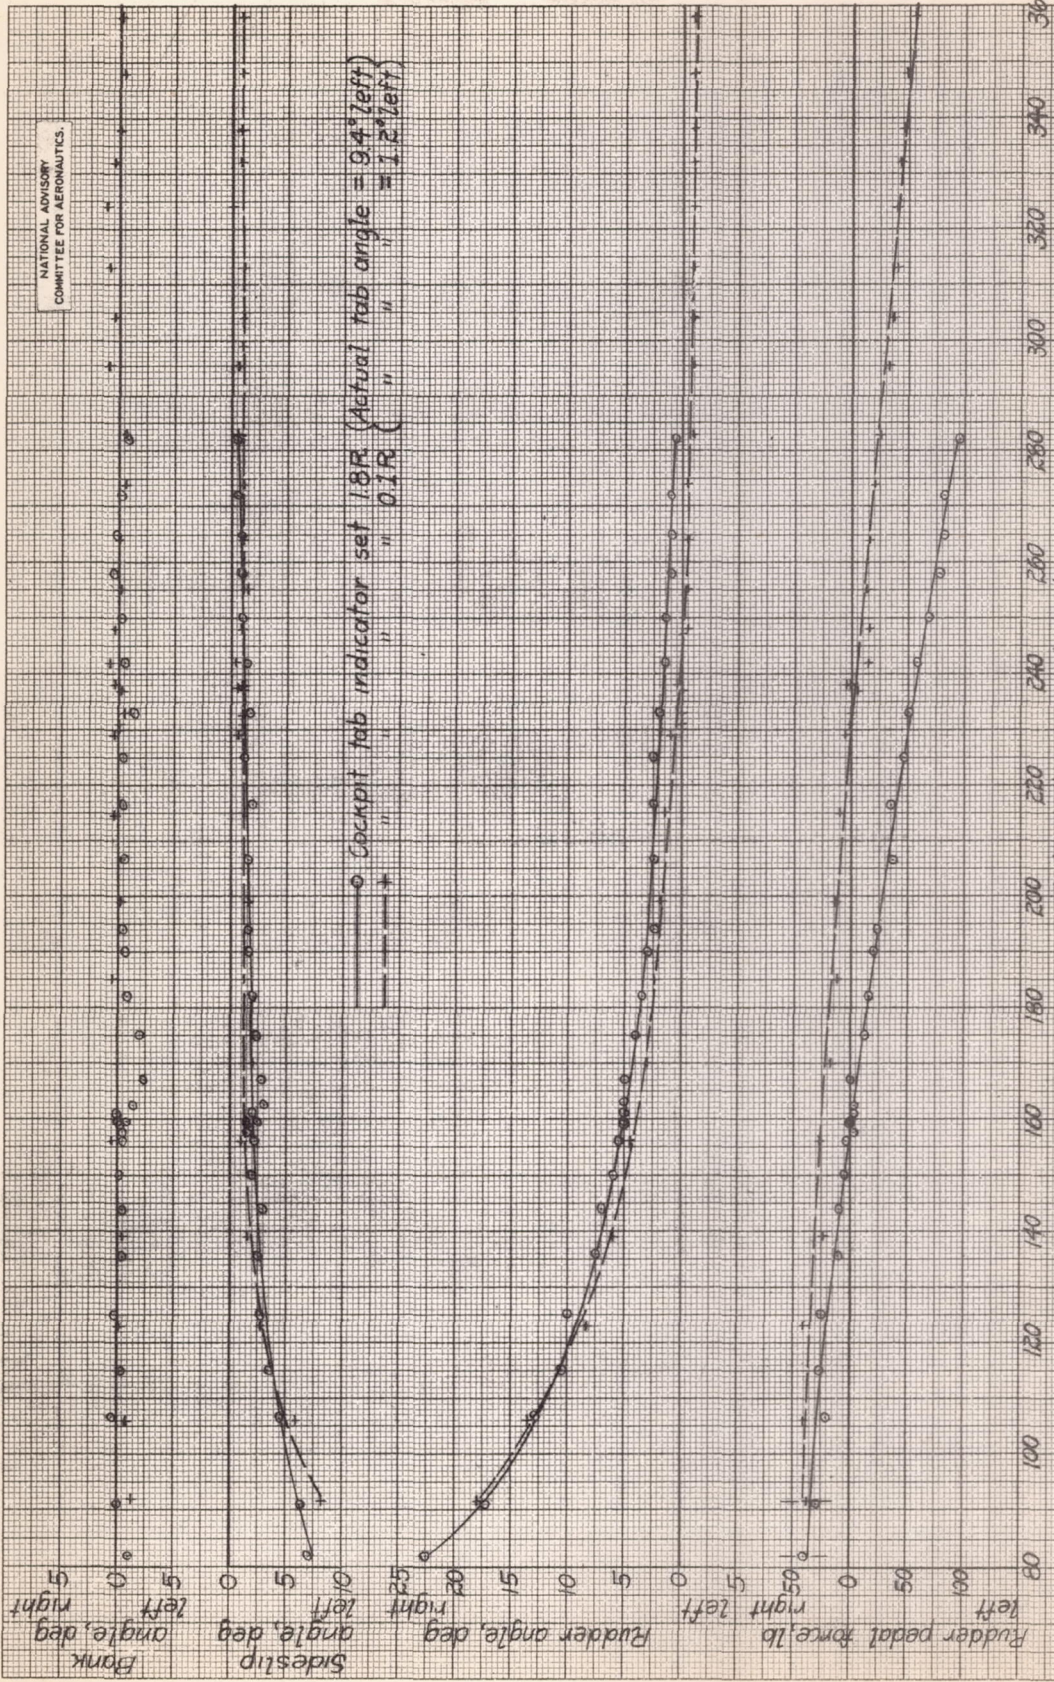
FIGURE 19. - DIRECTIONAL TRIM CHARACTERISTICS, P-10E AIRPLANE, FIN EXTENSION NO. 6 ON TALL VERTICAL TAIL, FIN OFFSET 0°, POWER, CLEAN CONDITION.

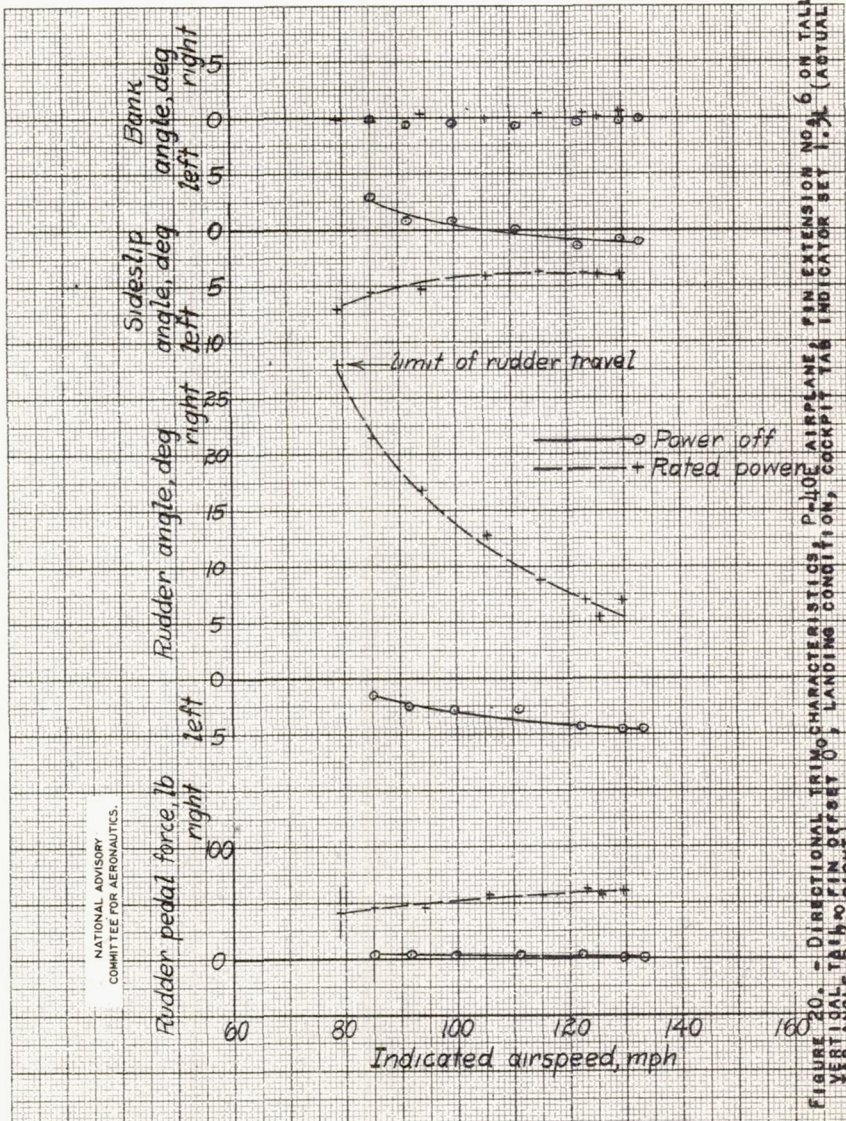
FIGURE 20. - DIRECTIONAL TRIM CHARACTERISTICS, P-40C AIRPLANE, FIN EXTENSION NO. 6 ON TALL VERTICAL TRIM, NO FIN OFFSET 0, LANDING CONDITION, COCKPIT YAG INDICATOR SET 1.0 (ACTUAL YAG ANGLE 5.7° RIGHT).

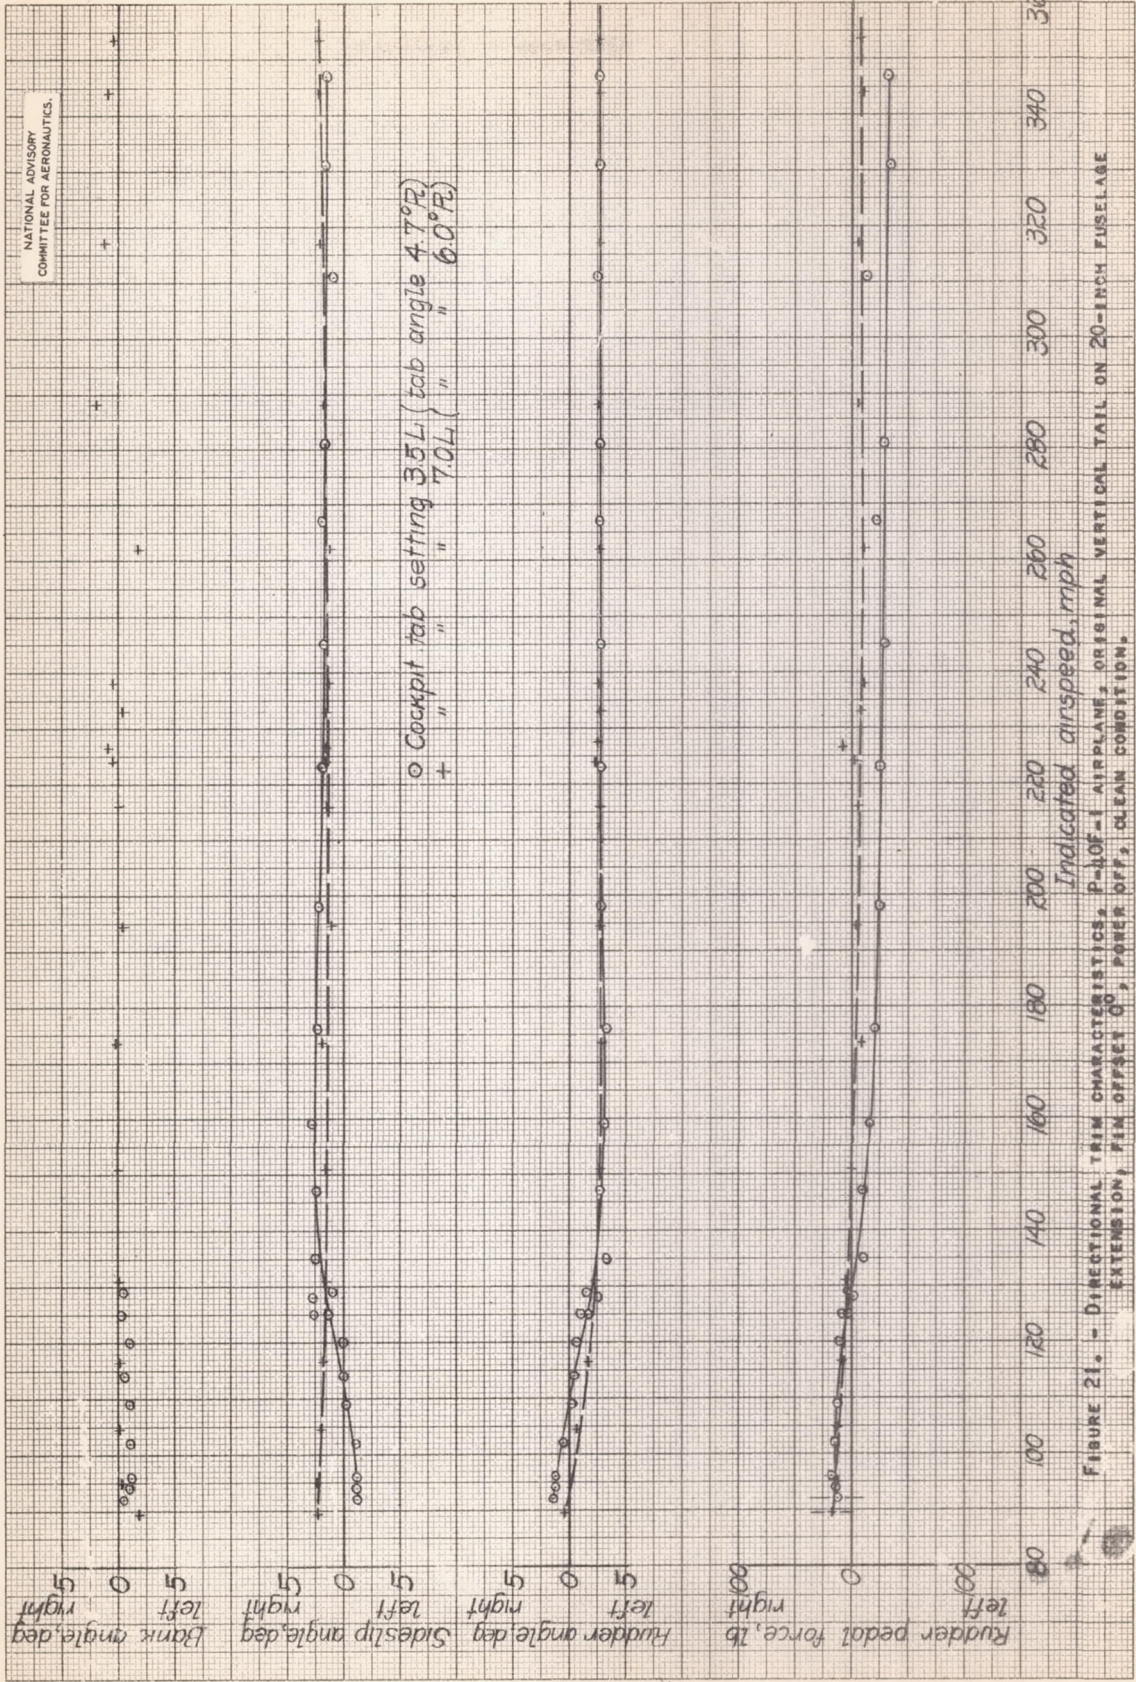
FIGURE 21. - DIRECTIONAL TRIM CHARACTERISTICS, P-40F-1 AIRPLANE, ORIGINAL VERTICAL TAIL ON 20-INCH FUSELAGE EXTENSION, FIN OFFSET 0°, POWER OFF, CLEAN CONDITION.

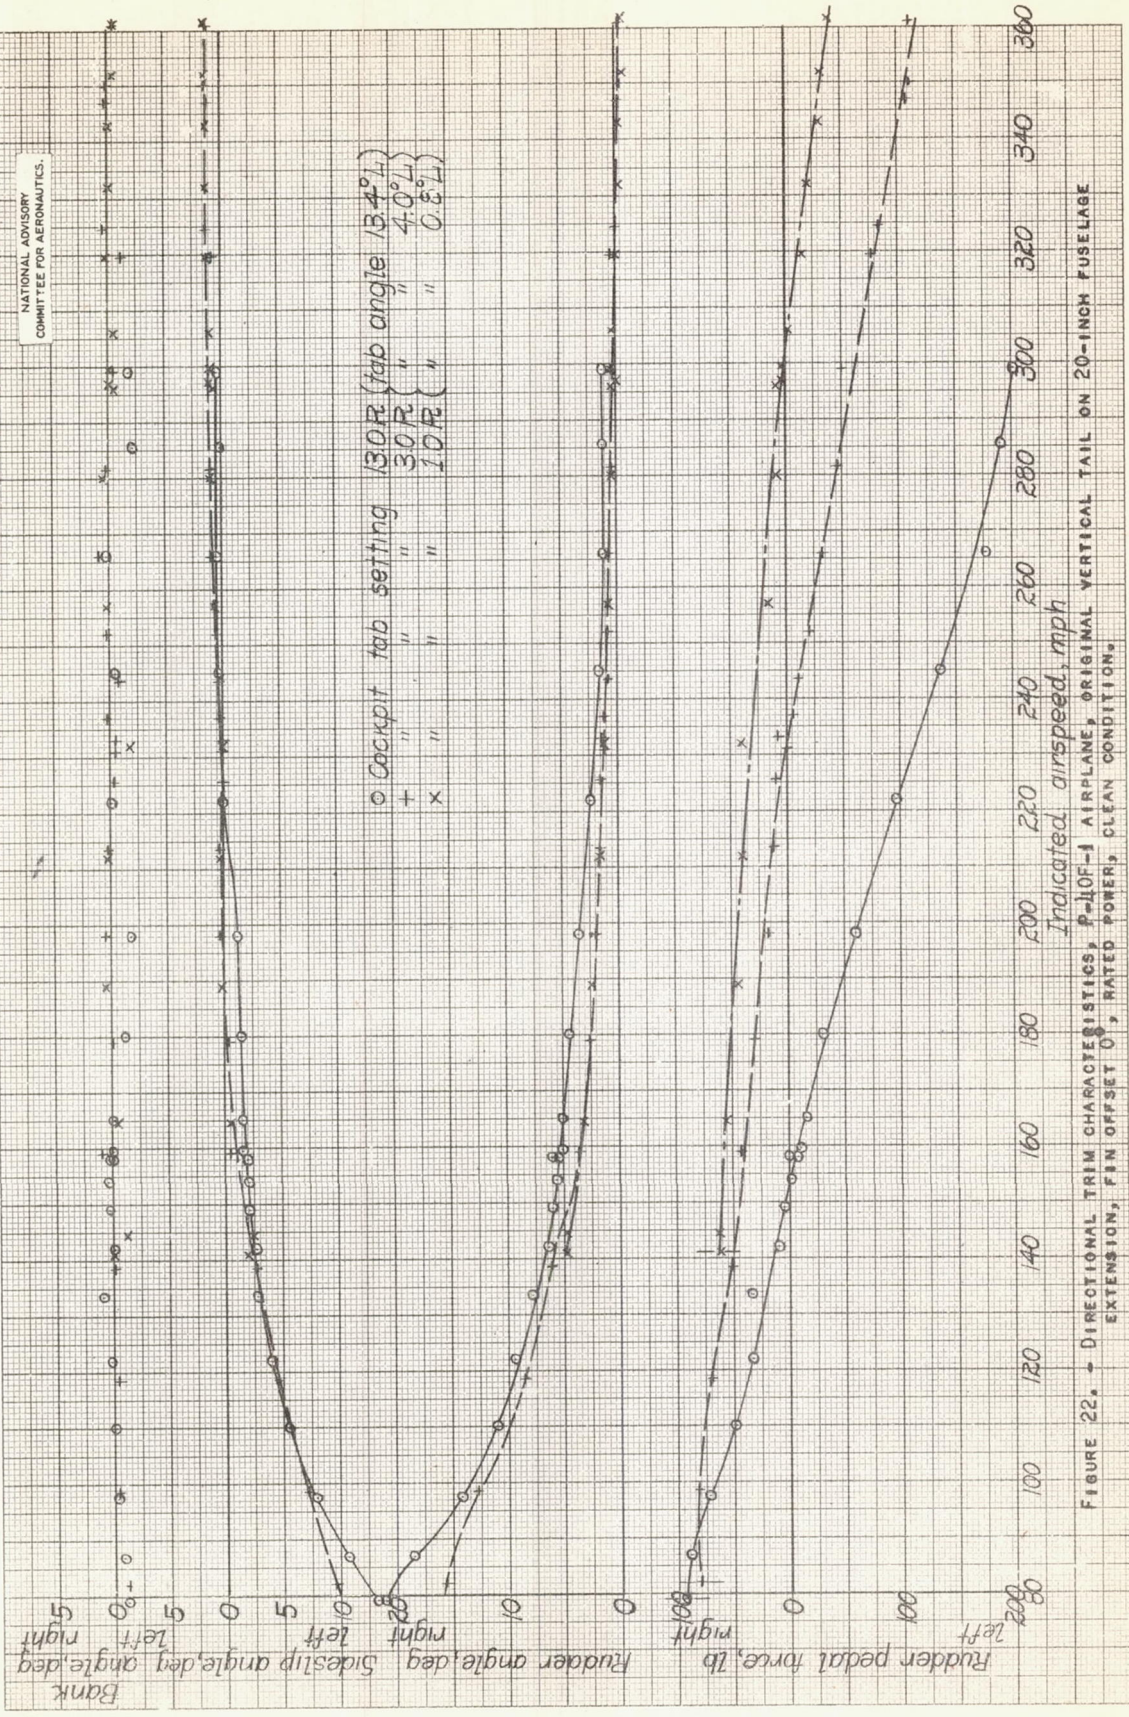
FIGURE 22. + DIRECTIONAL TRIM CHARACTERISTICS, P-10F-1 AIRPLANE, ORIGINAL VERTICAL TAIL ON 20-INCH FUSELAGE EXTENSION, FIN OFFSET 0, RATED POWER, CLEAN CONDITION.

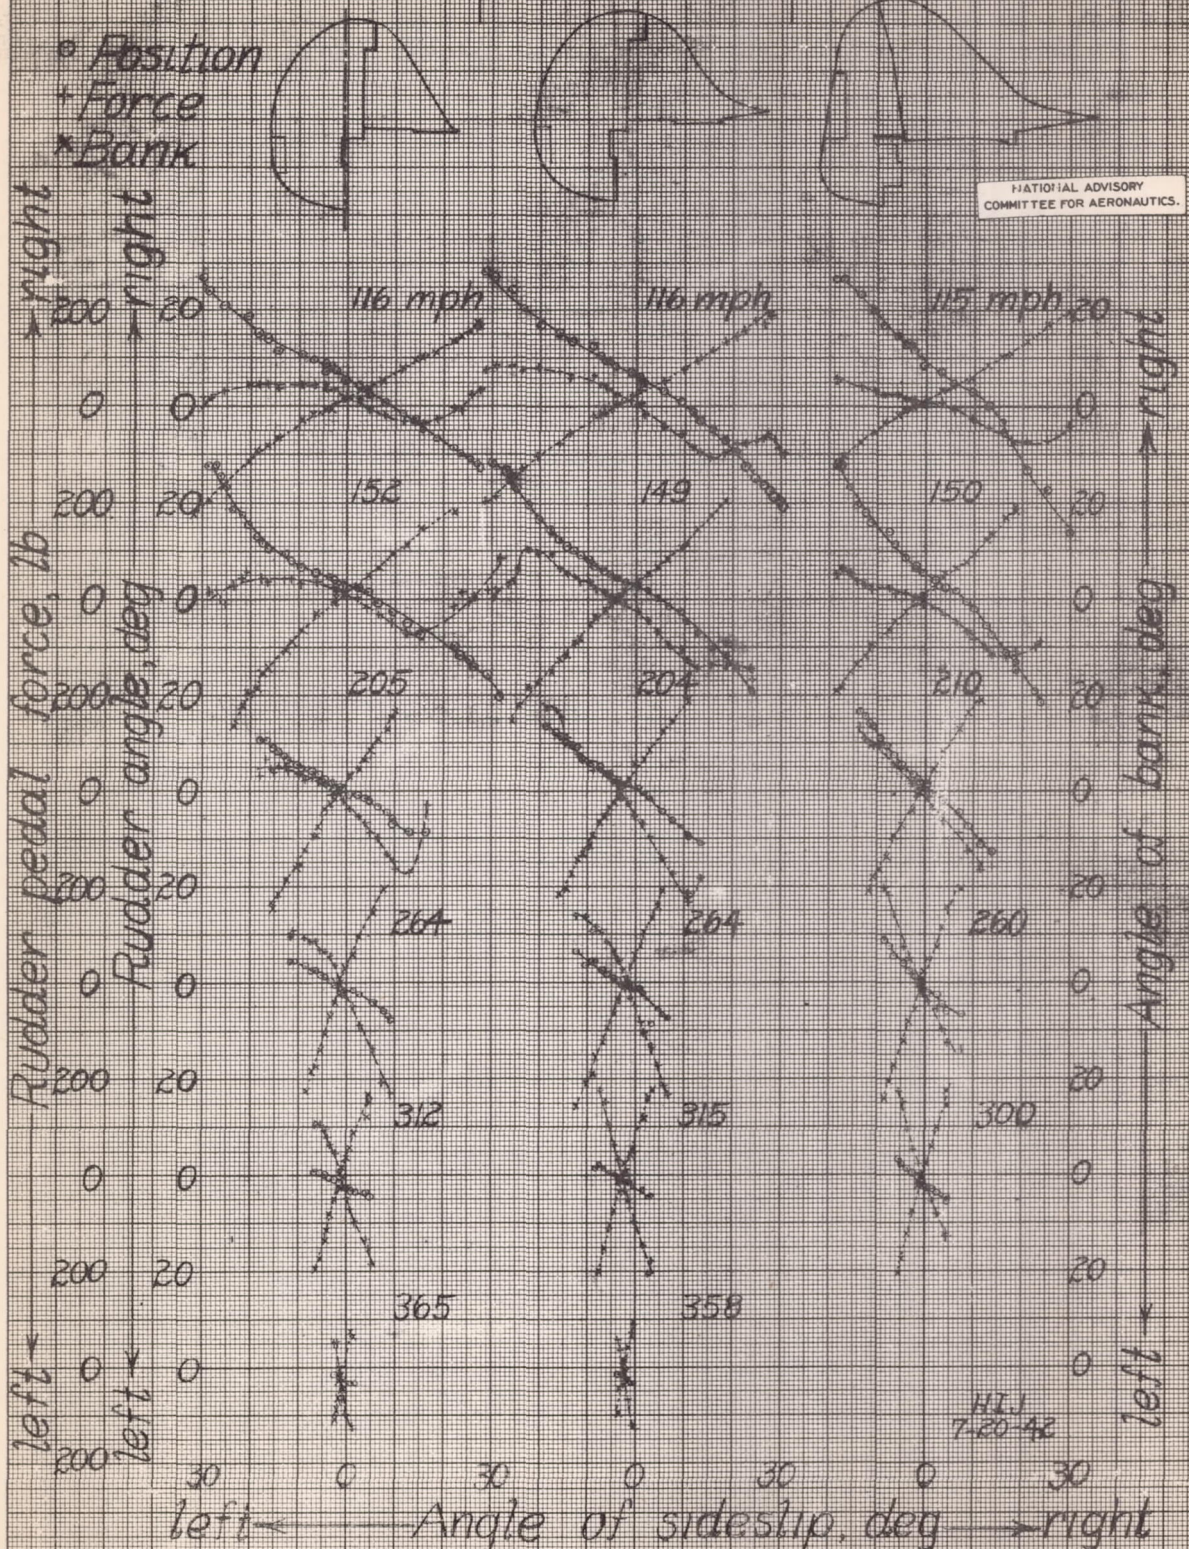
Figure 25 - Sideslip Characteristics of a P-40E Airplane at Various Indicated Airspeeds with Rated Power

The sideslip characteristics of the tail arrangements tested are shown in figures 25 and 26. Attention is

called to the rudder force reversals encountered in the lower speed range with rated power on with the original P-40E airplane. Sideslip characteristics for small angles of yaw are shown for all the tail configurations in figures 27 and 28.

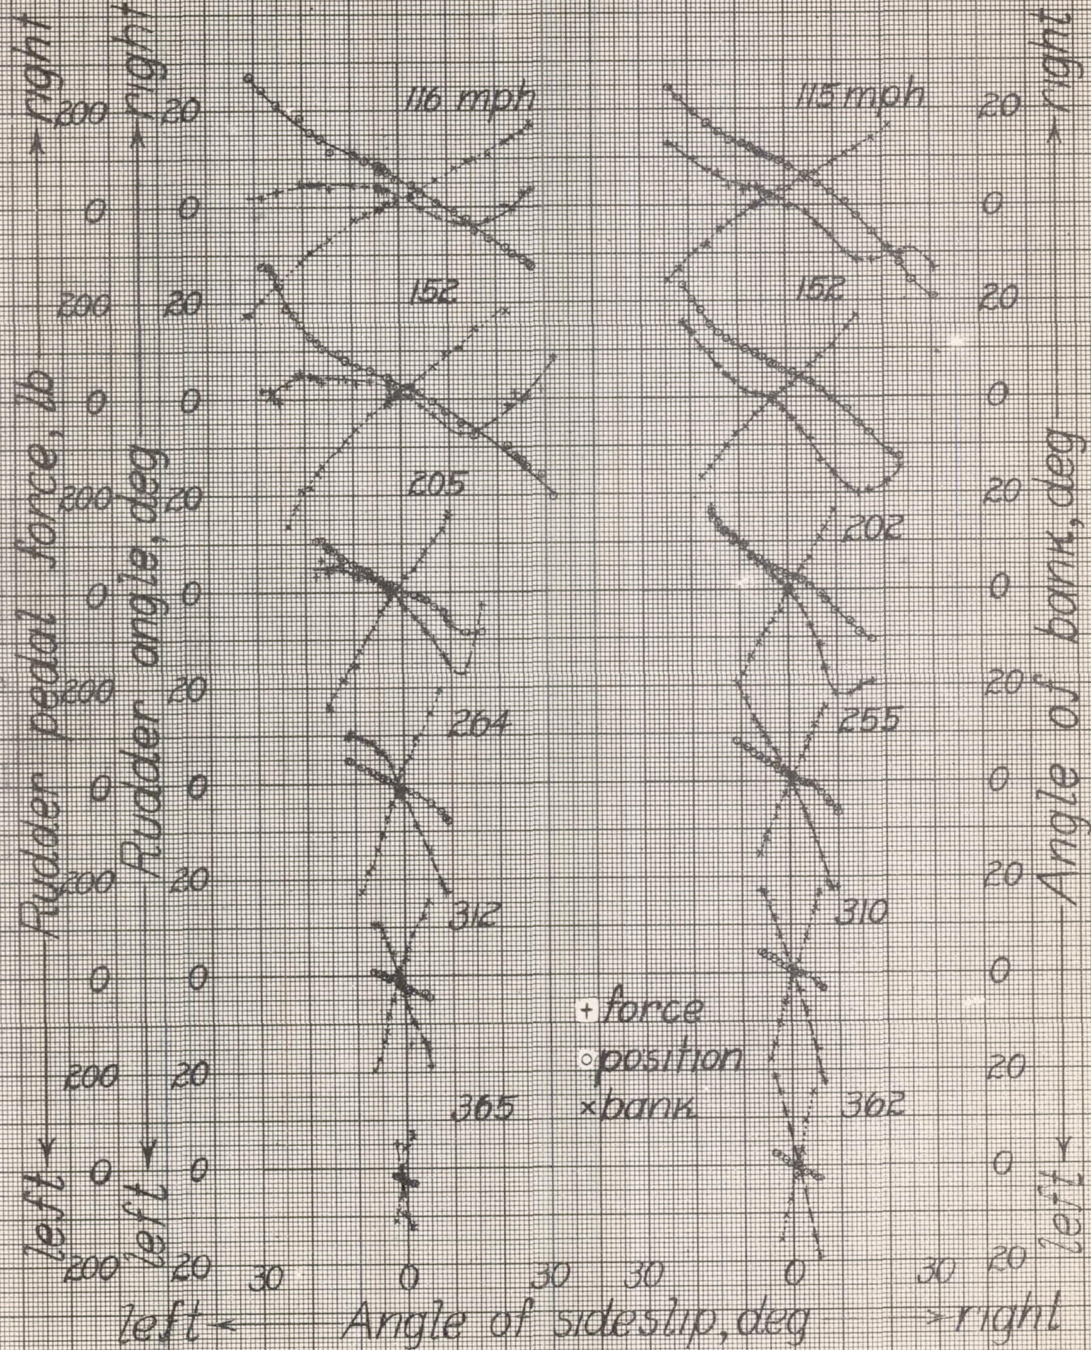
P-40E
 Fin Offset $1\frac{1}{2}^\circ$
 Balance Tab
 Original Fuselage

P-40F-1
 Fin Offset 0°
 No Balance Tab
 20" Fuselage Extension

Figure 25a-Sideslip Characteristics of P-40E and P-40F-1 Airplanes with Original Vertical Tails at Various Indicated Airspeeds with Rated Power

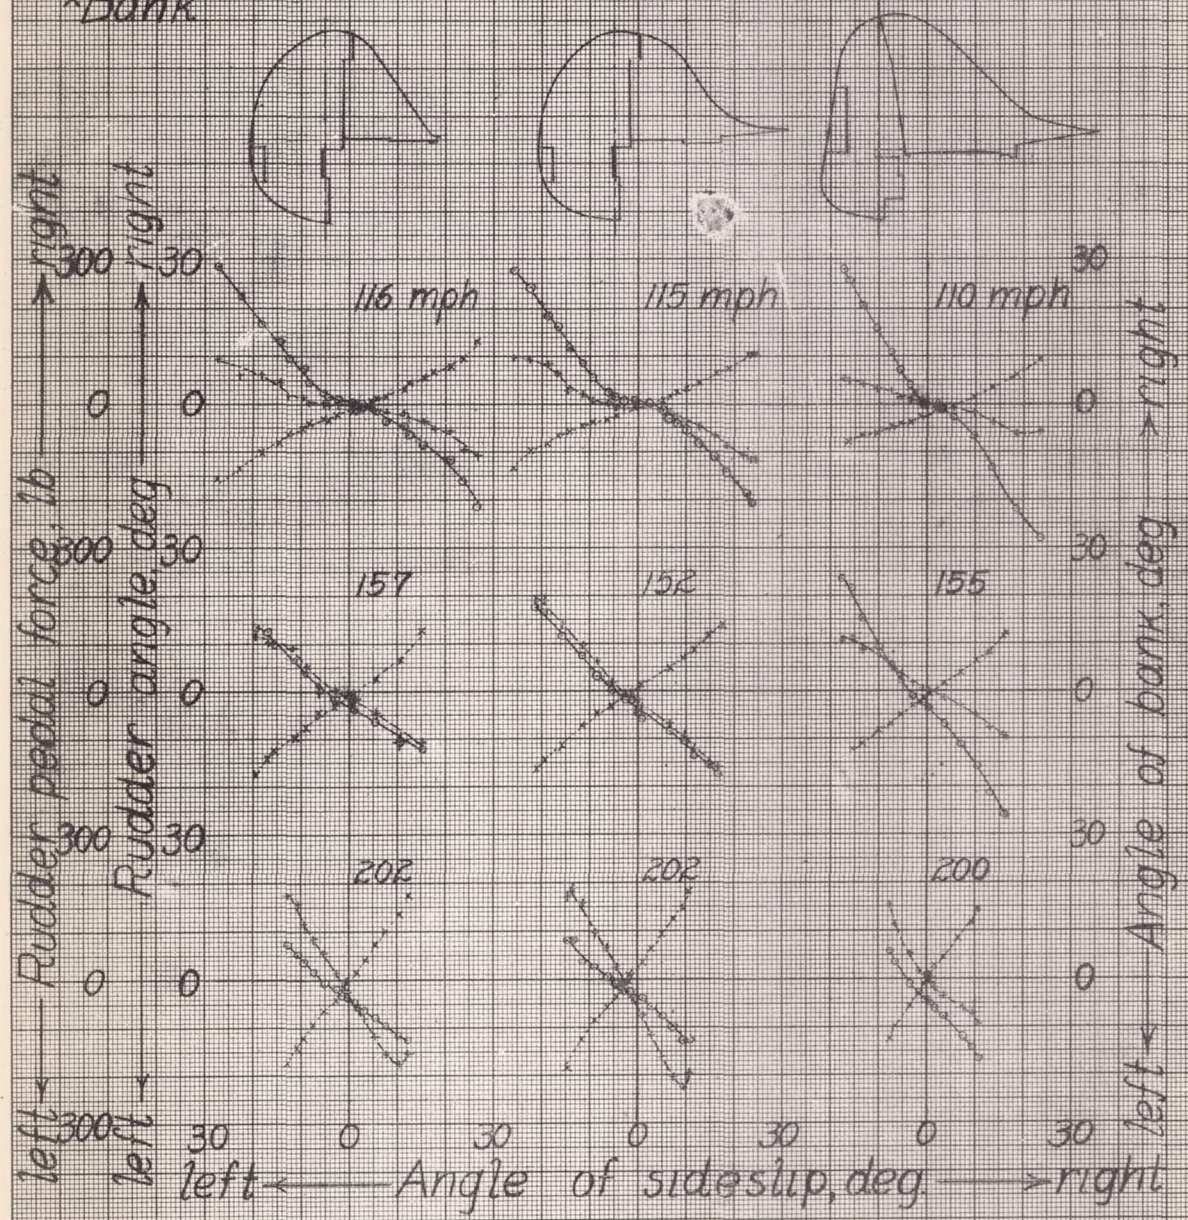
Figure 26 - Sideslip Characteristics of a P-40E airplane at Various Indicated Airspeeds with Power off.

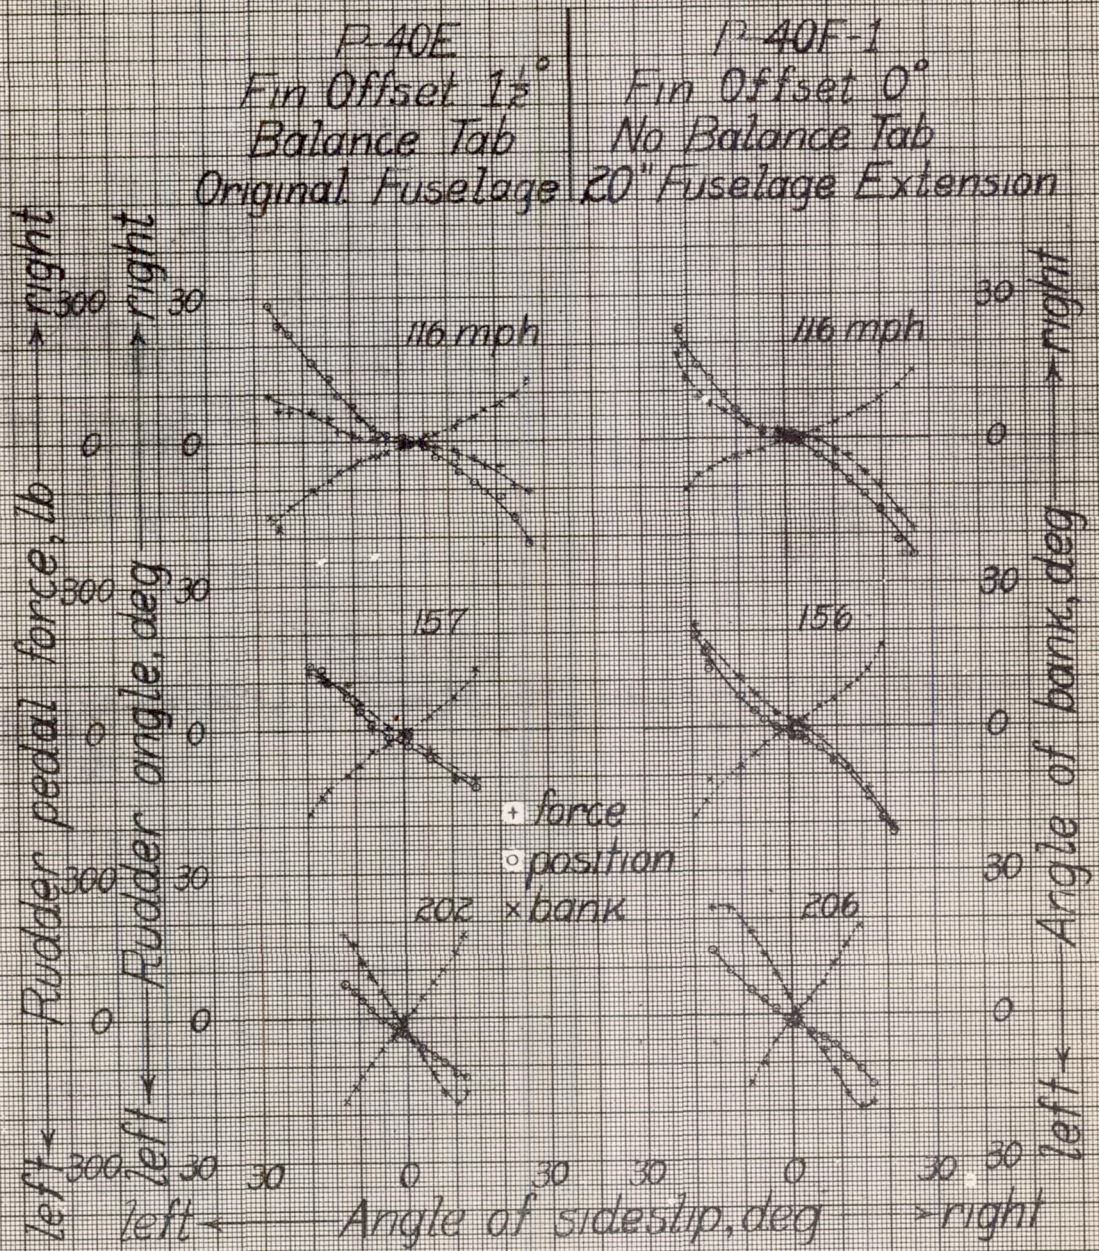
Figure 26a Sideslip Characteristics of P-40E and P-40F-1 Airplanes with Original Vertical Tails at Various Indicated Airspeeds with Power Off

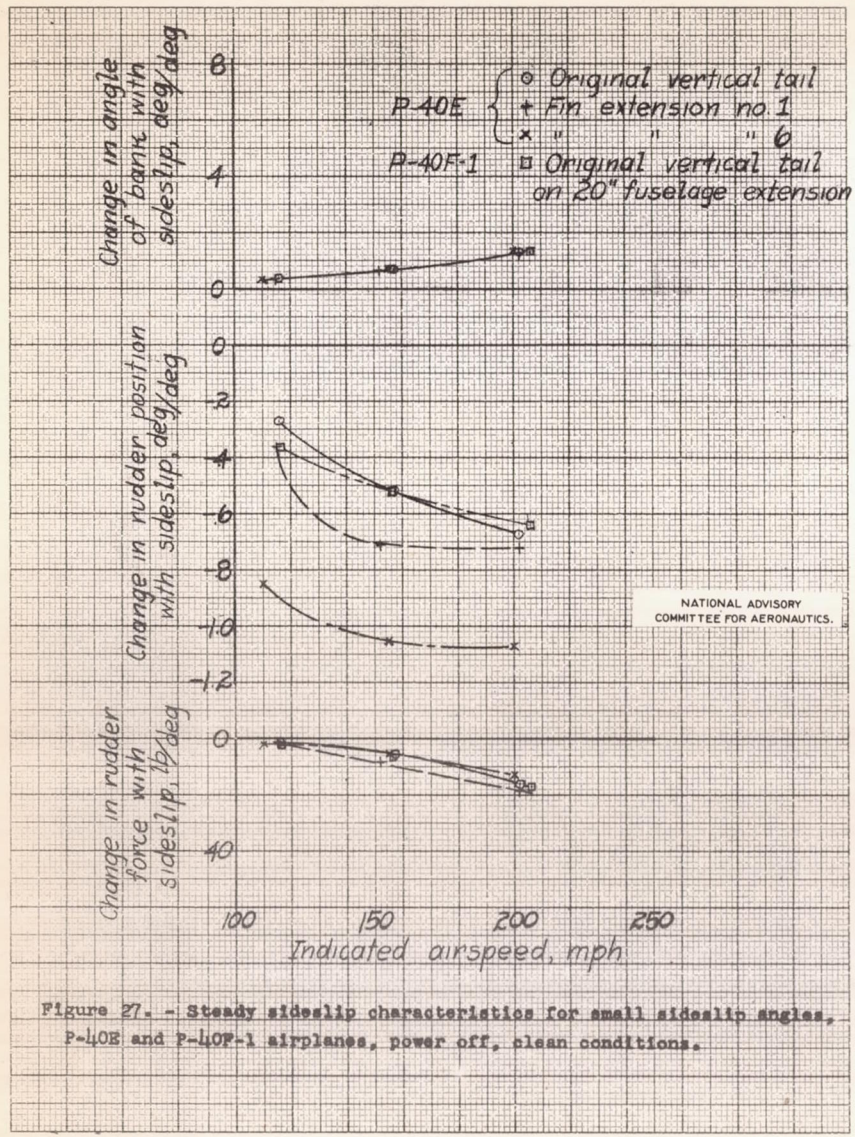
Figure 27. - Steady sideslip characteristics for small sideslip angles, P-40E and P-40F-1 airplanes, power off, clean conditions.

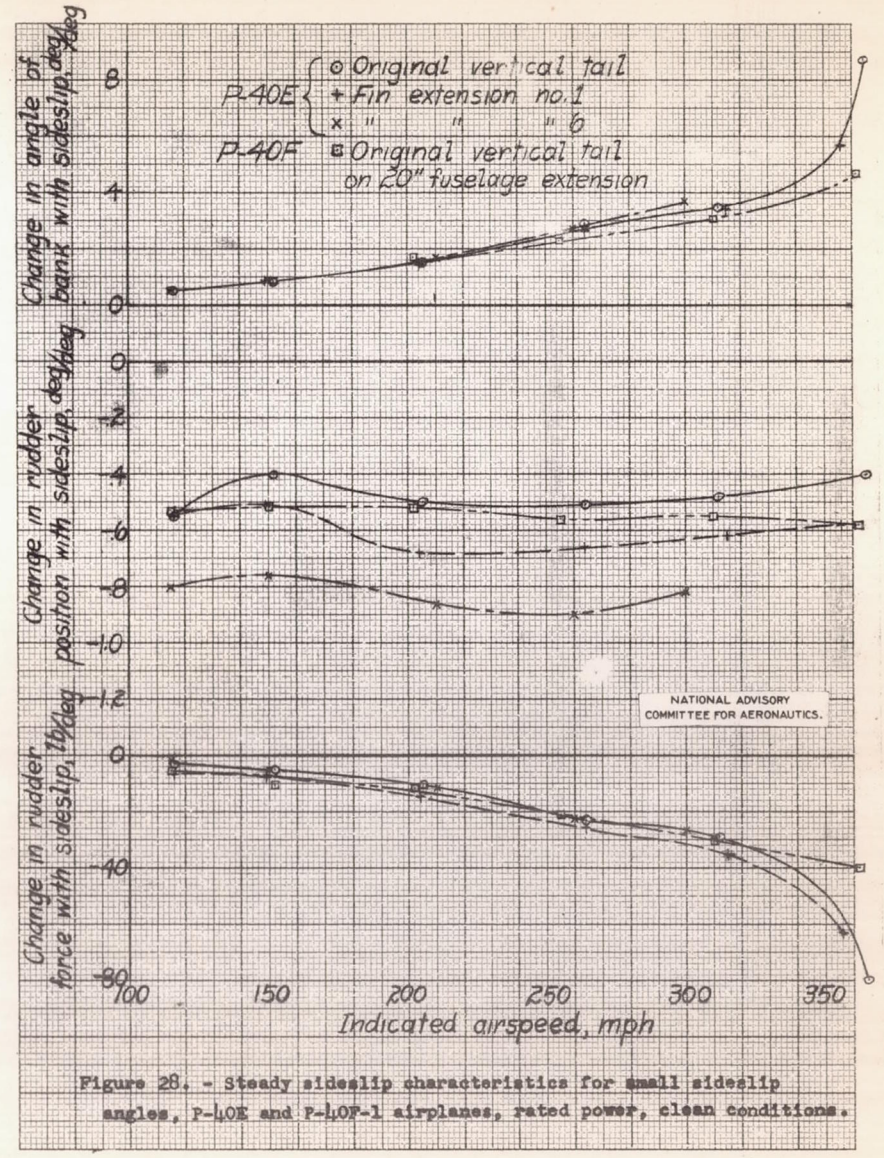
Figure 28. - Steady sideslip characteristics for small sideslip angles, P-40E and P-40F-1 airplanes, rated power, clean conditions.
