A SUMMARY OF DRAG RESULTS FROM RECENT

LANGLEY FULL-SCALE-TUNNEL TESTS OF

ARMY AND NAVY AIRPLANES

ADVANCE CONFIDENTIAL REPORT

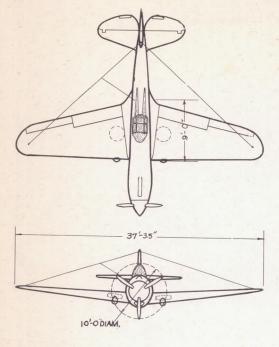
AIRPLANE I

Weight	60	00016
Wing section		
Root	NACA	2215
Tip	NACA	2209
Wing area2	36.0	sq.ft
Twin-row engine		
Military 1000 hp at 2700 rpm at	14,50	O ft
Propeller gear ratio		16:9

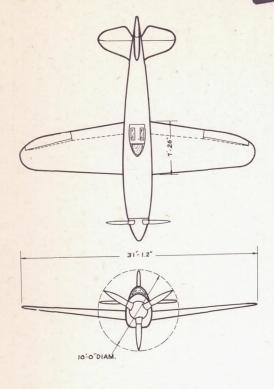
AIRPLANE 6

12-6 DIAM.

Weight 6500lb
Wing section
Root NACA 23016.5
Tip NACA 23009
Wing area 170.0 sq. ft
Inline liquid-cooled engine
1150 hp at 3000 rpm at 12,000 ft
Propeller gear ratio2:1

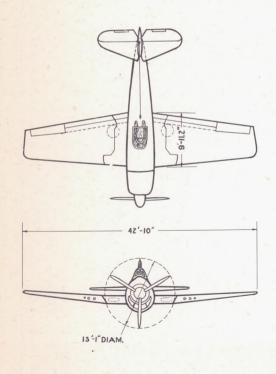
AIRPLANE 9

Weight	II,441 lb
Wing section	
Root	_NACA 23015.6 (Modified)
Tip	NACA 23009
	334.0 sq ft
Twin-row two-stage-su	percharged engine
1650 hp at 2700 rpm	at 25,000 ft
Propeller gear ratio _	2:I

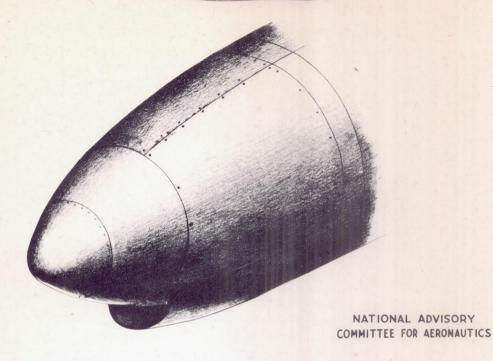
Figure 3. - Cowling drag on airplane 1.

ΔC_D , 0.0040 Q, 16,000 cu ft per min ΔV , 17 mph $H - p_0$, 0.40 q_0

The original long-nose cowling on airplane 1, which had a 20-inch propeller-shaft extension to permit a cowling shape of higher fineness ratio, included an inlet that was too small and leading edges that were too sharp. The sudden change in direction and the extreme expansion of the high-velocity cooling air into the large volume ahead of the engine resulted in a total-pressure recovery in front of the engine cylinders of only 0.40q₀. The drag coefficient was 0.0040 greater for the original installation with an exit area of 167 square inches (cooling flaps in closed position) and an air-flow quantity of approximately 16,000 cubic feet per minute at 350 miles per hour than for the sealed and smooth cowling with the scoop removed. Cowlings were developed in the Langley full-scale tunnel (figs. 3(b) and 3(d)) to reduce the drag of the original cowling.

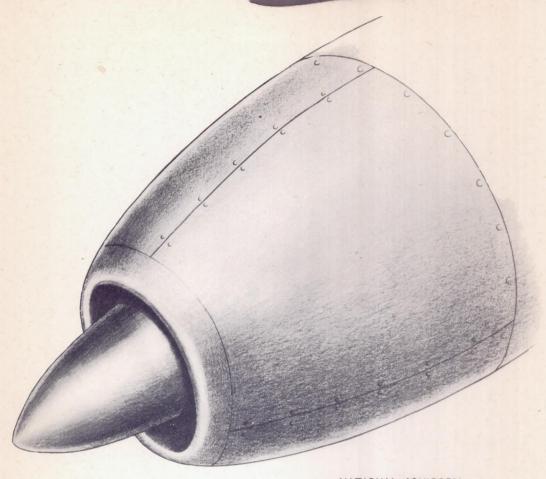
Figure 3.- Continued.

ΔC_D , 0.0027 Q, 17,000 cu ft per min ΔV , 13 mph H - p₀, 0.90q₀

A cowling with an annular inlet and an inlet-velocity ratio of 0.25, designed to reduce the kinetic-energy losses of the cooling air and to avoid the large external drag of the original cowling (fig. 3(a)), was next tested. As compared with the sealed and smooth cowling with the scoop removed, the airplane drag coefficient was increased to 0.0022 with an air flow of approximately 12,000 cubic feet per minute and to 0.0027 with an air flow of approximately 17,000 cubic feet per minute. Pressure measurements along the spinner indicated a flow reversal caused by a high adverse pressure gradient. The total pressure at the rear of the diffuser was slightly less than 0.900 for these conditions. The dimensions of the annular-inlet cowling with spinner A are given in figure 4.

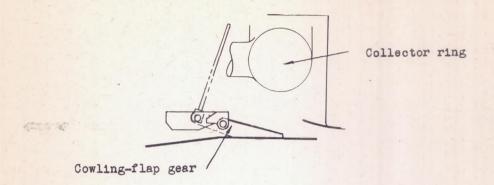
Section at original cowling outlet

In order to reduce the adverse pressure gradient along spinner A of figure 3(b) and to increase the total-pressure recovery in the diffuser, the inlet-velocity ratio was increased to about 0.5 on spinner B by increasing the spinner size and thus reducing the annular-inlet area. With the bottom exit open and the cowling flaps sealed, the cowling drag coefficient was reduced 0.0005 as compared with that measured with spinner A and the same outlet, and the air flow was increased to approximately 14,000 cubic feet per minute. The cowling flaps were then unsealed and the air flow was increased to approximately 21,000 cubic feet per minute, which was sufficient for the engine, carburetor, and oil cooler. The cowling drag coefficient of 0.0012 measured for this arrangement is the lowest that has been obtained in Langley full-scale-tunnel tests of cowlings for radial air-cooled engines. Pressure measurements over the cowling indicate that the critical Mach number is 0.74. The dimensions of the annular-inlet cowling with spinner B are given in figure 4.

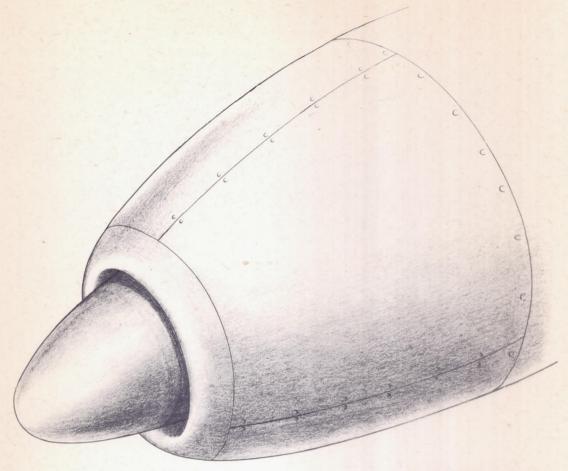
The drag of the annular-inlet cowling with spinner A was considered excessive and the outlet was next investigated (reference 3). Removing the cowling-flap gear and exhaust collector ring and installing a smooth outlet decreased the drag of the cowling by 0.0007 with an air flow of approximately 13,000 cubic feet per minute. In addition, a bottom exit was provided by removing the oil cooler and enlarging the oil-cooler exit to allow an engine-cooling-air flow of approximately 13,000 cubic feet per minute with the cowling flaps sealed. This arrangement further reduced the drag by 0.0004.

ΔCD , 0.0012 Q, 21,000 cu ft per min ΔV , 6 mph $H - P_0$, 0.97q₀

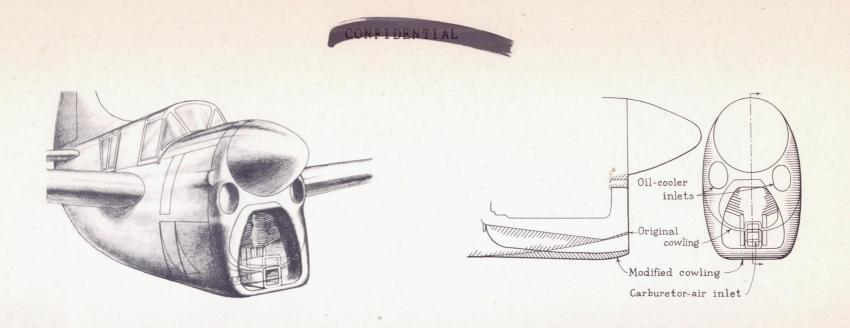
Figure 5. - Cowling modification on airplane 2.

Flight tests showed that the inline air-cooled engine of airplane 2 did not cool satisfactorily in any flight attitude in the original condition. Tests in the Langley full-scale tunnel revealed that losses in the cooling system were excessive because of restricted inlet and outlet openings. The inlet was accordingly lowered and its area increased from 188 square inches to 241 square inches and additional outlet openings of 75 square inches were installed on each side of the cowling. These modifications increased the power-on inlet total pressure 25 percent in the climb attitude, principally because the inlet was lowered into a region of higher slipstream velocity. In addition, the average total pressure in front of the engine cylinders was increased. The drag coefficient with propeller removed was decreased 0.0004 by the cowling modification. This reduction is attributed mainly to the improved shape of the cowling lip and the greater efficiency of the internal flow.

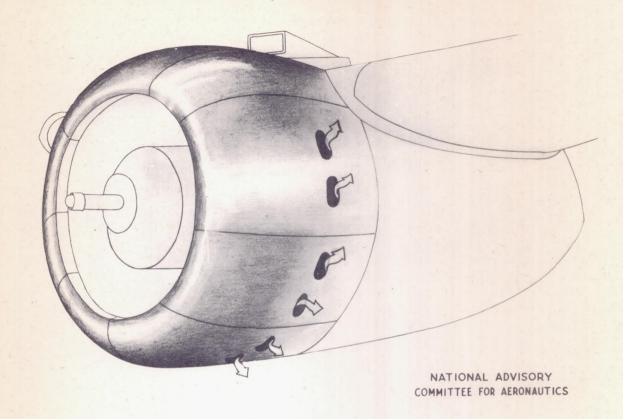
Figure 6. - Original cowling on airplane 3.

ΔC_D, 0.0041 ΔV, 13 mph

Some makeshift methods of controlling the air-flow quantity have been found to cause excessive drag. On airplane 3, for example, the designers cut eight holes, each with an area of 12.5 square inches, in the periphery of the cowling just behind the cylinder baffles in order to remedy unsatisfactory cooling of the engine in the climb condition. Tests by the Army and the manufacturer indicated that the cooling problem was not remedied for the climb condition and the flow disturbances caused by the holes resulted in an increase in drag coefficient of 0.0041 for the cowlings of the two engines, which corresponds to a decrease in the airplane high speed of about 13 miles per hour.

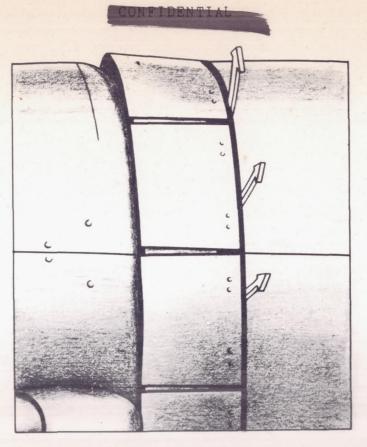
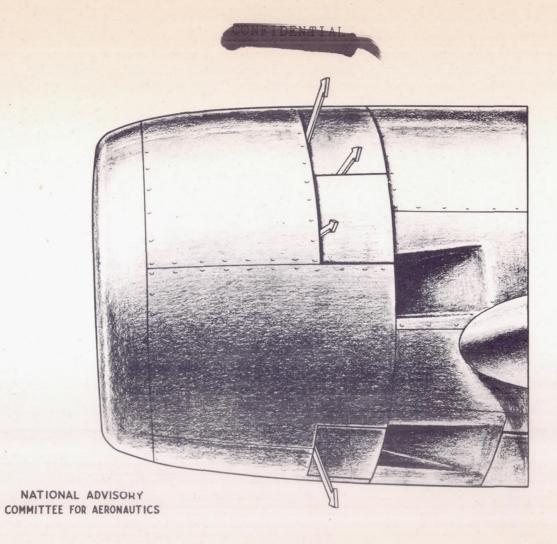
Figure 7: - Cowling-flap-gap drag.

Drag increases were measured when the doped-tape seals were removed from the gaps at the hinge line of the closed cowling flaps of airplanes 6, 8, and 10. The arrows show points of leakage that disturbed the external flow and resulted in an increase of drag. More complete sealing or directing the air flow backward would tend to eliminate this drag increment.

ΔC_D, 0.0005 ΔV, 3 mph

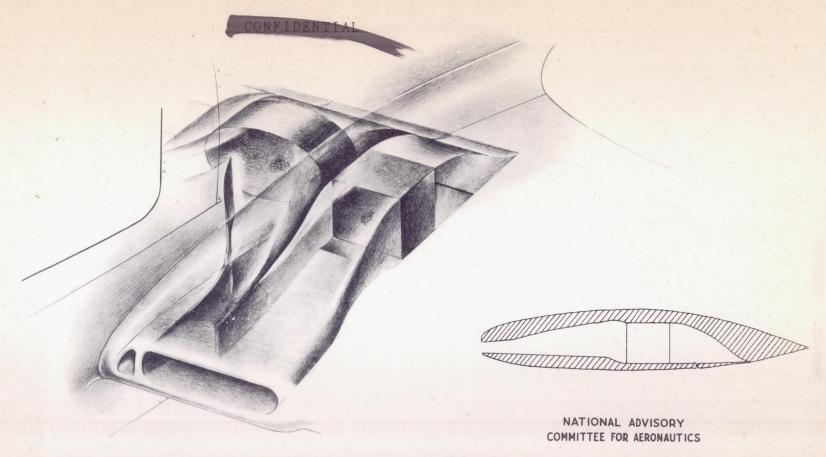
Figure 10. - Wing-duct inlet on airplane 11.

A drag-coefficient increment of 0.0013 was measured when the seals were removed from the wing-duct inlets and exits with the exit flaps at 0° for airplane 11 in the high-speed condition. Removing seals from holes in the top of the duct exits for flap-control push rods added an increment of 0.0004, which made the total-drag coefficient 0.0017 for the original installation with a large quantity of air flowing through the duct because of air leakage at the exit flap. Tests with the propeller operating showed that serious losses in total-pressure recovery occurred as a result of the misalinement of the duct lips to the air stream caused by the slipstream rotation. In order to remedy this condition, modified inlets were installed (fig. 11) with the plane of the inlet on the side of the upgoing propeller blade tilted 15° farther downward than the plane of the inlet on the side of the downgoing propeller blade. A further modification, which consisted of an increase in area of the right and left inlets from 55 to 73 square inches, was made to lower the inlet-velocity ratio. For the high-speed condition, with the exit flaps at 0°, the modified inlets decreased the drag coefficient 0.0005 and increased the total pressure at the faces of the radiators 15 percent. The cooling was improved for both the high-speed and climb conditions with the modified inlets.

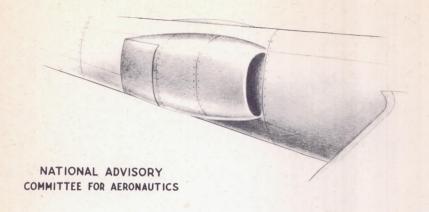
Figure 12. - Duct installations on airplane 4.

ΔCD, 0.0021 ΔV, 12 mph

The drag coefficient of the experimental airplane 4 with the four original coolant radiator ducts installed and with the outlet flaps open (exit seals removed) for the high-speed condition was 0.0021 greater than for the airplane with the ducts removed. Revised ducts for the production airplane were installed with a smaller inlet area and higher inlet-velocity ratio. The increase of drag coefficient due to the revised ducts was 0.0024 but the air-flow quantity was increased 9 percent as compared with that of the original duct. With the revised inlets and with the outlet flaps full open, however, the air-flow quantity was 6 percent less than with the original ducts for the same condition and the drag was 0.0051 as compared with 0.0043 for the original ducts. Since the ducts are in a region of low-energy air, sufficient cooling cannot be obtained with low drag.

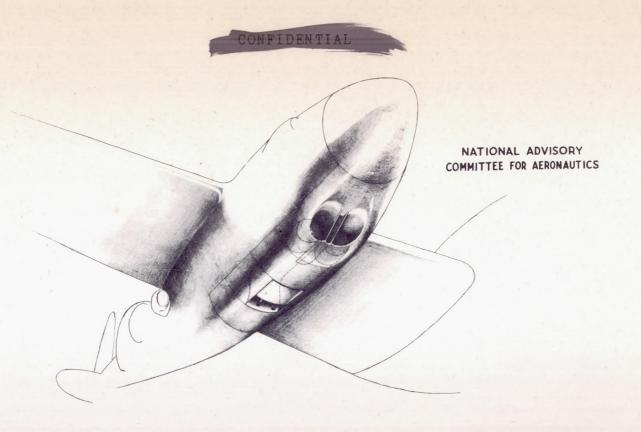
(b) Oil-cooler installation.

ΔCD, 0.0008 ΔV, 4 mph

The oil-cooler air inlet on airplane 4 is set at such a high oblique angle to the direction of the air stream that the flow tends to overrun the inlet. For the airplane in the high-speed attitude, the average total-pressure recovery at the faces of the oil coolers was only 0.33qo. Extending the lower lip of the inlet forward in order that the plane of the inlet will be more nearly normal to the local air flow should result in the recovery of most of the available total pressure. The increment of drag coefficient given on the figure is the difference in the drag of the airplane with both the inlets and outlets sealed and unsealed.

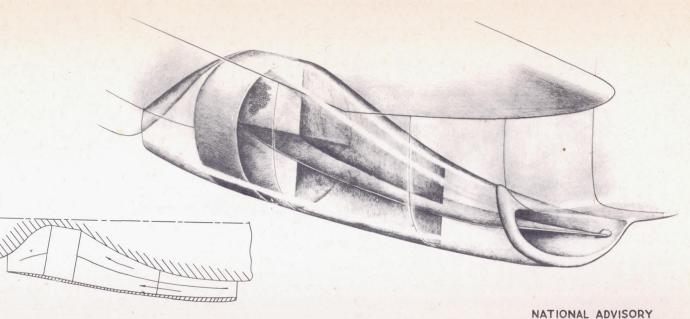
ΔC_D, 0.0004 ΔV, 2 mph

Vanes were installed in the rear underslung duct of airplane 7 to reduce the pressure losses at the radiator face as a result of separation caused by a thick boundary layer at the inlet. The drag coefficient was 0.0004 less with the guide vanes installed in the diffuser and the outlet than without the vanes. In addition, the pressure recovery at the radiator face was increased by the vane installation from 0.69 q_0 to 0.83 q_0 at $\alpha_T = 10.4$ °.

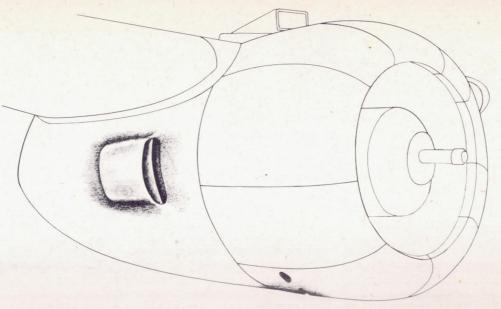
ΔC_D , 0.0018 Q/V₀, 0.12 ΔV , 7 mph H - p₀, 0.40q₀

The total-pressure recovery measured at the face of the oil cooler of airplane 3 for the high-speed condition was only 0.40q. This low recovery of total pressure is attributed to the thick boundary layer at the duct inlet. The drag due to ducts on both nacelles with the outlets open for the high-speed condition was 0.0018 greater than with the ducts removed. The Langley full-scale-tunnel modification to improve this installation is described in figure 14(b).

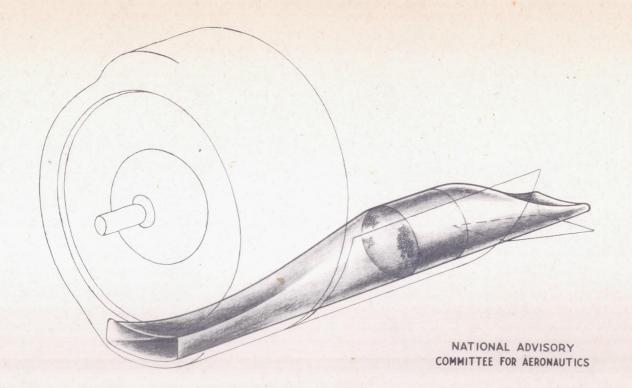
(b) Modified cowling and ducts.

ΔC_D , 0.0010 Q/V₀, 0.13 ΔV , 5 mph H - p₀, 0.95q₀

A new oil-cooler duct was constructed for airplane 3 having its inlet flush with the face of the cowling and a gradually expanding diffuser. The total-pressure recovery at the face of the oil cooler was increased to 0.95qo and the drag coefficient reduced by 0.0008 as a result of this modification.

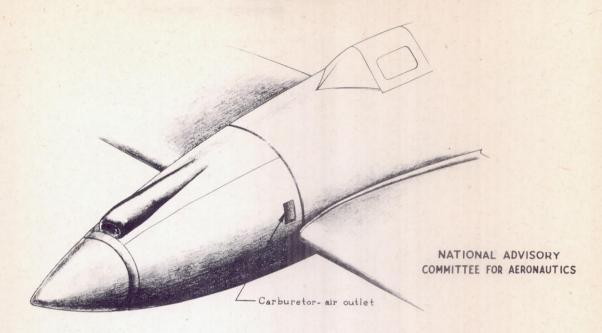
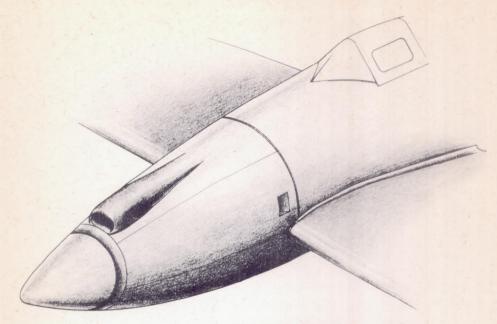
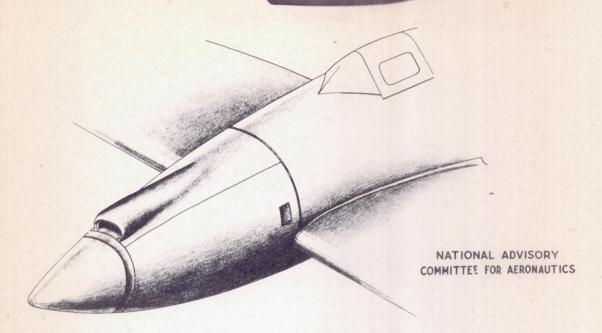
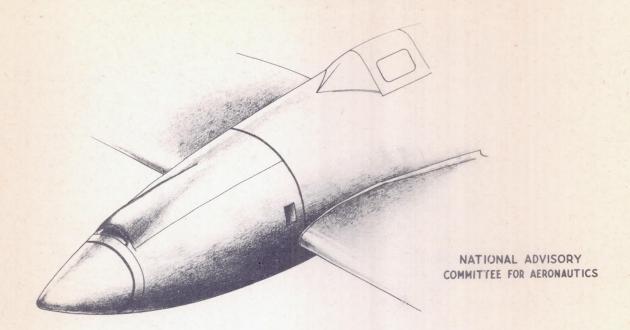
Figure 15. - Carburetor-air scoops on airplane 7.

V_1/V_0 , 0.49 Ram, 0.91 q_0 Q/ V_0 , 0.07 ΔC_D , 0.0002

The scoops tested on airplane 7 were of conventional protruding design. The inlet areas were varied for the different scoops and slight variations were also made in the external shapes of the scoops. The best results were obtained at inlet-velocity ratios between 0.4 and 0.5. At inlet-velocity ratios below about 0.3, boundary-layer separation occurred at the inlets. The increment of drag is the difference in drag of the airplane with and without the carburetor-air system and includes the drag due to flow through the outlet duct and the outlet losses.

V_1/V_0 , 0.33 Ram, 0.87 q_0 Q/ V_0 , 0.10 ΔC_D , 0.0006

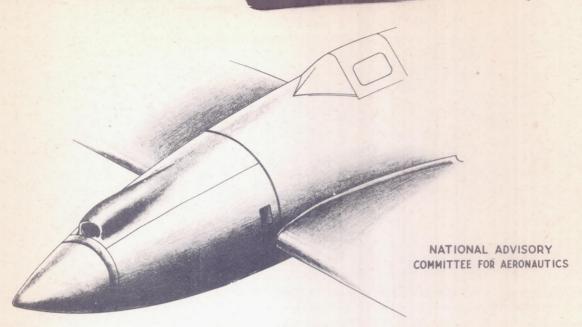
V_1/V_0 , 0.37 Ram, 0.91 q_0 Q/V₀, 0.07 ΔC_D , 0.0003

Propeller-operating tests were made with scoop 5 installed on airplane 7 to determine the advantage of turning the inlet directly into the slipstream. An increase in ram of 3 percent of the free-stream dynamic pressure was measured as a result of turning the scoop for the high-speed propeller-operating condition. The effect on the drag coefficient of turning the scoop was negligible.

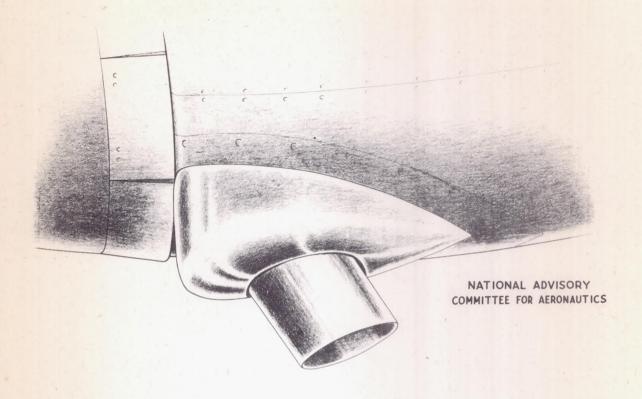
Figure 17 .- Exhaust-stack drag on airplane 8.

$\Delta C_{\rm D}$, 0.0021 ΔV , 9.5 mph

The large protrusion and the air leakage around the large-bore stovepipe exhaust stacks on airplane 8 account for a drag-coefficient increment of 0.0021. Engine-operating tests at low speed were made both with the original exhaust stacks installed and with individual jet exhaust stacks installed. The tests indicate that the increase in thrust due to the individual jet exhaust stacks would increase the airplane speed by approximately 13 miles per hour over the speed with the original exhaust stacks installed. This thrust increase includes the difference in drag between the original exhaust stacks and the individual jet exhaust stacks. Calculations based on the methods of reference 8 indicate that with the use of optimum-size jet exhaust stacks a further increase of 3 miles per hour would be possible.

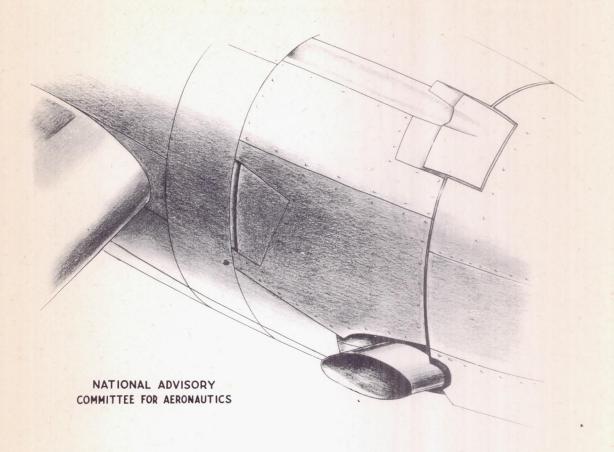
Figure 18. - Exhaust-stack drag on airplane 6.

ΔC_D, 0.0008 ΔV, 3 mph

The installation of this large-bore exhaust stack with large leakage gaps around the stack increased the drag by 0.0008. The use of stovepipe exhaust stacks of this type and of the type used on airplane 8 (fig. 17) should be avoided because of the large form drag.

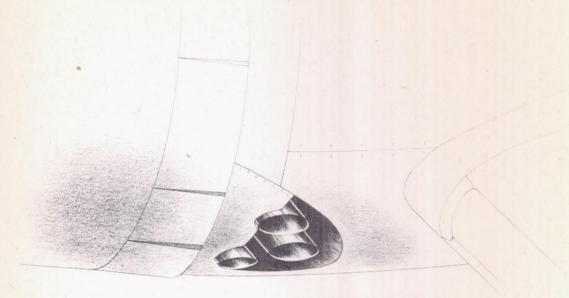
ΔC_D, 0.0010 ΔV, 6 mph

Removing the seal from the exhaust opening of airplane 9 increased the drag by 0.0010. The form drag of the installations shown in figures 17 and 18 has been avoided in this design; however, the large amount of air leakage from the compartment behind the engine out through the large opening around the exhaust stacks accounts for the excessive drag of the installation. Some of this drag would be reduced by directing the leakage flow rearward. Much larger gains can be obtained by the use of individual jet exhaust stacks.

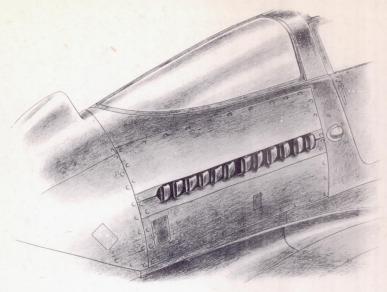
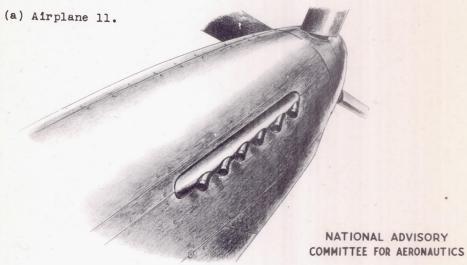
Removing the sealed metal fairings that enclosed the exhaust stacks of airplanes 11 and 12 increased the drag coefficient 0.0005 for airplane 11 and 0.0007 for airplane 12. These exhaust stacks are relatively good installations.

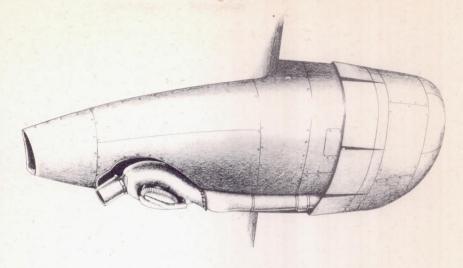
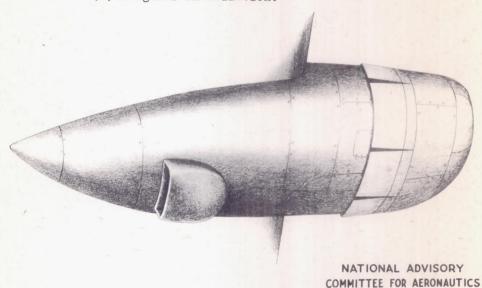
(a) Original installation.

(b) Submerged installation.

An increment of drag coefficient of 0.0040 was measured for the exposed supercharger of the original installation of airplane 5 (fig. 21(a)). Submerging the supercharger and sealing the opening at the end of the nacelle as shown in figure 21(b) decreased the drag coefficient of the installation to 0.0027. For the propeller-operating condition, the difference in drag will be much greater because the submerged installation will direct the exhaust gases rearward. The submerged installation would require shroud cooling. The drag increments are given for four nacelles and are based on the airplane wing area.

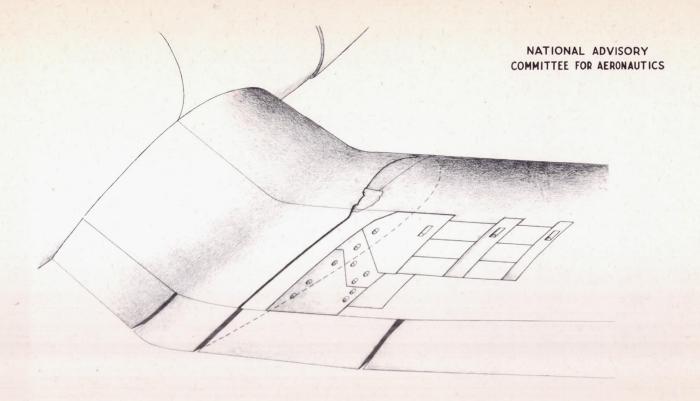
Figure 22.- Effect on wing drag of irregularities and leakage on airplane 9.

The unusually large number of cover plates, access doors, butt joints, and air-leakage points on the wing of airplane 9 caused a drag increase of 0.0012. Most of this drag could have been avoided by better fitting and elimination of air leakage.

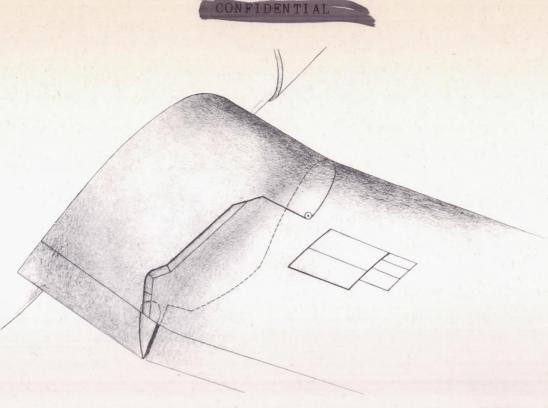
Figure 23 .- Effect on wing drag of irregularities and leakage on airplane 10.

An increase in drag coefficient of 0.0007 was measured when the doped-tape seals were removed from the gaps at the wing-fold joint and gun-access and ammunition doors. Considerable leakage drag can be eliminated by sealing these gaps.

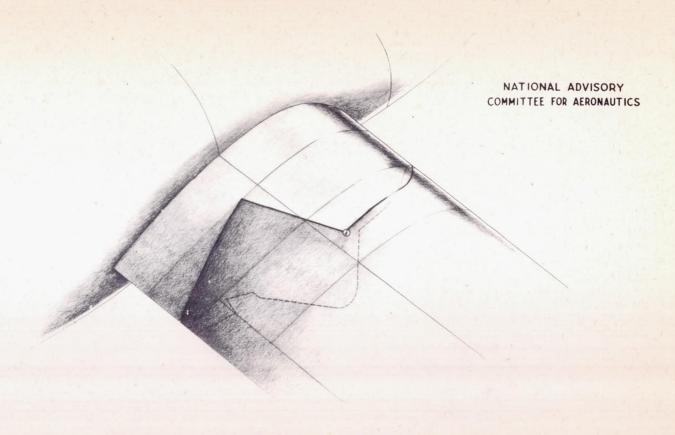
Figure 24.- Effect on wing drag of leakage on airplane 6.

ΔCD, 0.0004 ΔV, 2 mph

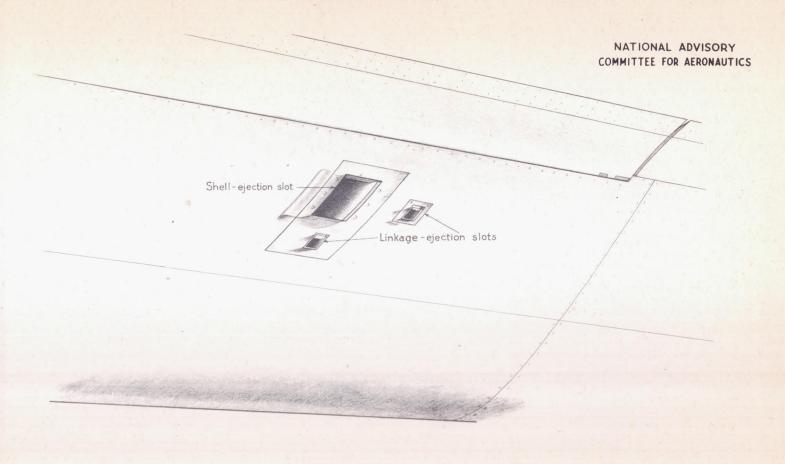
Figure 25 .- Effect on wing drag of irregularities and leakage on airplane 12.

Air entered the large shell- and linkage-ejection slots on the under surface of the wing of airplane 12 and leaked through the ammunition doors on the upper surface, thus increasing the drag. Sealing the slots when the guns are not in use or sealing the ammunition doors would eliminate this drag increment.

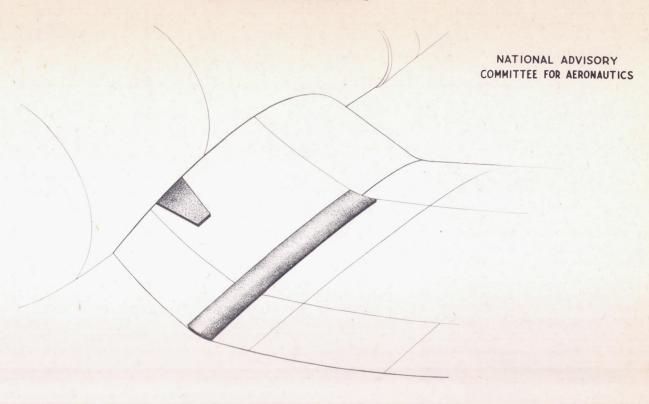
Figure 26 .- Effect on wing drag of sanded walkway on airplane 9.

ΔC_D, 0.0010 ΔV, 5 mph

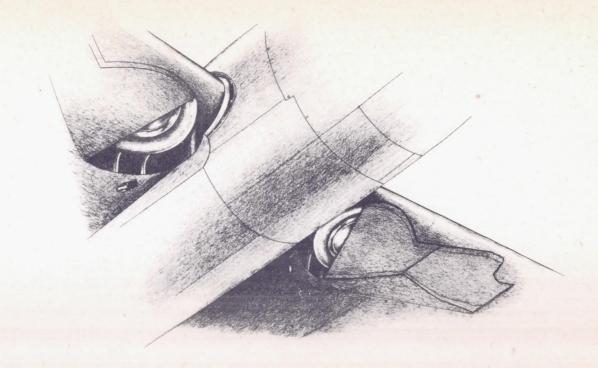
ΔCD, 0.0005 ΔV, 3 mph

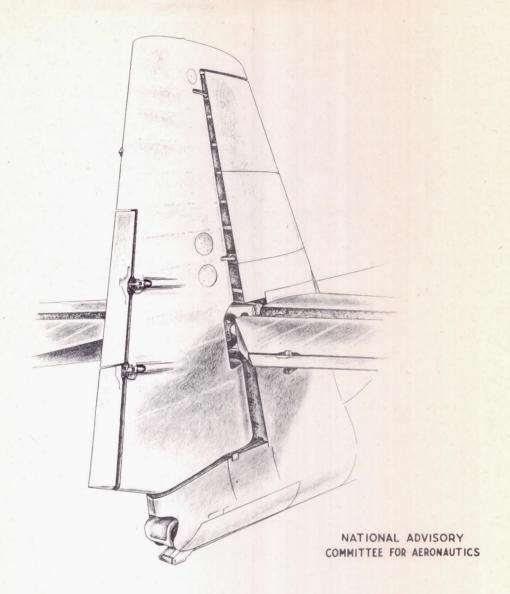
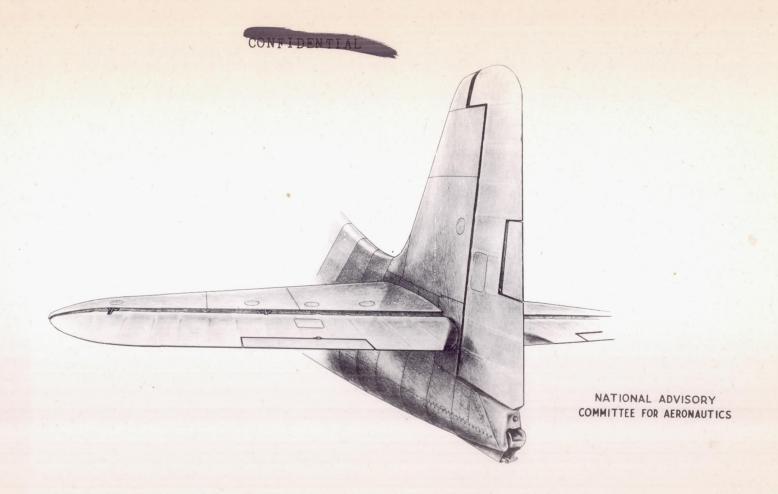
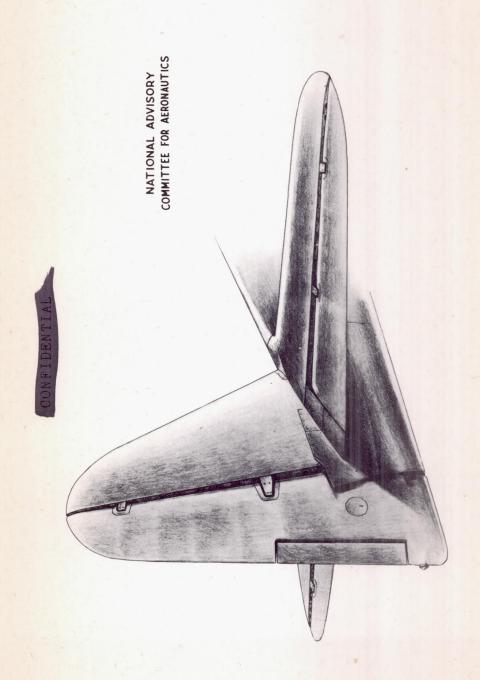
ΔC_D , 0.0009 ΔV , 5 mph

An increase in drag was measured when the tape seals and metal fairings were removed from the gaps on the horizontal and vertical tail surfaces of these airplanes. In order to reduce the drag due to these gaps, the lightening holes in the spars of the fixed part of the tail should be sealed, the gaps between the fixed and movable surfaces should be made as small as possible, and the fuselage should be sealed off at a rear bulkhead.

ΔC_D , 0.0005 ΔV , 3 mph

ΔC_D, 0.0007 ΔV, 4 mph (c) Airplane II. Figure 30.- Concluded.

Large gaps between the fixed and the movable tail surfaces have been found to cause increases in drag and to lower the effectiveness of the tail surfaces. Three typical examples of the drag increments caused by tail-surface gaps are shown in figure 30.

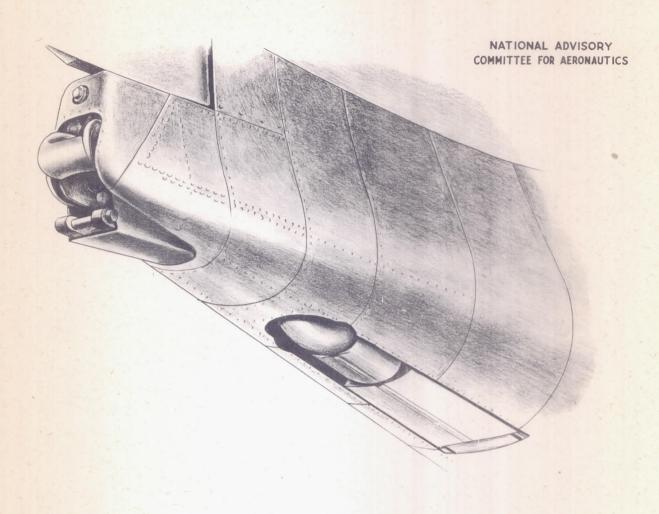
Figure 31. - Drag of tail wheel and arresting hook on airplane 10.

Removing seals and fairings from the openings at the tail wheel and arresting hook of airplane 10 increased the drag coefficient by 0.0005. This increment is largely due to leakage through these openings. The drag of these items can be reduced by external fairing and sealing or by internal sealing of the bulkhead in front of the tail-wheel well.

Failure to enclose the tail wheel and arresting hook in a suitable sealed fairing increased the drag coefficient of sirplane 10 as described in figure 31.

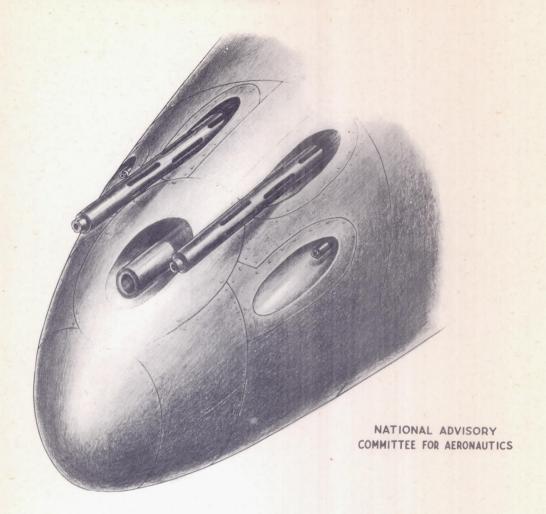
Figure 32. - Armament drag on airplane 4.

ΔC_D, 0.0008 ΔV, 5 mph

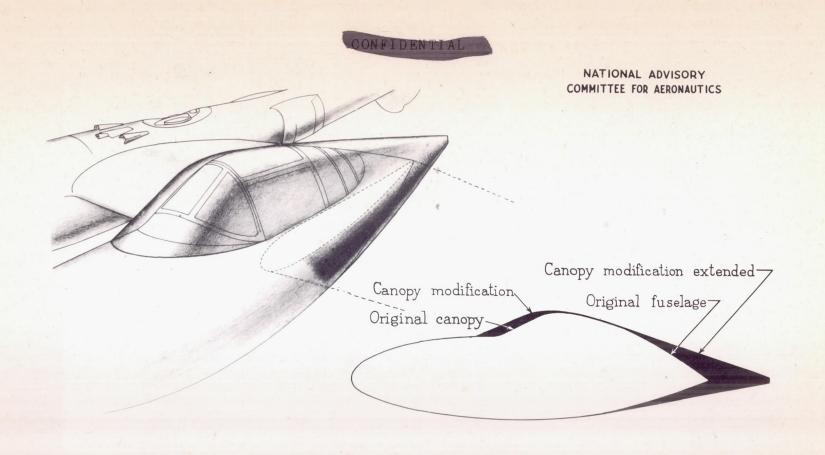
Figure 38. - Canopy modification on airplane 4.

The canopy modification for airplane 4, which included a 3-foot extension of the afterbody, was designed to reduce the high negative pressures over the canopy peak and to prevent flow separation at the rear of the canopy. The critical speed of the canopy was increased by 44 miles per hour as a result of this modification. Drag results are unavailable for these configurations.

Short afterbodies and sharp edges should be avoided on airplane canopies since they cause flow separation and low critical speeds. Points of air leakage through canopies should be eliminated, if possible. The results of tests to improve the canopy installations on airplanes 4 and 9 are described in figures 37 and 38.

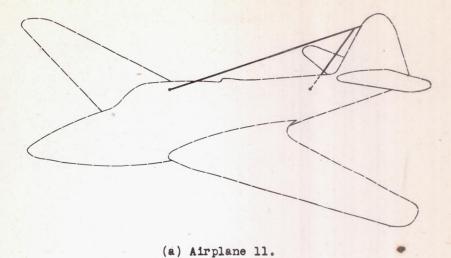
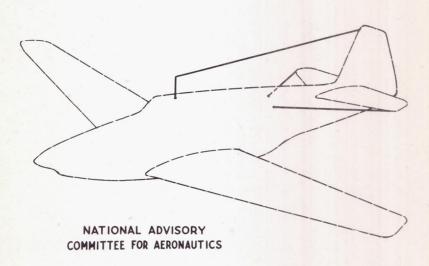
Figure 40. - Radio-antenna drag on airplanes 11 and 12.

The drag-coefficient increments were measured as the difference between the drag with radio antennas installed and removed. The drag due to each of these installations is excessive and is due mainly to the thick antenna masts. Low-drag radio-antenna installations are shown in figure 40.

Three examples of radio-antenna installations considered to have excessive drag are shown in figure 39. Radio-antenna installations for which no appreciable drag was measured are shown in figure 40. The use of masts with thickness ratios of the order of 25 percent has been found to be the main source of drag on radio-antenna installations. If a mast must be used, the type of mast used on airplane 12, which was a thin flat metal rod, is recommended.
