Pioneer Venus 12.5 km Anomaly Workshop Report (Volume I)

*Proceedings of a workshop held at
Moffett Field, California
September 28-29, 1993*

Summary

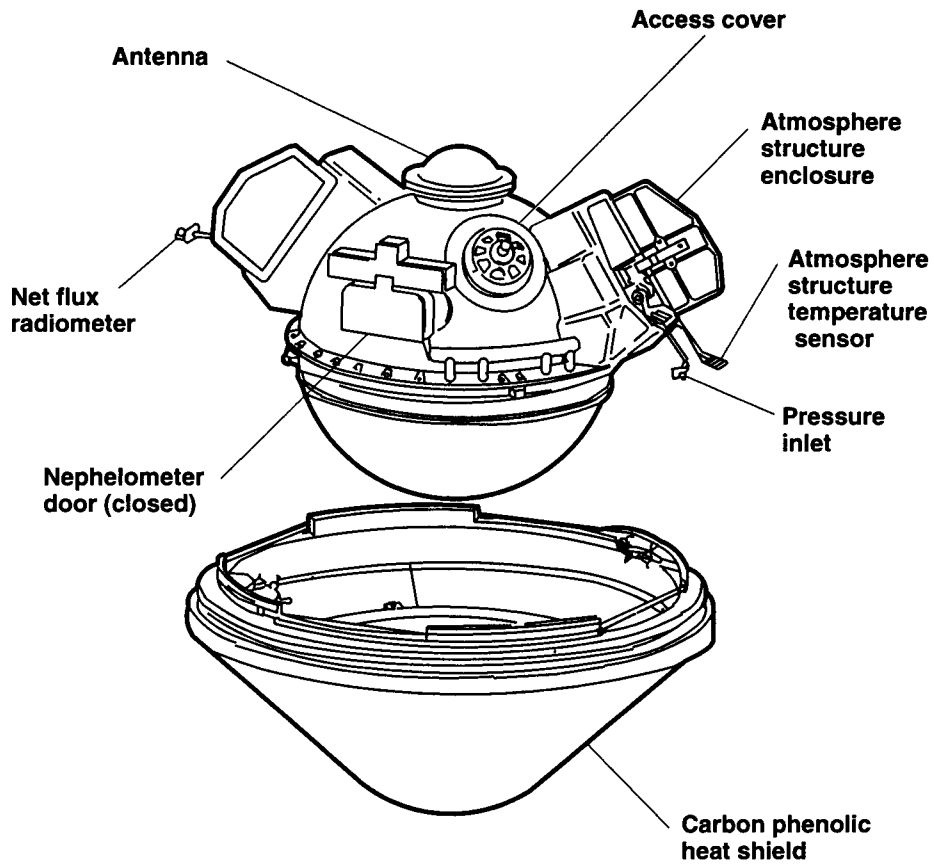
Figure 1. Descent configurations of the Pioneer Venus probes. (a) Small probe.

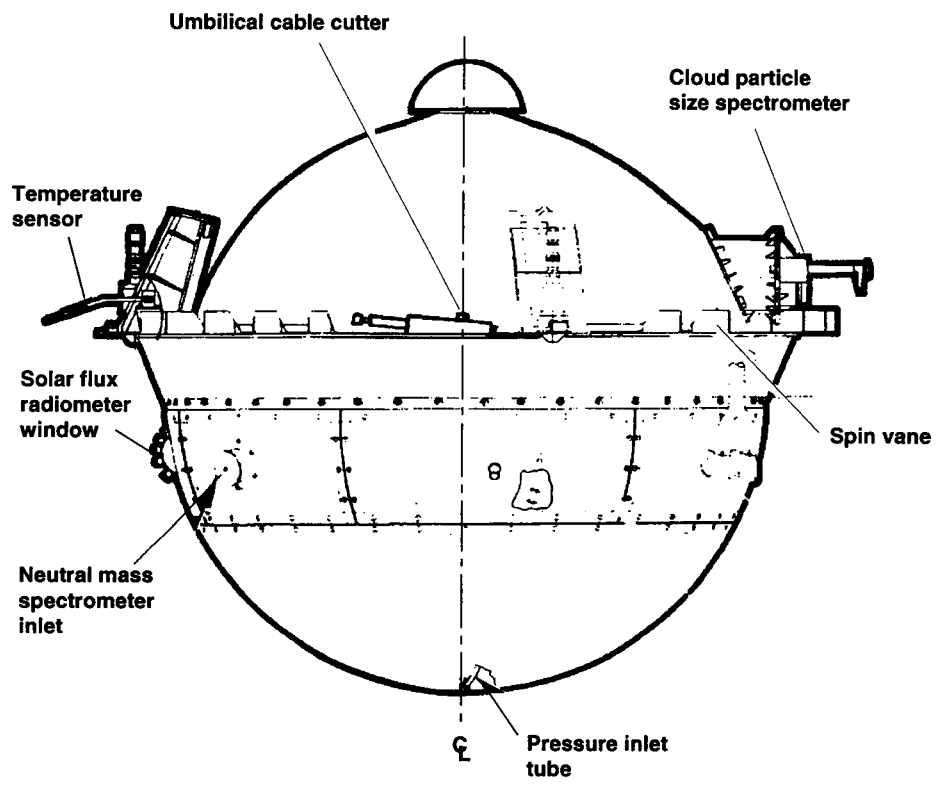
Figure 1. Concluded. (b) Large probe.

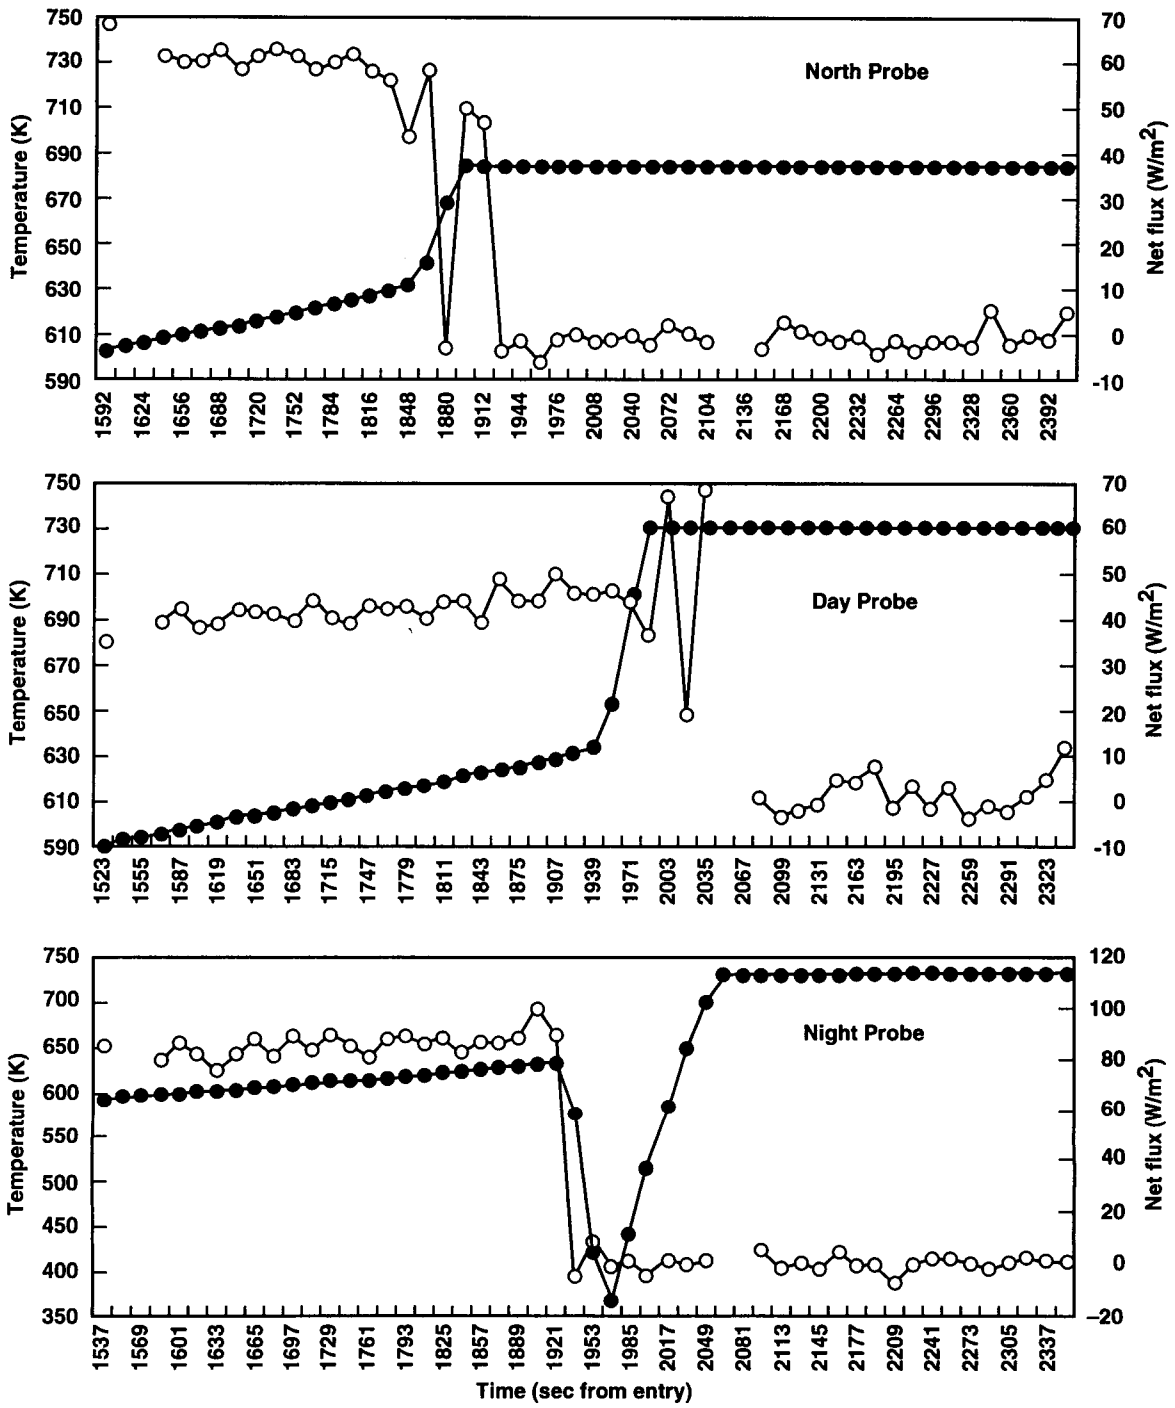
Figure 2. Data from the net flux radiometer late in the descent of the three small probes. Open symbols are net fluxes; filled symbols, atmospheric temperatures.

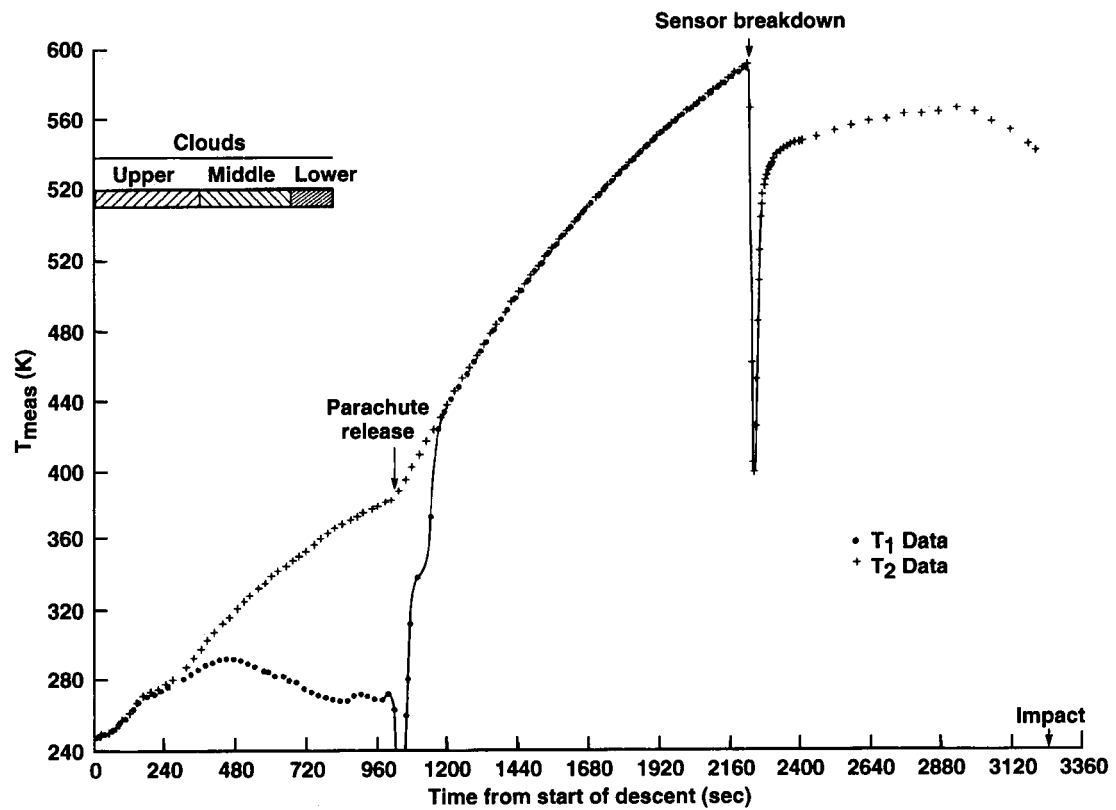
Figure 3. Atmosphere structure instrument temperature sensor breakdowns. (a) Large probe.

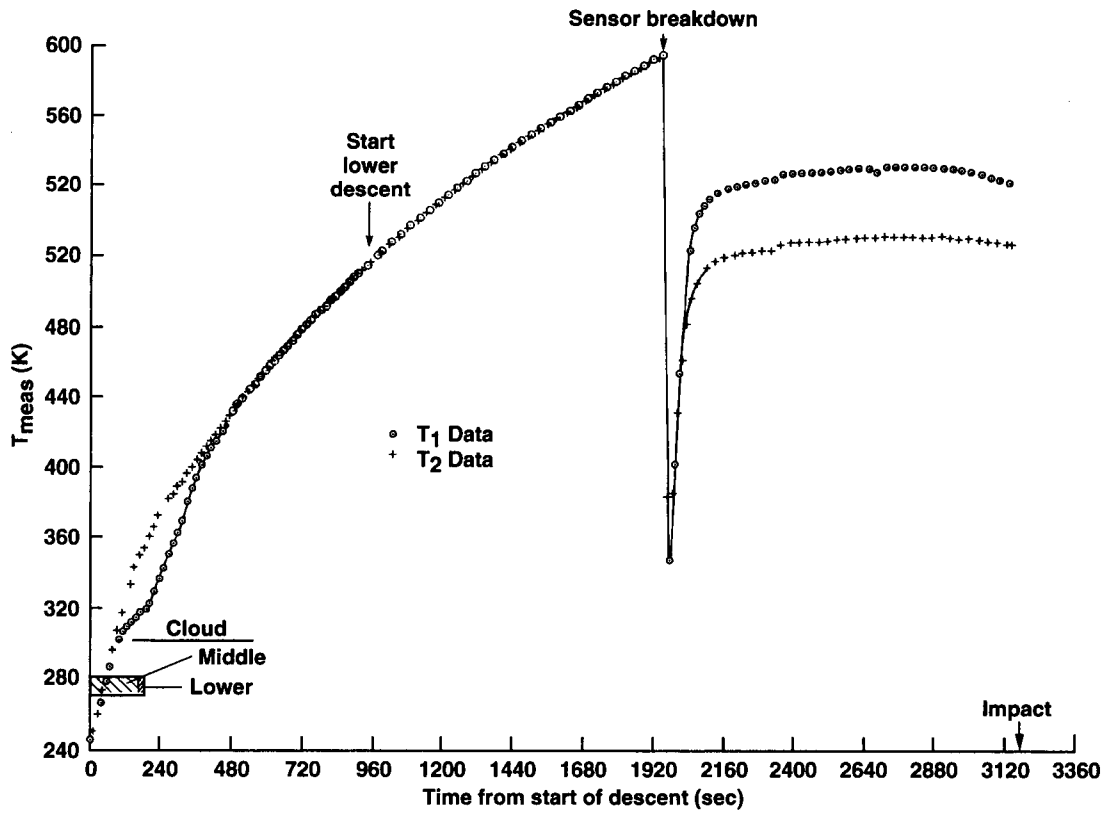
Figure 3. Concluded. (b) North probe.

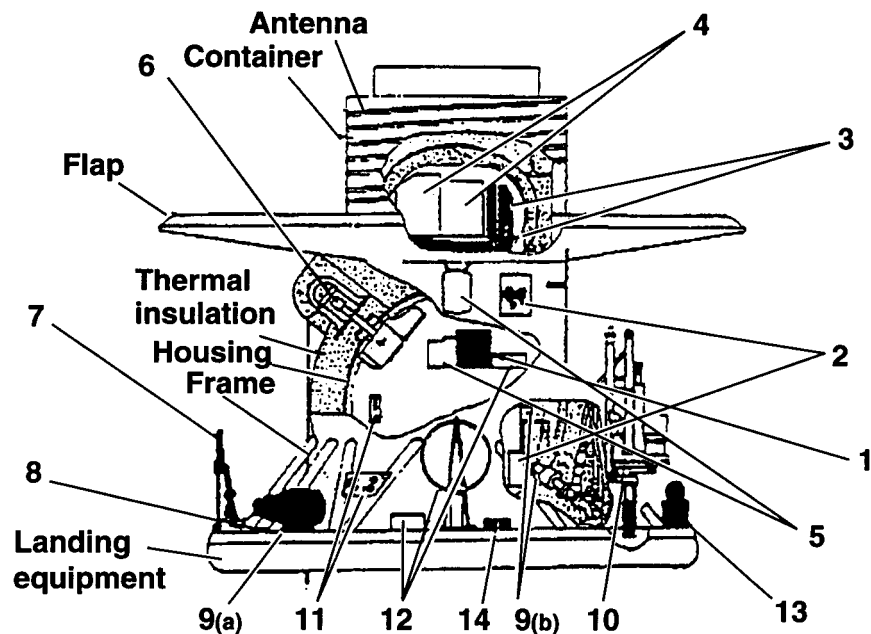
Figure 4. Concluded. (b) Instrument locations; (1) accelerometer, (2) particle size spectrometers, (3) mass spectrometer, (4) gas chromatograph (atmosphere and particles), (5) solar spectrometer photometer, (6) camera (used after landing), (7) soil mechanical properties and electrical conductivity instrument, (8) oxygen detector (9) (a) and (b) x-ray fluorescence spectrometers (soil chemical analysis), (10) soil sampling mechanism for x-ray fluorescence analysis, (11) descent pressure and temperature sensors, (12) microwave spectrometer, (13) hydrometer (measured atmospheric water content during descent), and (14) solar radiometer (measured luminosity during descent).

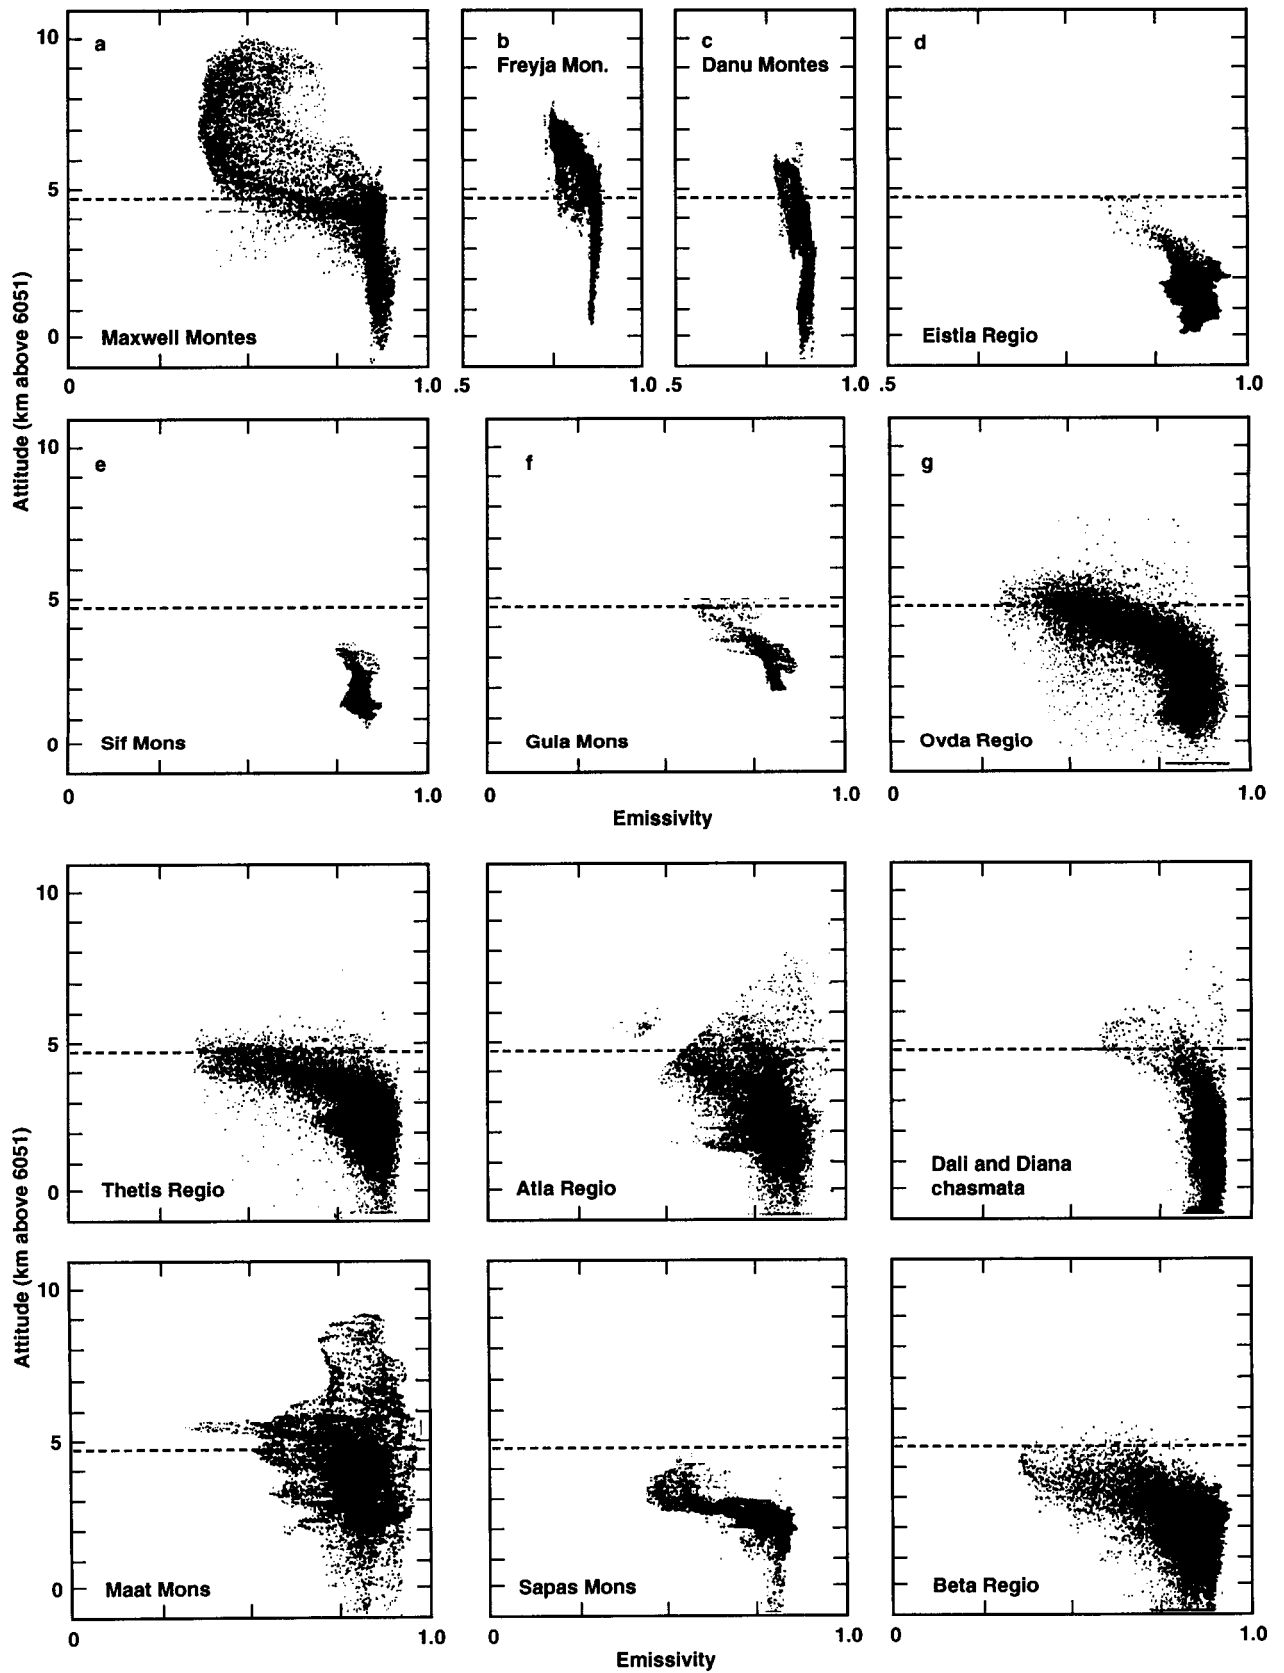
Figure 5. Magellan data on the radio emissivity of Venus' surface as a function of altitude (ref. 27).
