NASA/FAA Tailplane Icing Program Overview

Prepared for the
37th Aerospace Sciences Meeting & Exhibit
sponsored by the American Institute of Aeronautics and Astronautics
Reno, Nevada, January 11-14, 1999

NASA/FAA TAILPLANE ICING PROGRAM OVERVIEW

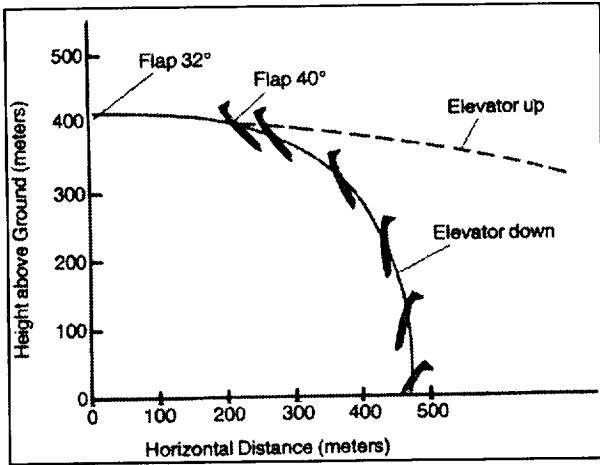
Figure 1 Trajectory of Vickers Viscount accident in Stockholm, Sweden 1977

The ICTS events usually occurred on final approach, when flaps were extended. Ice on the horizontal tail caused premature flow separation. The separated flow could not attain pressure recovery over the elevator and resulted in stick force reversal (control column pulled away from the pilot). The aircraft would pitch nose down and rapidly lose altitude (Figure 1).

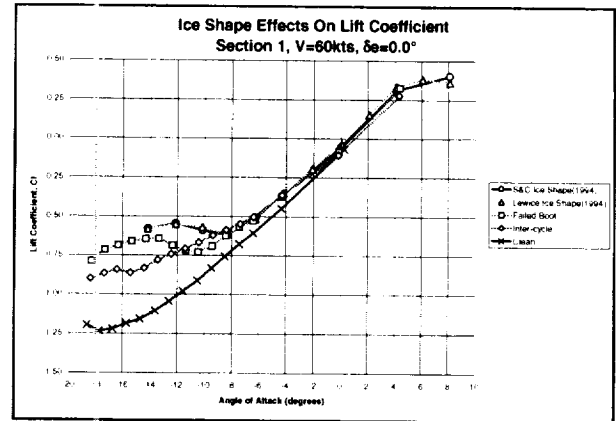
Figure 10 C_l Summary for all ice shapes

A sample of the aero wind tunnel results for one elevator deflection ($\delta e=0^\circ$) can be seen in Figure 10-Figure 13. All aeroperformance coefficients (C_l , C_d , C_m and C_{He}) are affected by the ice contamination to some degree. Ranking the ice shapes in terms of lift coefficient, the least affected was the inter-cycle ice, followed by the failed boot ice, and ending with both the S&C and LEWICE ice shapes

having the most degradation in C_{lmax} and reduction in stalling angle of attack. The reductions in C_{lmax} and stalling angle of attack for each shape are listed in Table 1.

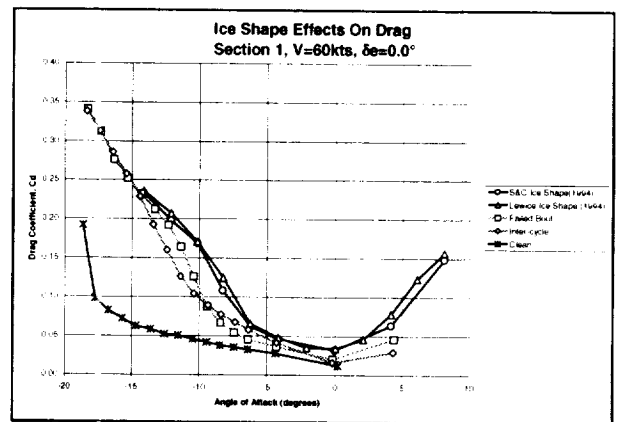
Figure 11 C_d data summary for all ice shapes

Similarly, there was an increase in drag coefficient with each ice shape. The LEWICE shape had the greatest increase in drag overall. The pitching moment coefficient followed a similar trend to the lift coefficient. All shapes caused an early departure to a positive pitching moment, but the LEWICE and S&C shapes caused this to happen at the least negative alpha. The hinge moment coefficient had some unusual characteristics with two of the ice shapes. With the S&C and LEWICE shapes, the C_{He} behavior was as expected. Premature separation caused a rapid increase in the C_{He} , which is typically attributed to the "yoke snatch" experienced by pilots during a tailplane stall. But for both ice castings, the C_{He} was initially reduced below the baseline and then followed the expected trend of a rapid increase in C_{He} as the angle of attack became more negative. One possible explanation for this behavior may be the very rough texture and 3D nature of the ice castings. These irregular protrusions may have acted as vortex generators, which energized the boundary layer and reduced the hinge moment for the lower angles of attack. However, as the angle of attack was further increased, the separation bubble extended far enough down the chord to cause the hinge moment shift as was seen in the other two ice shape cases. This phenomenon may be airfoil specific and was not explored further because it was not central to the program tasks.

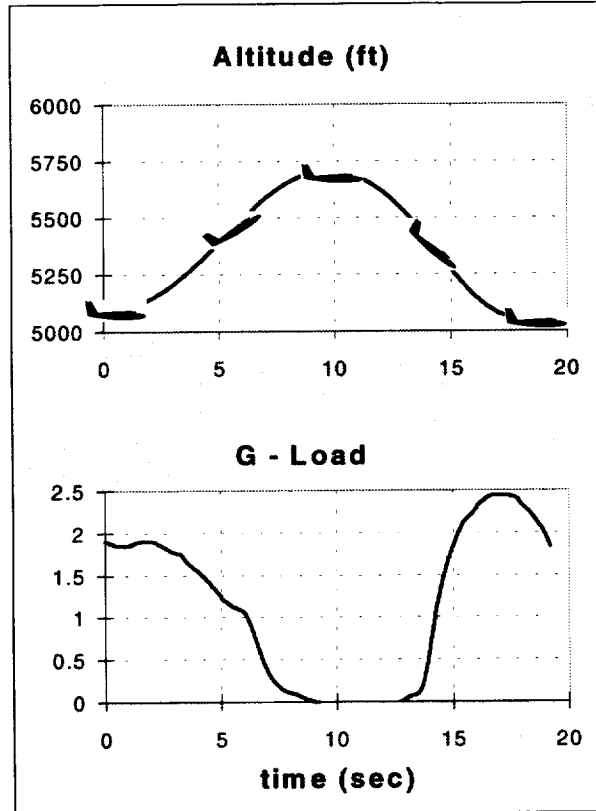
Figure 15 Zero-G Pushover Sample, $\delta F=0$, $V=1.4V_s$

The steady wings level and steady heading sideslip test points were 1-G unaccelerated steady test points and are self-explanatory. The pushover was a longitudinal-axis maneuver to reduce normal acceleration to zero-G by the pilot performing a series of nose-up and nose-down control inputs. Figure 15 provides a graphical representation of a pushover to zero-G. The trim point recovery was similar to the pushover, but the nose-down push on the control column was limited to the column position where trim was established. Stall recovery maneuvers were initiated from a near-stall speed where a nose-down control column was implemented to recover from the stall. Wind-up turns were performed through steep-turns to reach 2-G normal acceleration.

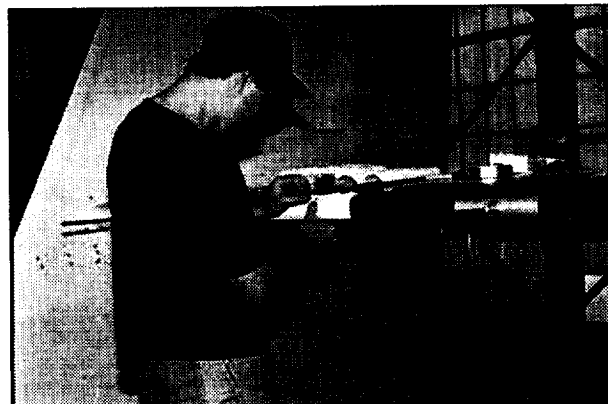
Figure 16 Installation of ice cast on tail

The second phase of flight tests was conducted on the Twin Otter between July and October 1997. After repeating selected baseline tests, the inter-cycle ice castings were mounted to the horizontal tail (Figure 16-Figure 17). Flight tests points included 1-G steady wings level, steady heading sideslips, thrust transitions, pushovers, and elevator doublets. These maneuvers were conducted for the full range of flap settings [0, 10, 20, 30, & 40] and airspeeds [V_s to V_{ic}]. Note: The DHC-6 is placarded to warn pilots not to extend the flaps greater than 10° in icing conditions. This flight test was executed in a highly structured research environment in order to capture a full compliment of aircraft configurations. NASA LeRC subscribes to the 10° flap limitation in routine icing operations and does not recommend exceeding the manufacturers stated limitations. Table 3 provides a summary of the maneuvers flown with the inter-cycle ice shape.
