**A Return to Innovative Engineering Design, Critical Thinking and Systems
Engineering**

The International Thermal Conductivity Conference (ITCC) and the
International Thermal Expansion Symposium (ITES)
Birmingham, Alabama
June 24-27, 2007

Charles J. Camarda
Deputy Director for Advanced Projects
NASA Engineering and Safety Center (NESC)

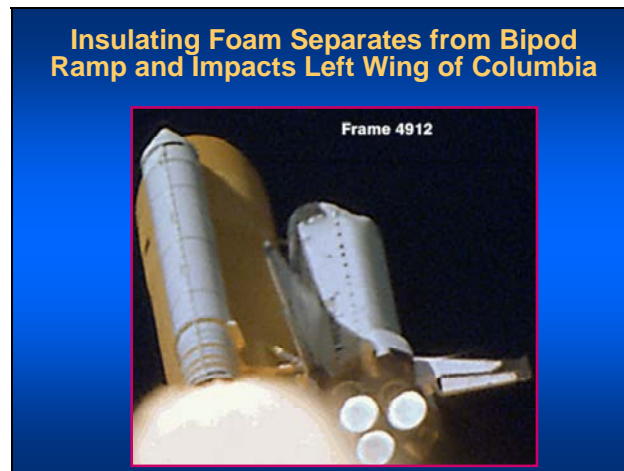
Figure 2. Launch video of STS-107 illustrating the impact of a large piece of external tank (ET) foam hitting the lower surface of the Orbiter.

The cause of the *Columbia* tragedy as described in the CAIB report [5] was twofold: a technical cause determined to be a piece of bi-pod foam which liberated during ascent and critically damaged a section of the Space Shuttle wing leading edge; and an equally important social/organizational cause which allowed several critical social issues to develop which caused wrong decisions to be made and impeded the flow of critical information. Figure 2 is the opening scene from the digitally-enhanced launch day video of STS-107 which shows a large piece of bi-pod foam liberating from the External Tank (ET) of the Space Shuttle and hitting the lower surface of the Orbiter and breaking up into tiny particles after impact.

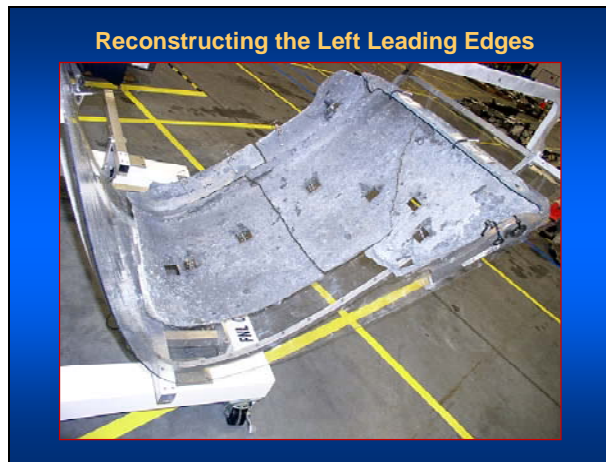
Figure 4. Inner surface of port wing RCC leading edge panel with thin metal coating believed to be deposited during hot gas ingress to the wing cavity.

A photograph of the inner surface of a port wing leading edge panel, shown in Figure 4, indicates there was a thin metallic film which was deposited on the inner RCC surface. This metallic coating probably resulted from a breach in the LE panel which vaporized the Inconel 617 metallic TPS protecting the front wing spar and was then deposited on the cooler inner surface of the panel. Hence, the leading theory was that the damage probably occurred on the lower surface of one of the port wing panels causing a hole to grow during entry, hot gas to ingress into the LE cavity, and eventually destroyed the vehicle.

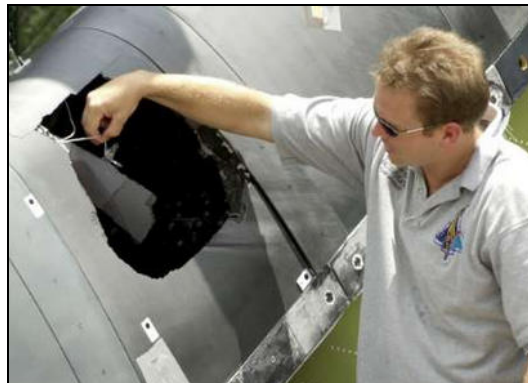
Figure 5. Large hole in panel 8 post test at Southwest Research Institute (SwRI).

As part of the Columbia Accident Investigation, a series of foam impact tests were conducted to understand the physics of the problem and to definitively ascertain if large foam impacts could cause critical damage to the wing leading edge. The result of a full-scale impact test of a rectangular piece of BX-250 foam (1150 cubic inches and 1.6 lbs) traveling at 777 fps (530 mph) is shown in Figure 5.

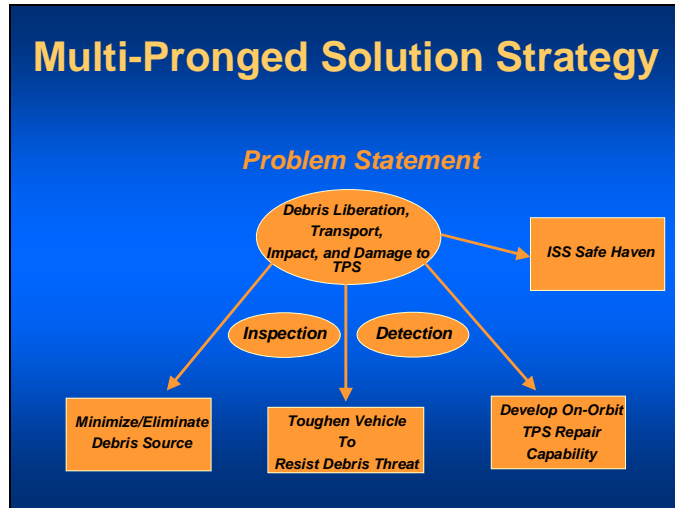
Figure 6. Multi-pronged solution strategy to ensure a safe return to flight (RTF).

When you pan out and look at the entire problem from a RTF Team perspective, there was a multi-pronged solution strategy to mitigate risks to allow us to return to flight (Figure 6): 1) The Space Shuttle Program (SSP) would do everything possible to understand and mitigate the root causes of debris liberation, aerodynamic transport, impact and damage tolerance of the thermal protection systems (TPS); 2) The teams would develop both an inspection capability which could detect minimum size critical damage to the TPS and also detect impacts to the wing leading edges which could cause damage; 3) Minimize or eliminate debris sources; 4) Toughen the LE, if possible, to resist impact damage; and 5) Develop an on-orbit repair capability in the event of a contingency of the safe-haven or rescue-vehicle backup.

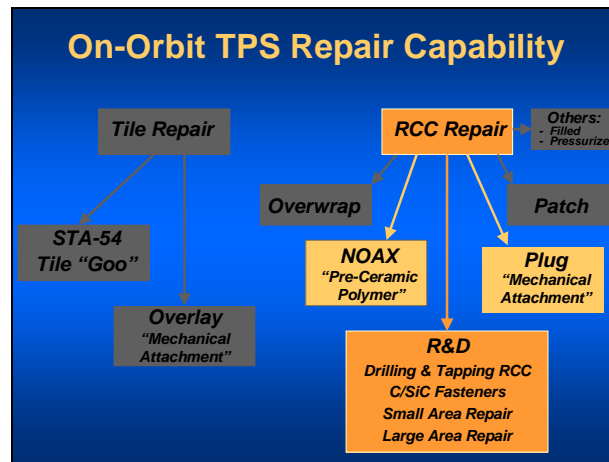
Figure 7. Thermal protection system (TPS) concepts investigated.

In the category of RCC repair, there were several options initially evaluated which included (Figure 7): 1) an “overwrap” concept which were complete C-SiC curved panels specially sized to fit securely over each individual RCC panel (44 total for port and starboard RCC leading edges); 2) “crack repair” pre-ceramic polymers such as NOAX (Non-Oxide Ablative Experimental) which were designed to be applied over small damaged regions (small areas of coating loss or small holes or cracks); 3) “Plug” concepts which were mechanical patches/plugs of C-SiC material which were secured through a hole in the wing leading edge (~1 inch diameter) by a high-temperature fastener; 4) a “patch” concept which was a flexible patch of high-temperature material which is cured in place and adhesively bonds over the damaged region of RCC; 5) filled leading edge cavity options; and 6) a separate set of solutions developed by an R&D team which provided an alternative

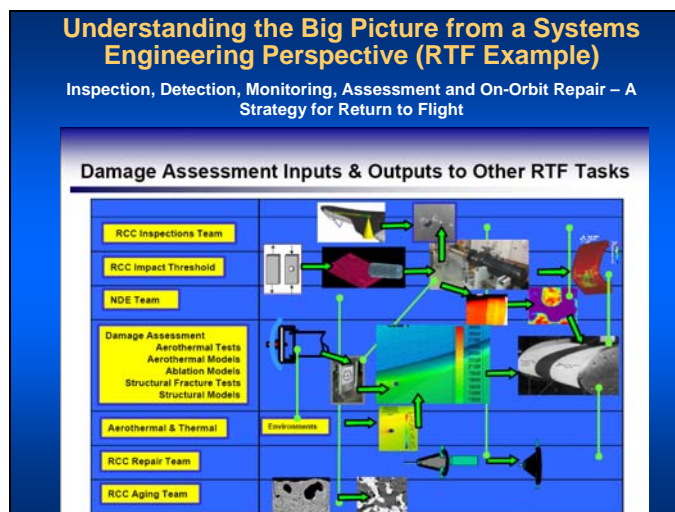
Figure 8. Demonstration of an integrated approach to solving the RCC inspection and repair problem.

Figure 8 pans us back out for a moment and allows us to view how the RCC Repair Project must fit within the overall strategy for RTF. It looks at the total picture for RCC repair and shows the interfaces and interconnections to other ongoing RTF projects is critical.

Figure 8 also attempts to illustrate the connectivity and integration of each of the various RTF activities associated with RCC inspection and repair (e.g., RCC inspection; impact threshold (damage criteria); non-destructive evaluation (NDE); damage assessment, aerothermal analysis and test; RCC repair; and effects of aging on RCC material properties).

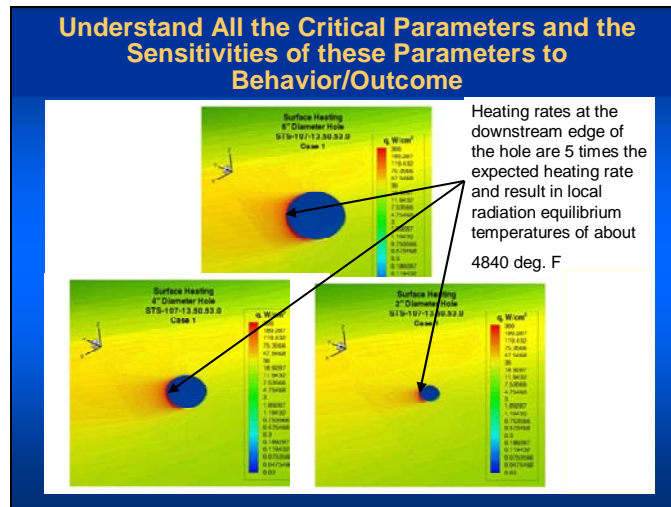
Figure 12. Computational fluid dynamic (CFD) analyses of flow at an angle to a hole in a wing leading edge and associated increases in heating and temperature of the downstream lip of the hole.

While conducting computational fluid dynamics (CFD) analyses of various size holes in RCC during entry to assess the possible causes of the accident, Dr. Peter Gnoffo of NASA's Langley Research Center (LaRC), discovered that when flow occurs at an angle to the damaged RCC leading edge, the downstream lip of the hole experiences heating up to five times that at the stagnation region of the leading edge as shown in Figure 12.

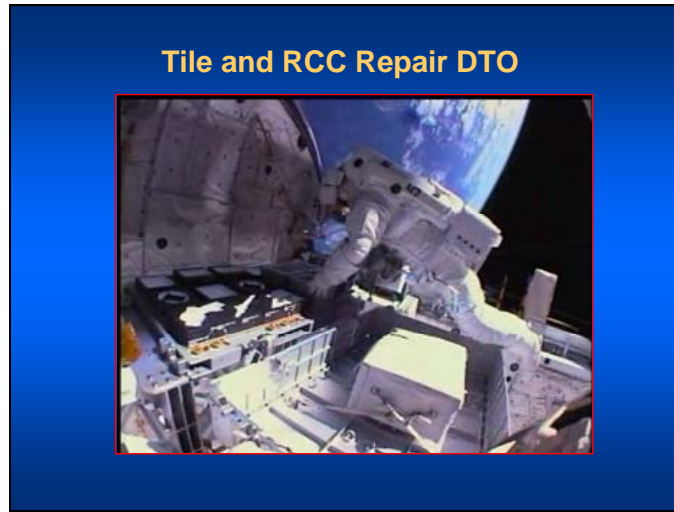
Figure 26 is a picture of astronaut Steve Robinson evaluating several of the newly developed tile and RCC TPS repair techniques in the payload bay of STS-114.

Figure 26. EVA astronaut Steve Robinson demonstrating several tile and RCC TPS repair techniques in the payload bay during STS-114.

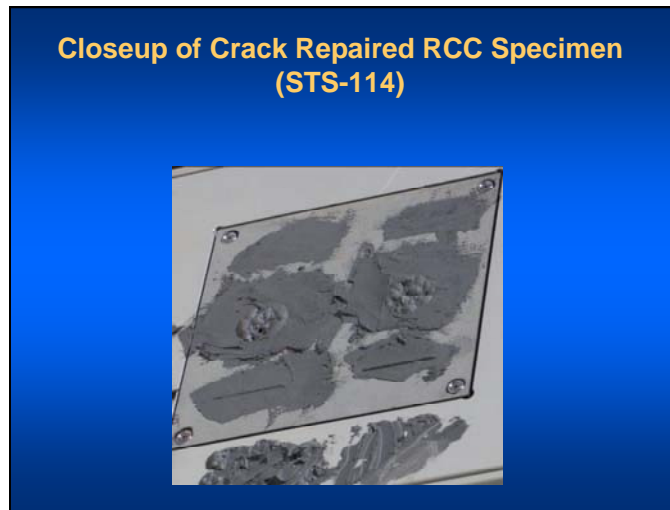
Figure 27. Closeup of RCC crack repaired specimen using NOAX pre-ceramic polymer on orbit during STS-114.

Figure 27 is a closeup of the NOAX RCC crack repair Detailed Test Objective (DTO) after the NOAX material cured after several orbits. Notice that even though the material was outgassed and kept in a vacuum cartridge prior to flight, the material still can outgas and bubble up when applied on orbit if proper procedures are not developed. The potential problem with such outgassing is that the porosity formed can fracture during entry heating and form defects which can cause excessive local heating similar to that exhibited during the arcjet test shown in Figure 25.

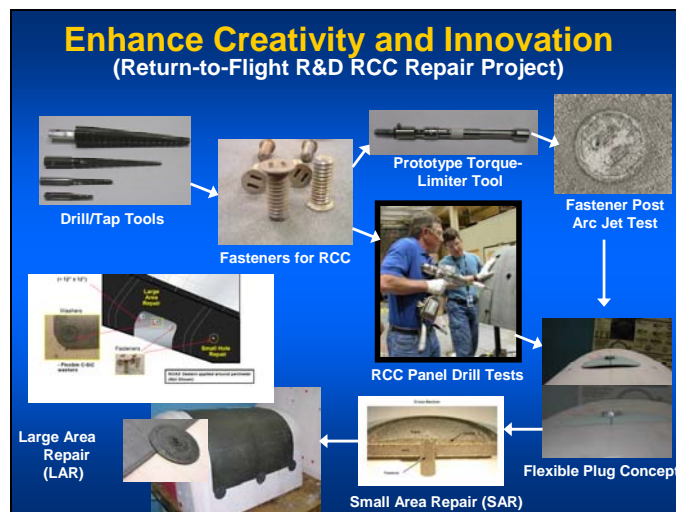
Figure 29. Some of the tools developed for on-orbit RCC repair by the R&D RCC Repair Team.

Prior to the initiation of the R&D RCC Repair Team, the SSP had expended considerable resources to develop on-orbit RCC repair techniques. After over a year of effort by industry (Boeing, Lockheed, ATK Thiokol, etc.) and NASA, in June 2004 we had not yet survived the full entry heating profile of the highest heating location on the leading edge. Both the NOAX crack repair and the plug repair concepts were failing wedge arcjet tests both at ARC and at JSC. After the initial innovative design workshop of the R&D RCC Repair Team, a plan for developing a series of new ideas and concepts was put in place with the intention of developing and maturing a collection of tools for repairing damaged RCC on orbit with sizes ranging from small coating damage to large holes (~16 x 16 inches). The various tools developed are shown in Figure 29.

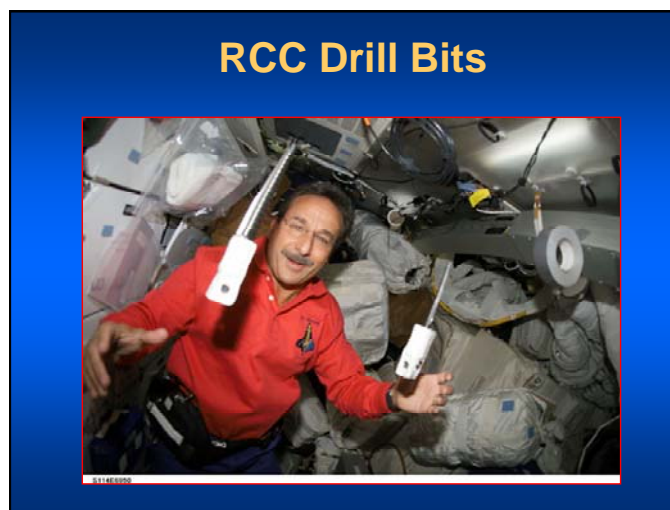
Figure 33. STS-114 RTF astronaut Charlie Camarda with self advancing step-tap drill bits on orbit.

We then enlarged our small team to include a skilled toolmaker from LaRC (Ron Penner) and went to a small machine shop to fabricate several of our initial prototypes. The bits design was stepped to minimize the normal force necessary to below 5 lbs. We conducted tests using the PGT to verify that we could drill and tap up to a 1-inch hole in RCC with less than 5 lbs normal force (Figure 32). We were also able to design, fabricate, test and flight certify a set of such drill bits in only 7 months time from initial conception (Figure 33). See references [19] and [20] for further details concerning the development of the self-advancing step-tap drill.

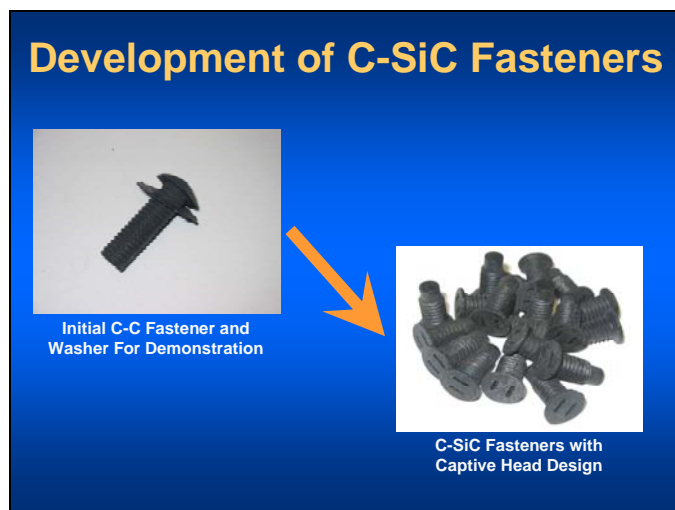
Figure 34. R&D development of C-SiC fasteners to be used alone (to plug small hole damage and/or in conjunction with the small- and large-area repair concepts (SAR and LAR)).

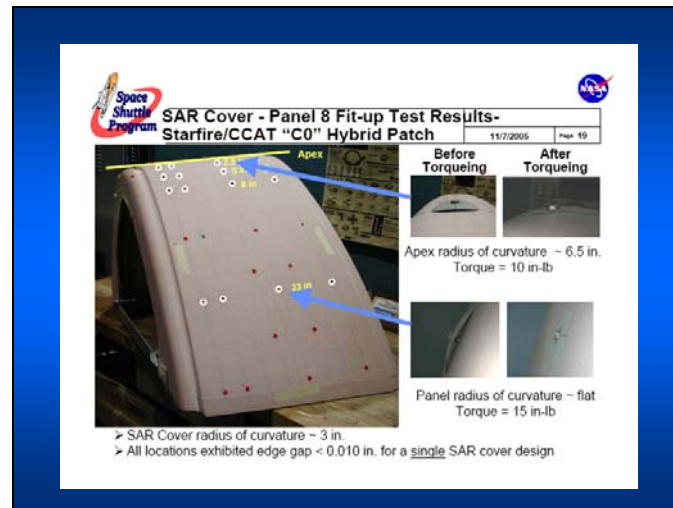
Figure 39. Fit check of the R&D RCC Repair Team's 4-inch diameter doubly curved, C-SiC small area repair (SAR) concept on the most highly curved Orbiter RCC leading edge.

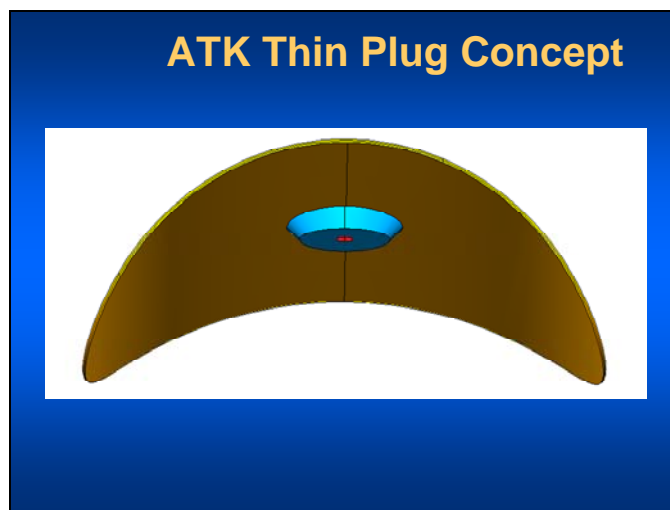
Figure 44. Final design of the “new” ATK Thiokol thin, flexible C-SiC plug for RCC repair.

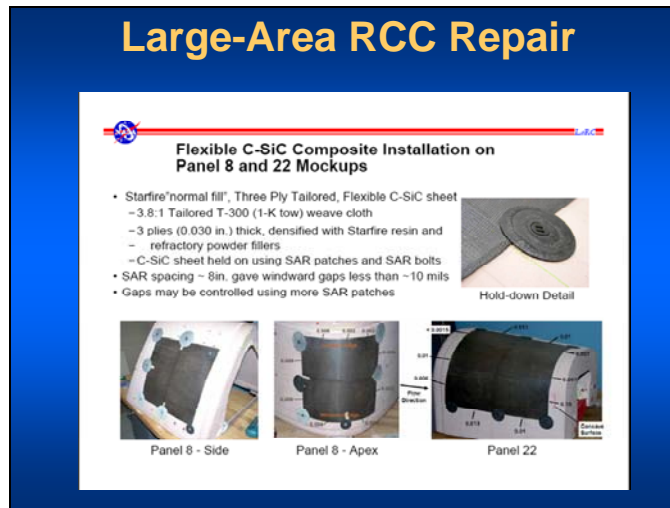
Figure 48. Demonstration of large area repair (LAR) concept and attachment means to repair a RCC wing leading edge.
