NASA/TM-2008-215105

Eddy Current COPV Overwrap and Liner Thickness Measurement System and Data Analysis for 40-Inch Kevlar COPVs SN002 and SN027

Buzz Wincheski
NASA Langley Research Center

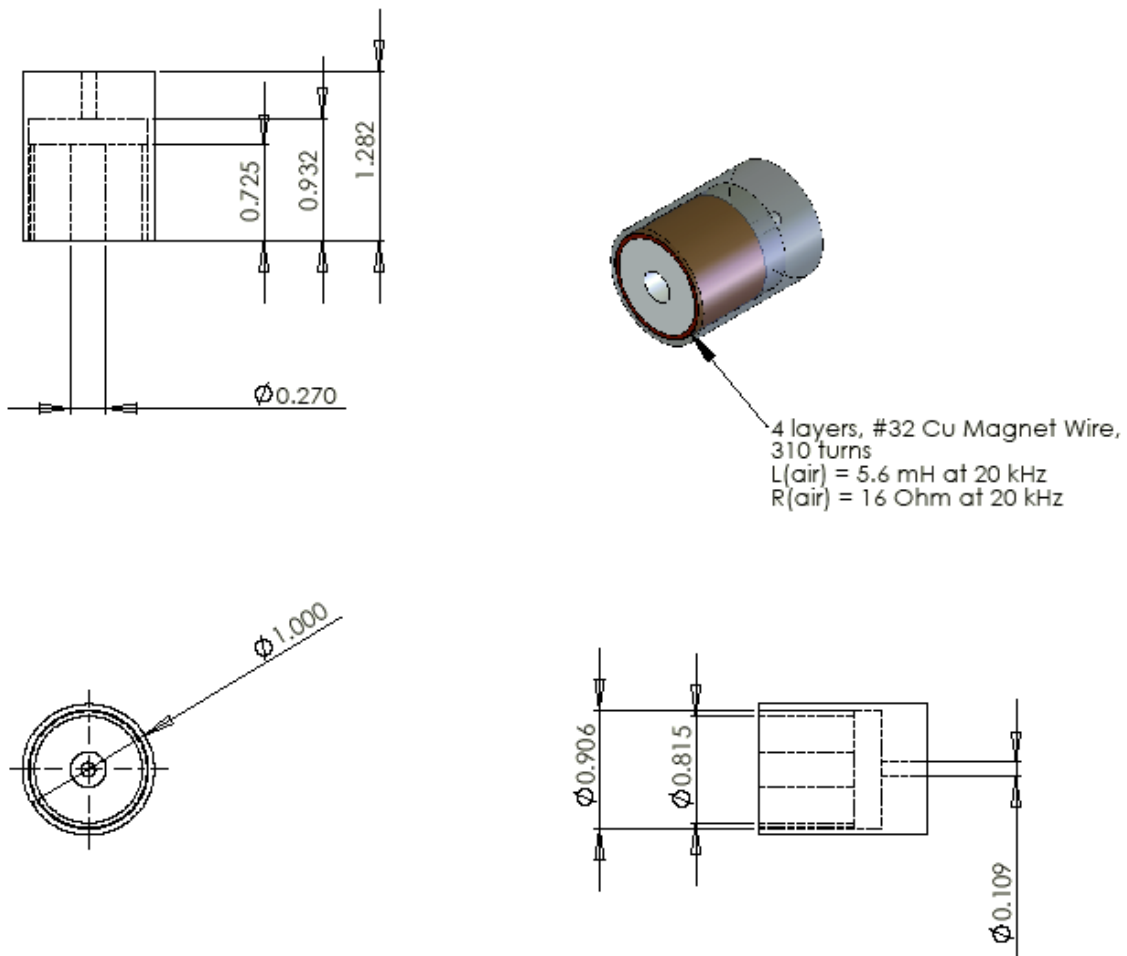
Fig. 1. Eddy current sensor design.

Engineering drawings of the COPV eddy current probe and Eddy current sensor mount designs are given in Figs. 1 and 2. All dimensions are in inches.

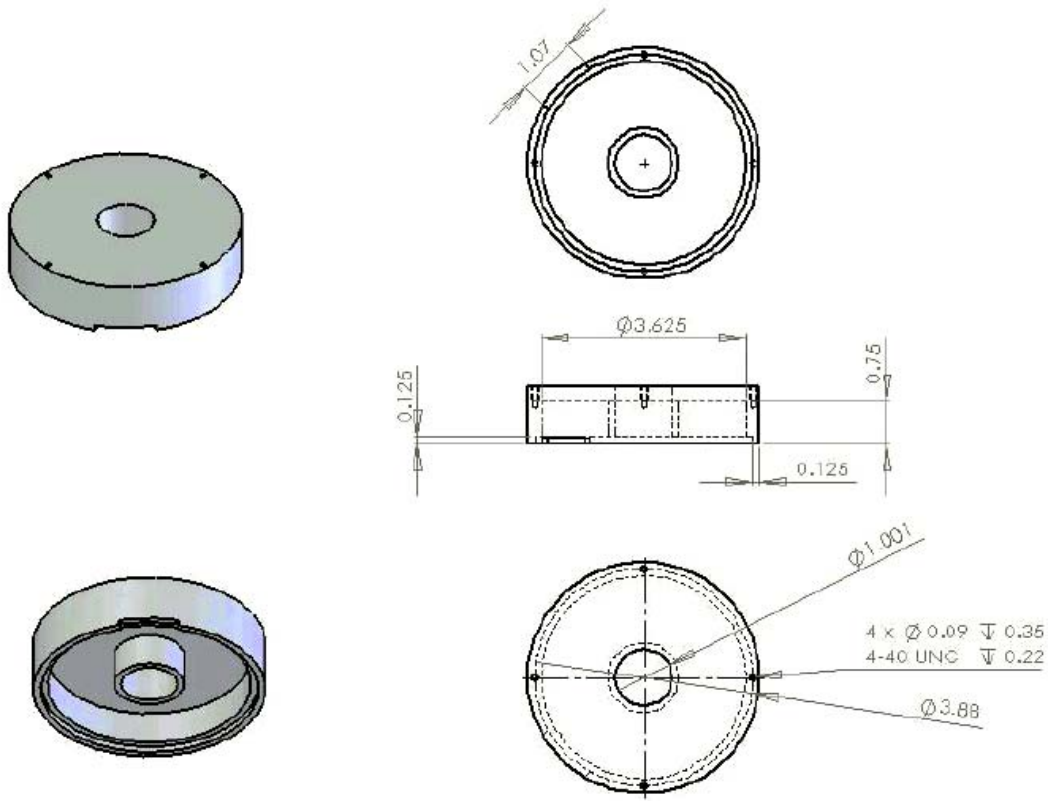
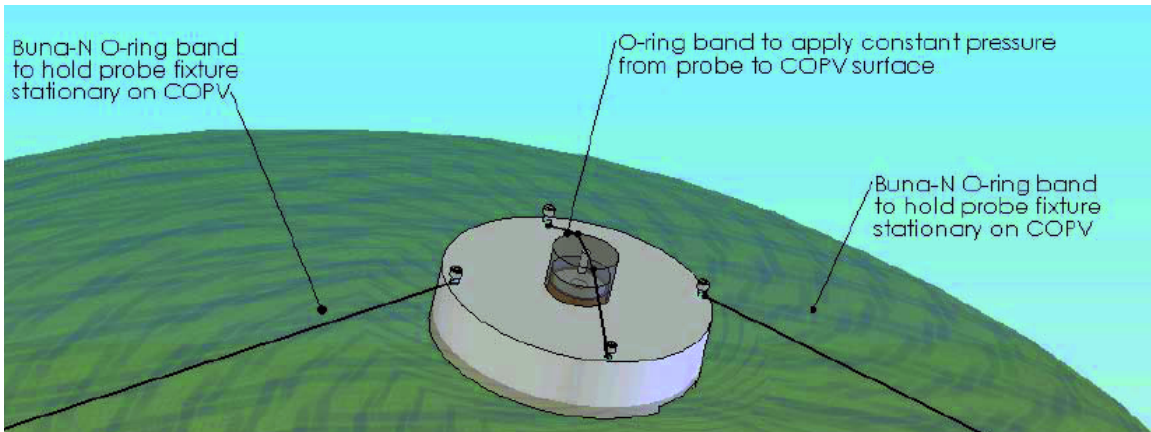
Manufactured From Black Delrin, McMaster Car Part #9986K22
 Mass = 4.5 Oz, 6 Oz with probe installed
 Buna-N and Cork composite shim, 1/16" thick (McMater Car Part # 96165K32),
 placed between part and COPV in three locations to form stable base.

Fig. 2. Eddy current probe mount and sensor mounting configuration.

Following testing and calibration, the eddy current system was transferred to NASA White Sands Test Facility for sensor installation, field calibration, and testing. Eddy current sensors were mounted using the probe mount shown in Fig. 2. A circumferential O-ring was used to hold the probe mount stationary on the COPV and a second O-ring fastened to the probe mount maintained a constant force on the eddy current sensor normal to the COPV surface. The mounting location of the sensors on the COPV is described in WSTF-TP-1085-07.A, “Space Shuttle Orbiter Main Propulsion System P/N MC282-0082-0101 S/N 002 and Orbital Maneuvering System P/N MC282-0082-001 S/N 027 COPV Health Assessment” [1].

As shown in Fig. 2, a small access notch was machined into the probe mount to enable a field calibration of the sensors to changes in the overwrap thickness. Nonconducting shims of 5, 10, 15 and 20 mils were sequentially inserted through this notch and placed between the probe and the outer layer of the COPV overwrap. Fig. 5 displays the field calibration data acquired for sensor 3 mounted on COPV SN002. A large spike in the data is observed as the probe is pulled away from the surface to enable each of the four successive shims to be placed between the probe and the COPV. Each shim was kept in place for approximately 10 seconds before being pulled out. The

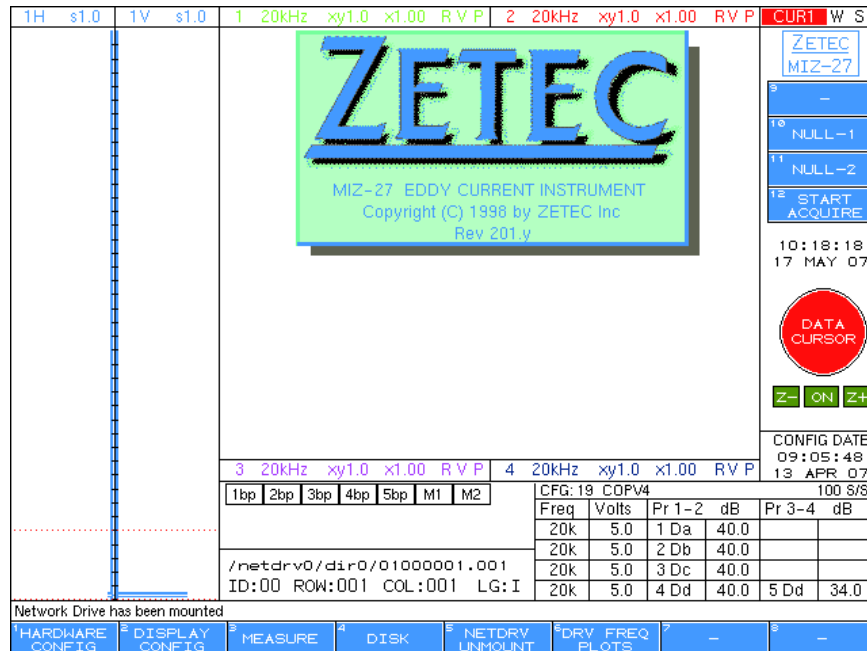
Fig. 3. Front panel of eddy current instrument after startup.

A 20 foot cable connects each of the sensors to the back of the eddy current instrument. The corresponding channel number on the Miz-27 displays the output for each sensor. Cables are labeled at all ends. During testing a 20 kHz, 5.0V drive is supplied to the test coils and a 40dB gain is applied across the measurement bridge. A 34dB gain is used on the trigger channel. All system settings are stored in nonvolatile memory on the Miz-27 instrument. Fig. 3 show the front panel boot up screen of the eddy current instrument. The system is configured to display sensors 1-4 on ‘Page(1)’,

and trigger channel 5 along with sensors 2,3 and 4 on 'Page(2)'. Labeled buttons on the bottom of the instrument are used to change the page being viewed in the display. During data acquisition all five channels of data are stored to mass storage at a rate of 100 Hz.

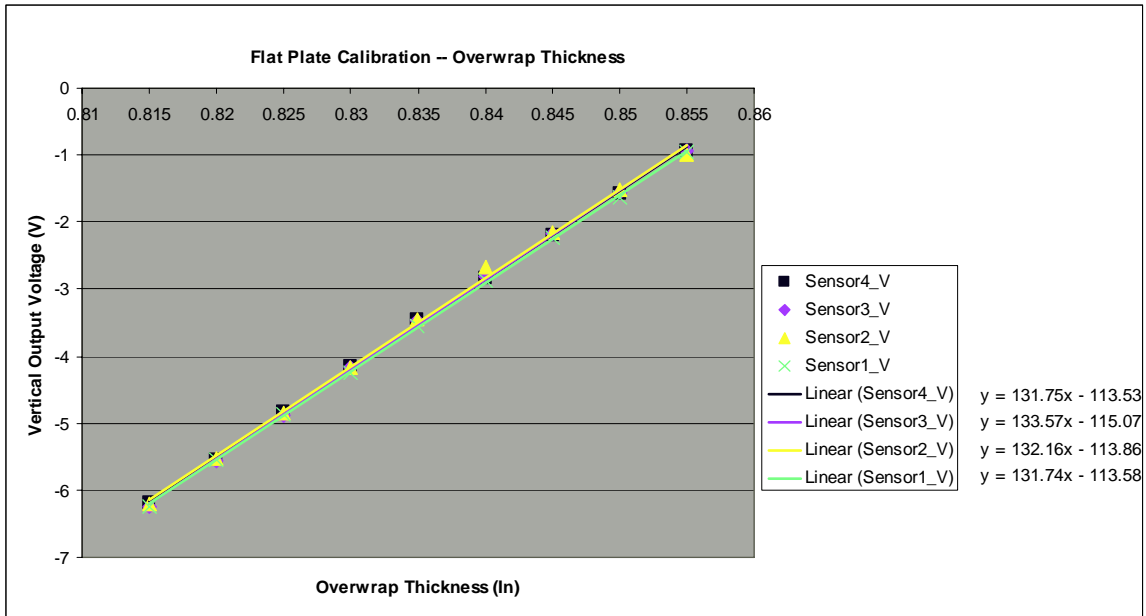
Fig. 4. Laboratory calibration data for system sensitivity to overwrap thickness changes.

A plot of the vertical output voltage of the sensors versus changing stand-off (simulating changes in overwrap thickness) for each of the sensors is given in Fig. 4. A linear fit to the data is also shown in the plot, with the results indicating a sensitivity of approximately 130 mV/mil for each of the sensors.

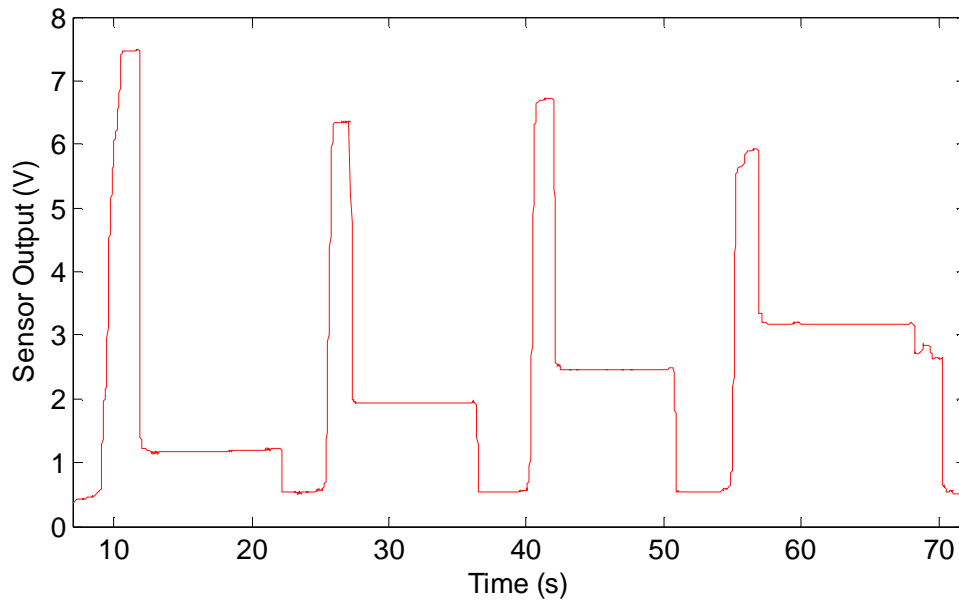
Fig. 5. Field calibration data for sensor 3 mounted on COPV SN002. Data corresponds to 5,10,15 and 20 mil shims placed between COPV and sensor at approximately 10, 25, 40, and 55 seconds.

resulting drop in voltage for each shim thickness was measured and the calibration factor determined by fitting a straight line to the output voltage versus shim thickness plots. Table 2 lists the calculated calibration factors for each sensor mounted on both COPV SNs 002 and 027.

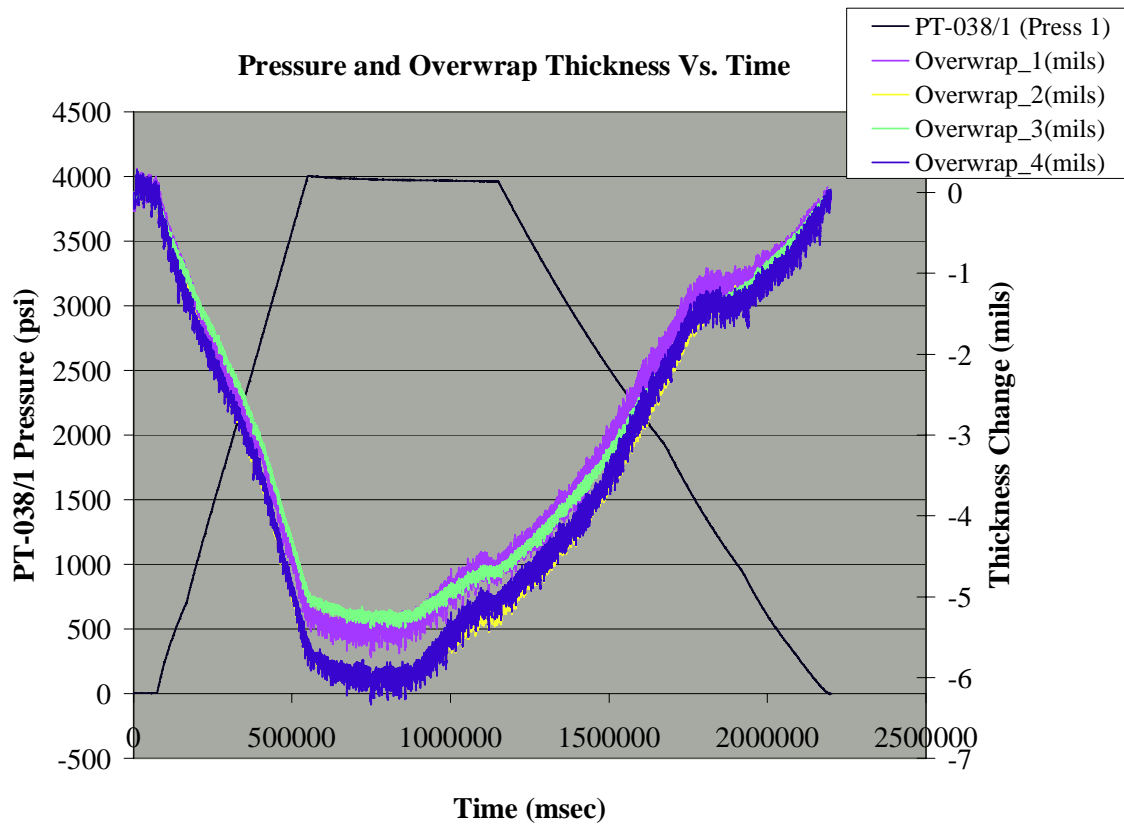
Fig. 6. Measured pressure and overwrap thickness change for COPV SN002.

Figs. 6 and 8 display the measured overwrap thickness changes and pressurization as a function of time for COPV SNs 002 and 027 respectively. Figs. 7 and 9 display the overwrap thickness changes versus pressurization for these data sets. Both sets of data

have been corrected for an assumed linear drift of the eddy current sensor data between the trigger signal and the end of the pressure cycle. A second correction has also been applied to account for the effect of cyclic temperature variations on the eddy current sensor response. The coefficients for this second correction were determined from the response of the trigger channel, sensor 5. This channel consisted of an equivalent eddy current sensor not in contact with the COPV. Upon initiation of the pressurization cycle a momentary change in impedance is applied to sensor 5 through the use of a timing circuit. In this circuit, a 5V, 25mA signal is used to switch in an extra load to the matching network to produce a timing mark in the data file. Post processing of the data is used to identify this signal and synchronize eddy current data with pressurization data. As the sensor is not in contact with the COPV, data acquired during the remainder of the test can be analyzed to remove environmental effects from the data not associated with changes in the COPV.

The eddy current sensor data is seen to correlate very well with the pressurization data, with all sensors showing a similar response. For COPV SN002, the thickness change at maximum pressure is slightly over 5 mils for sensors 1 and 3, and about 6 mils for sensors 2 and 4. The data recorded for SN027 shows maximum thickness changes near 5 mils for each sensor. The overwrap thickness change versus pressure plots, Figs. 7 and 9, display a linear response with no apparent hysteresis in the data. Although temperature effects have been filtered as described above, a slight cyclic periodicity to the data can still be observed and is presumed to be due to temperature change artifacts.

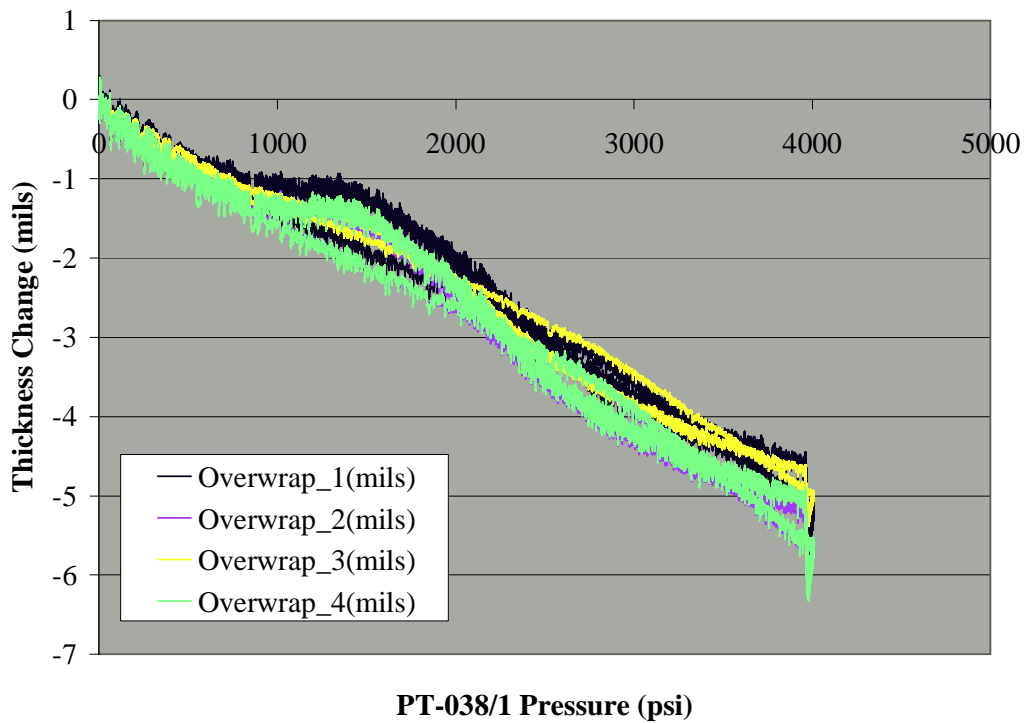
Fig. 7. COPV SN002 overwrap thickness change versus pressure.

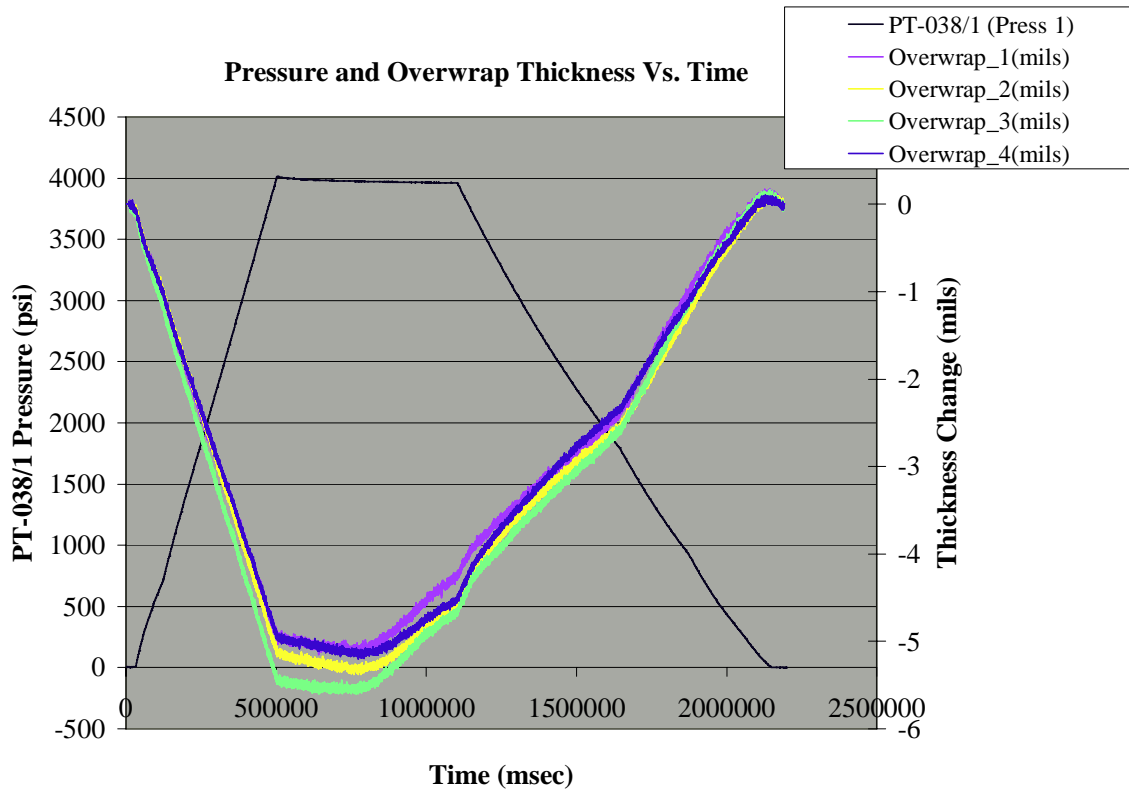
Fig. 8. Measured pressure and overwrap thickness change for COPV SN027.

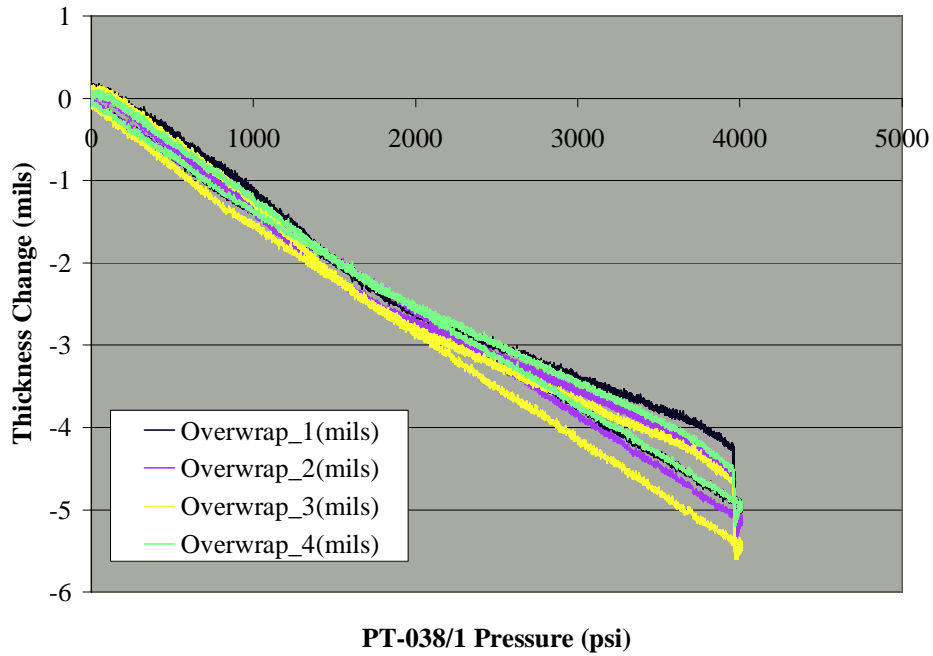
Fig. 9. COPV SN027 overwrap thickness change versus pressure.

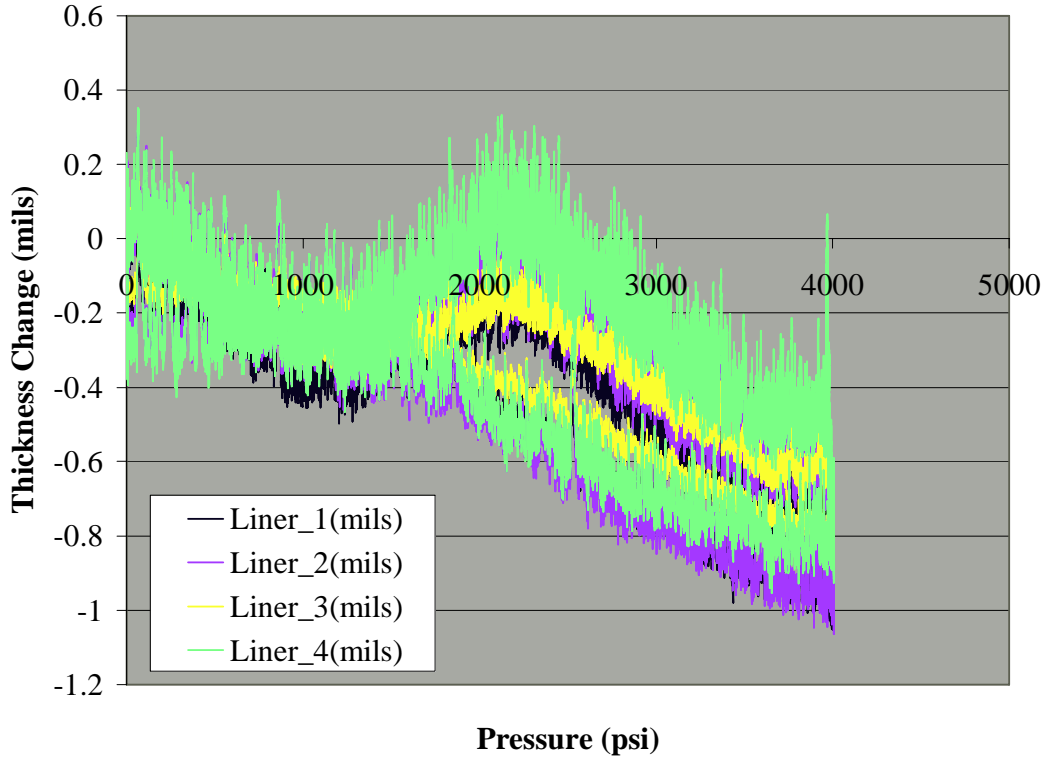
Fig. 10. COPV SN002 liner thickness change versus pressure.

Figs. 10 and 11 display the measured change in liner thickness versus pressure for COPV SNs 002 and 027 respectively. The much smaller thickness changes, < 1 mil, result in a lower signal to noise ratio for these measurements. In addition, the processing steps used to remove the cyclic temperature variations were seen to increase the high frequency noise on the horizontal (liner thickness) channel of the eddy current instrument. A clear trend of decreasing liner thickness with increasing pressure is nonetheless observed in the data for each vessel.

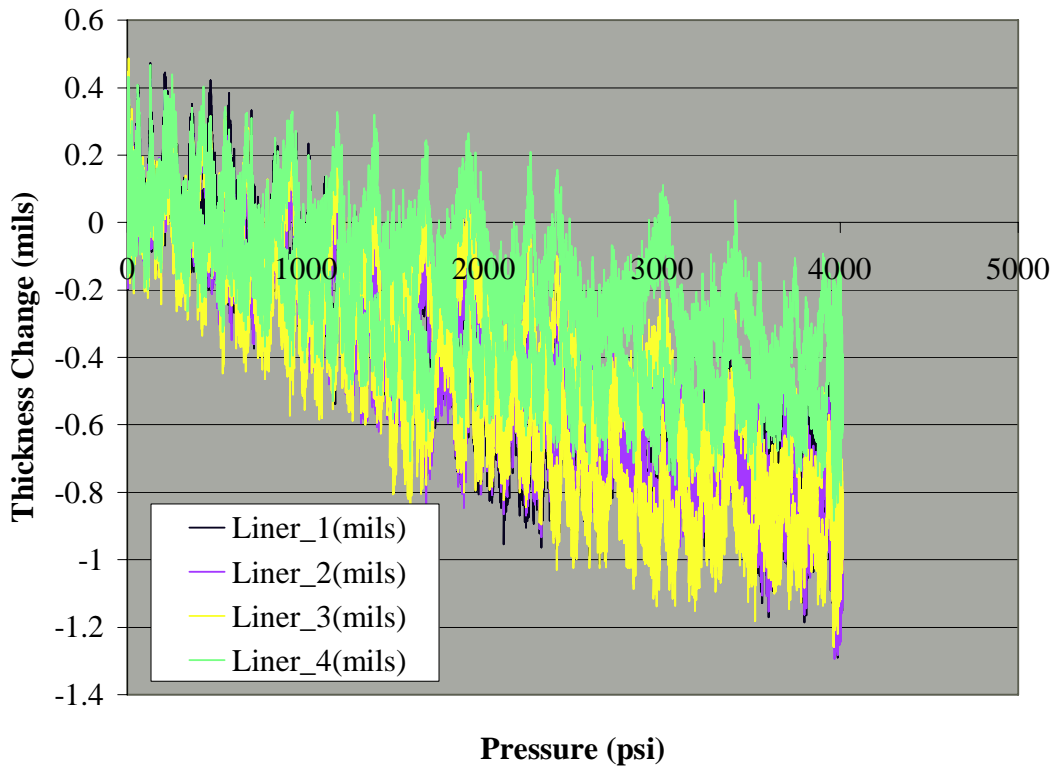
Fig. 11. COPV SN027 liner thickness change versus pressure.
